# Ecological Impact Assessment

Stables and yard

Lagonda Stud, Pottersheath, Welwyn, AL6 9SU

Report No: 3303

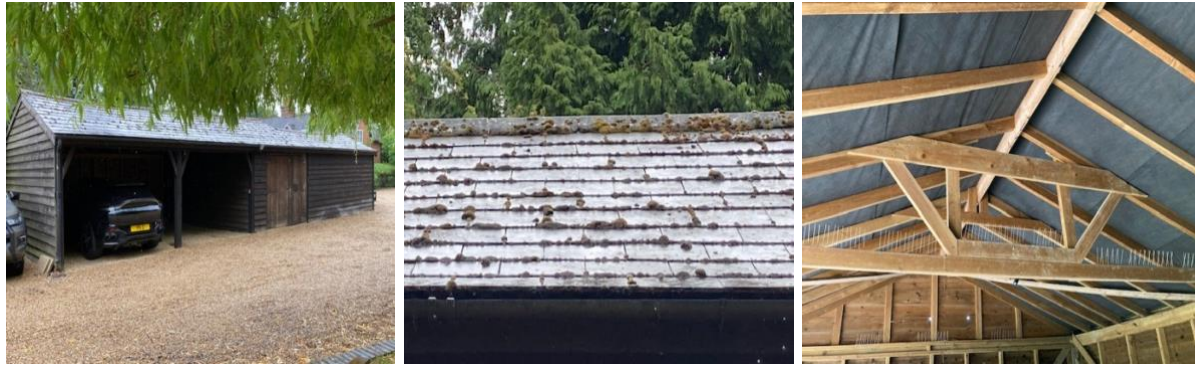
*Figure 3-6 Building G - Garage Block*

The roof is pitched and there is no loft void present. The roof covering is in excellent condition, and the roof is lined with a modern plastic membrane. The central ridge beam is narrow, and the rafters are all modern sawn timbers with no open mortise joints.

The walls are wooden and single-skinned, providing no suitable cavities for roosting.

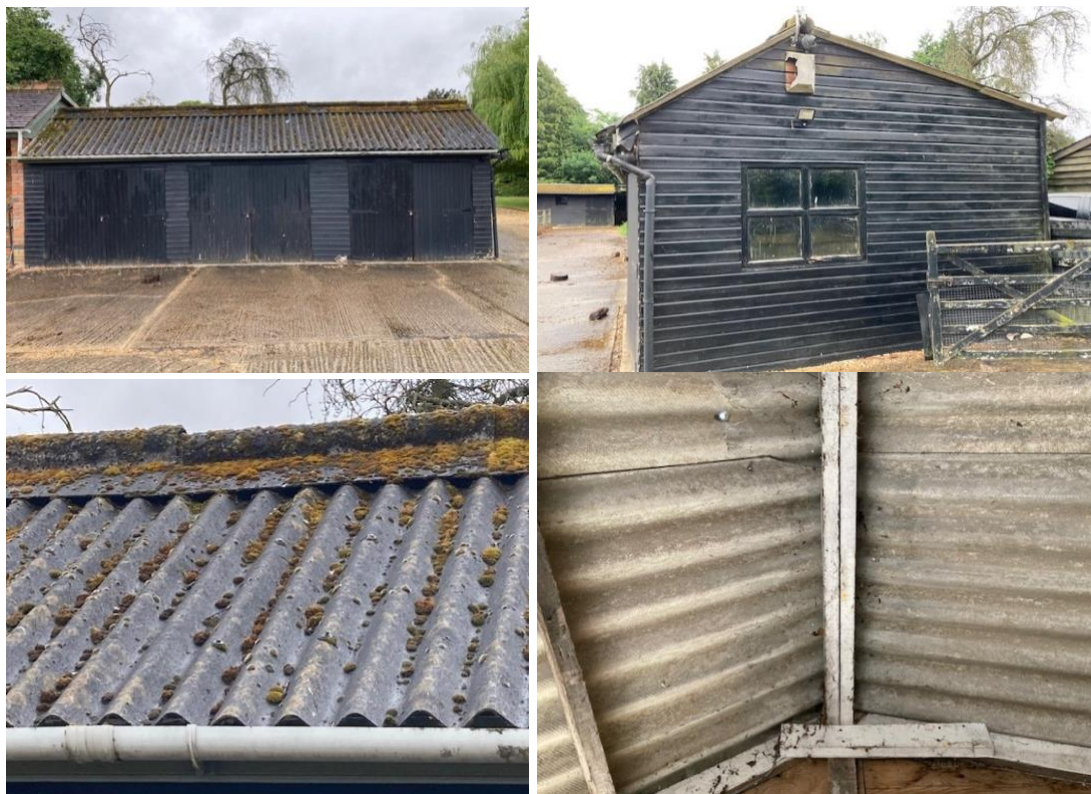
*Figure 3-7 Building A*

This building directly adjoins Building B and has an unlined, pitched corrugated asbestos roof, that appears to be in excellent condition. The central ridge and all rafters are narrow with no suitable crevices for bats to utilise as roost locations. There is no loft void, and the interior is well-lit by several windows. The walls are wooden and single-skinned, providing no suitable cavities for roosting.

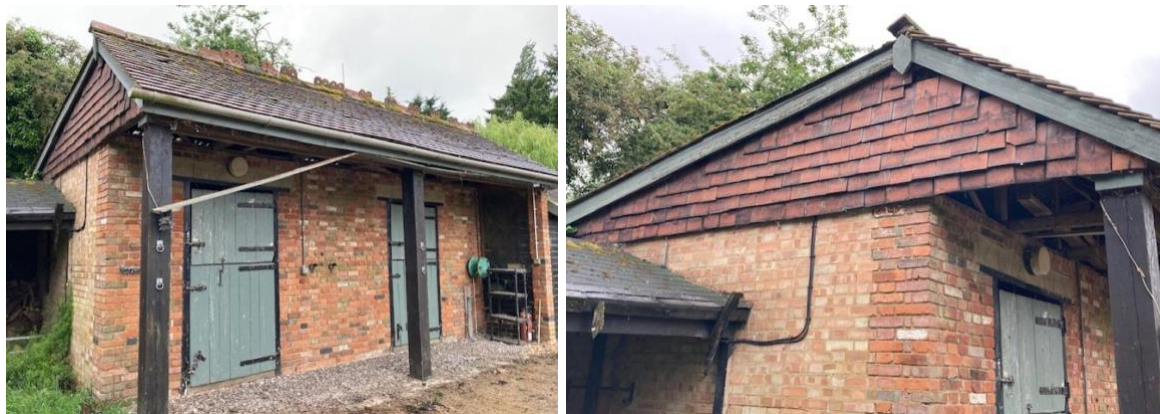
Figure 3-8 Building B-Double Stable Unit

This small outbuilding is a double stable unit which directly adjoins Buildings B and C. It has an asymmetrical pitched, unlined corrugated asbestos roof to the rear, a tiled elevation to the front and a hung tile section on the side elevation. There is open access to the interior of the building which is extensively used by pigeons. The walls are brick and single-skinned, providing no suitable cavities for roosting. The tiled sections are timber lined.

Building B has low potential for roosting bats due to the presence of hung tile and the occasional missing roof tile, both of which are timber lined, providing a potential cavity for bats beneath. No other suitable roosting features were identified on or within the building.

Building B has low potential for roosting bats; therefore, it is recommended that a **single** dusk emergence survey be carried out, with **two** surveyors to cover the building (Note: The Emergence Survey was undertaken on 8/7/2025).

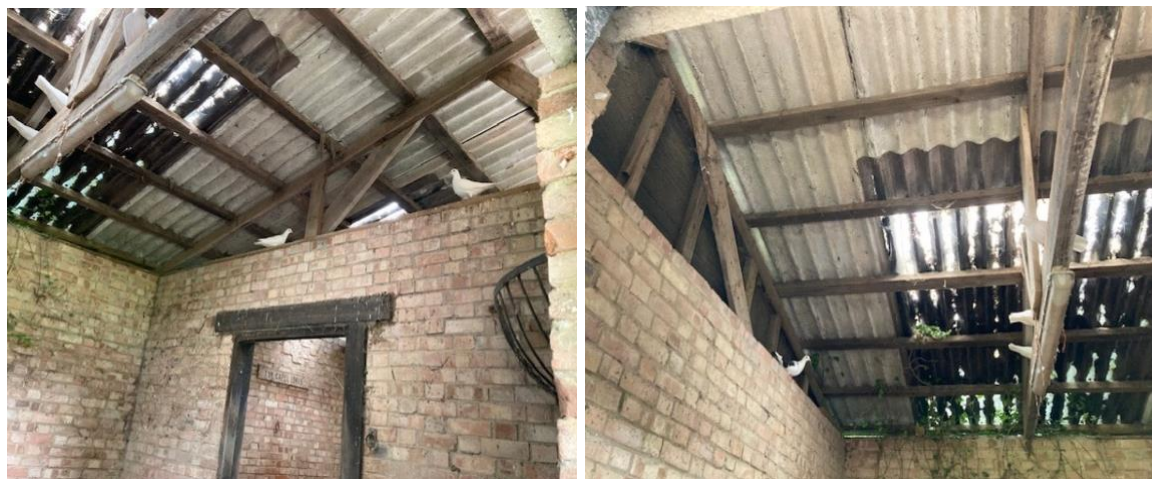
Figure 3-9 Interior of Building B

Other than pigeons/doves which have taken over building B there was no evidence of nesting birds within any of the buildings on site and no disused or active birds' nests were found.

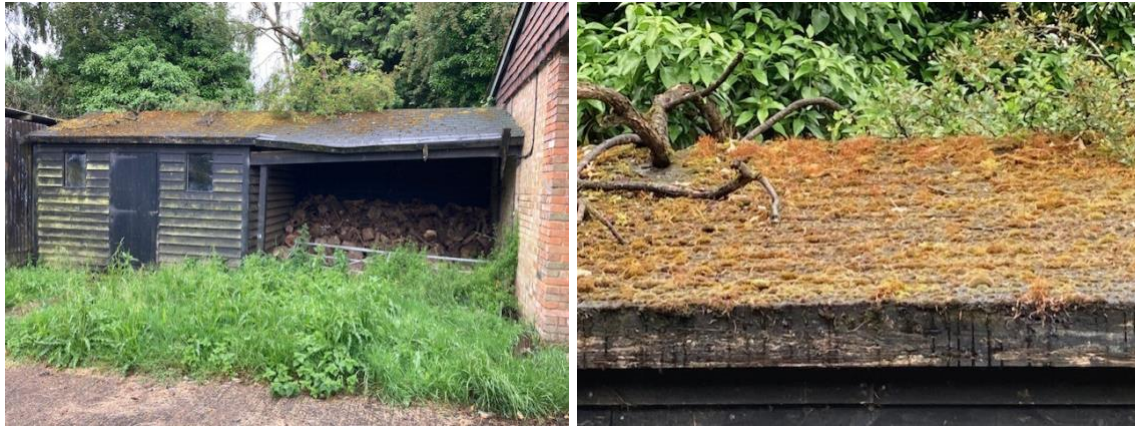
*Figure 3-10 Building C- Outbuilding*

This small outbuilding adjoins Buildings B and D and is divided into an open-fronted wood store and a closed storage unit with two windows. It has a pitched, felt sheet roof that is timber lined. The rafters are of modern-sawn timbers with a narrow central ridge beam and no open mortise joints are present. The walls are wooden and single-skinned, also providing no suitable cavities for roosting bats.

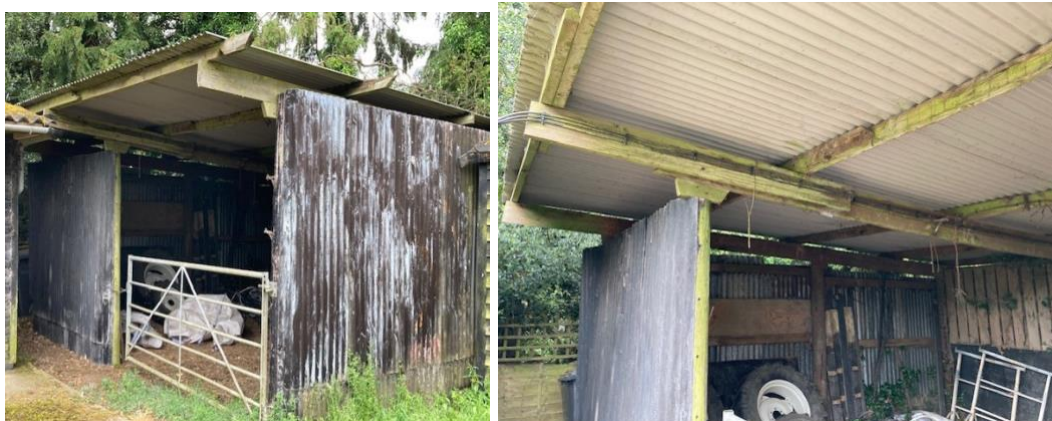
*Figure 3-12 Building D*

This small outbuilding, adjacent to Building C has a sloping corrugated iron roof that is unlined and supported by modern-sawn timbers.

The structure is open along most of the front elevation, providing an interior that is both well-lit and draughty, with extensive cobwebs. The walls are a mix of corrugated iron and single-skin wooden panelling.

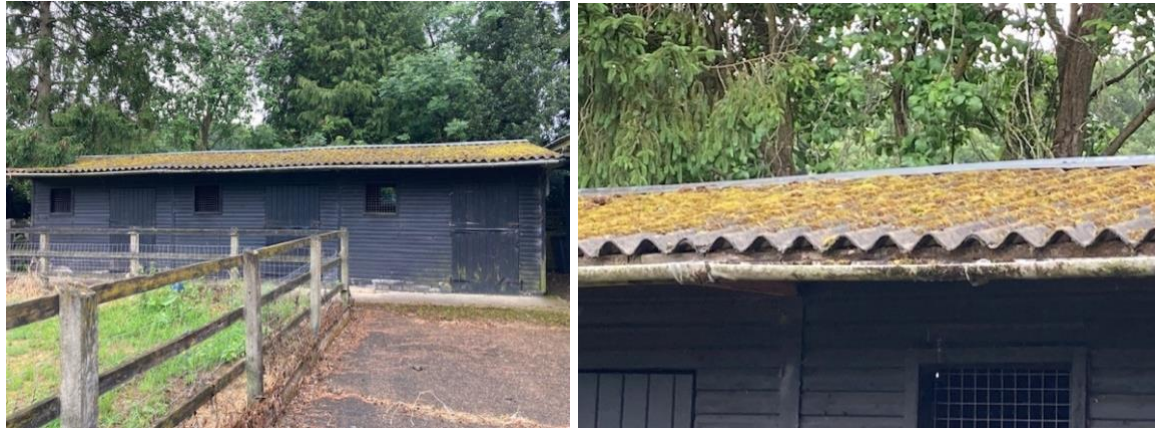
*Figure 3-13 Building E*

sawn timbers, with only a narrow central ridge beam, and no open mortise joints are present.

The walls are wooden and single-skinned, providing no suitable cavities for roosting.

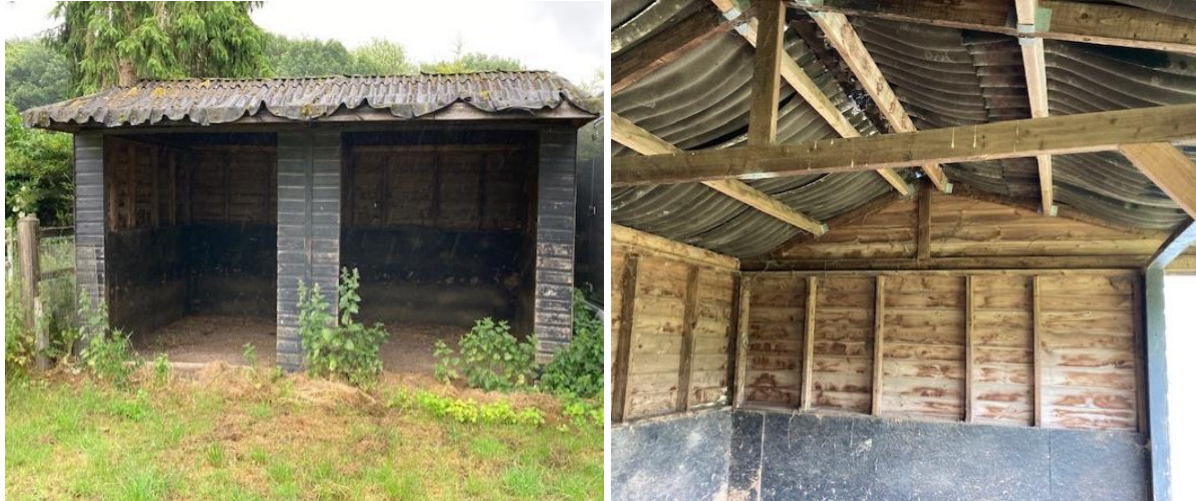
*Figure 3-15 Building F Exterior and Interior*

The structure is open sided on the front elevation, and the interior is well-lit and draughty. The walls are wooden and single-skinned, providing no suitable cavities for roosting.

The rafters are of modern-sawn timbers, with no central ridge beam, and no open mortise joints are present.

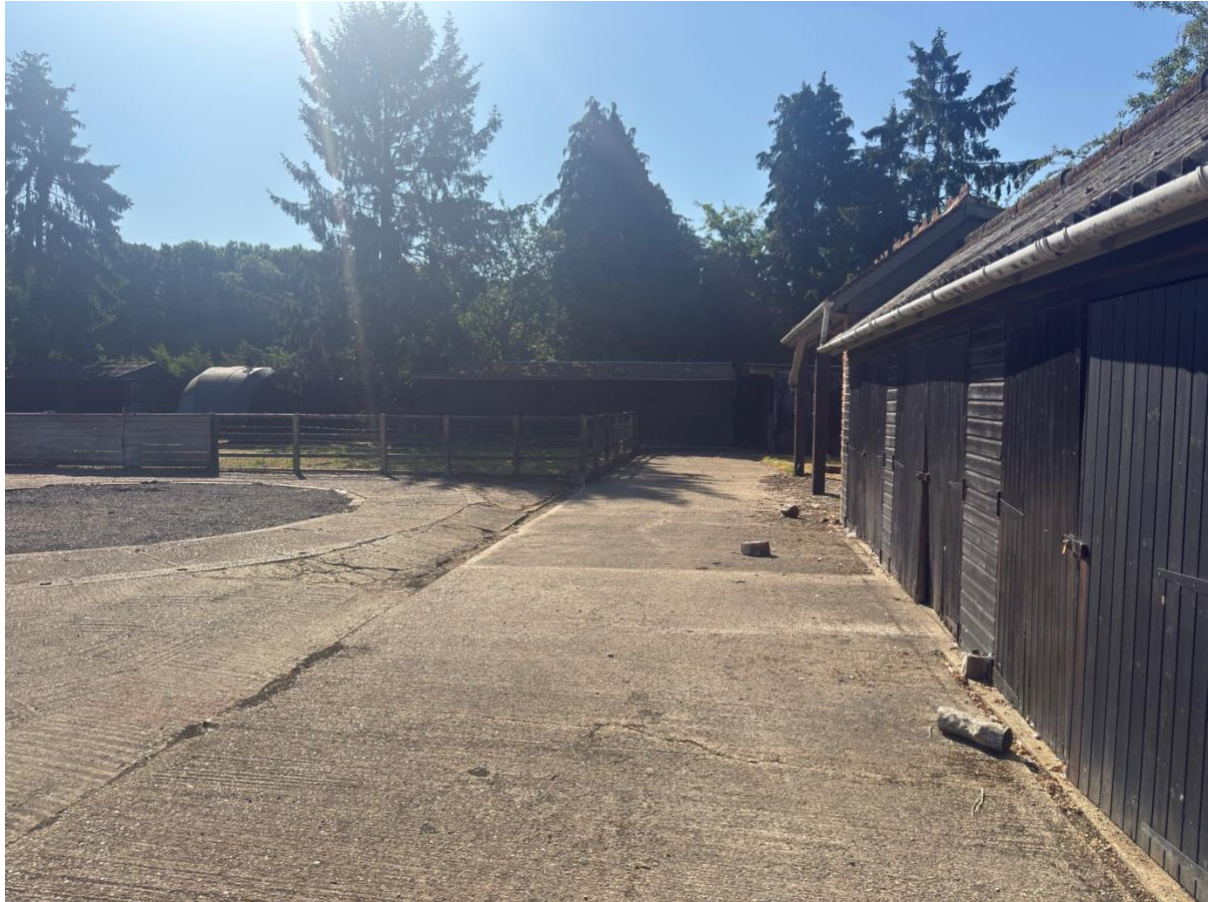
Entrance to the proposed development site is via the existing gravelled drive from Pottersheath Road, this extends along the front of the stable block and includes concrete paths and yard.

*Figure 3-16 Hard standing in front of the stable buildings A-D*

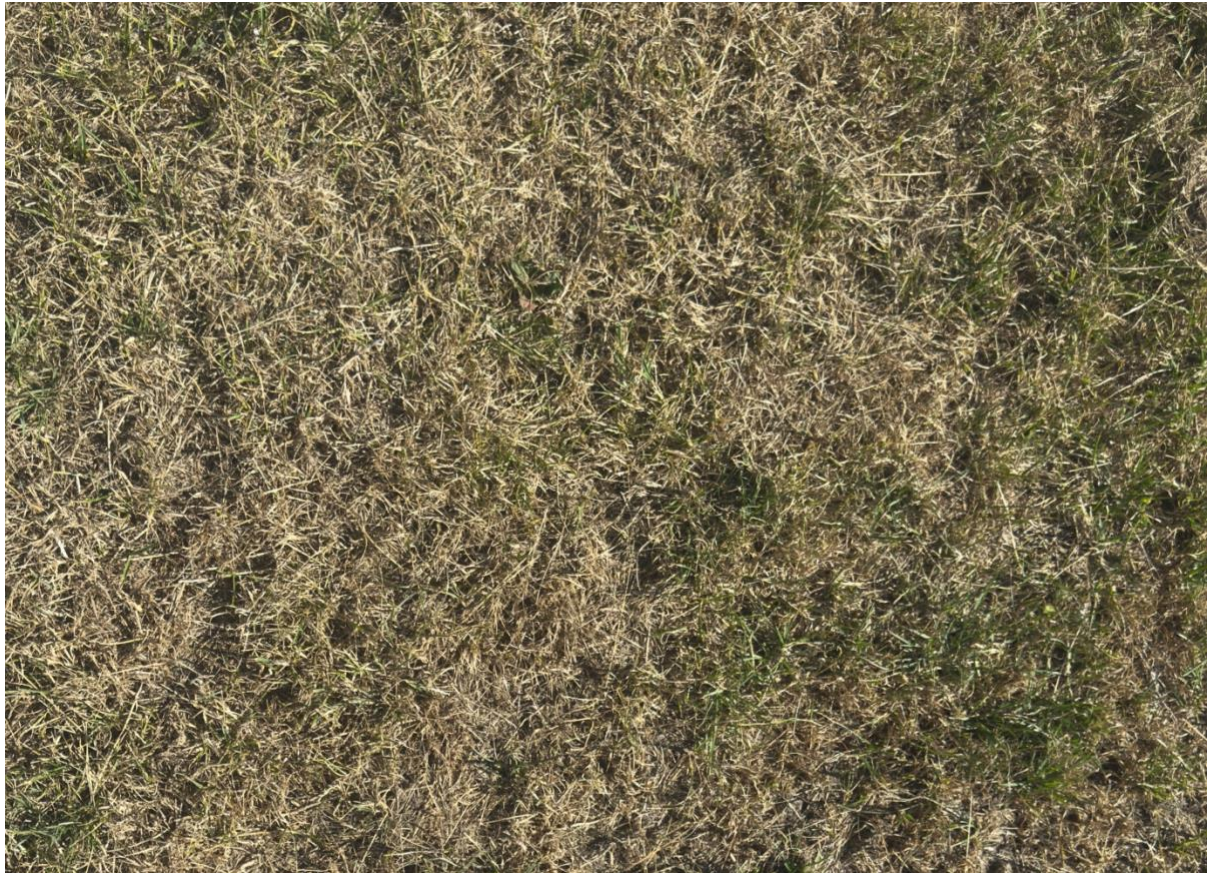
A small area of paddock is included within the red line boundary. Species present are almost exclusively perennial ryegrass and occasional cock's-foot, no forb species were present.

*Figure 3-17 Closely mown modified grassland found in the paddock area*

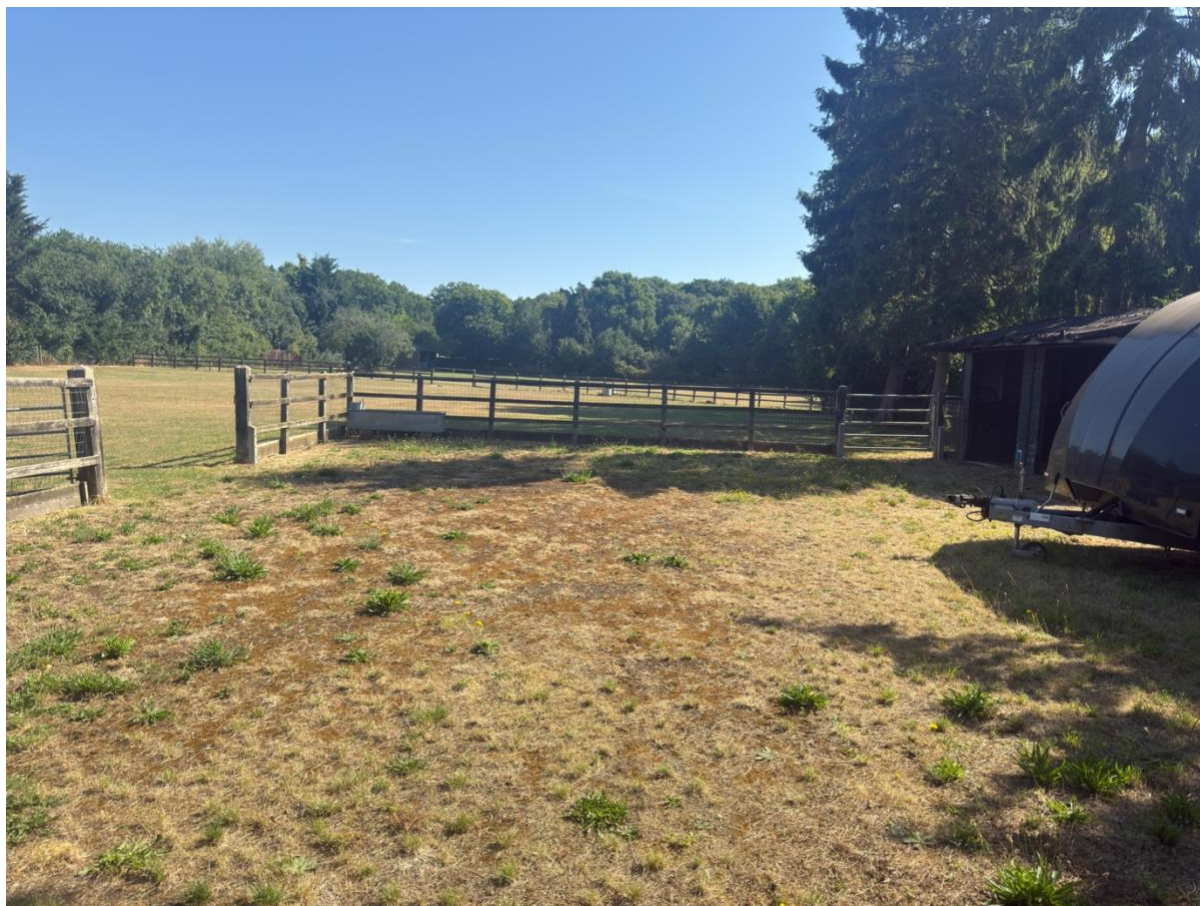
A disused ménage is also present. This was once a crushed and compressed cinder-based substrate which is now deteriorating with approx. 70% ruderal/ephemeral species cover. Of quadrats taken, there were no more than five species per m<sup>2</sup>.

*Figure 3-18 Vegetated menage*

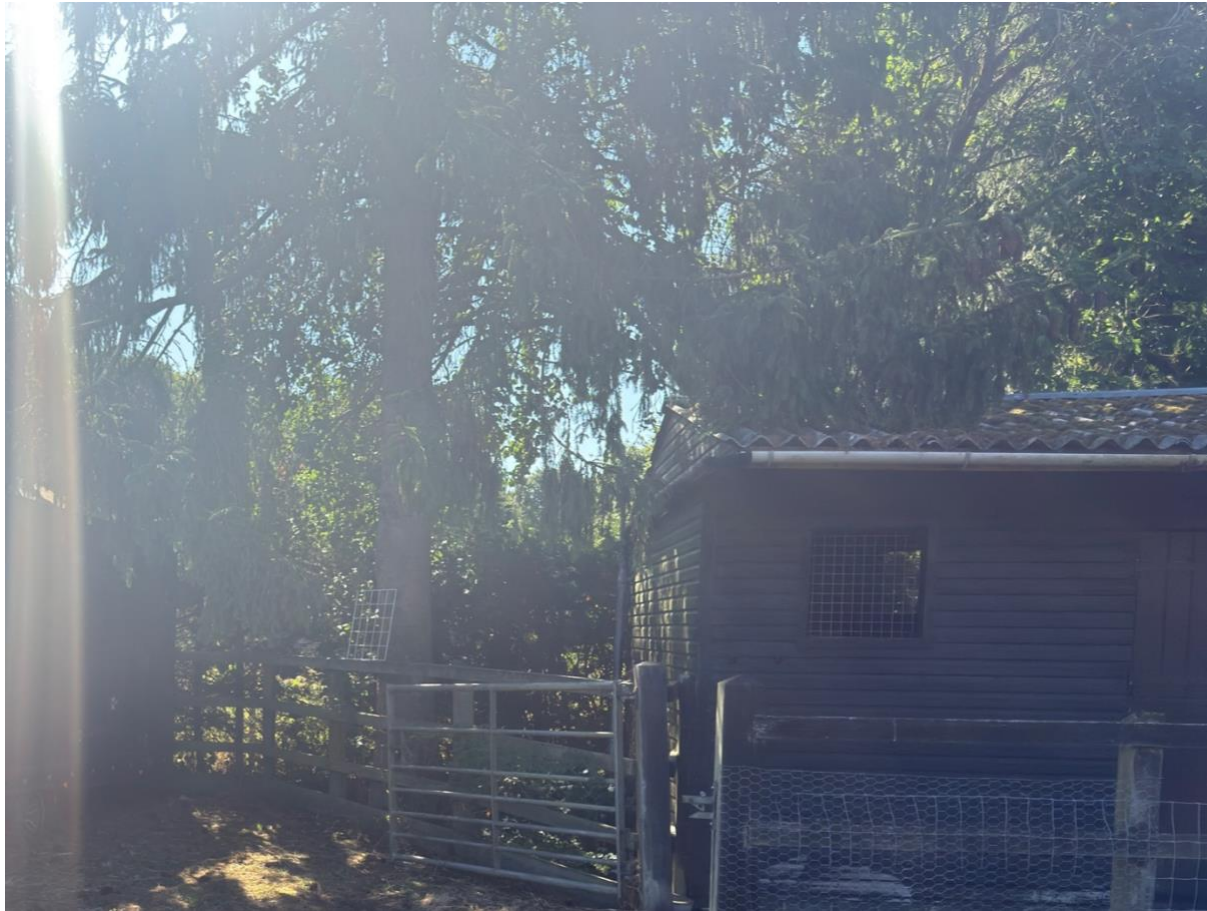
A small Norway spruce is located between the menage and Building E, over a patch of grassland within a small fenced off section, two further small trees are located adjacent to the boundary behind Building D and three further small trees are located along the eastern boundary of the paddock.

*Figure 3-19 Norway spruce on site*

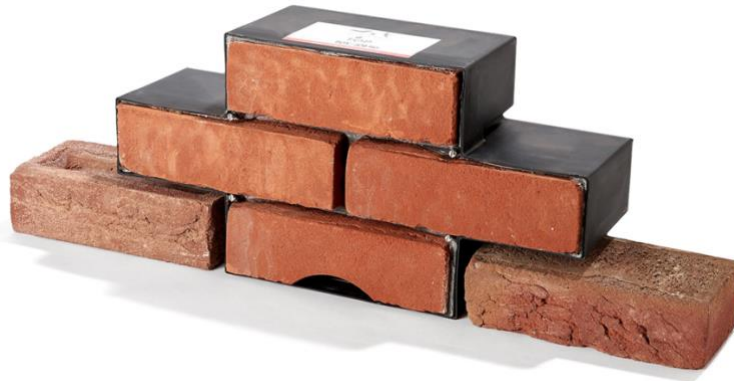
Example of built in bat box ([Bird Brick Houses](#))

It is recommended that two integrated bat boxes be installed within the new building. Ideally, these should face southeast/southwest and be no less than 3m above ground level. These require no maintenance and can be faced in any material for aesthetic purposes.
