# ARBORICULTURAL IMPACT ASSESSMENT

(INC. TREE SURVEY TO BS 5837:2012)

PROJECT - The Ruddery, Ashwell

DOC. REF - P5515-AIA01 V2

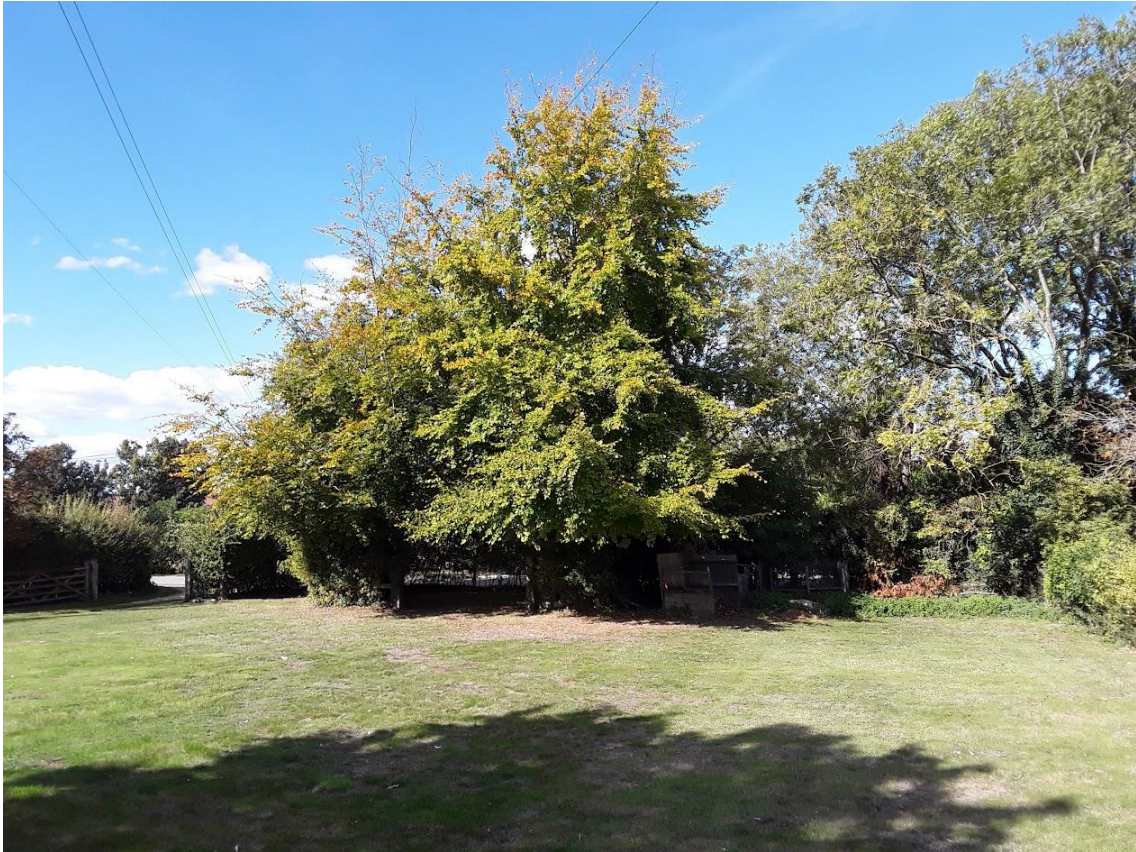
*Figure 1 – Looking northwards at T26 and T27 and the area for the proposed new garage.*

The excavation and installation of the garage foundations has the potential to result in significant RPA incursions to T26 and T27 if standard trench foundations were to be used.

Owing to the size of the potential incursions, specialist low impact foundations will need to be used when within an RPA so as to minimise root damage. Suitable options include (a) micro piles, (b) screw piles, (c) small concrete pad foundations.

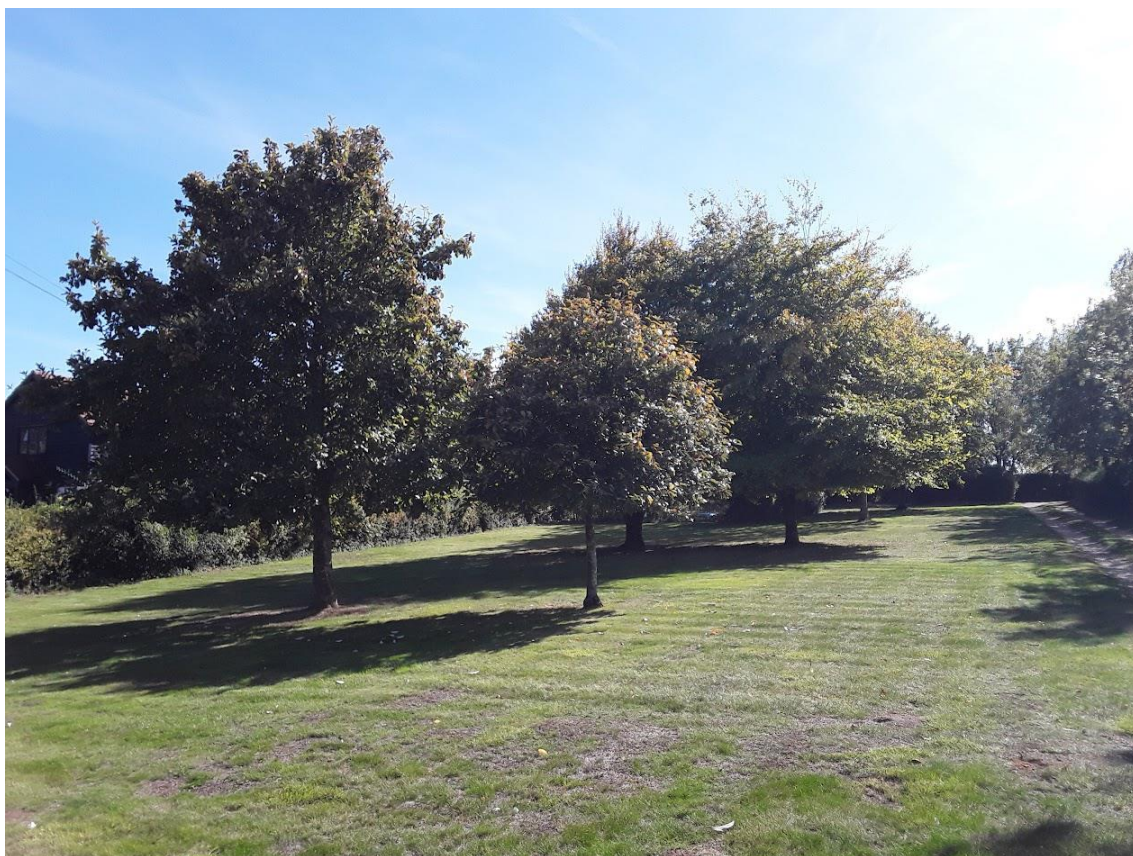
*Figure 2 – Looking southwards towards T21-T23.*

4 trees (T20, T21, T23, T28) of category 'B' value are to be removed. Owing to their moderate value, mitigation tree planting should be incorporated into the landscaping of the site (see mitigation requirements below).

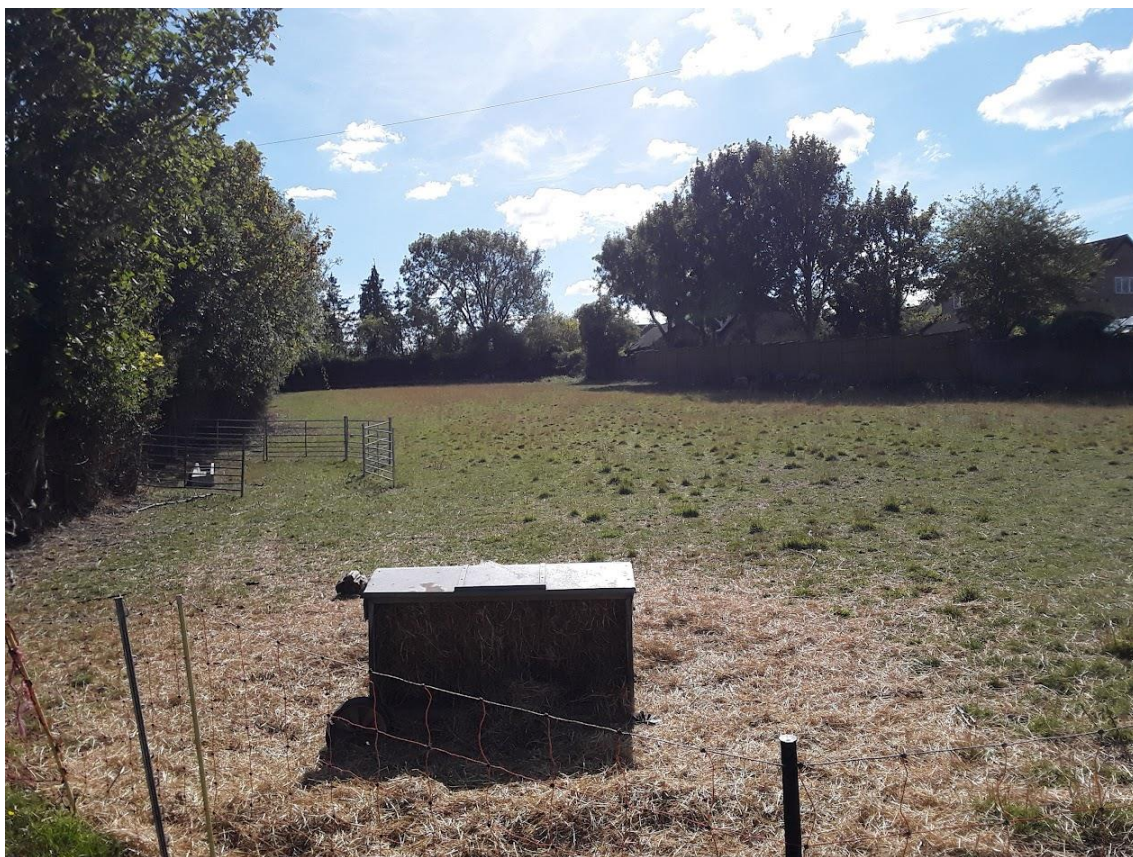
*Figure 3 – Looking southwards towards the location for Plot 1 and Plot 2.*

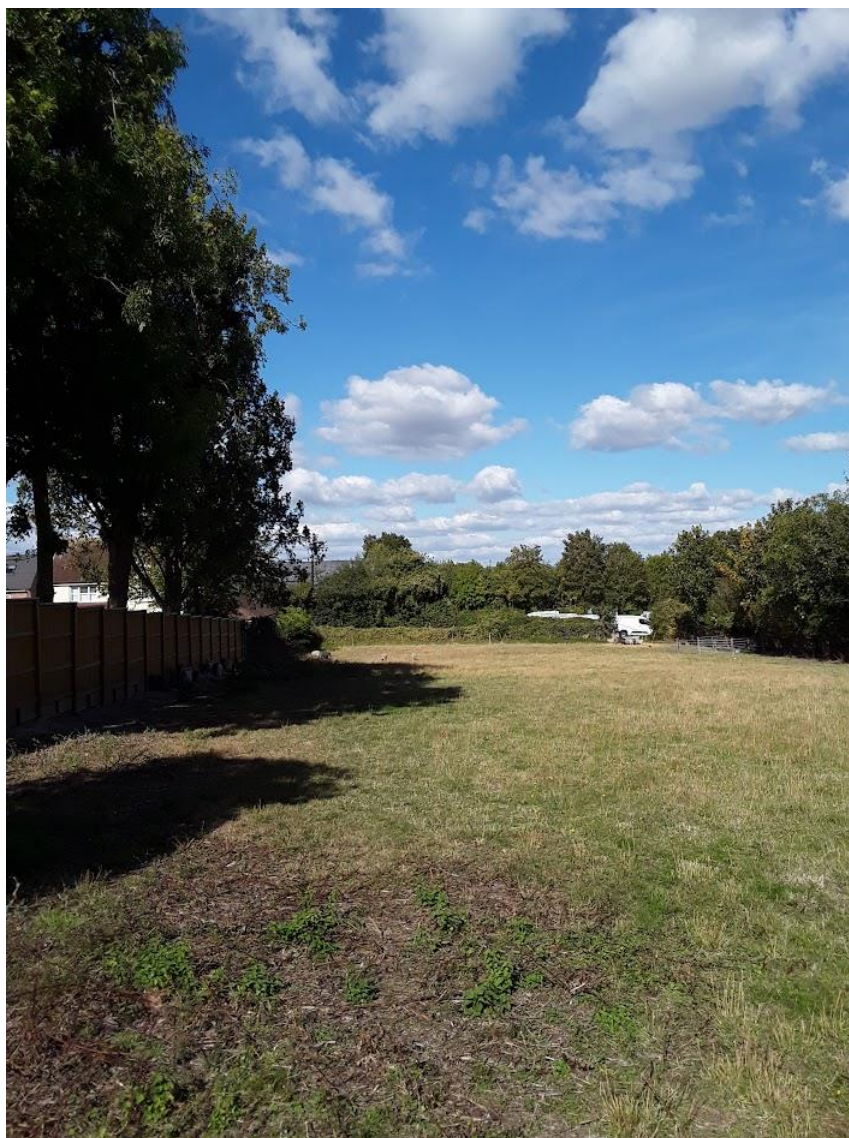
*Figure 4 – Looking northwards at T1-T7 and the area for the proposed new driveway.*

- T1 (C1) - Crown lift overhanging tertiary branches and tips to provide 4.5m clearance with the ground.
- T3 (B1) - Crown lift overhanging tertiary branches and tips to provide 4.5m clearance with the ground.
- T4 (B1) - Crown lift overhanging tertiary branches and tips to provide 4.5m clearance with the ground.
- T5 (B1) - Crown lift overhanging tertiary branches and tips to provide 4.5m clearance with the ground.
- T6 (B1) - Crown lift overhanging tertiary branches and tips to provide 4.5m clearance with the ground.
- T7 (B1) - Crown lift overhanging tertiary branches and tips to provide 4.5m clearance with the ground.
- T26 (B1) - Crown lift tertiary branches and tips to provide 4.5m clearance with the ground.
- T27 (B3) - Crown lift tertiary branches and tips to provide 4.5m clearance with the ground.
- G2 (B1) - Reduce western crown by ~1.5m

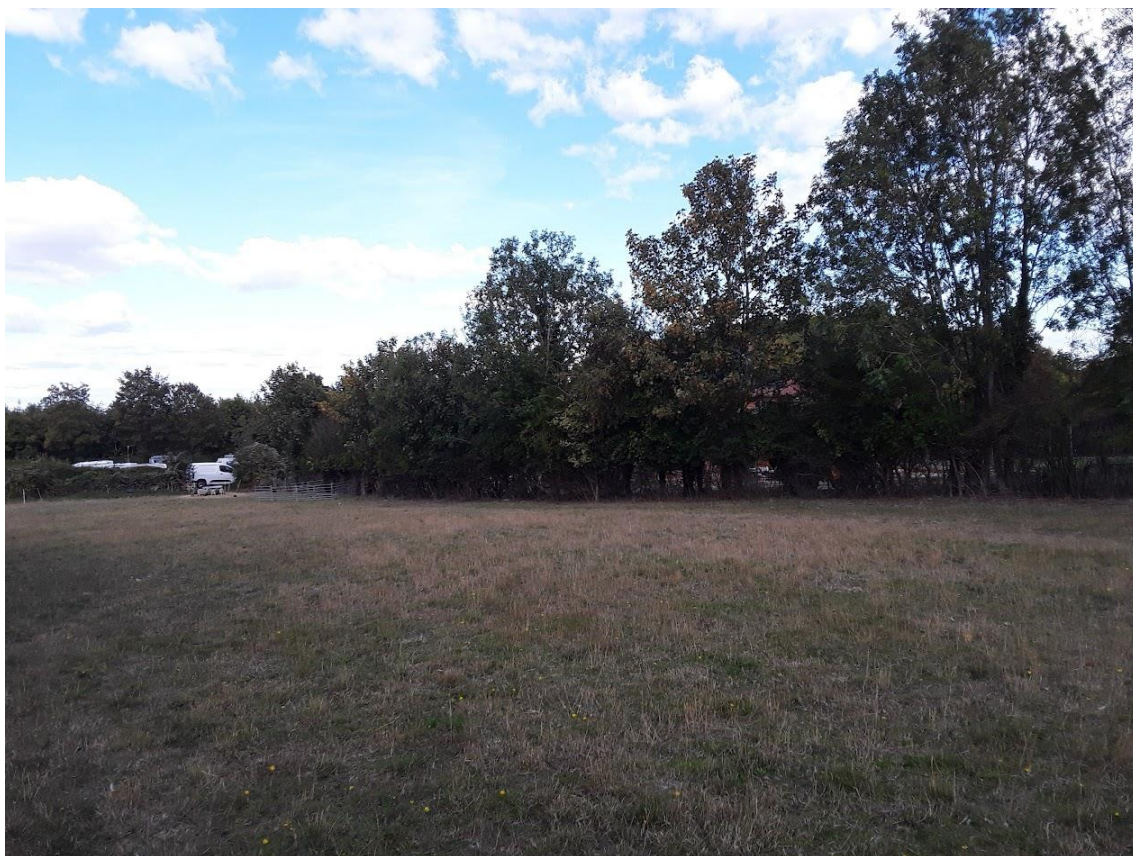
*Figure 5 – Looking north eastwards at G2.*

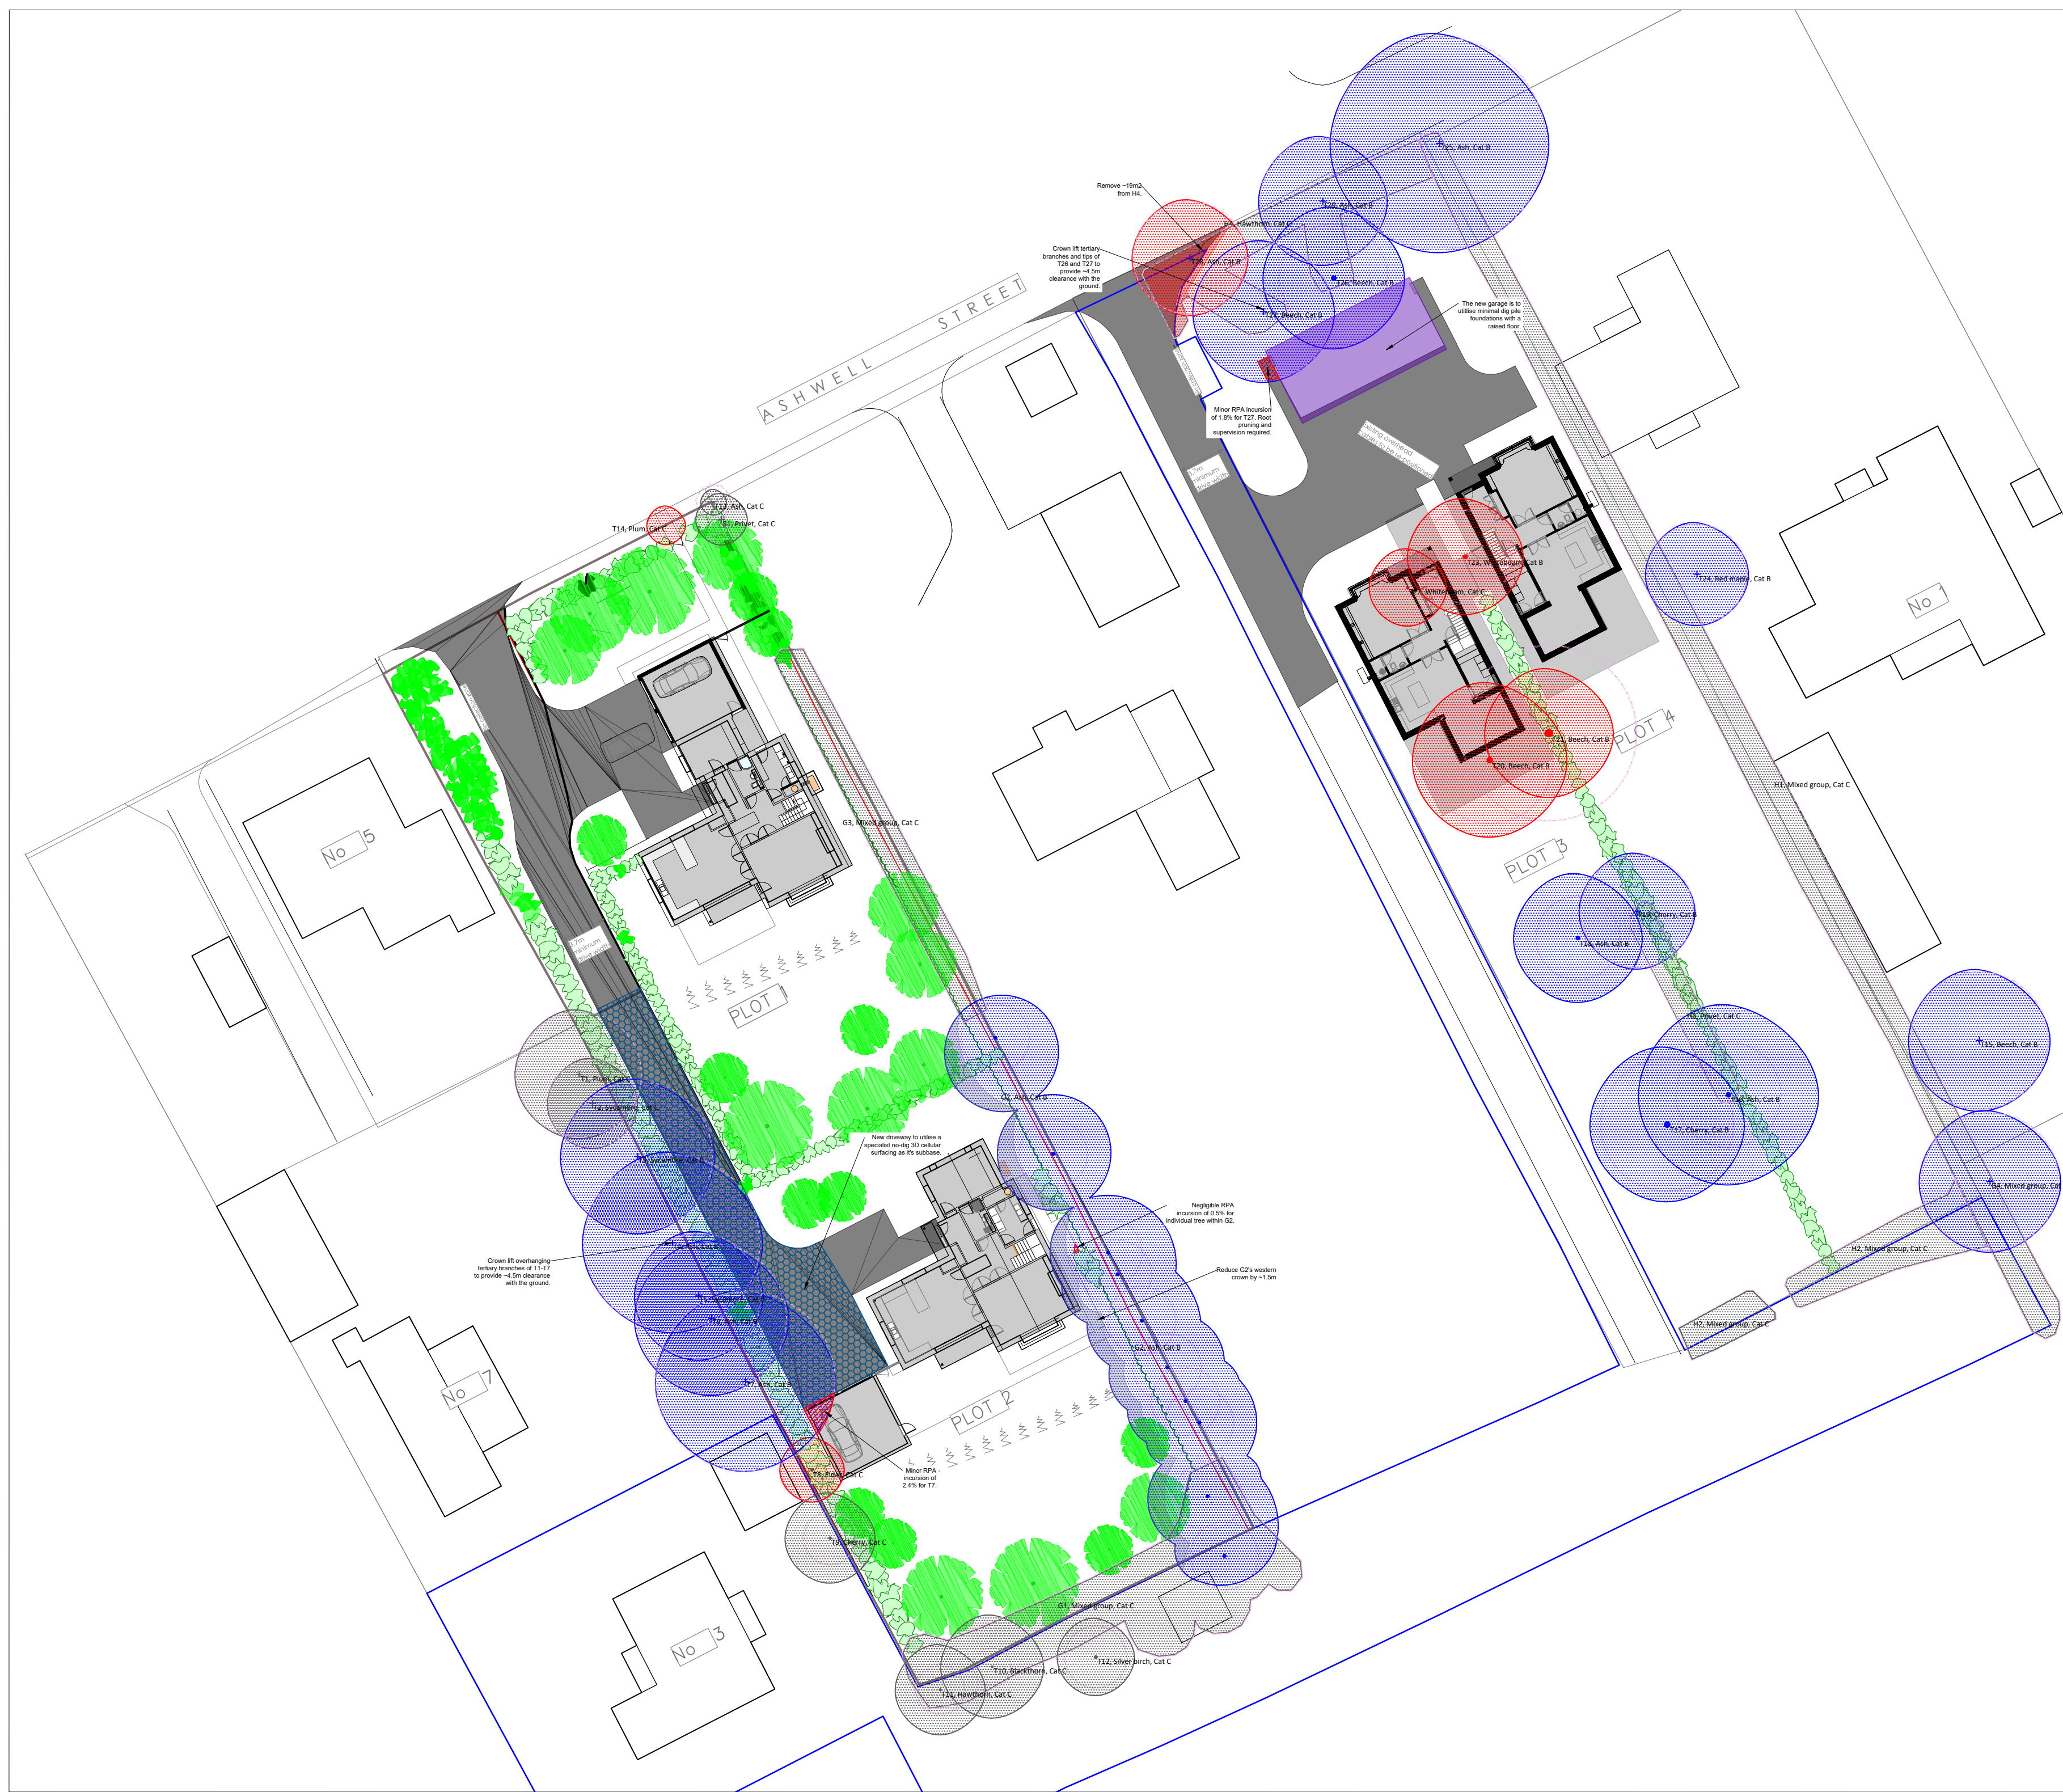
## ARB. SITE PLAN (PROPOSED)

The trees considered significant within the context of the development are numbered and assigned a prefix of 'T' or 'G' to describe whether they are an individual or a group, and 'S' or 'H' for a shrub or hedge. Using this identification number, further information for each tree/group can be found within the survey schedule.

- H4 (C1) - Remove ~19m<sup>2</sup> from westernmost side. (See ASP02 for exact location) – this will facilitate the alterations to the existing site entrance.
