ROADSIDE BARN  
HALL FARM  
ASHWELL ROAD, NEWNHAM  
HERTFORDSHIRE

PRELIMINARY ROOST ASSESSMENT

| <b>Report Reference</b> | 3188 - 01 - 2026 | |

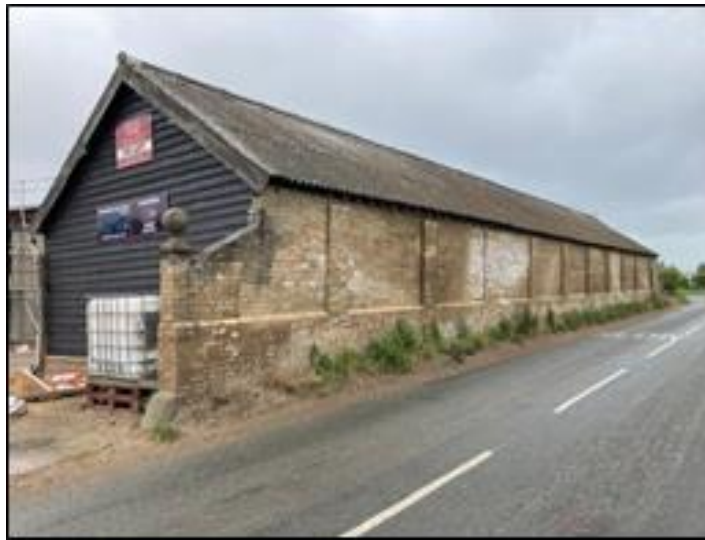
- 2.1 The objective of the daytime PRA was to view the existing site layout and to inspect the exterior and interior of the building (see cover photograph) from ground level in order to assess its suitability to act as a bat roost site(s) by identifying the presence of any 'potential roost features' that bats could utilise.

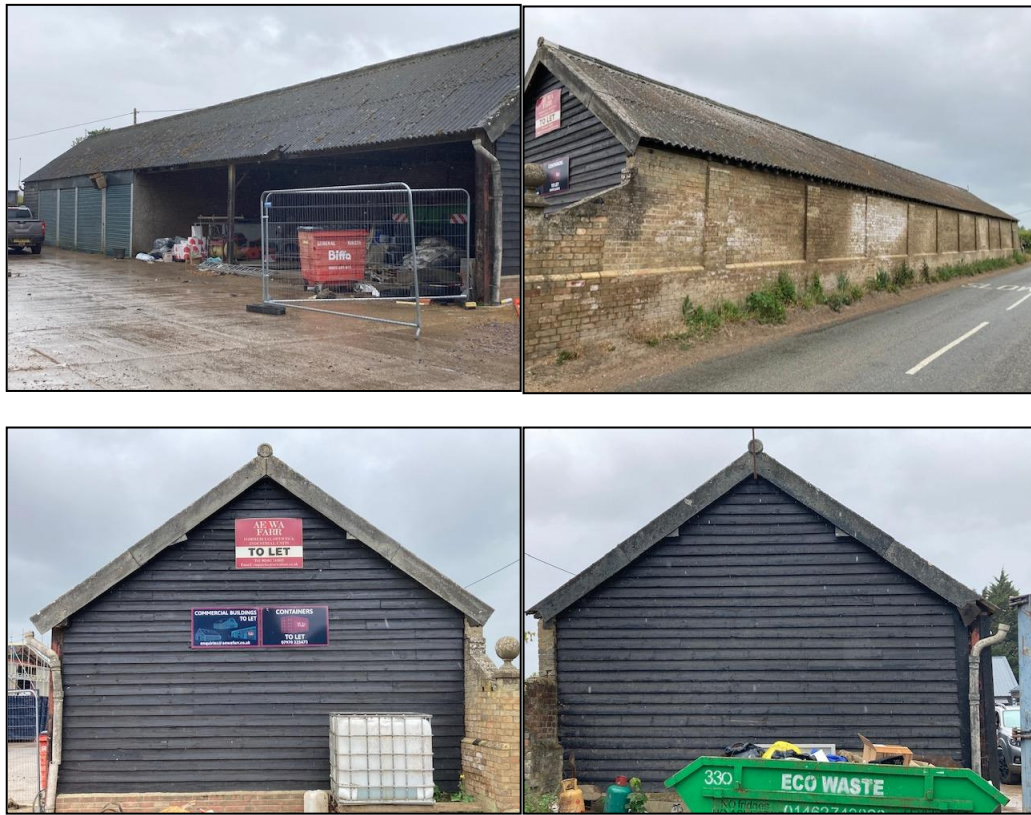
Photographs 1 - 4: Front, rear & side elevations

The building comprises a single-storey, modern barn (see photographs 1 - 4 below) that is currently in use for storage.

The walls are of brick construction, with approximately half the front elevation being open-sided and the remaining section secured with roller shutters, giving

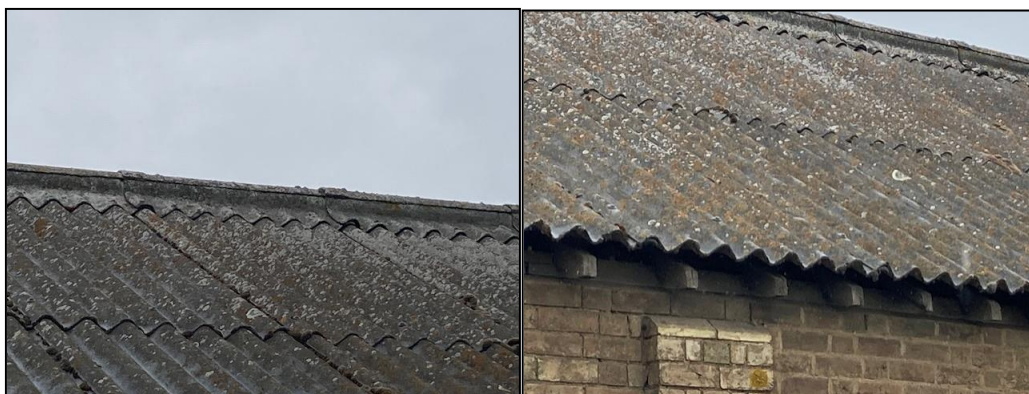
Photographs 5 - 6: Corrugated asbestos roof

The roof of the building (see photographs 5 - 6 below) is comprised of pitched corrugated asbestos sheeting, in excellent condition, that affords no 'potential roost features' that bats could utilise. There are no chimneys present and there is no loft void present.
