## Bat Emergence Survey

25 Lower Road,  
Breachwood  
Green, SG4 8NS

On Behalf of:  
**Pentangle Design Group**

**July 2026**

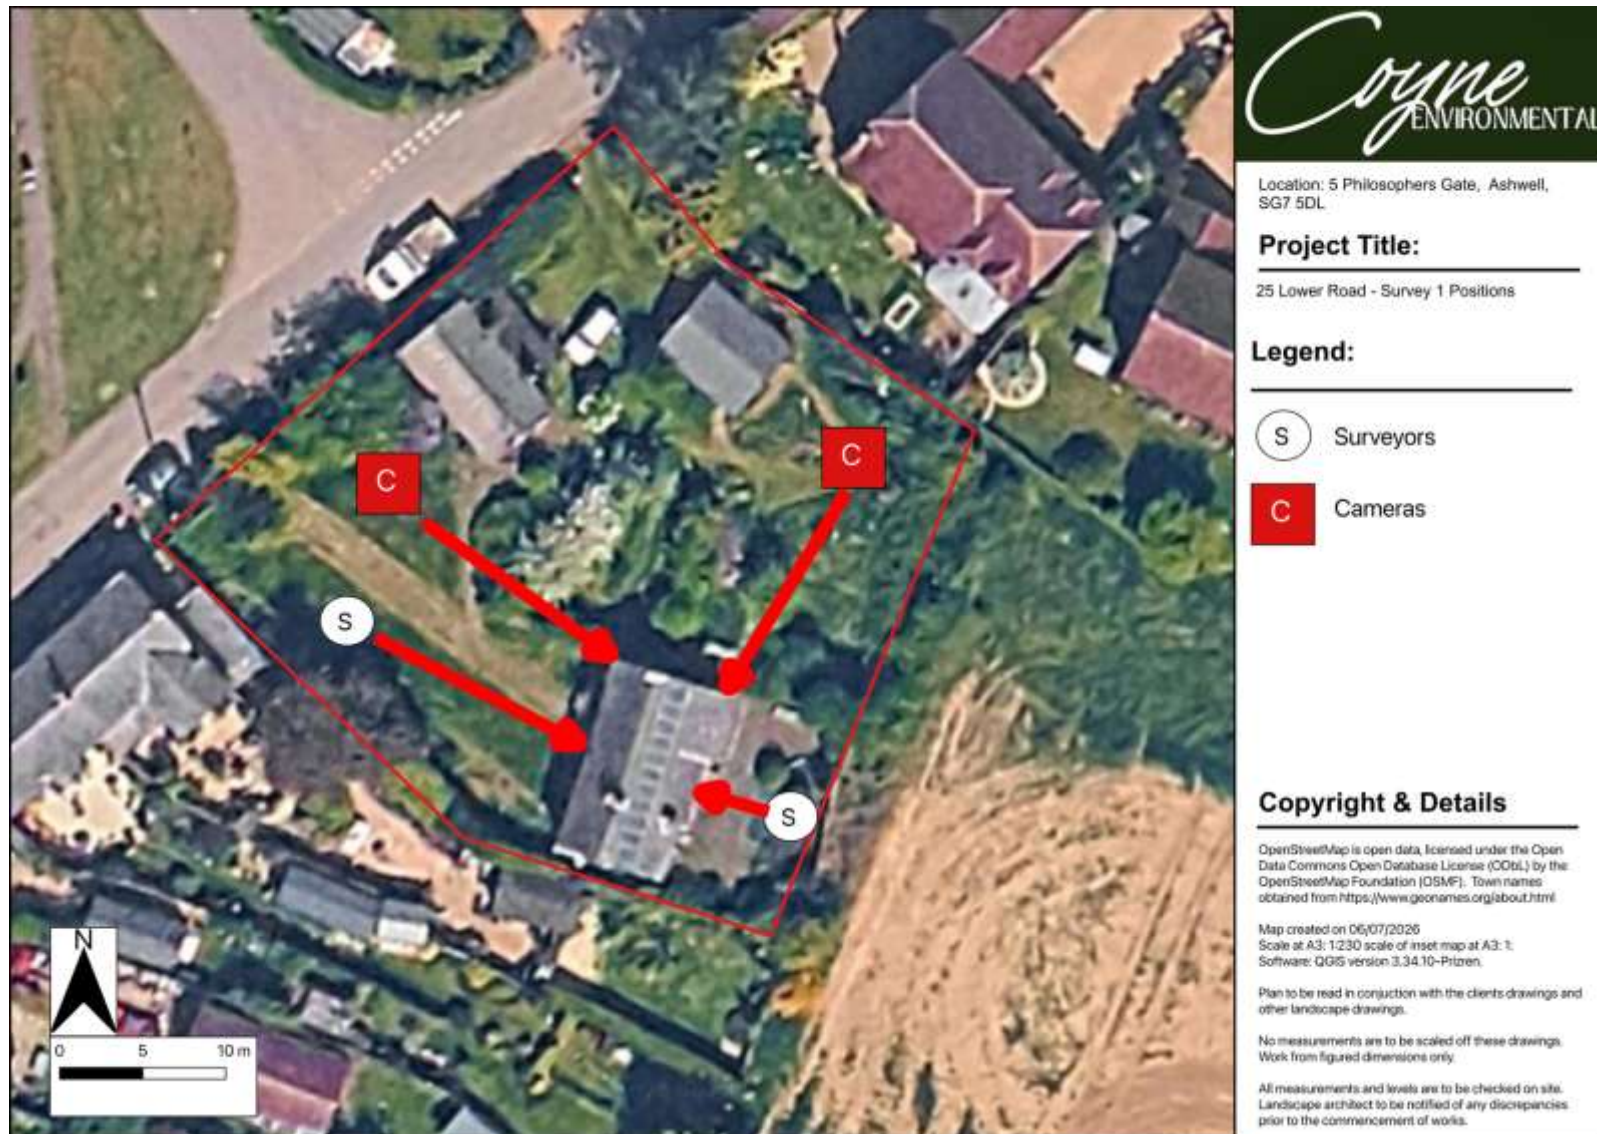
**Figure 2: Marked positions of surveyor's on survey 1**

- 7.1.1 The first survey (22 May 2026) recorded moderate bat activity across the site, with feeding and passing behaviours from Common Pipistrelle (*Pipistrellus pipistrellus*), Soprano Pipistrelle (*Pipistrellus pygmaeus*) and a single Brown Long-eared (*Plecotus auritus*) pass. Activity was concentrated around the building and hedgerow boundaries, with bats observed feeding over and around B1 and along the front porch area. A possible emergence was noted visually during the survey; however, subsequent review of the camera footage did not confirm this observation.

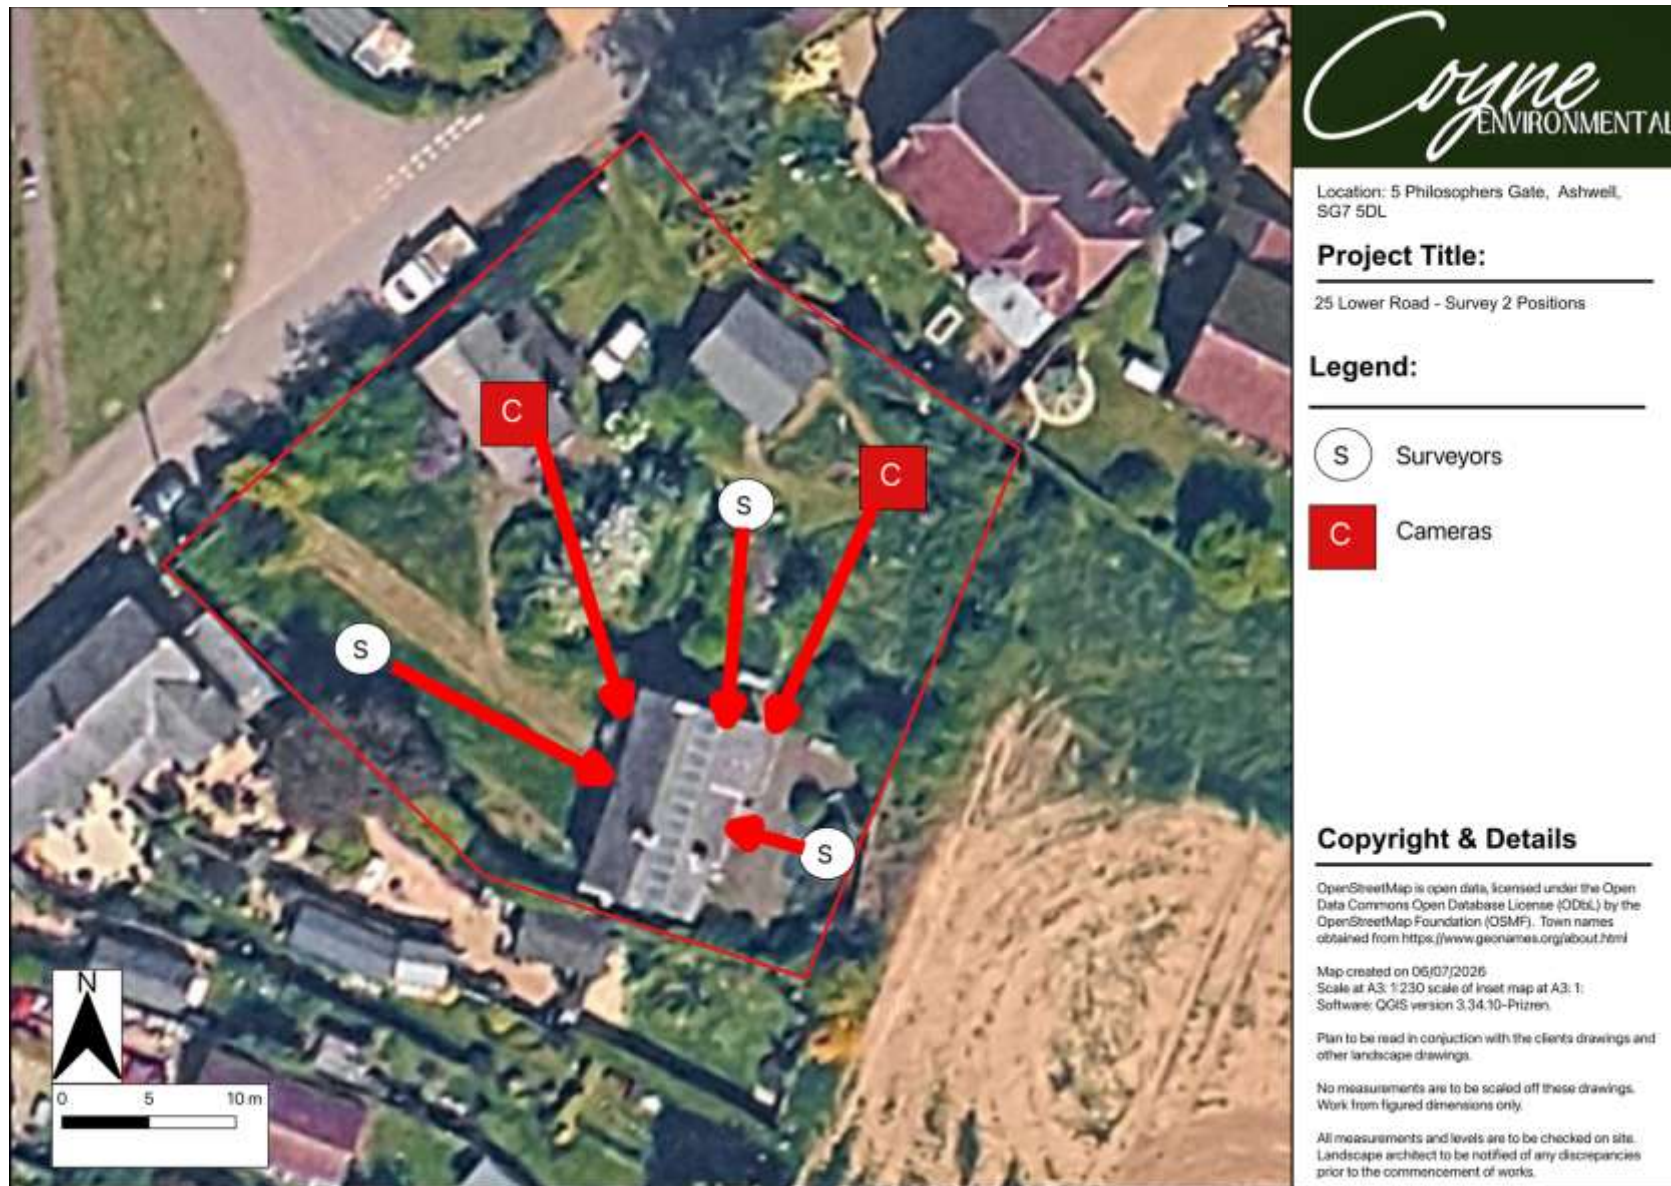
**Figure 3: Marked surveyors positions on night 2 of 2**

- 7.1.2 The second survey (30 June 2026) recorded low bat activity, limited to Common Pipistrelle. Activity comprised occasional commuting, feeding and distant passes across the site. No bats were observed entering or exiting B1 at any point during the survey. Light rain began at approximately 22:37, after which no further bat activity was recorded. Two hedgehogs were noted during the survey along with deer droppings.
