Report prepared for: Elissa Williams

For the Site of: Windmill House, Rushden, SG9 0SH

# Preliminary Roost Assessment (PRA)

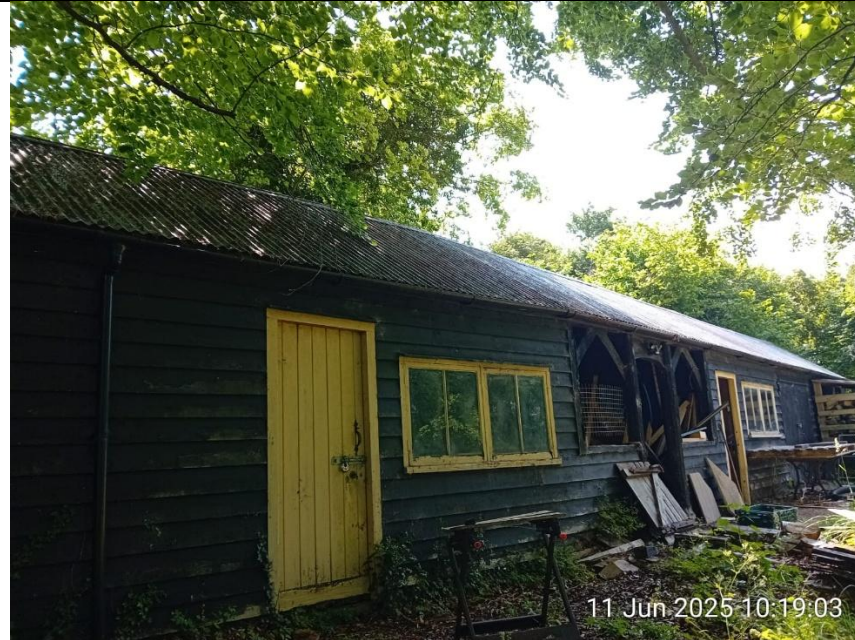
Figure 2: Front elevation of B1

| Building/Tree/Structure Number | Description |
|---|---|
| B1 | <p><b>External</b></p> <p>B1 is a single-storey outbuilding, with a gable ended roof. The building is timber weatherboarded, and the roof is covered in corrugated metal roofing sheets.</p> <p>The rear elevation is largely obstructed by vegetation.</p> |

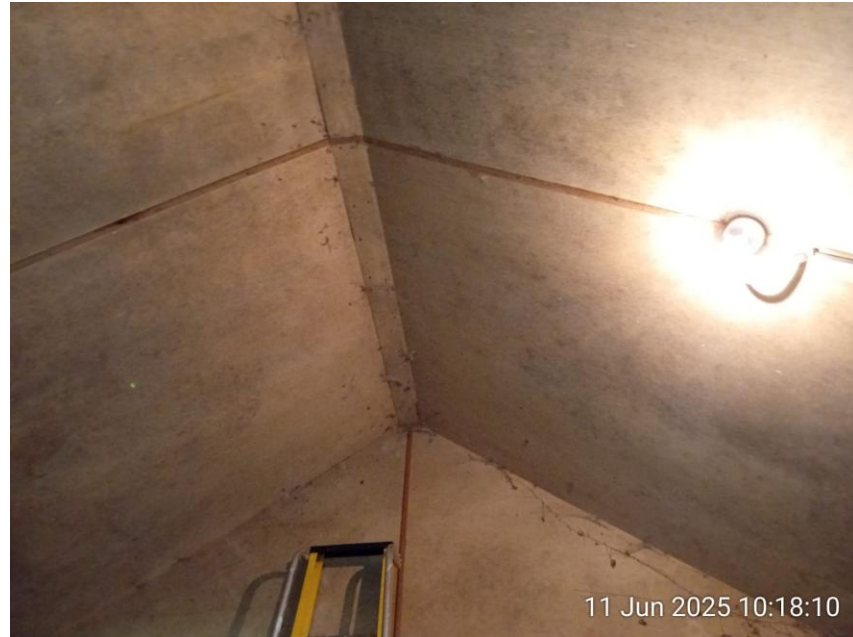
Figure 4: Example of boarded interior of B1

Within, the walls are timber lined and the roof is vaulted, with no loft voids present, and is constructed from timber boards.

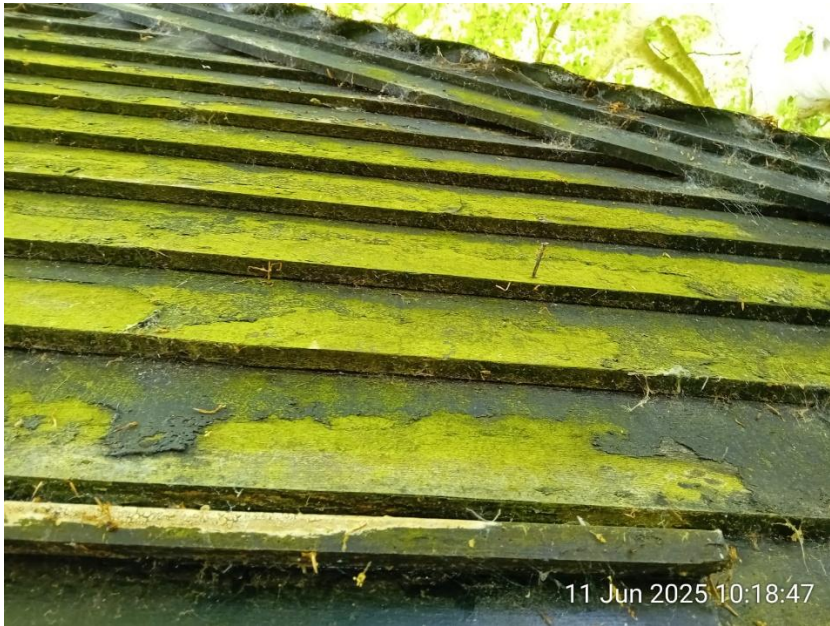
| Potential for bat use | <p>Level of likelihood of presence -<br/>B1 - Negligible</p> <p>The timber weather boarding across the exterior of B1 is tight fitting with no gaps observed, and the metal roofing sheets do not provide suitable roosting opportunities. There is open access to the interior in places, however, the interior is lined with wooden boarding and does not have any beams or other potential roosting features.</p> <p>Figure 6: Example of tight weatherboarding</p> <p>Bats may use the surrounding habitat for foraging or commuting.</p> |

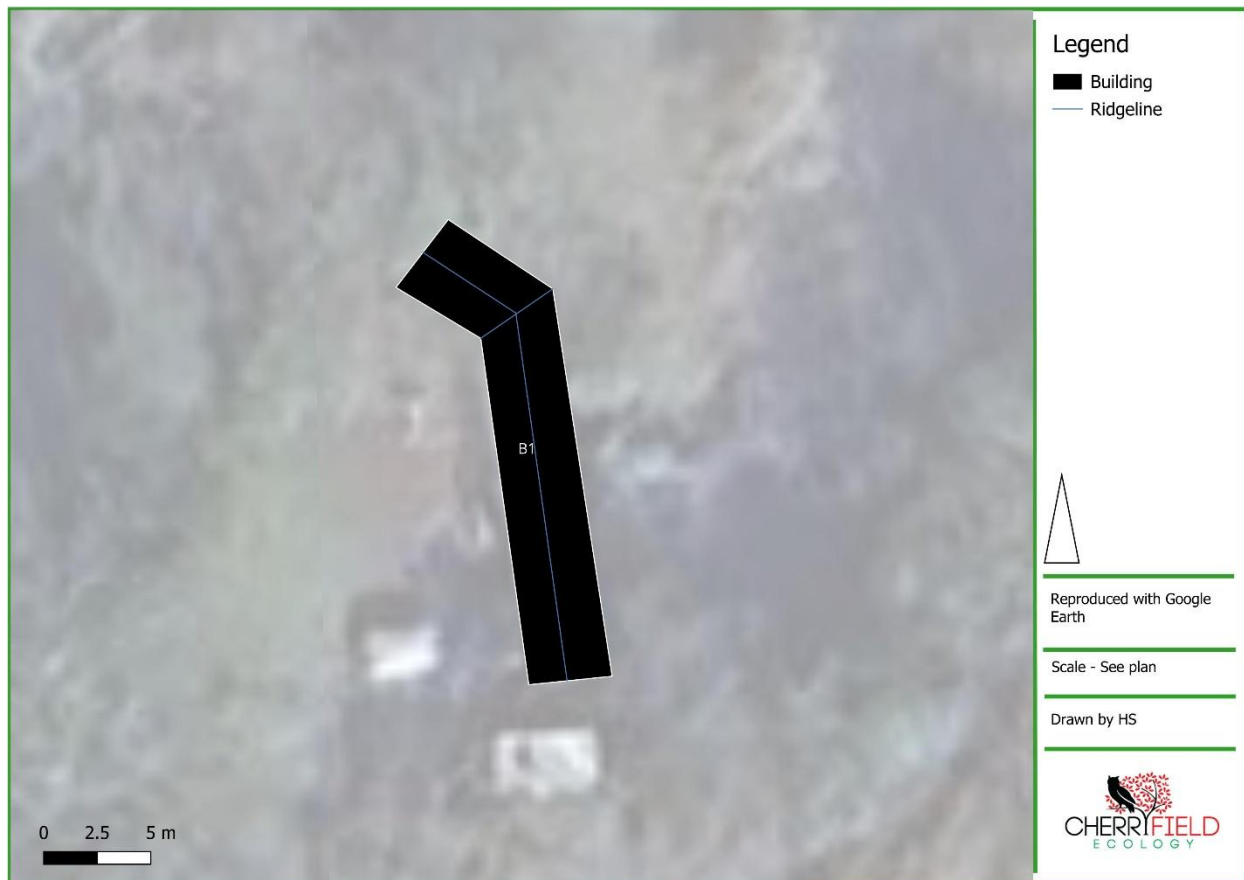
Figure 7: Site Plan

This section details the structures reference and description (see Figure 7 for Site Plan).
