# ARBORICULTURAL IMPLICATIONS ASSESSMENT

TALBOT WAY AND KRISTIANSAND WAY AND FLINT ROAD  
ALLOTMENTS  
FLINT ROAD  
LETCHWORTH GARDEN CITY  
HERTFORDSHIRE  
SG6 1TY

Ref: TRE/TWAKEAFRAFR LGCH/Rev C

Drawing Title:  
BS5837 Plan

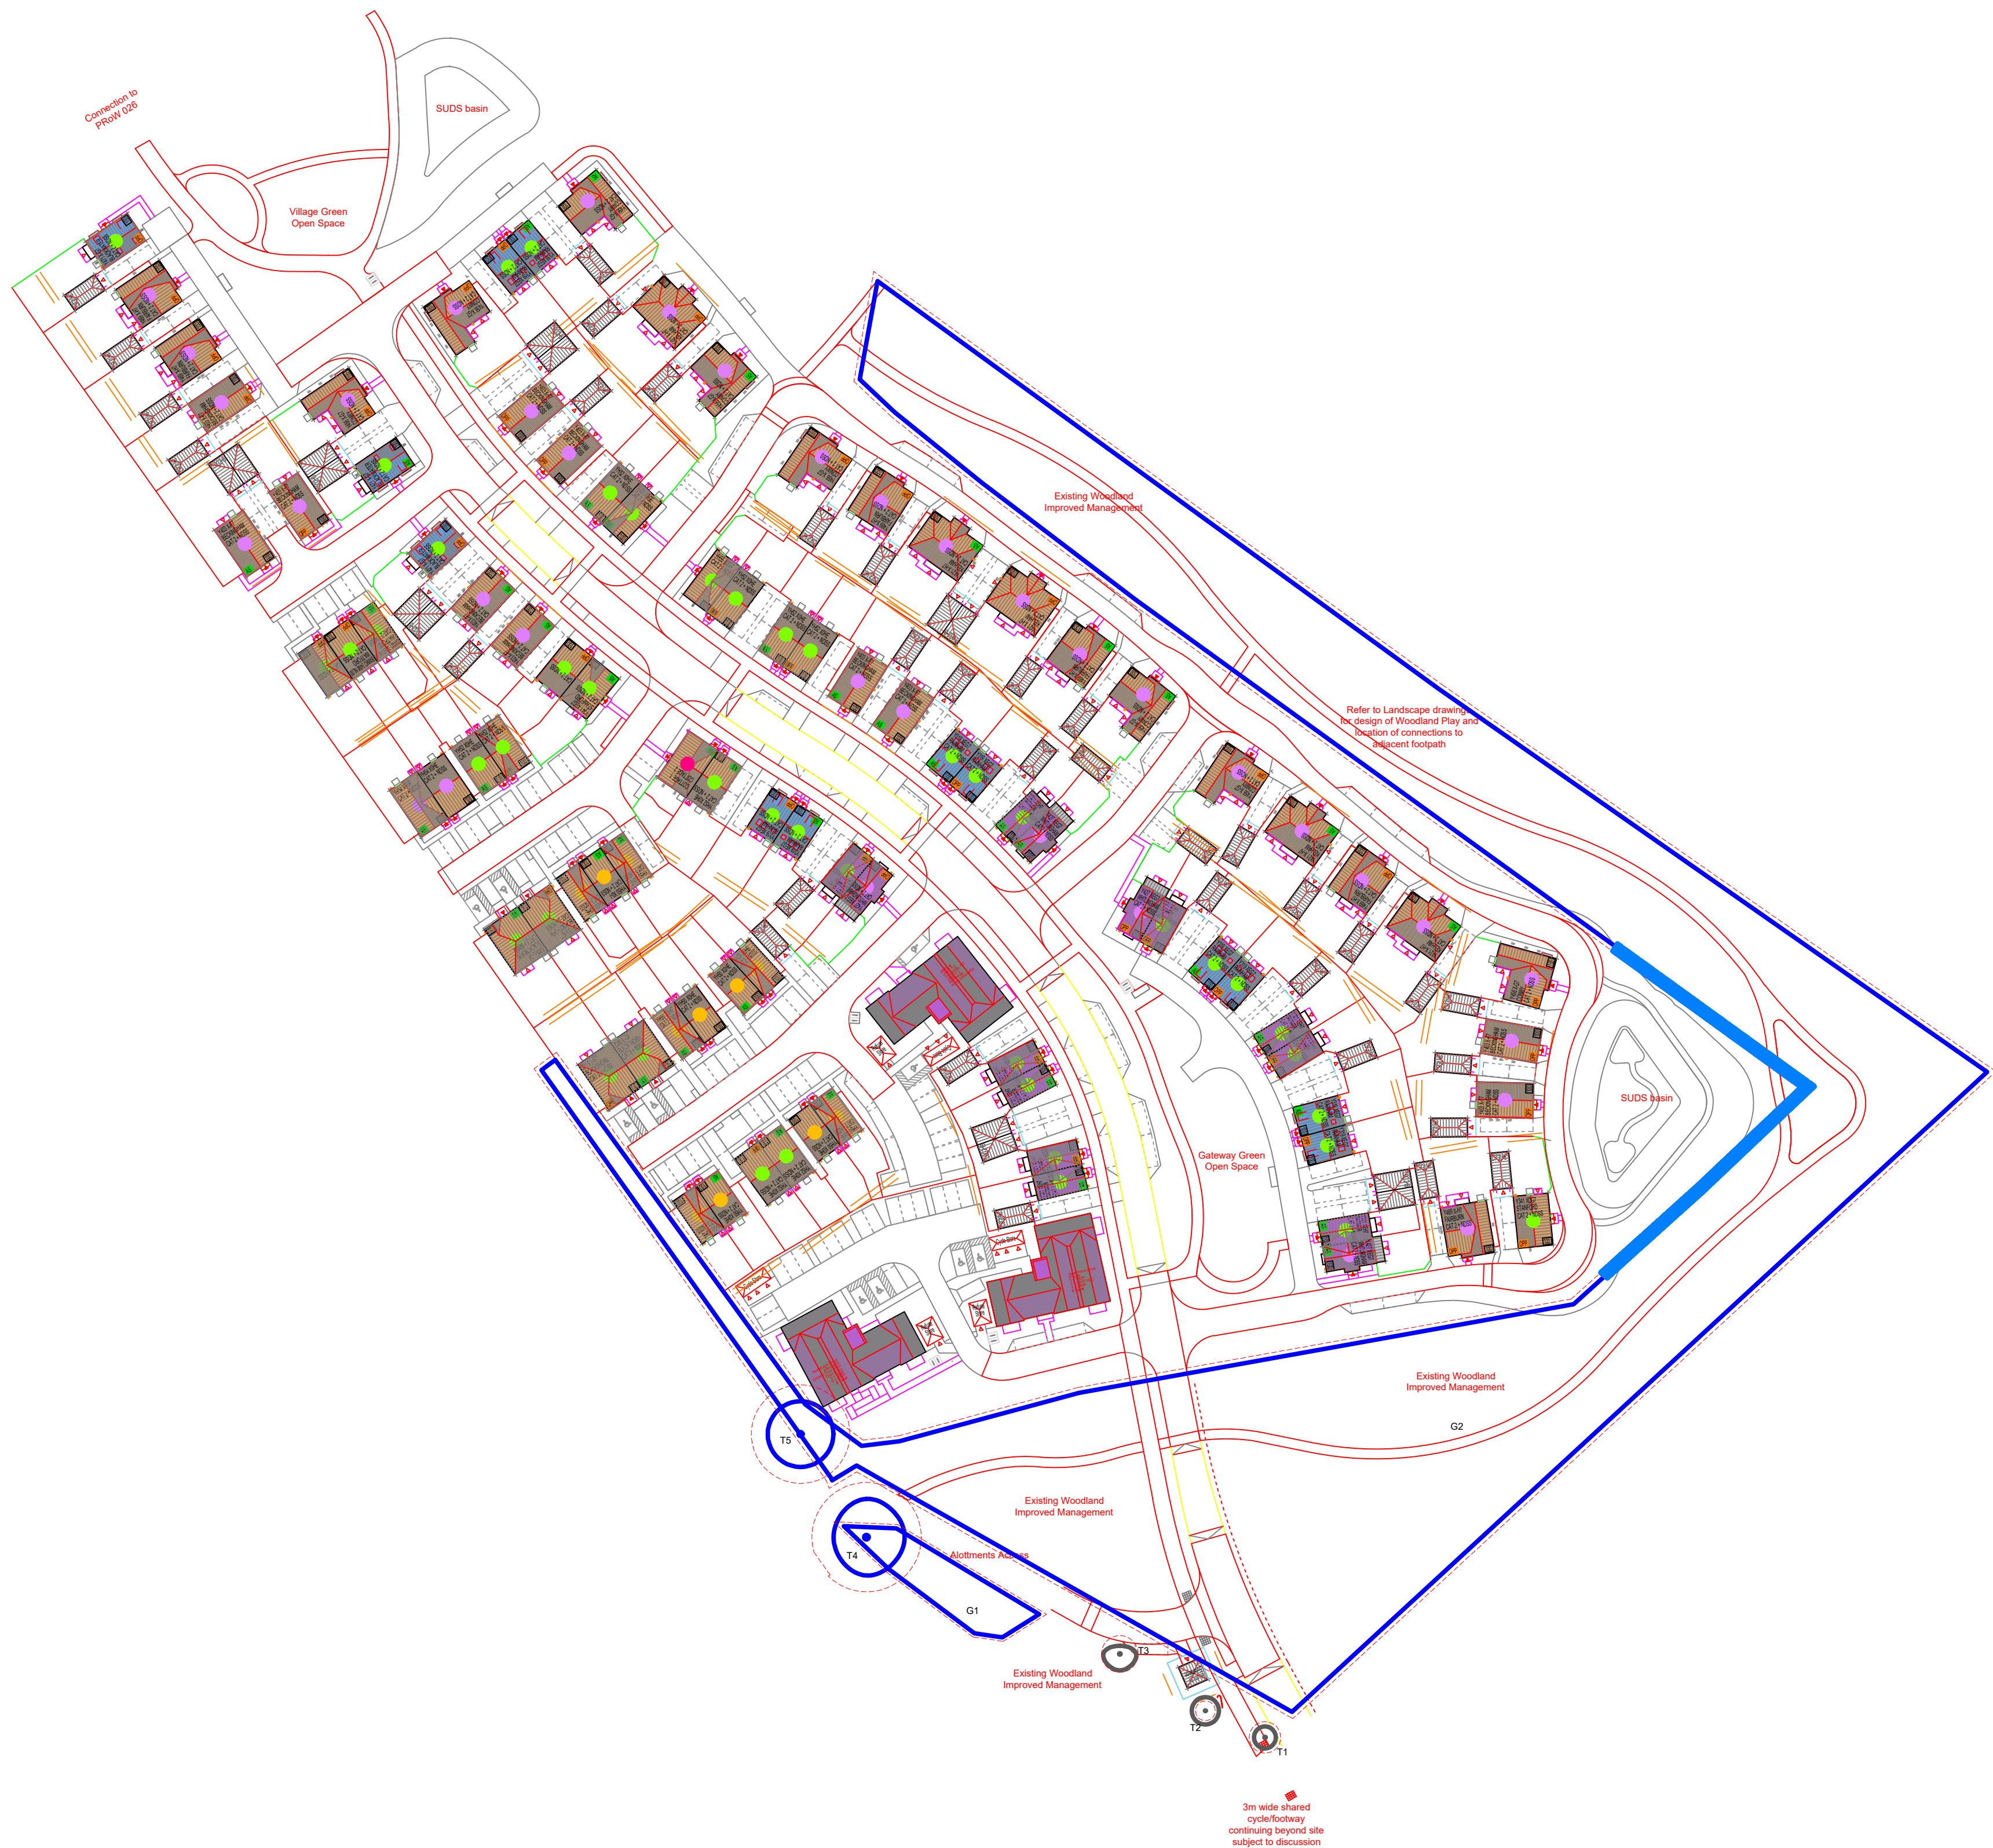
Drawing Title:  
AIS Plan  
Drawing No:  
LTWLWC/AIS/01 Rev C  
Date: 19/05/2026 Scale: 1:800@A1 Drawn by: CJ

- Category A Trees
- Category B Trees
- Category C Trees
- Category U Trees
- Root protection area

- 3.1 Due to the proposed development and its associated infrastructure there are a number of locations where the proposals are in close proximity to the trees surveyed. The Site Layout Plan within appendix three identifies the trees in relation to the proposed development.
- 3.2 In order to fully assess the impact of the proposals an Impact Table has been created detailing each tree, which shows the proximity of the associated works to the tree.
- 3.3 This can then be assessed in accordance with BS 5837:2012 to determine whether the development will have a detrimental impact on the health of each tree. Once this has been determined remedial measures can be detailed to reduce the impact the proposals will have on the treescape.

- 5.2.1 The impact table below shows the proposed development having a minor encroachment into the root protection area of T5. It is felt that due to the species, condition and limited extent of encroachment the proposal will not have a detrimental impact on the safe useful life expectancy of these trees.
- 5.2.2 Section 7.5.3 of BS 5837:2012 advises that where a slab or minor structure is to be formed within the RPA it should not exceed 20% of any existing unsurfaced ground. The table below details the amount of encroachment within the RPA.
