# DESKTOP STUDY REPORT

| Site Address: | Glebe House Stables, Hinxworth Road, Hinxworth, Baldock, Herts.<br>SG7 5HB |
| Project No.: | 19533 |

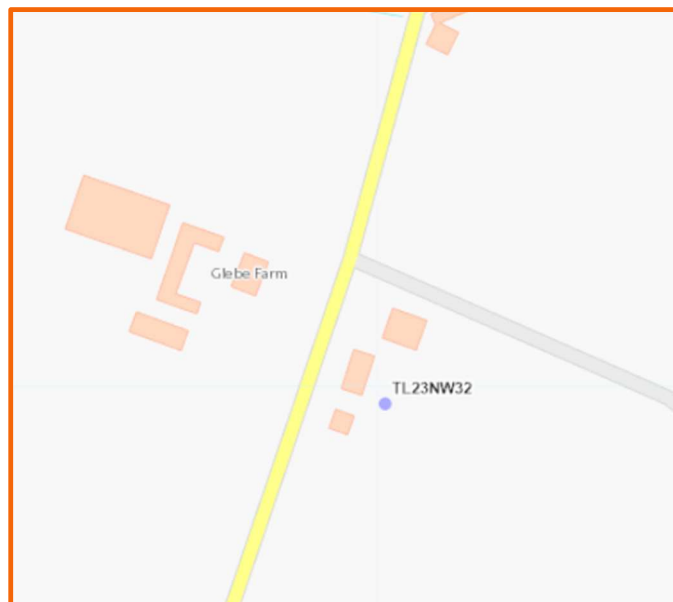
A BGS Boreholes are reported to the southeast of the site which noted boulder clay over chalk. In 1960 a hand pump was recorded in place although was disused.
