# DESK STUDY & GROUND INVESTIGATION REPORT

Newmarket Road  
Royston  
Hertfordshire

Client: Countryside Properties

J16202

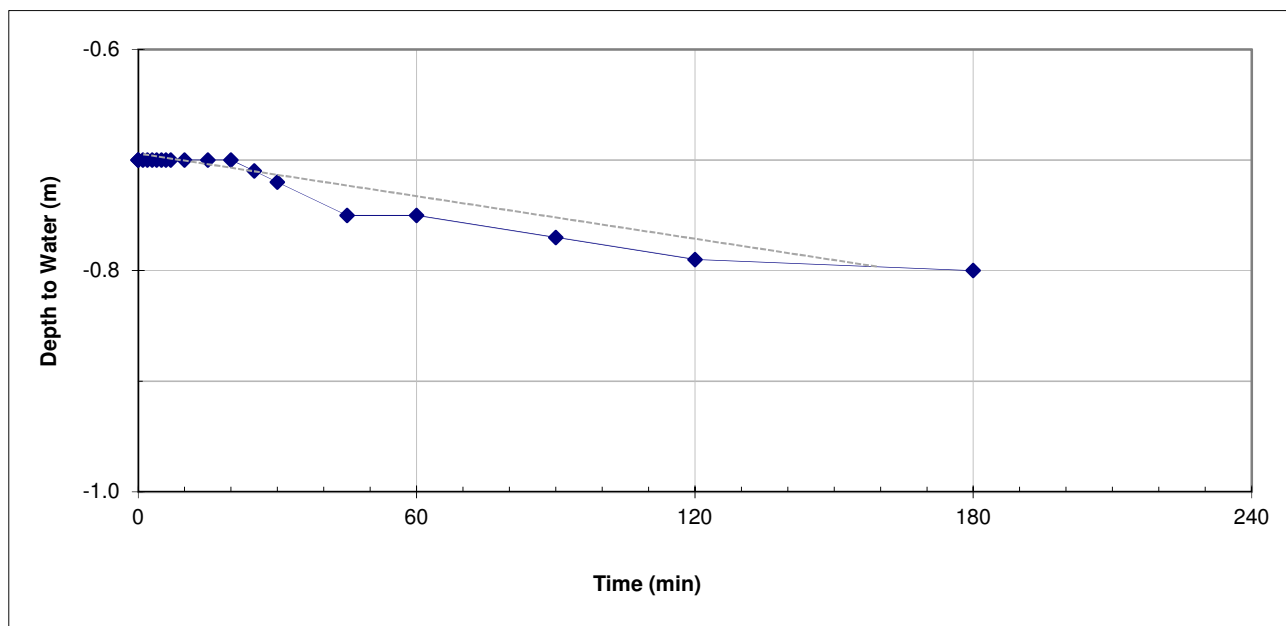
Trial Pit No. TP1 Soakage Test No. 1  
Pit Length (m) 2.2 Pit Width (m) 0.6 Pit Depth (m) 1

Design Soakage Rate 5.1E-06 m/s (based on linear portion of graph as shown)  
0.44 m/day

As the laboratory testing has indicated that the chalk is of low density to the full depth investigated in the trial pits, shallow soakaways would need to be located at a minimum distance of 10 m from any foundations. It is considered that soakaways with a 5 m lateral offset and an impermeable plain well screen over the upper 5 m below nearest foundation levels, will provide sufficient assurance.

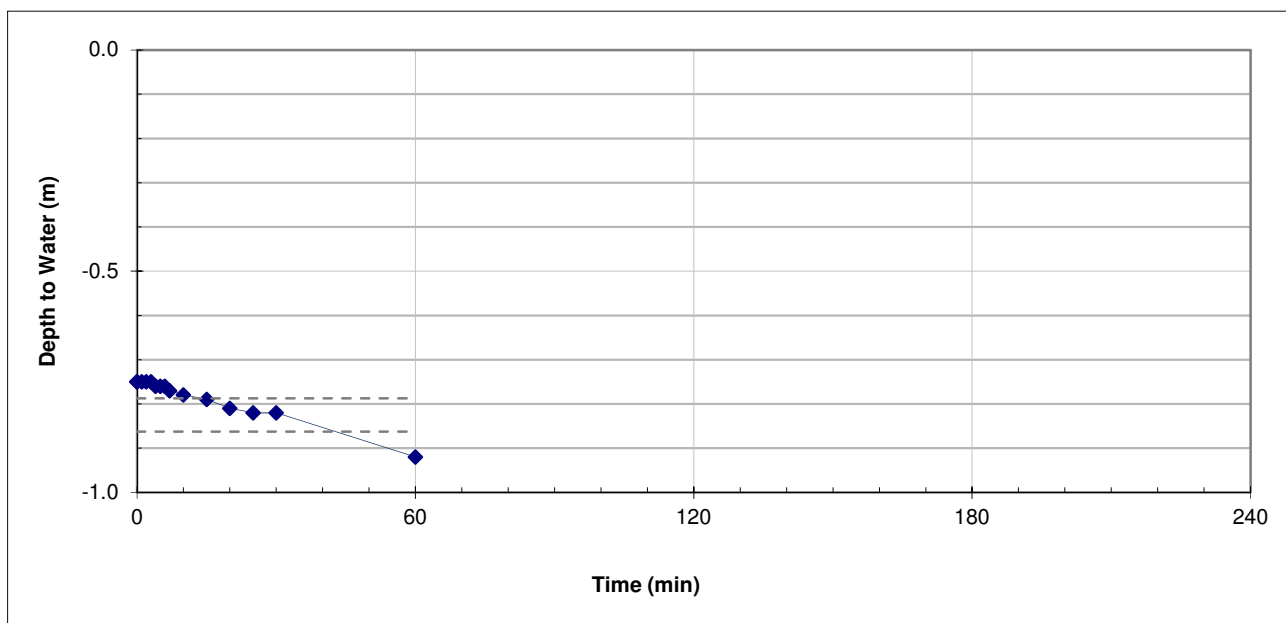
Trial Pit No. TP2 Soakage Test No. 1  
Pit Length (m) 2.2 Pit Width (m) 0.6 Pit Depth (m) 0.9

Design Soakage Rate 3.5E-05 m/s (based on BRE 365 method)  
3.04 m/day

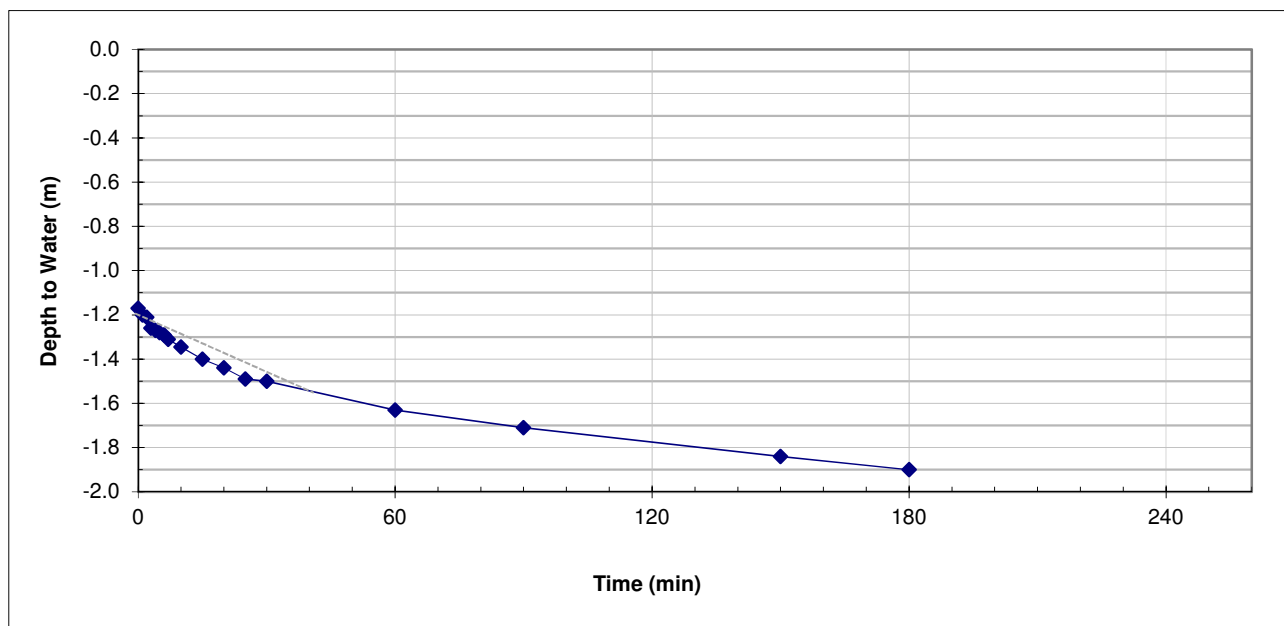
Trial Pit No. TP6 Soakage Test No. 1  
Pit Length (m) 2.1 Pit Width (m) 0.7 Pit Depth (m) 2.5

Design Soakage Rate 3.0E-05 m/s (based on linear portion of graph as shown)  
2.57 m/day

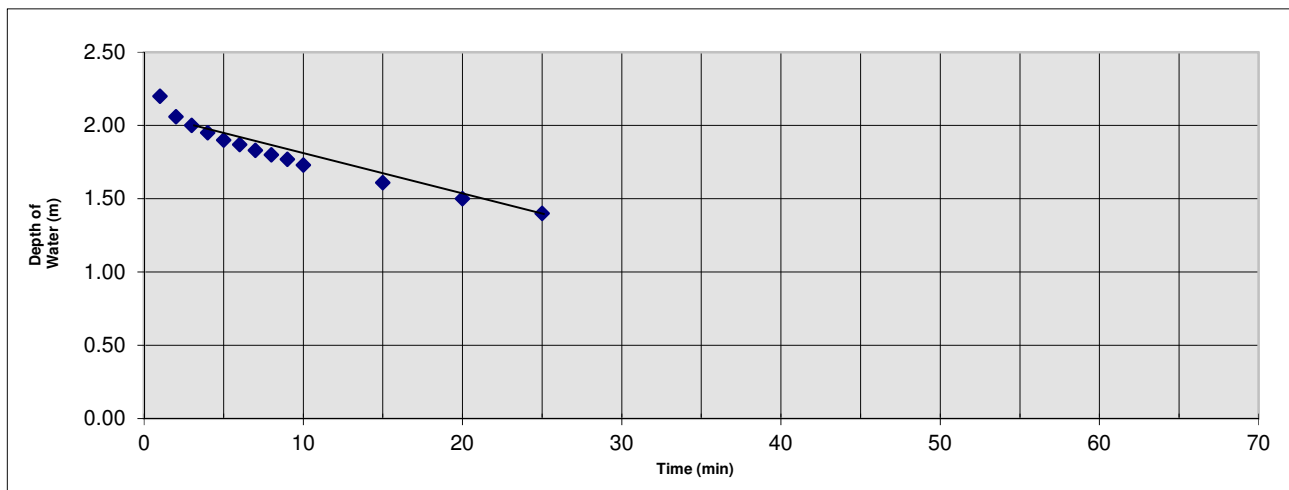
**Test No:** 1

Test carried out in Cable percussion borehole  
Borehole collapsed to 3.6 m after 25 minutes

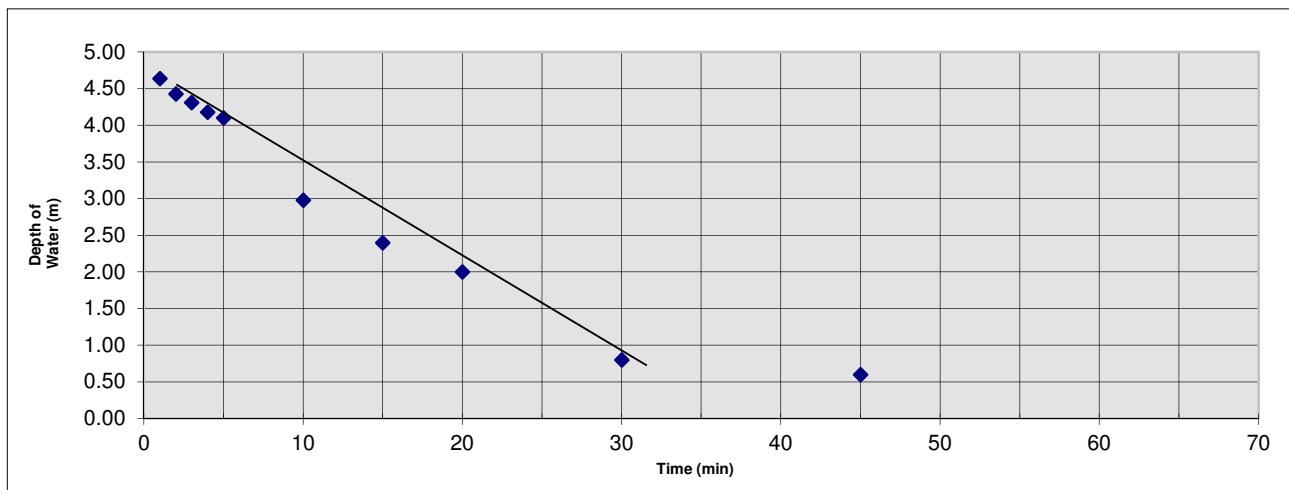
**Test No:** 1

Test carried out in Cable percussion borehole  
Sides of borehole remained stable during test

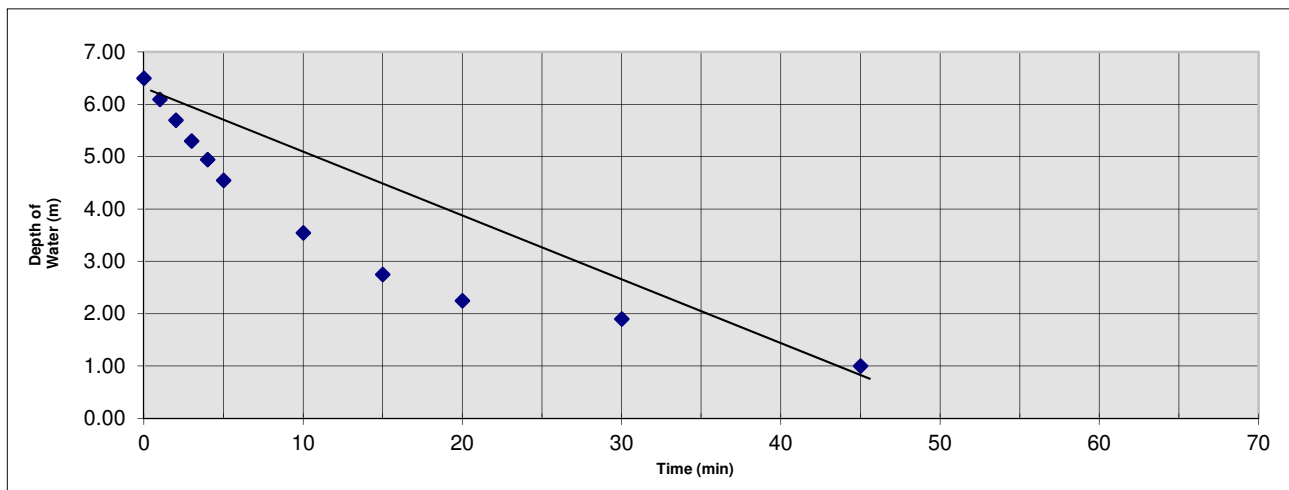
**Test No:** 1

Test carried out in Cable percussion borehole  
Sides of borehole remained stable during test

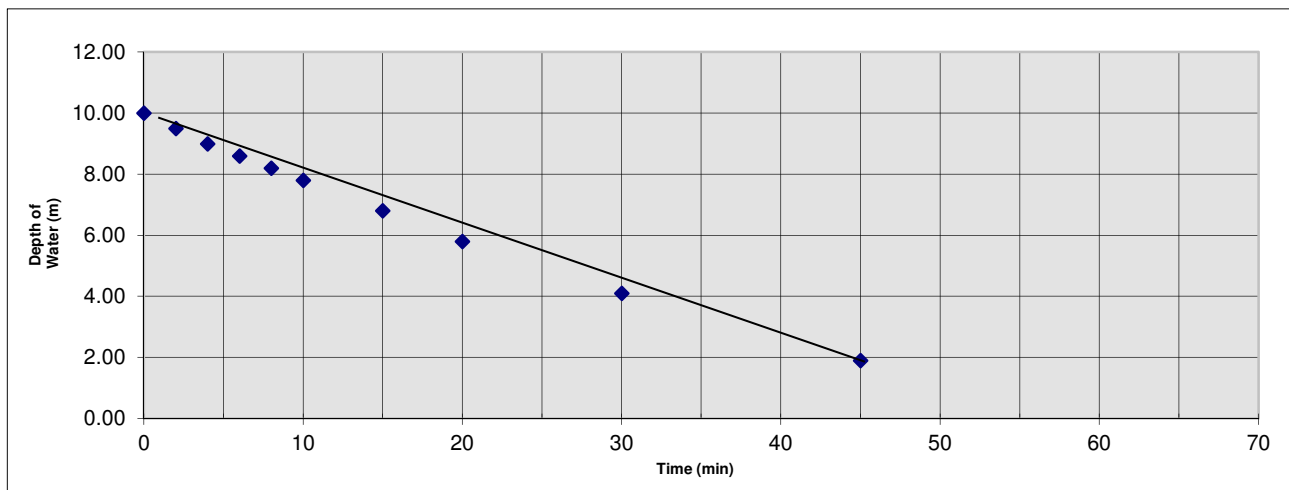
**Test No:** 3

Test carried out in Cable percussion borehole  
Sides of borehole remained stable during test
