# **Appendix F**

**Accessibility Audit Walking Routes (WRAT)  
Score and Improvements drawings  
& Summary document**

LAND NORTH EAST OF GREAT ASHBY STEVENAGE

ACCESSIBILITY AUDIT WALKING ROUTES (WRAT) SCORE

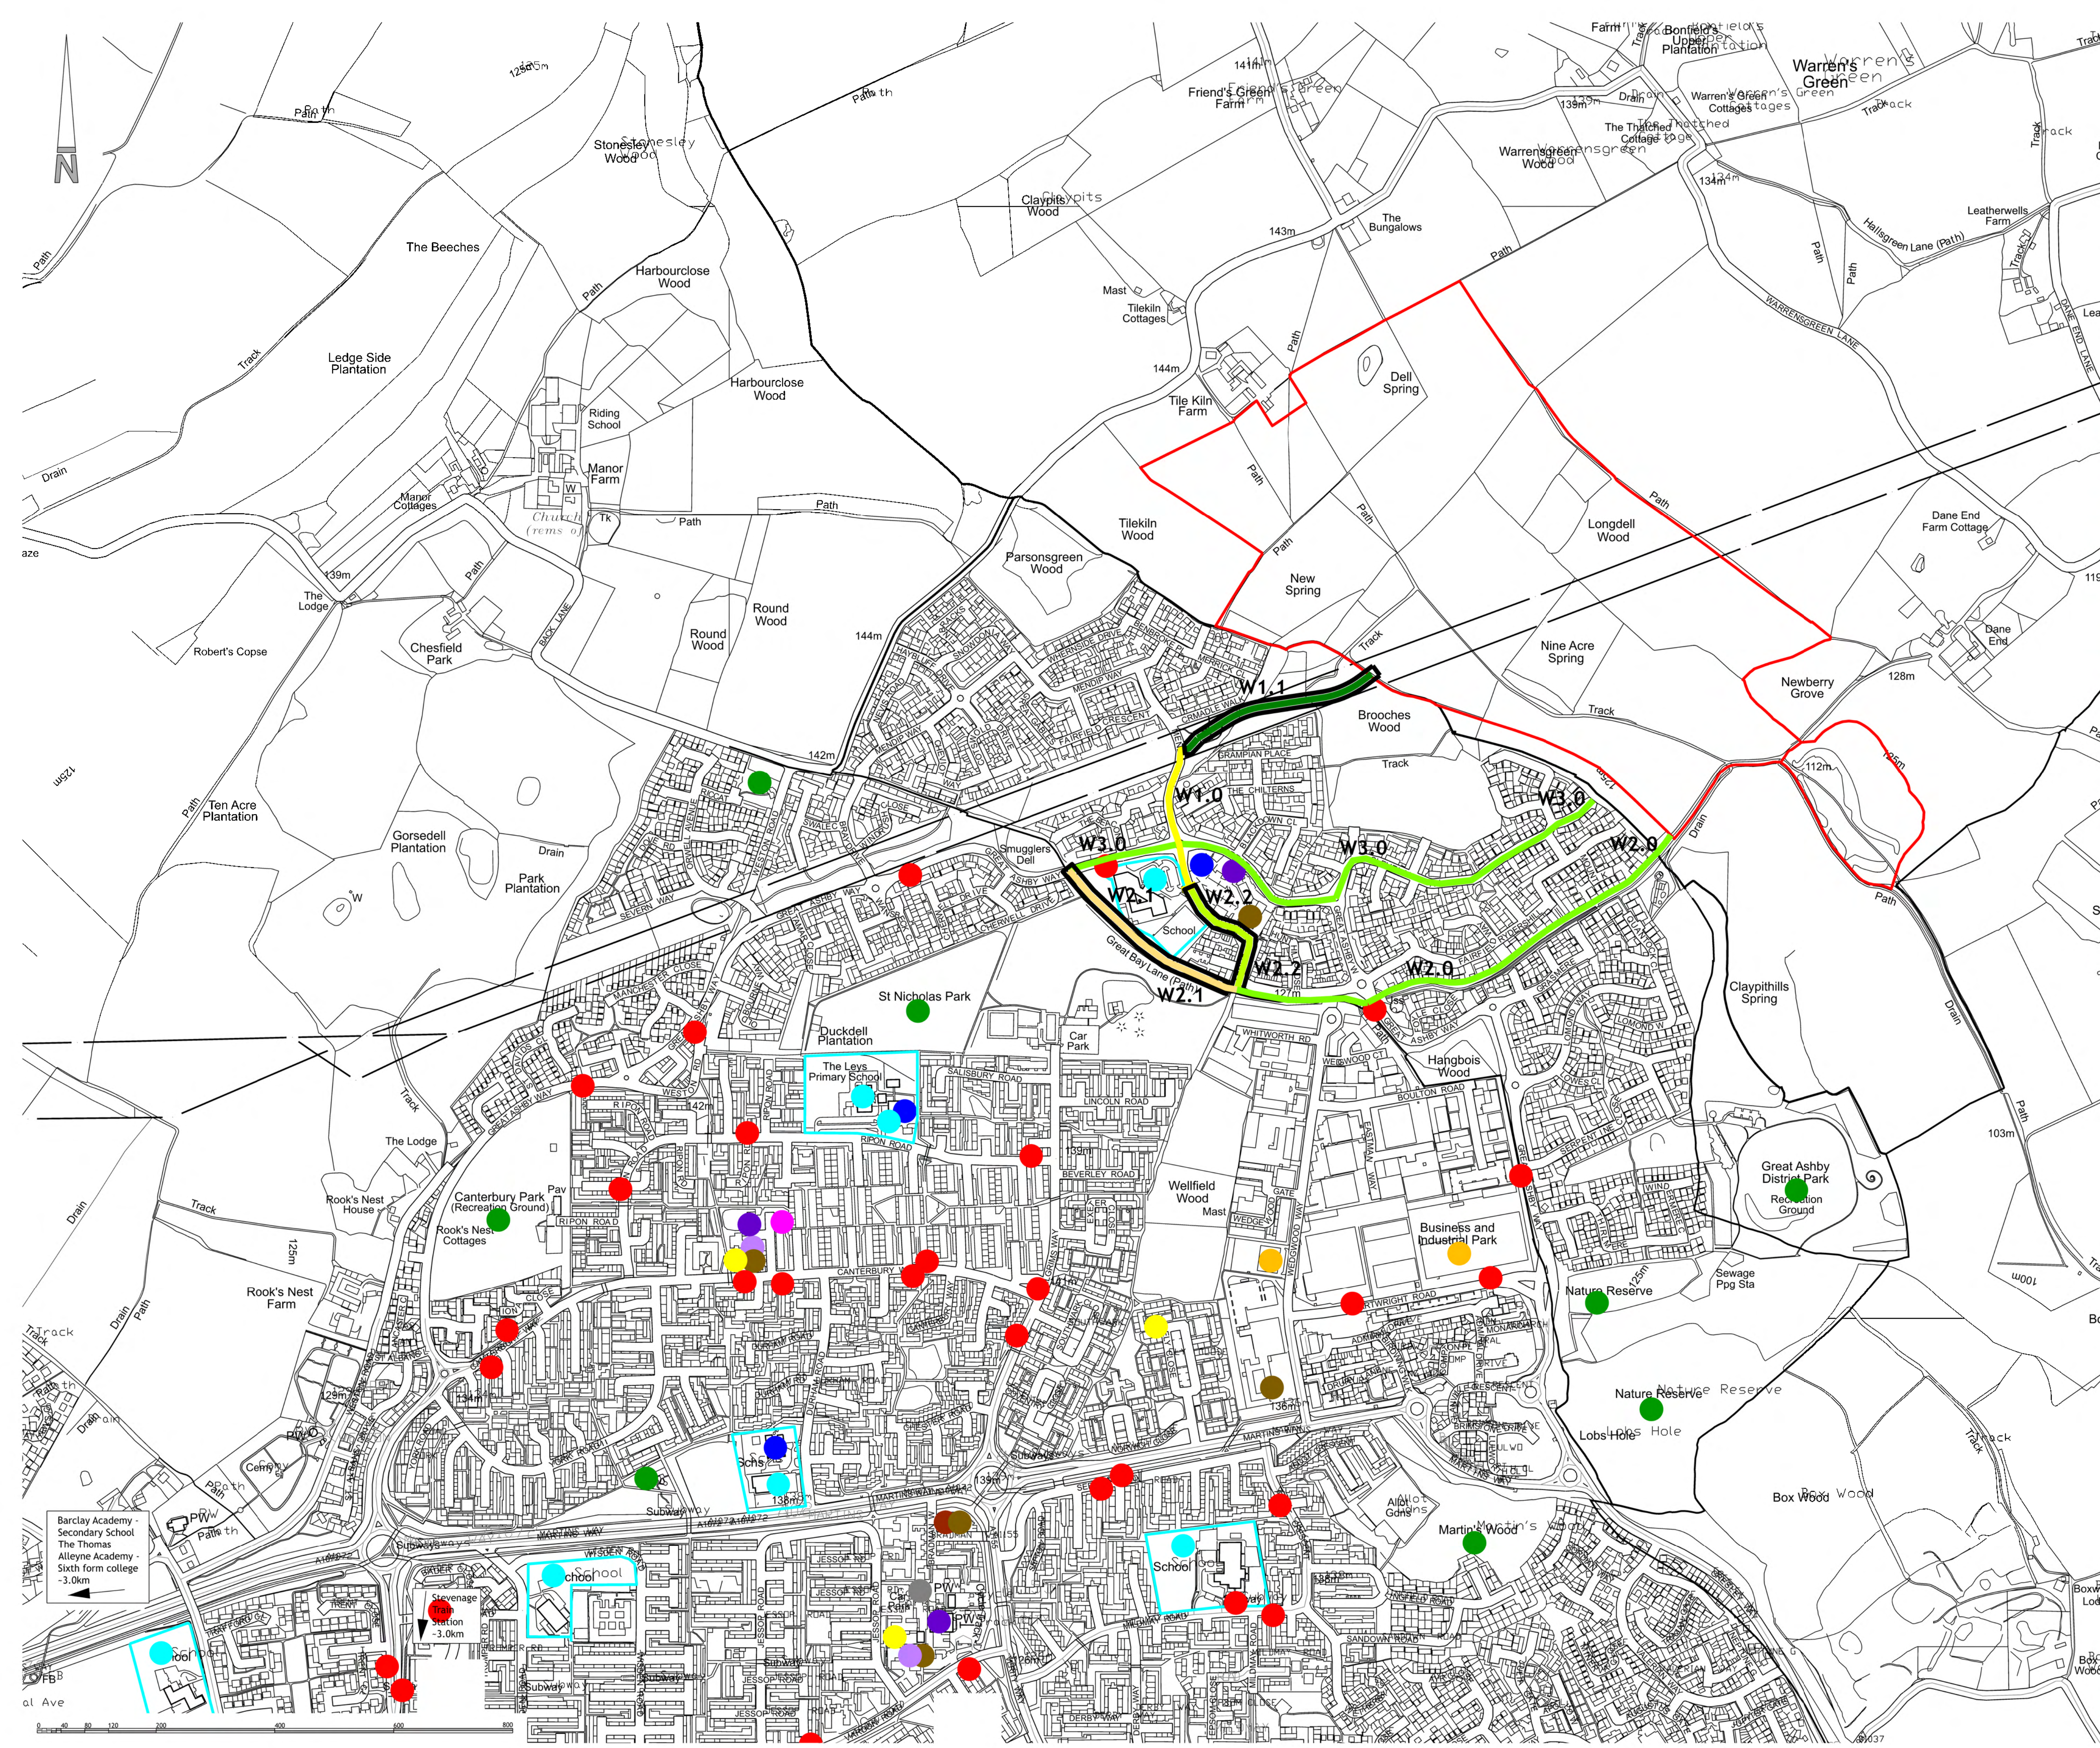
| DRAWING NO. | 19244-ASHB-5-113 | REV | A | |

- KEY
- Application Site
- Accessibility Audit Walking Routes (WRAT) Score :
- 0-10%
  - 11-20%
  - 21-30%
  - 31-40%
  - 41-50%
  - 51-60%
  - 61-70%
  - 71-80%
  - 81-90%
  - 91-100%
- Bus Stop
  - Primary School
  - Nursery / Pre-School
  - Employment Centres
  - Community Halls
  - Pharmacy
  - GP Surgery
  - Convenience Shop
  - Cafe / Pub / Restaurant
  - Park / Outdoor space
  - Places of Worship

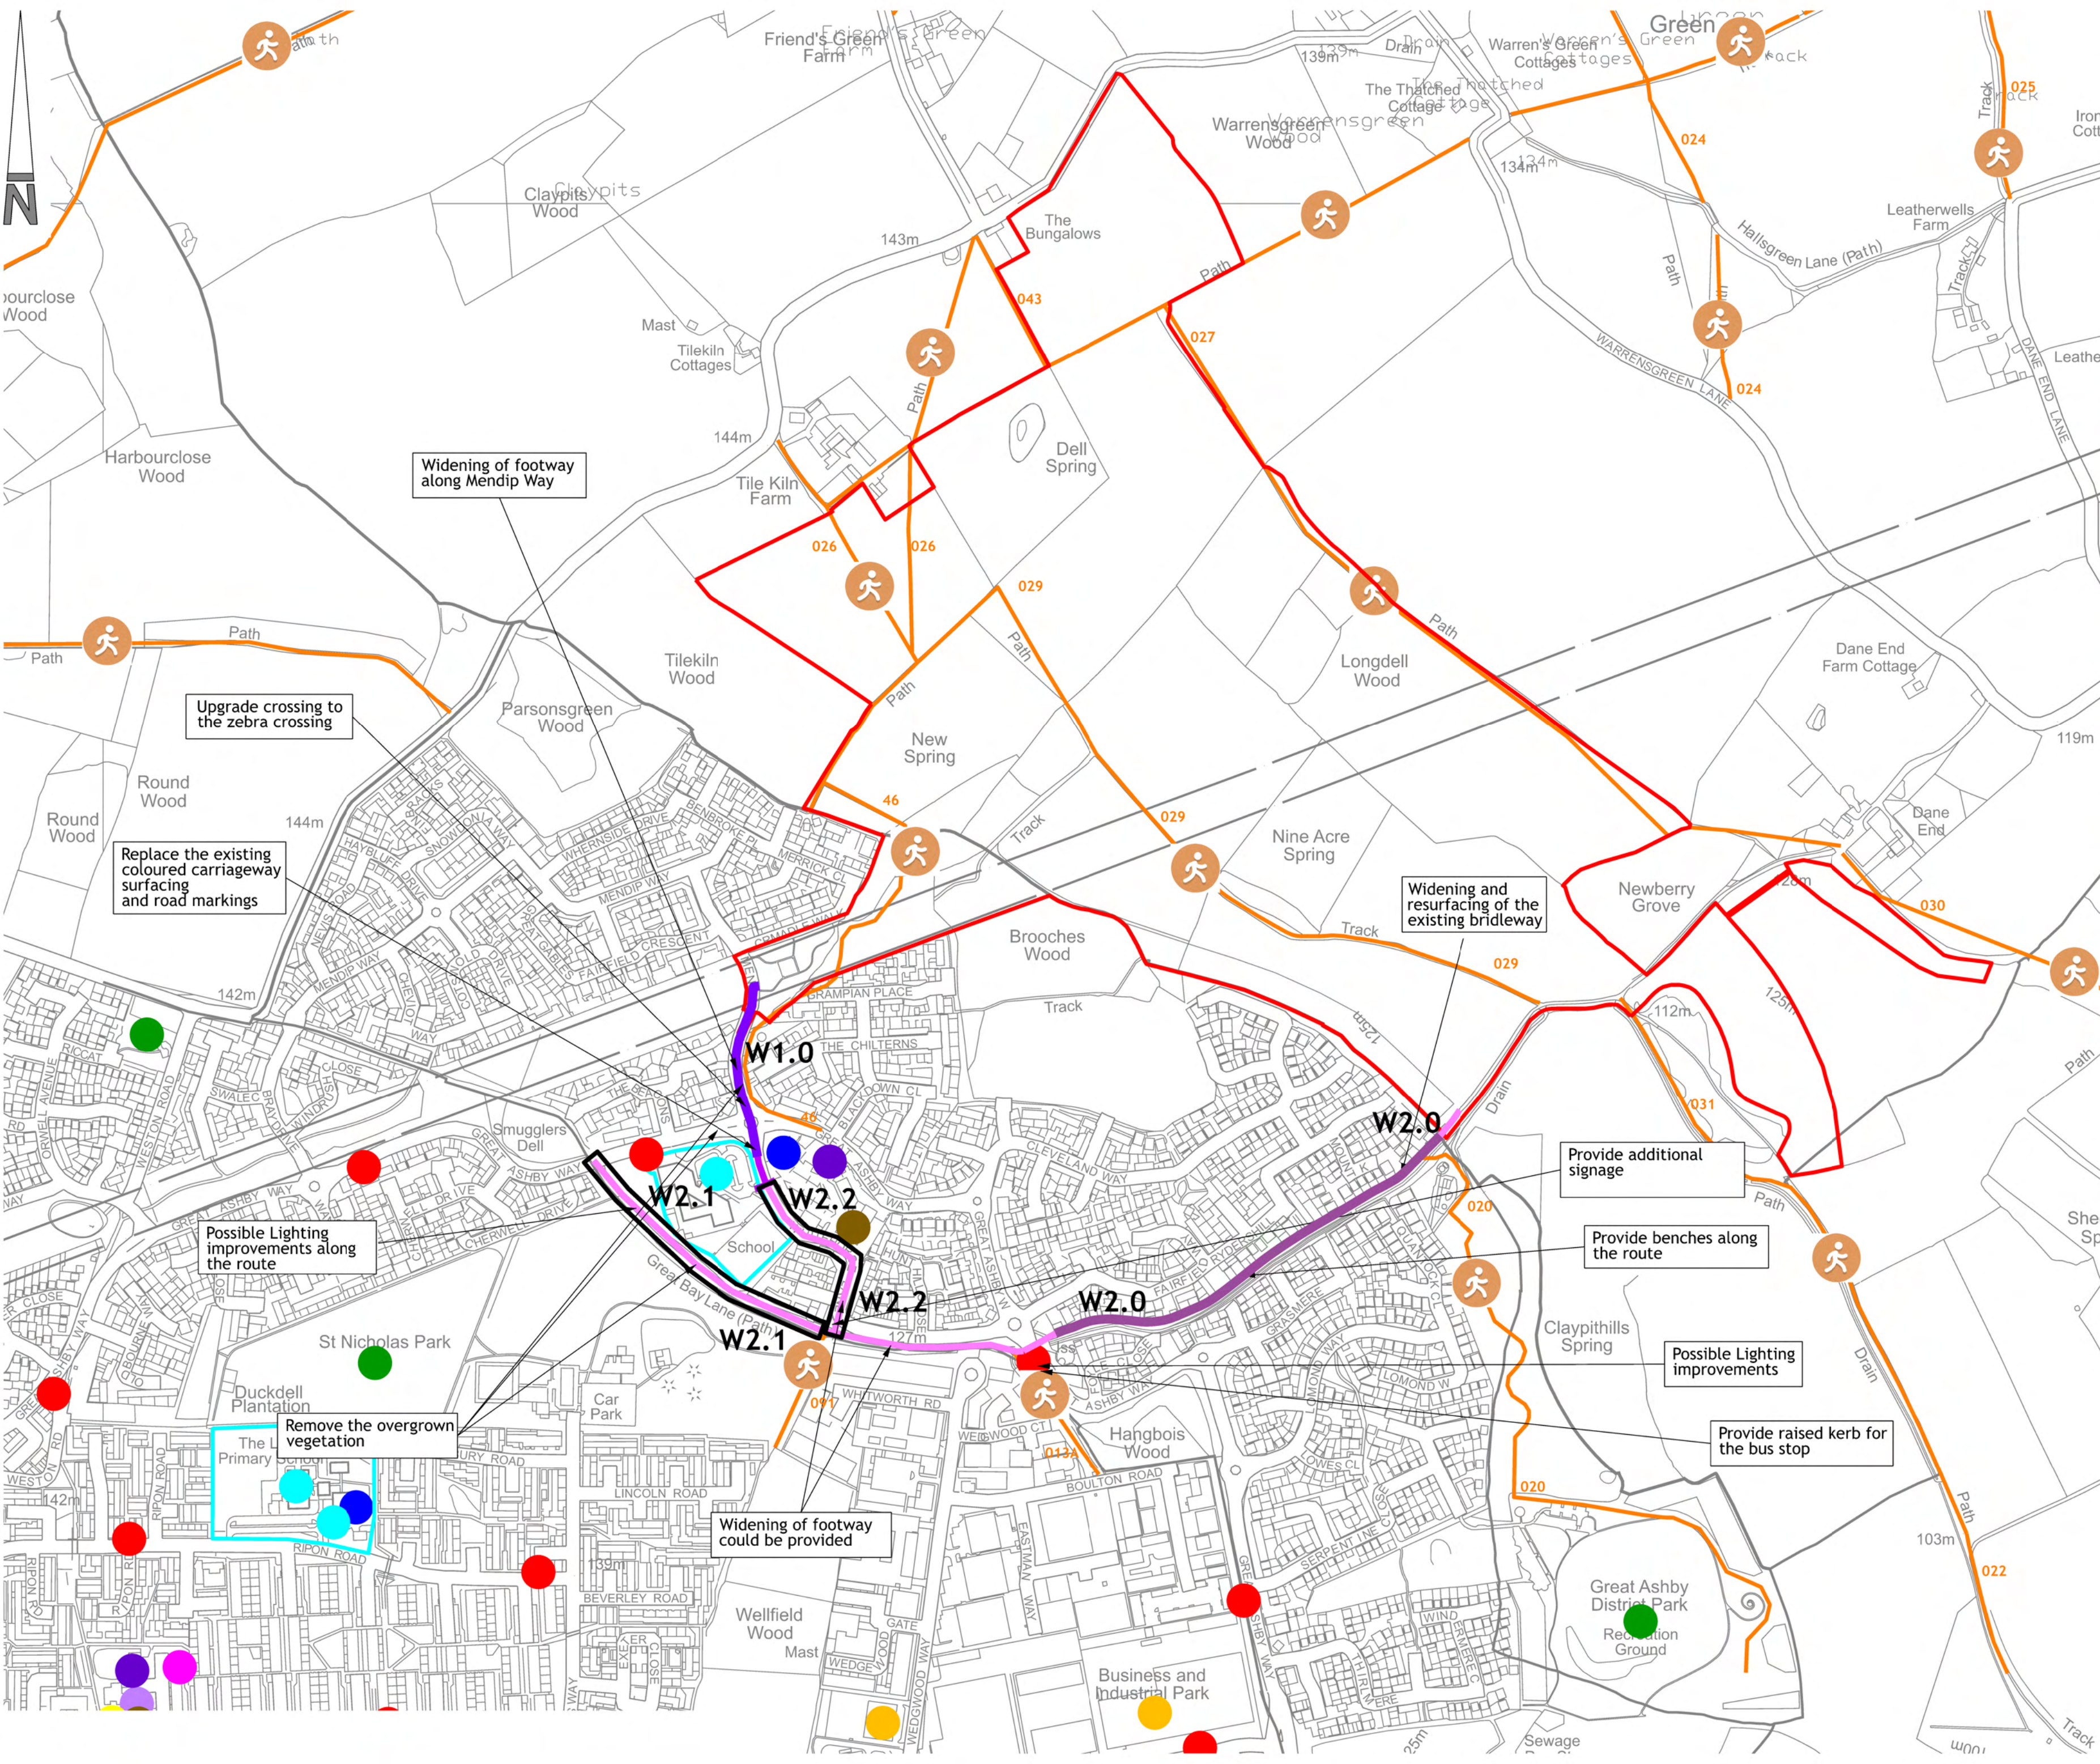
DRAWING NO. 19244-ASHB-5-121 REV D

- KEY**
- Application Site
  - Public Right of Way - Foopath
  - Accessibility Audit Walking Route 1.0 (WRAT)
  - Walking Route 1 Possible widening location
  - Accessibility Audit Walking Route 2.0 (WRAT)
  - Accessibility Audit Walking Route 2.1 (WRAT)
  - Accessibility Audit Walking Route 2.2 (WRAT)
  - Walking Route 2 Possible widening location
  - Bus Stop
  - School
  - Nursery / Pre-School
  - Employment Centres
  - Community Halls
  - Pharmacy
  - GP Surgery
  - Convenience Shop
  - Cafe / Pub / Restaurant
  - Park / Outdoor space
  - Places of Worship

DETAILS ACCESSIBILITY AUDIT WALKING ROUTES POSSIBLE IMPROVEMENTS

| Comments | overgrown vegetaion along eastern footway on Mendip Way ; Eastern footway less than 1.5m just before roundabout Mendip Way / Great Ashby |
| Actions | trim overgrown vegetation along eastern footway on Mendip Way; possible widening of footway along Mendip Way |
