## 206: Tilehouse Street

Design and Access Statement

Loft conversion and new dormer to create new home office. This will include alterations to the double bedroom on the second level. The proposed works also include an extension of the existing basement, consisting of a new utility and w/c at the front of the property. Existing coal chute opened up to introduce natural light at the front. New lightwell to the rear garden.

23 Tilehouse Street

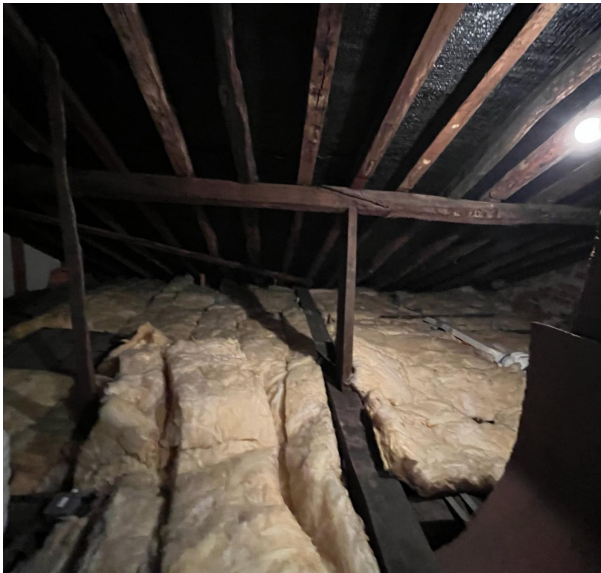
The existing roof structure from within the loft

| EXTERIOR ELEVATIONS AND ELEMENTS | | | | |
|---|---|---|---|---|
| The Existing roof/loft area | Moderate | Moderate | <p>Evidential:<br/>The roof structure is formed from a combination of handcut timbers and some sawn timbers. Reviewing the timbers, the notches, peg holes and junctions there is evidence that these were not originally in the current configuration or indeed re-used from other buildings, re-assembled at later date into the current roof form. The date of this assembly and the nature of more contemporary bracing , roof felt and modern fixings suggests that this was toward the end of the last century.</p> <p>Historical:<br/>The existing chimney is visible within the loft space, and the brickwork is visible here where it is plastered in the floors below. The top of the existing ceilings are visible in the loft area. A plaster and lath ceiling is visible over the bedroom at the front, a plasterboard ceiling is visible with evidence of more recent ceiling joists over the bedroom to the rear indicating the more recent removal of this ceiling. Whilst the evidential value of the flat ceiling to the rear bedroom may be moderate, its historic value is low.</p> <p>Aesthetic:<br/>The aesthetic significance of the loft space is moderate in nature due to the presence of the historic timbers however the structure itself is contemporary and the linings and roof finishes are low.</p> | Historical Significance is moderate, with a higher level evidential significance to the front side of the property |

Mitigation:  
- The existing roof timbers whilst appearing historic are not originally configured , and have been re-used as part of a mid-late 20th century alteration of the existing roof. The front area of roof would be retained, and the rear portion which incorporates a number of more recent sawn timbers along with re-used historic timbers would be reconfigured to create the new dormer. The alteration would be in-line with the previous life of the roof elements; involving the re-use of the historic timbers as part of the new construction and an ‘honest’ repair methodology undertaken to retain a degree of legibility between new and historic structural elements for future generations. The rear pitch of the roof is set at an angle and profile which does not appear original within the limits of historic tiled or slate roofs and timber elements therefore it is considered that there is a limited evidential or historic heritage loss as a result of these alterations.

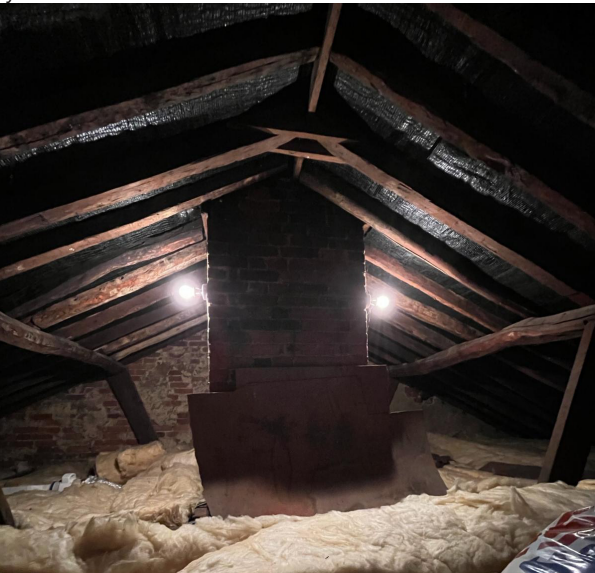
The existing chimney from within the loft

| Chimney breast/stack | Considerable | High | Historical, Evidential and Aesthetic: The existing chimney contributes to the streetscape of tilehouse street, and its central position in the plan of the property is evidence of the pre-Georgian era design of properties where these elements were located off the gables. | |

- To clarify the existing chimney will be retained, repaired using lime mortar (existing cement removed) and exposed internally, with new clay pots resulting in a modest heritage gain

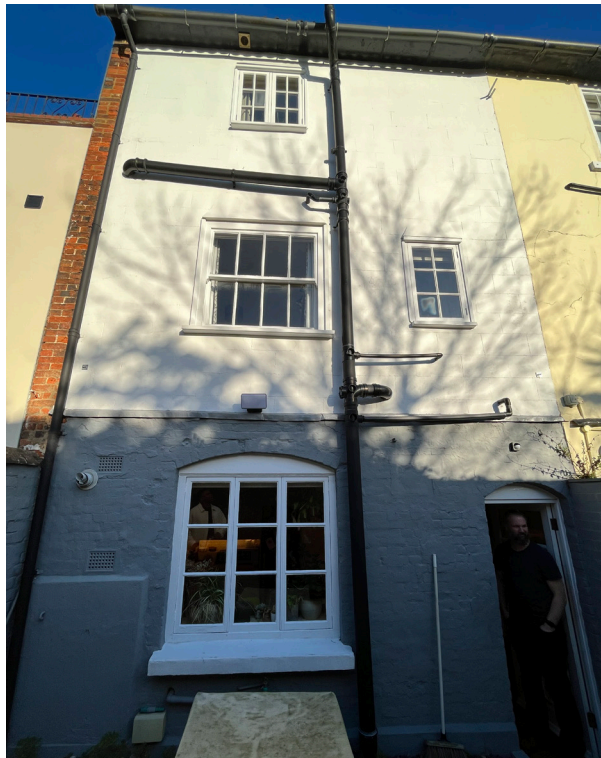
The rear elevation from the yard area

South Western elevation:  
Existing render good condition + lower level brickwork in variable condition  
Existing timber framed windows in moderate condition.  
Existing roof pitch in poor condition

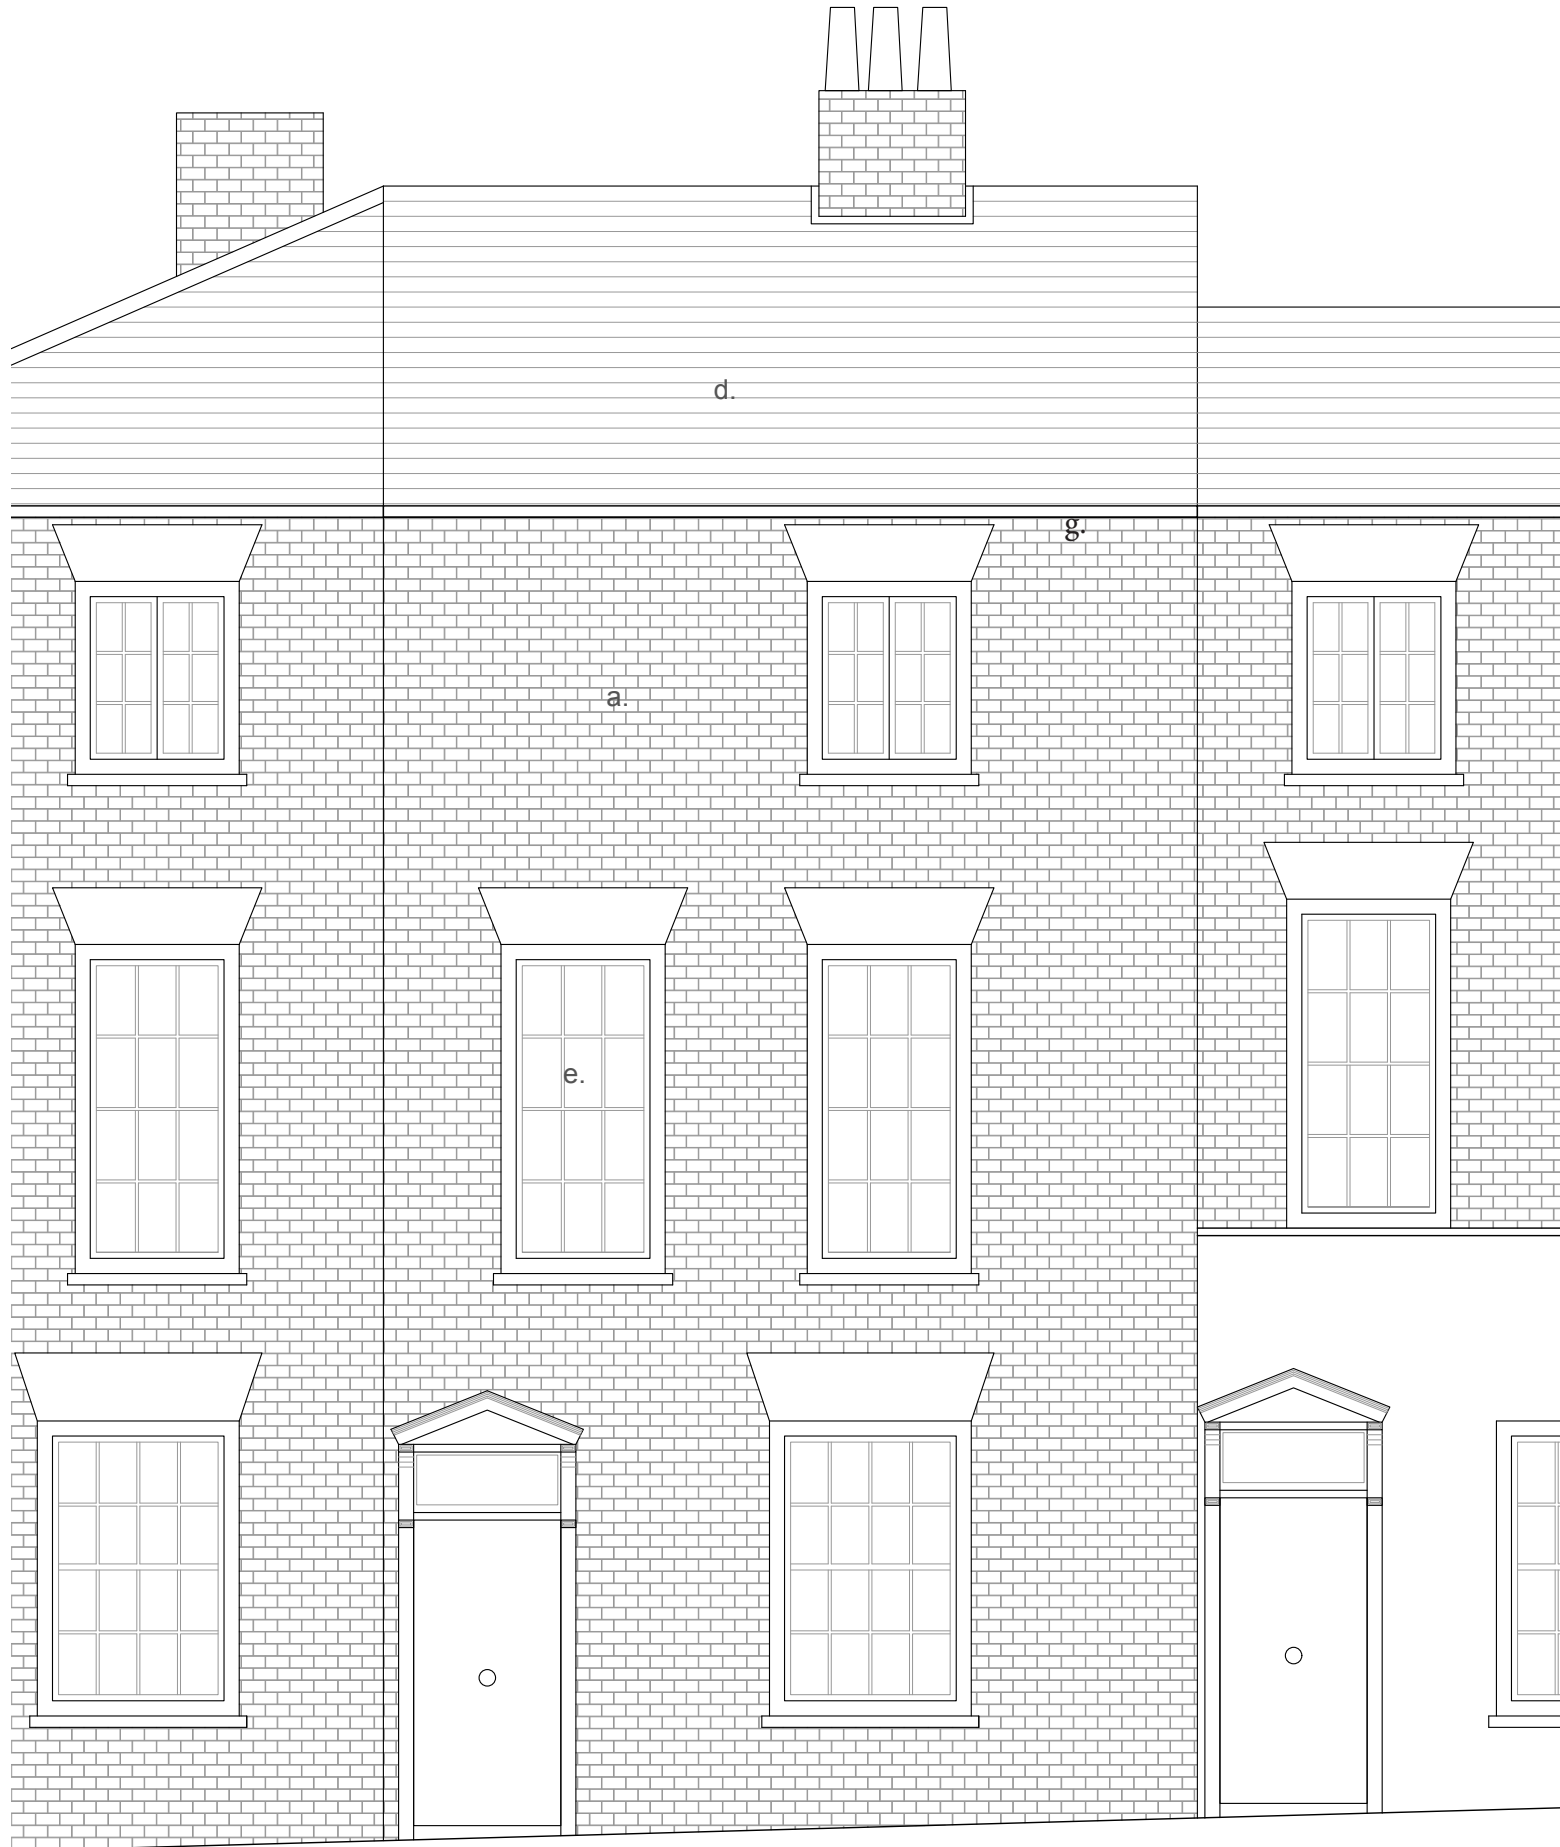
Job No. 206 Existing Front Elevation

- a. Existing brickwork
- b. Existing painted Brickwork
- c. Existing Painted Blockwork
- d. Existing clay tile roof
- e. Existing timber sash and case windows
- f. Existing 2 meter high fence
- g. Existing Rainwater goods

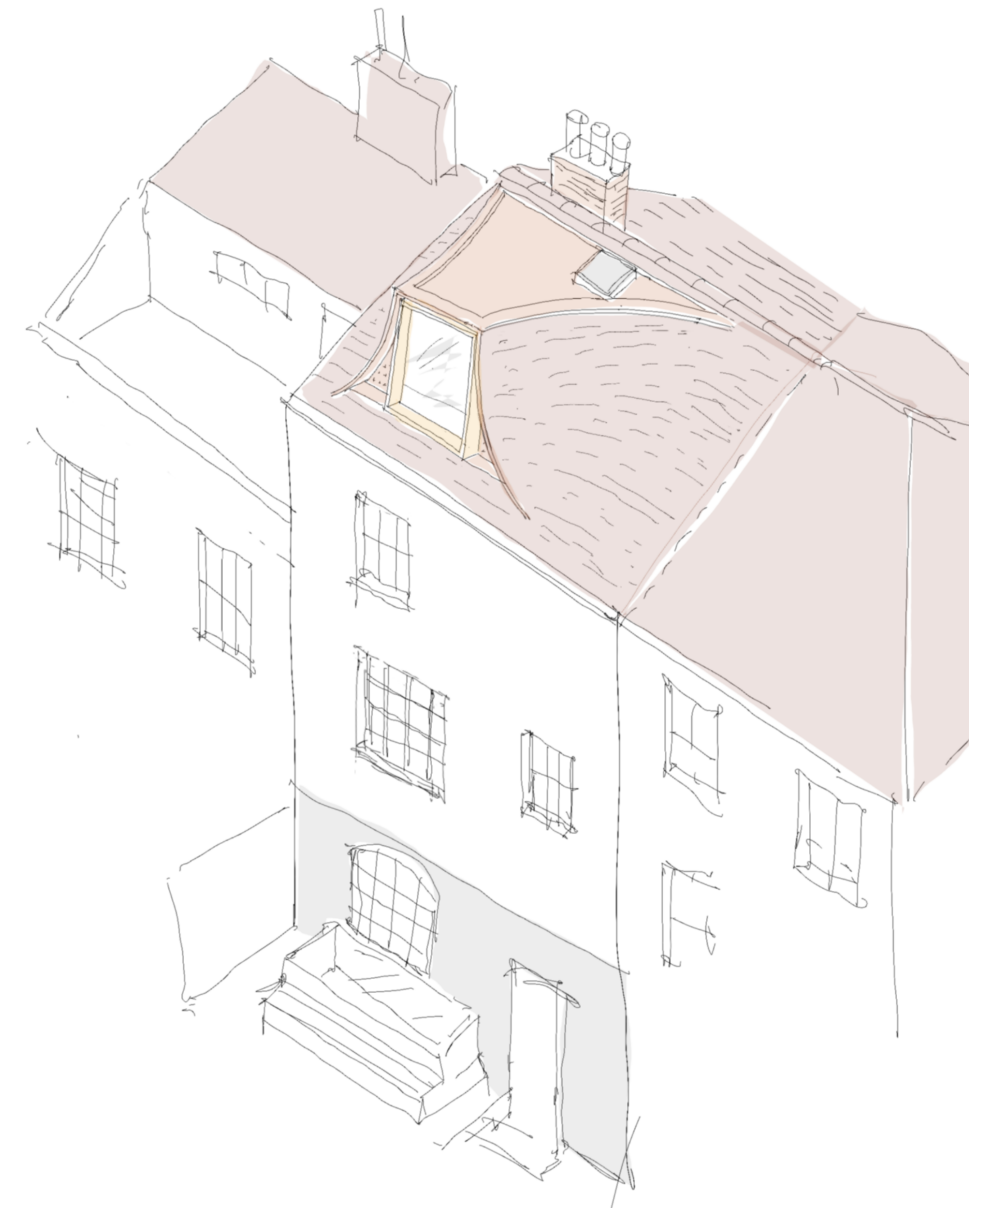
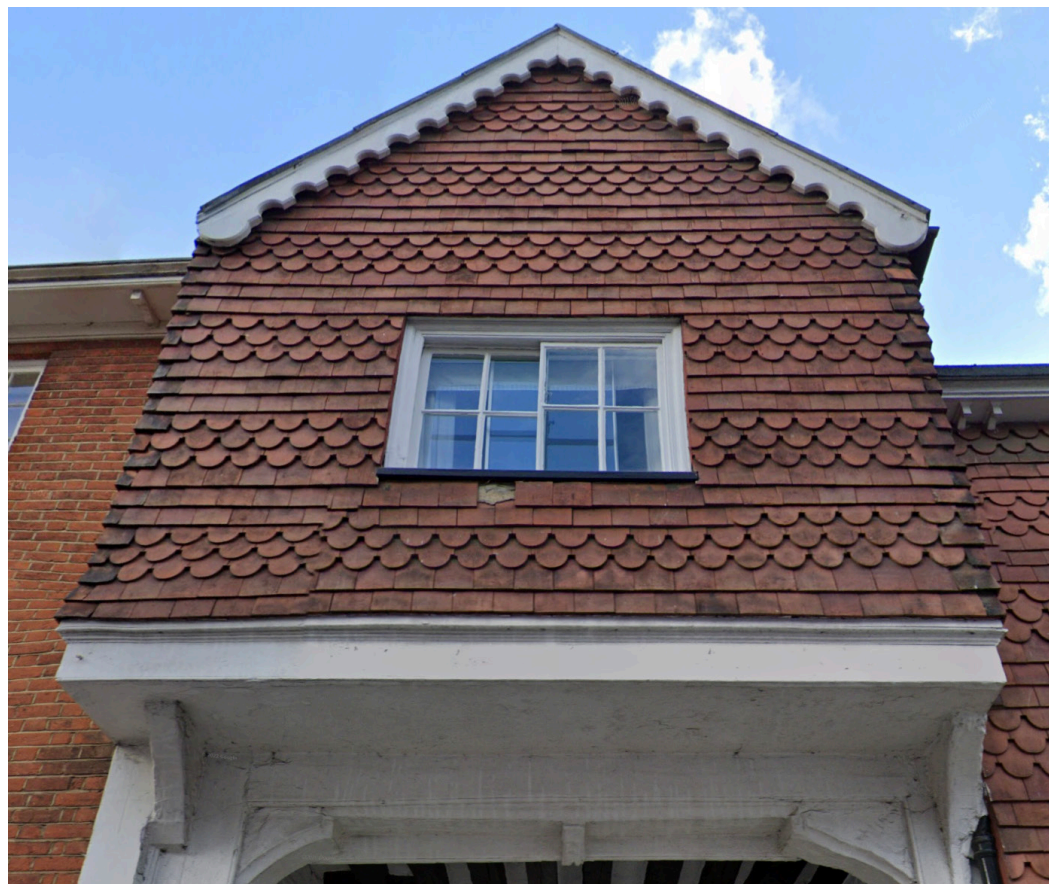
- The new swept dormer has chamfered sides that avoid overshadowing to neighboring properties.
- Oxidised copper roof detailing./edgings
- The new light well detail will be integrated into a new seating feature
