# HOO FARM, WHITWELL, HITCHIN, SG4 8AE HERITAGE IMPACT ASSESSMENT

FEBRUARY 2025

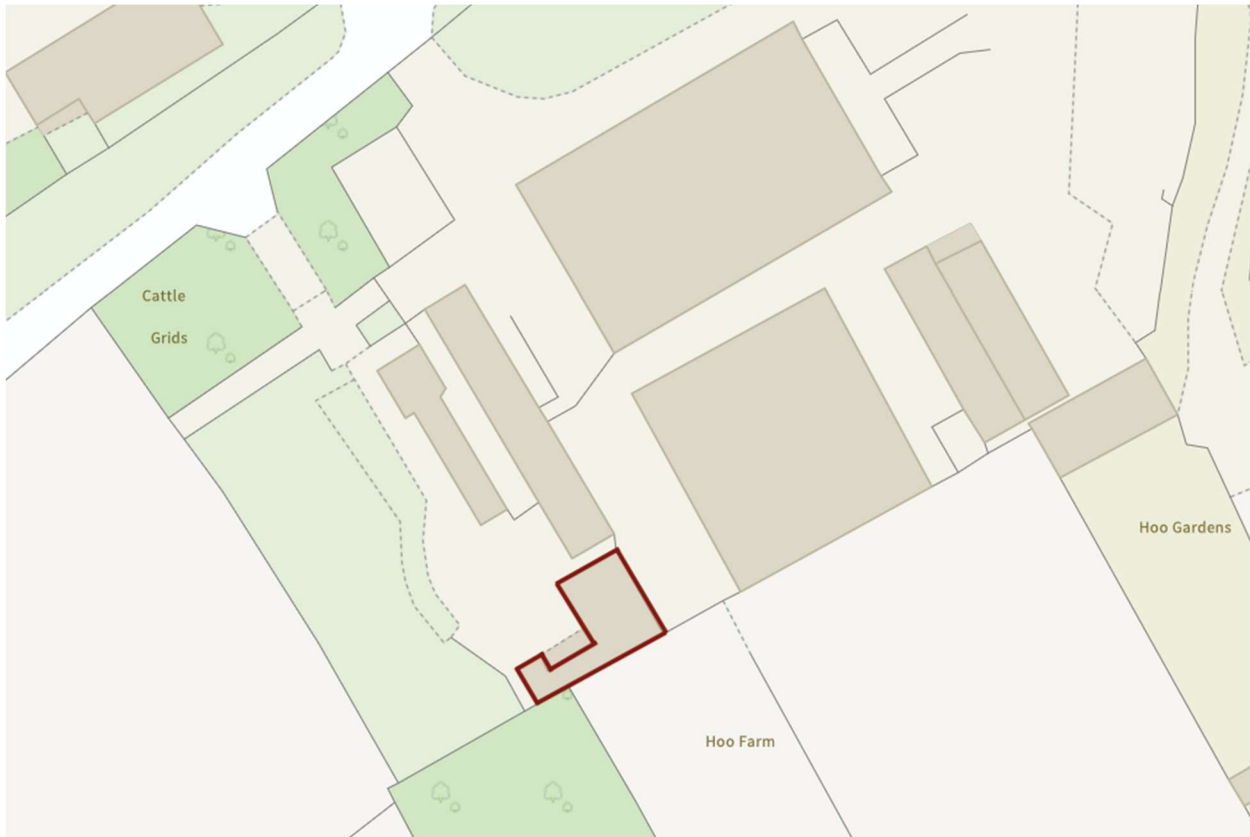
### 1.3 Site plan

Fig. 1 The study site is outlined in red.

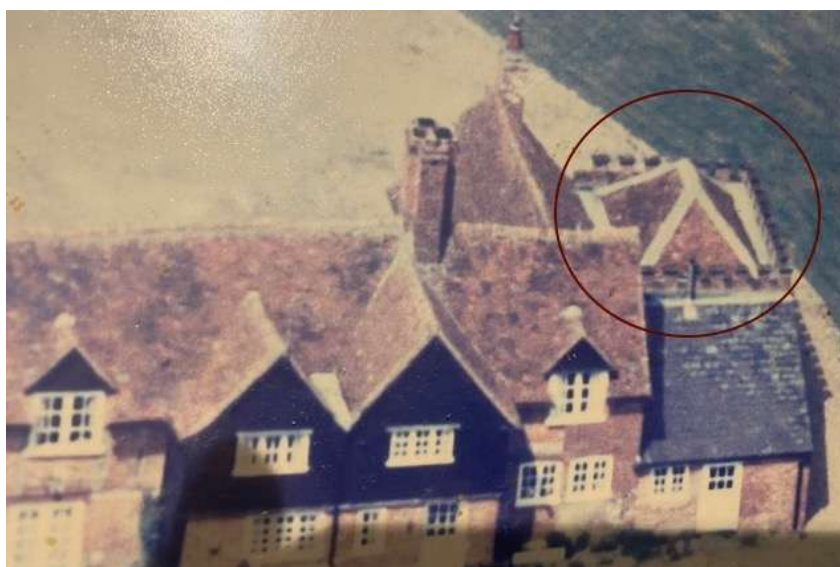
Fig.19 Fig. Castellated roof similar on the Hoo Estate[Source:Family photograph]

The roof has undergone alterations, with a previous castellated parapet replaced by a mono-pitch slate roof. While the top segments of the arched window's glazing remain, the lower sections have been replaced, and the south and west elevations now feature modern metal-framed rectangular windows, which detract from the historic character of the structure. The original glazing and castellated parapet suggest an early Gothic Revival influence, characteristic of the late 18th century.

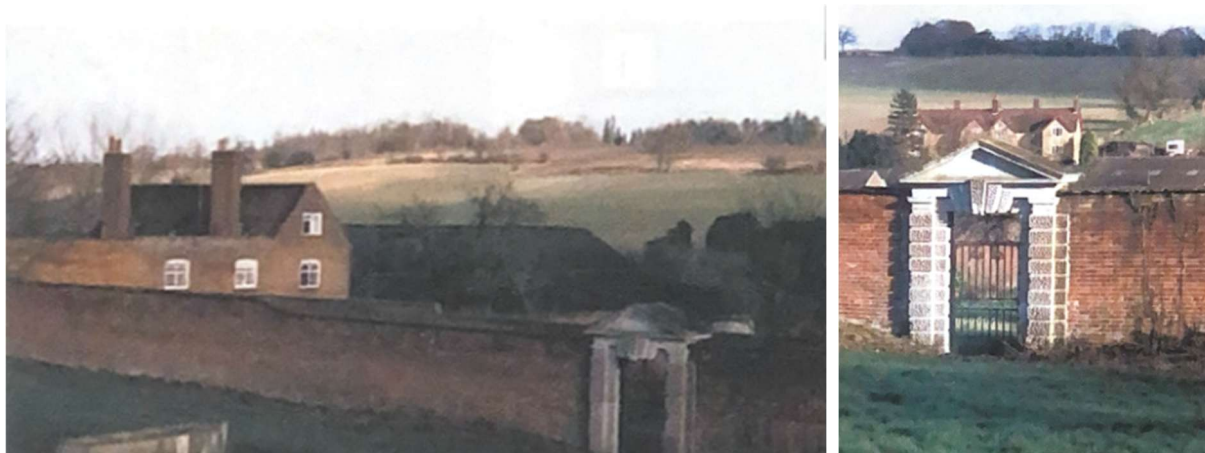
Figs.21-22 Boundary walls and entrances to Kitchen Garden LHS Hoo Farm RHS Entrance from former mansion site.  
[Source: Herts Gardens Trust]

The physical relationship between the farmhouse and the walled kitchen garden suggests a direct link to estate food production. Surviving structural elements, including original doorways, remnants of glasshouse foundations, and access routes, provide valuable evidence of historical land use and agricultural practices. Situated within Hoo Park, a registered historic park and garden, the farmstead retains its rural character and contributes to the estate's broader historical landscape.

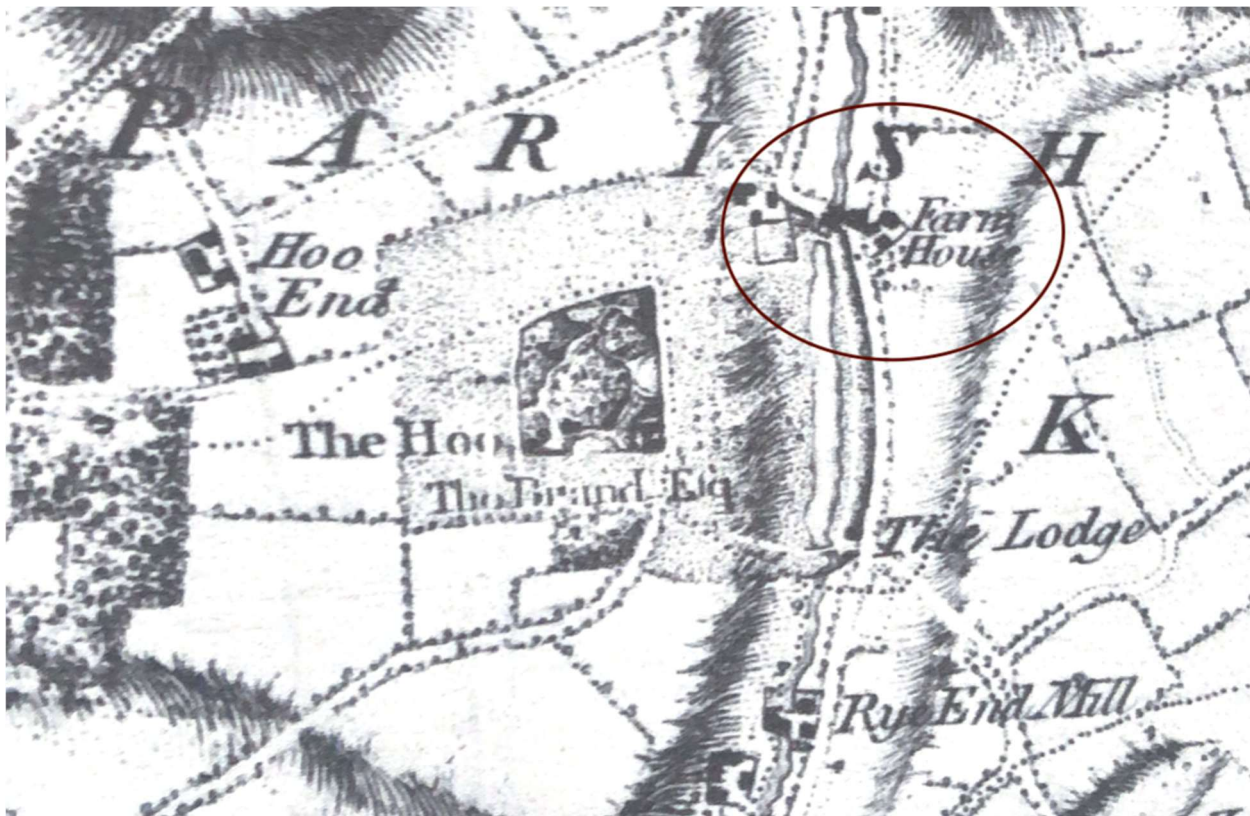
Fig.24 Drury & Andrews' County Map 1766

In the middle of the 18th century the estate was remodelled to create a landscape park which was first shown on the county map by Drury and Andrews, 1766 [Fig.24]. The map shows an extensive roughly square park with an area of ornamental shrubbery or woodland at its heart containing serpentine paths. The house occupied the south-east corner of the shrubbery/wood and was approached by a lane from the direction of Kimpton to the south-west. The course of the former drive is hinted at and other secondary drives and paths headed north-east and east from the northern corner of the shrubbery towards the farm. A building identified as 'The Lodge' stood between the bridge and the public road at the south east corner of the park. West of the northern end of the lake, at the north-east corner of the park, was a simple, square walled garden and adjacent was Hoo 'Farm House'.

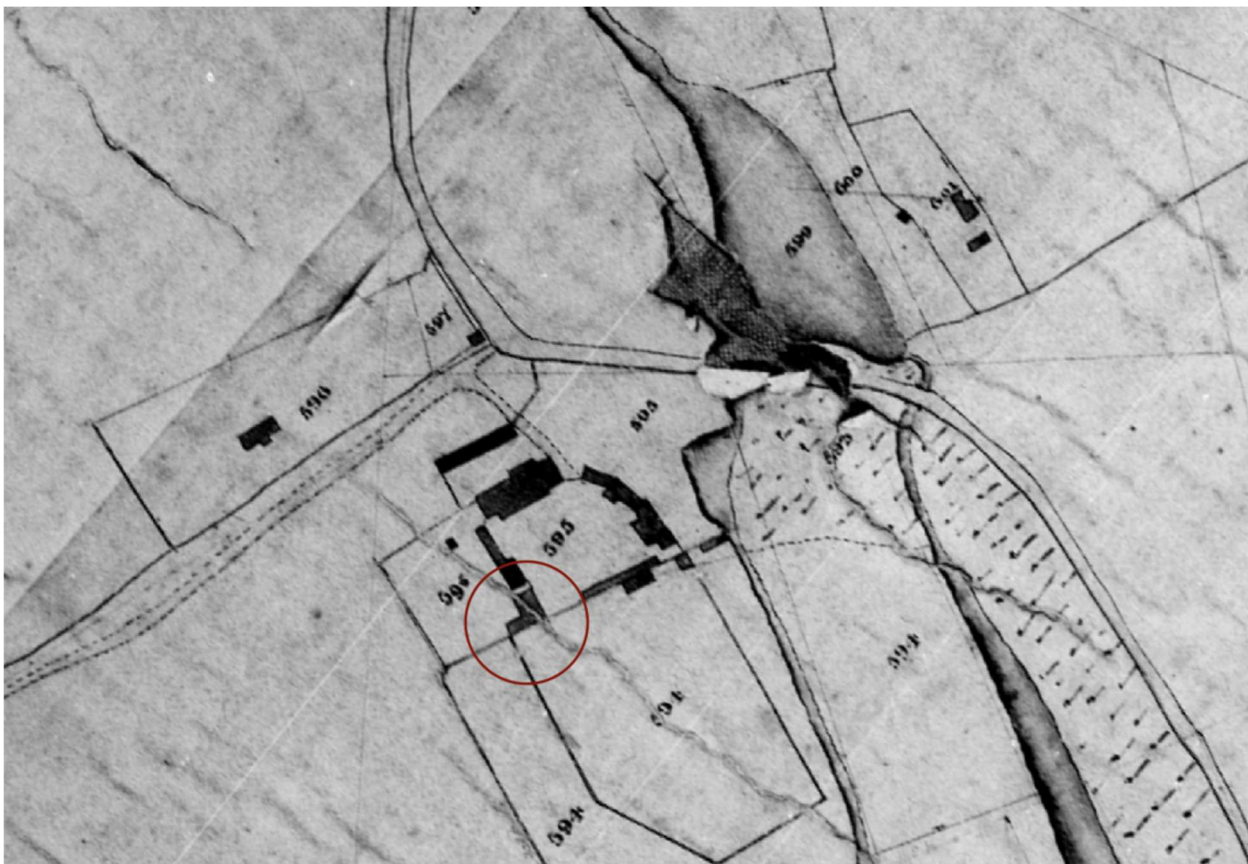
Fig.25 Tithe map 1841: plots 595 'Farm Homestead' & 594 'Garden Wilderness' [Source: <https://www.thegenealogist.co.uk/>]

Detail of the footprint of the buildings at Hoo Farm can be gained from a Tithe map (1841) [Fig.25]. The house and attached dairy have attained their current form with farm buildings arranged around a central yard. The large building on the north is a threshing barn. South of the house is a large rectangular enclosure with the western corner omitted that is described in the tithe record as a 'Garden Wilderness'.

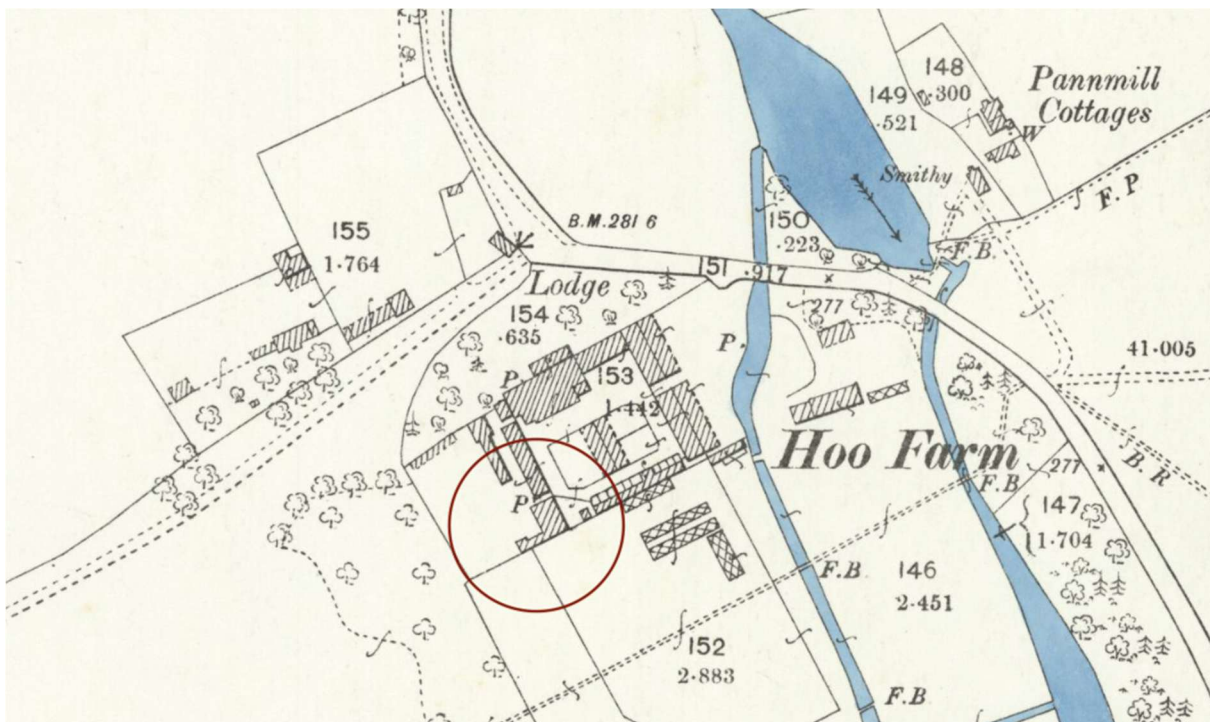
Fig.27 Hertfordshire Sheet XX.9, Revised 1898 Published: 1897 Size: OS 25" Reproduced with the permission of the National Library of Scotland

Comparison between the Tithe Map and the 1897-98 Ordnance Survey Map [Fig.26] reveals key changes at Hoo Farm, showing its evolution from a compact farmstead with a few central buildings into a more structured and diversified operation. By the late 19th century, additional structures - glasshouses denoted by cross-hatching, and outbuildings suggest agricultural expansion and increased functionality tied to its primary purpose as the 'home farm' for The Hoo. Infrastructure improvements, including a more established road network and refined boundaries, indicate deliberate landscape shaping, linked to the Hoo Estate's parkland. Changes in land use reflect a shift from open agricultural fields to walled enclosures used for horticulture, and the developed infrastructure near water sources points to enhanced water management. Overall, these transformations reflect broader 19th-century trends in rural estate management and adaptation, and the Victorian ideal of a productive home farm to primarily meet the estate owners' domestic needs.

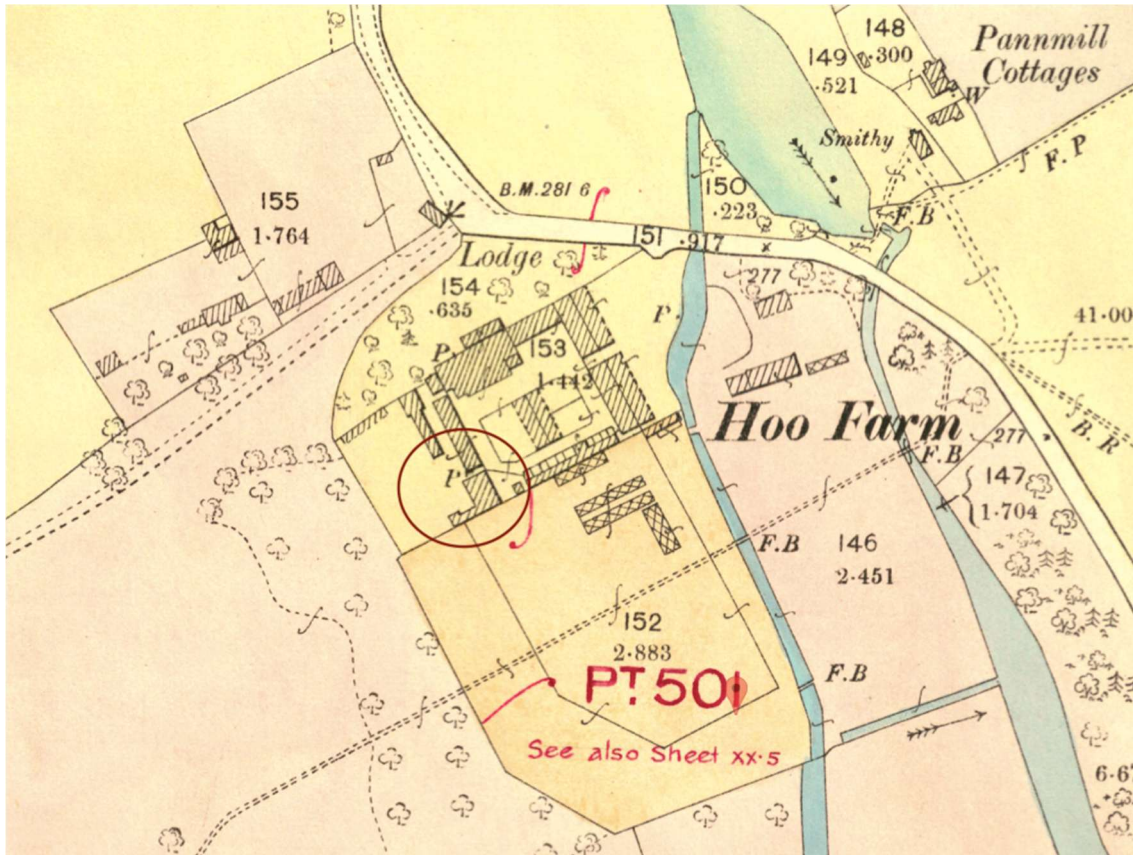
Fig.28 District Valuer Annotated Map : Lloyd George' Domesday Survey 1910-14

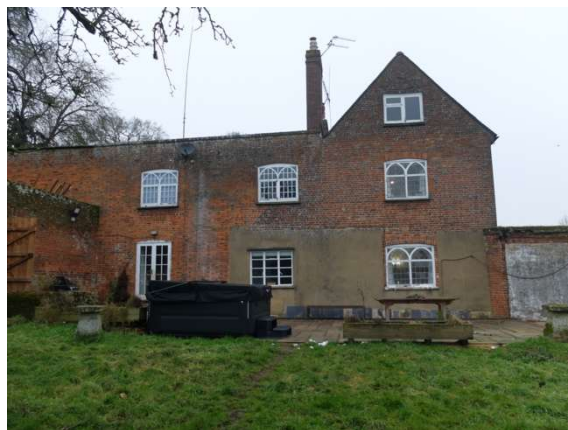
Fig.32 S facing with Gothic Revival feature windows

The windows on the south walled garden elevation of the farmhouse are distinctive with an arched upper section, which consists of a pair of semi-circular arches with decorative intersecting glazing bars, forming a fan-like pattern. The glazing comprises small individual glass panes, held in place by lead cames. The lower sections of the windows consist of square and rectangular panes arranged in a grid pattern, contrasting with the elegant curves of the upper arches. This Gothic Revival inspired detail adds an element of architectural refinement to the otherwise simple brick façade. The windows are set within segmental brick arches.

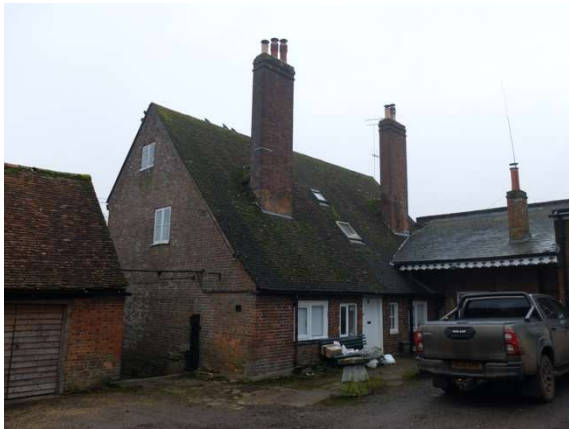
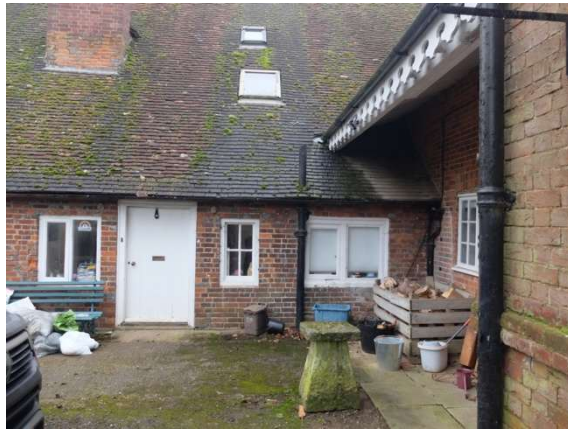
Figs.33 & 34 Yard elevation W with single storey section connecting to the former Dairy

The main entrance in use is on the west elevation facing into an open courtyard. Here the farmhouse is two storeys with an attic, featuring a symmetrical arrangement of sash and casement windows. Some windows have been replaced with modern uPVC units, although original features such as brick arch lintels and timber frames remain. The south elevation faces the Walled Kitchen Garden. This side is more irregular, with a taller gabled section likely representing an early core of the building. The connection between the farmhouse and walled kitchen garden is historically significant, suggesting a link between domestic and agricultural functions.

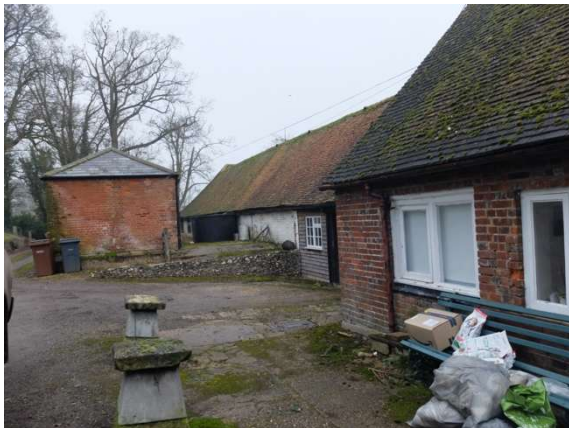
Fig.35 Looking N towards farm outbuildings

The setting of a heritage asset is defined as ‘the surroundings in which a heritage asset is experienced’ (NPPF, Annex 2: Glossary). The farmhouse is approached from a lane from the north running alongside several of the low brick barn ranges. Farm buildings, north and east of the farmhouse are arranged in a traditional courtyard layout, with barns and outbuildings forming a defined working yard. Barns and Stables are constructed of red brick, some with black timber weatherboarding on upper sections. These appear to be 18th or early 19th century, originally serving as stables and storage. There are several large 20th-century barns, with steel and timber frames infilling the central area of the yard used for livestock and equipment storage.

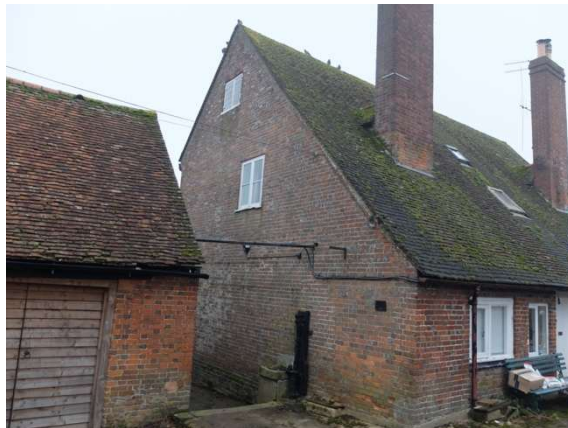
Fig.36 N gable and catslide roof

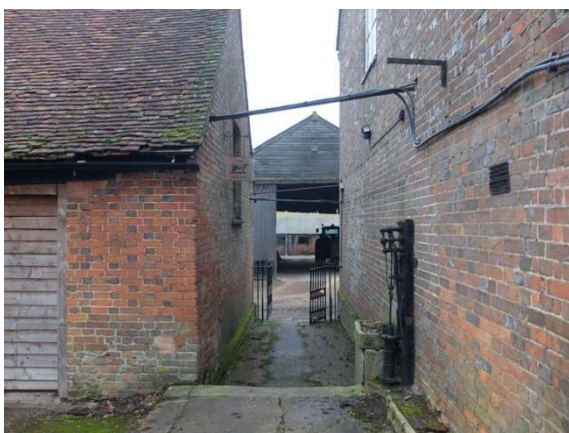
Fig.37 Change of level sloping from E to W

Internally the plan form has been adapted around a symmetrical footprint accommodating changes in floor levels reflecting the sloping nature of the site from west to east. The principal east facing main elevation is rarely used and the main focus of the house is on the west where the current kitchen and former dairy is located. There is a central staircase in the main range and a very steep winder stair leading off a sitting room formed in the single storey link extension between the house and dairy. Despite its unusual configuration the basic plan form of the house and dairy is unchanged since the 19th century as shown on tithe and OS maps.

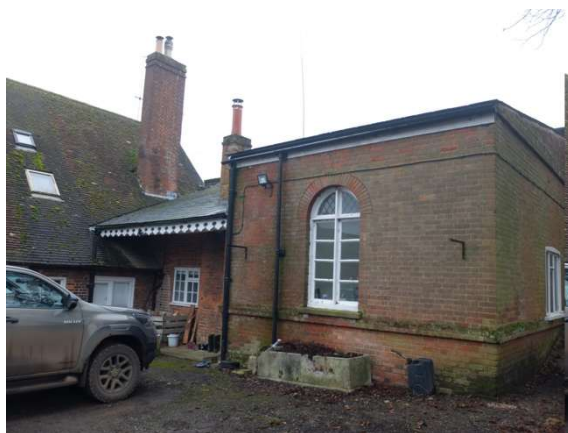
Fig.38 Former dairy with arched window

The former dairy wing consists of a single-storey extension featuring a large arched window, likely part of an original series of at least three, designed to maximize natural light and create an airy internal space. Dating from the late 18th to early 19th century, the dairy has since been repurposed for domestic use.

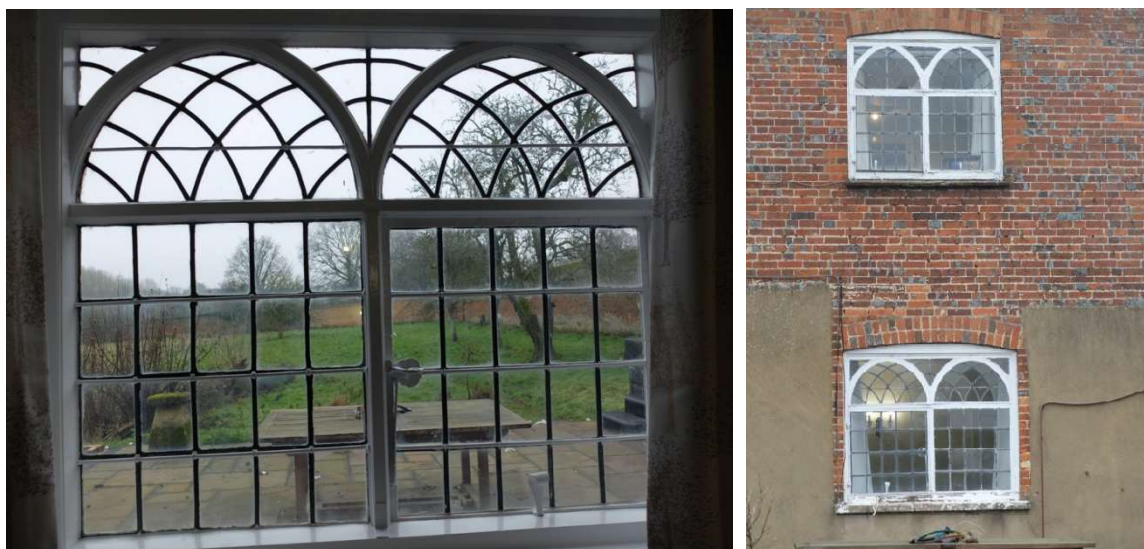
Fig.39 & 40 Gothic Revival influenced glazing on S elevation of farmhouse: timber frames and lead comes.

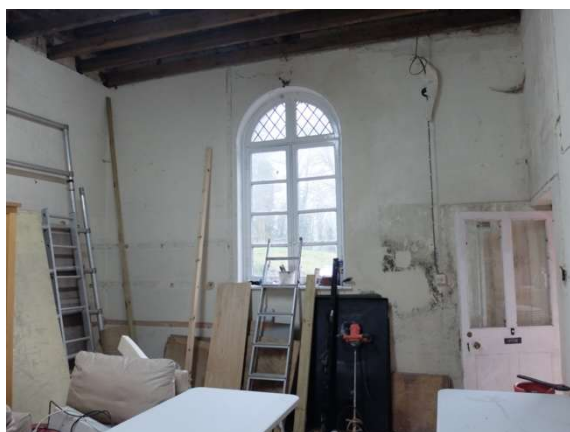
Fig.41 Arched window in the former dairy.

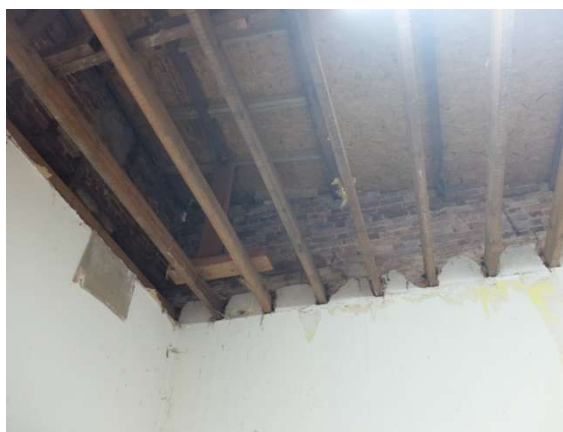
Fig.42 Roof structure exposed due to a leak in the SW corner

The 2016 roof works have failed in part and a new covering is proposed of artificial interlocking slates, a lighter weight material that will not put undue stress on the outer walls. The new roof form will include a verge, rear parapet, and eaves for the kitchen extension.

The roof of the kitchen extension, which underwent repairs in 2016, has partially failed, necessitating further intervention. The proposed lightweight artificial slate roof provides a practical alternative that will reduce stress on the outer walls. Additionally, the inclusion of a verge, rear parapet, and eaves respects an earlier form of the building while addressing structural deficiencies. There is reasonable evidence to suggest that this section of the building has been significantly altered in the past. If implemented sensitively, the replacement roof will enhance the structure's longevity without compromising its historic character. Adjustments to the roofline will not obscure or detract from historic elevations or architectural detailing.

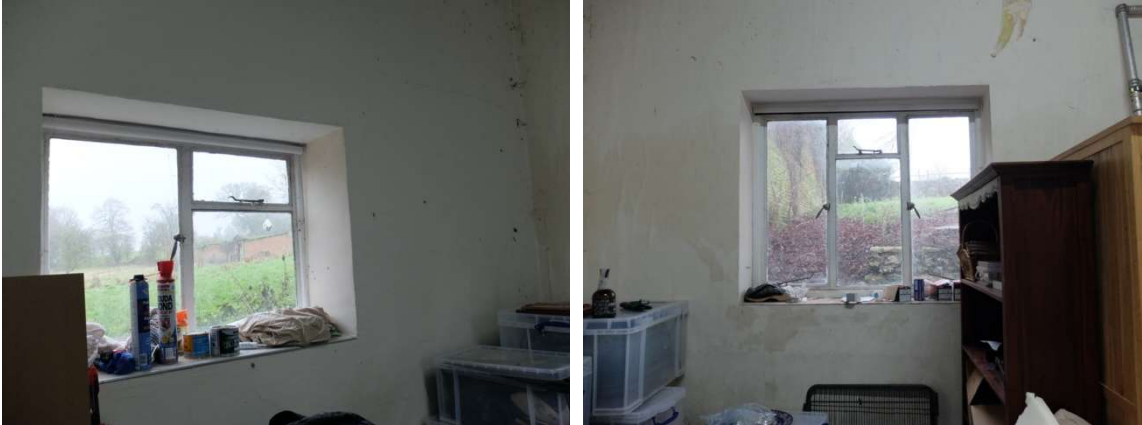
Fig.43 & 44 Metal-framed replacement windows in the former dairy.

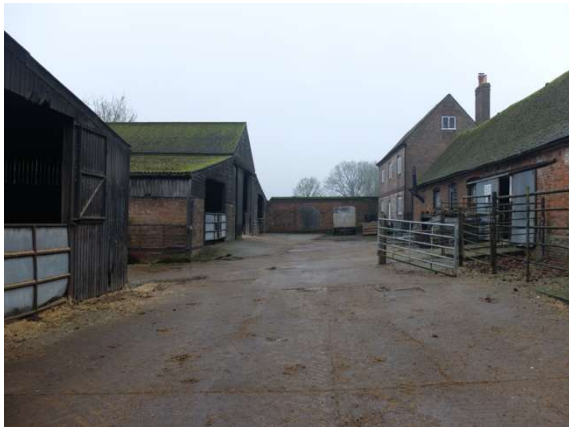
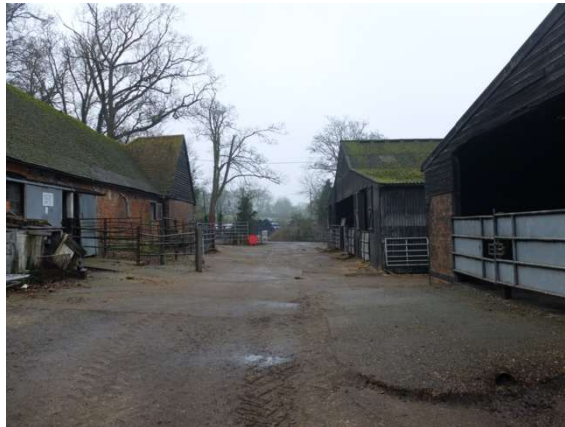
Fig.45 & 46 Central axis LHS looking S towards walled garden and farmhouse RHS N following the line of barns and sheds

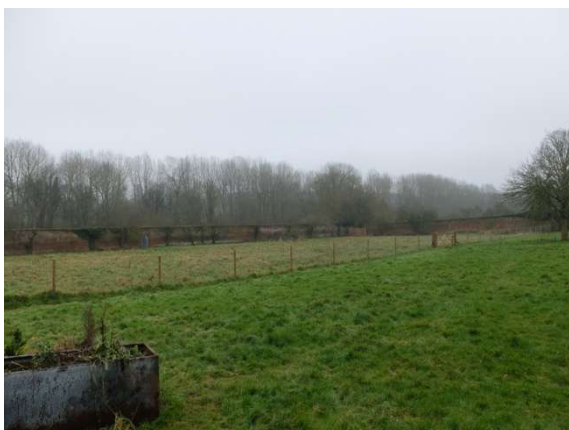
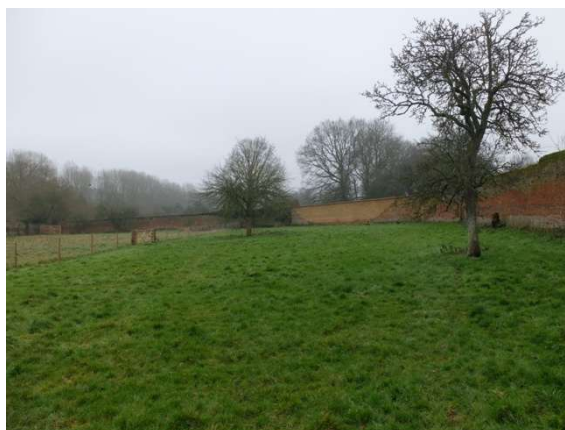
Fig.47 & 48 The walled garden S of the farmhouse

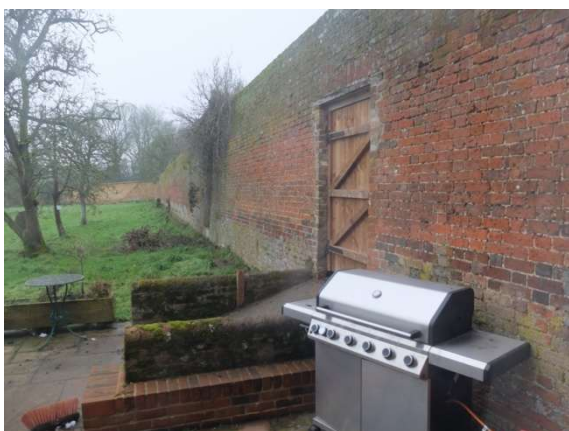
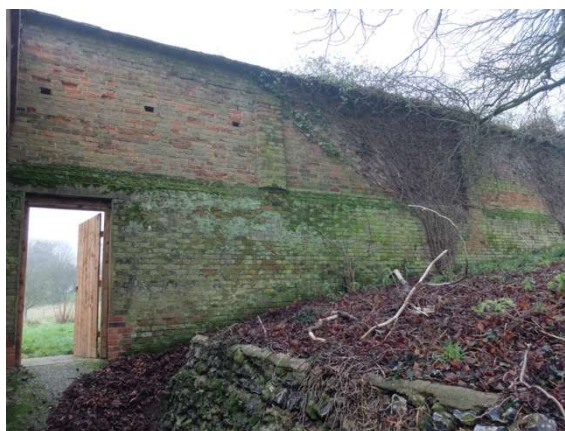
Fig.49 & 50 Boundary walls of varying heights and phases of construction.

The walled kitchen garden, located to the south, is a substantial and historically significant feature, enclosed by high brick walls that retain remnants of original gateways and glasshouse structures. The walls are constructed in Flemish bond, incorporating angled brick buttresses in a contrasting brick, likely added at a later date but exhibiting a clear design intent. Several doorways are set into the walls, framed with either stone or brick headers. The height of the walls varies, with some sections capped with stone or mortar, while others are partially overgrown with ivy.

Externally the listed walls that surround the garden (former kitchen garden) have structural issues and it is proposed that the height is raised by one brick course to improve weather resistance. There is a programme

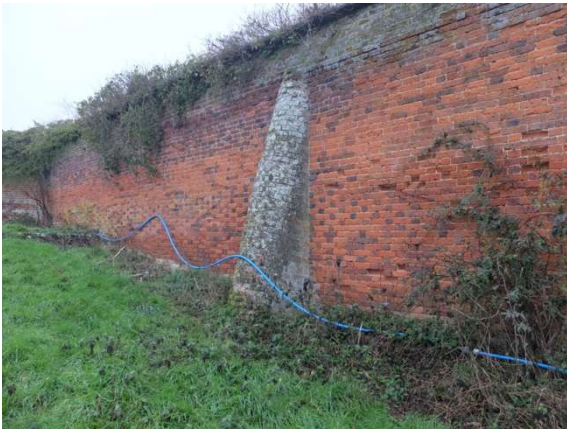
Fig.51 Brick buttresses and diaper brickwork

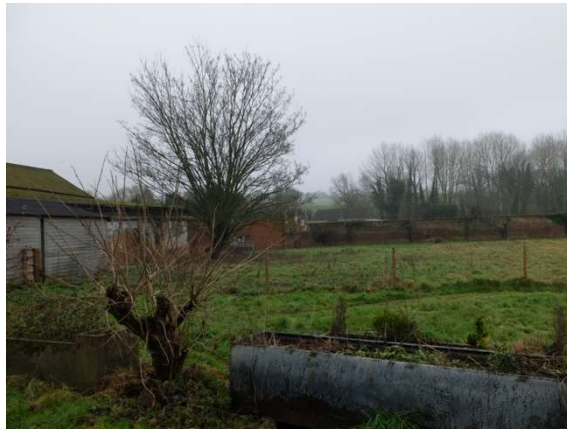
Fig.52 Timber stables in place of glasshouses looking E
