## Preliminary Roost Assessment

Highwood, Hitchwood Lane, Preston, Hitchin, Hertfordshire SG4 7RY

This report is prepared to inform a planning application with the North Hertfordshire District Council. The proposal is described as:  
The renovation and repurposing of an agricultural building into a domestic dwelling.

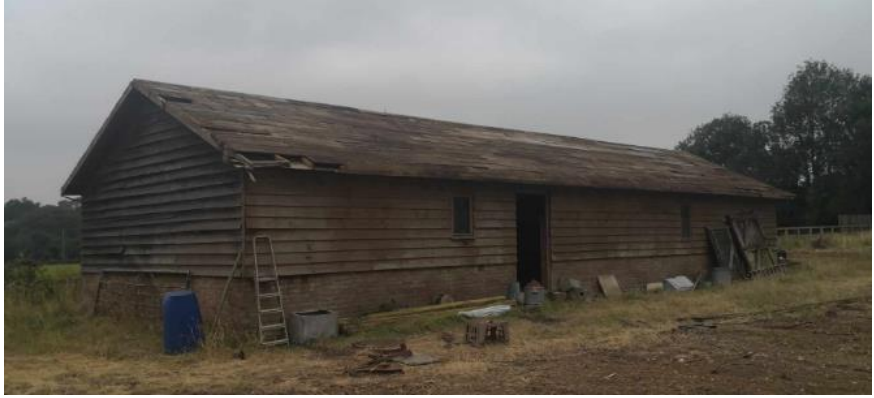
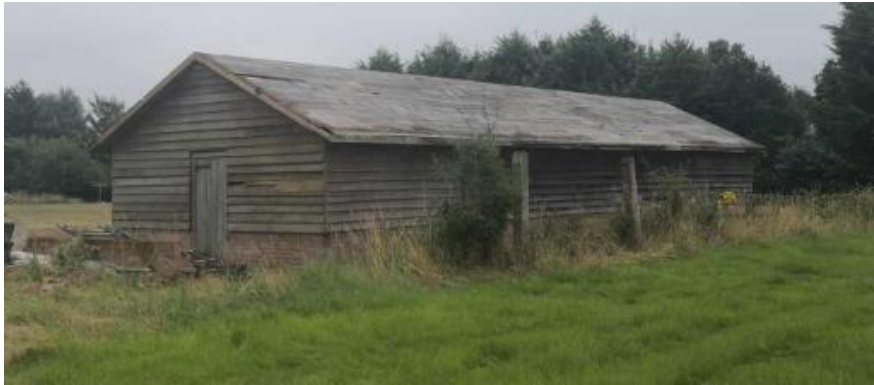
| Field survey results | Photos |
|---|---|
| <p><i>Summary of Survey Findings (including UKHabs codes)</i></p> <p>There is one building on site.</p> <p><b>u1b5</b></p> <p>The chicken shed (<b>B1</b>) is a timber and concrete brick structure, previously used as its namesake. The exterior of <b>B1</b> is constructed of timber cladding, which contains a multitude of gaps and holes as the wood has aged. Warped timber cladding makes excellent roosting habitat for crevice dwelling bats. However, the lack of insulating material between the exterior cladding and interior wall does not provide optimal shelter from wind and as such lowers the value of this feature for roosting bats. There are no exterior roofing materials on <b>B1</b>. According to the client, the exterior roofing materials of <b>B1</b> were torn off during a storm earlier in 2024; the last remnants of the roof are sarking boards attached to the battens. These allow a great deal of light spill to the interior.</p> <p>The interior of <b>B1</b> is bare and lacks finish. Exposed</p> | <p><i>Figure 1. South and east elevations of <b>B1</b>.</i></p> <p><i>Figure 2. North and west elevations of <b>B1</b>.</i></p> |

| <i>Recommendations</i> | <p><b>Roosting habitat</b></p> <p>Due to the low value for roosting bats, one bat emergence and re-entry survey (BERS) is required for <b>B1</b> during the active bat season (May – September) to confirm presence or likely-absence of bats roosting in or on the building. Two surveyors assisted by night vision aids (NVAs) are to provide adequate coverage of all elevations. In the unlikely event a bat roost is identified within <b>B1</b>, further licencing will be required, including a European Protected Species Licence (EPSL) application to Natural England. The EPSL application requires that all surveys have been undertaken within the most recent active bat season and planning permission must have been granted and all relevant wildlife-related conditions have been discharged prior to submission.</p> <p><b>Foraging and commuting habitat</b></p> <p>Lighting mitigation may be required based on the BERS outcome.</p> <p>Further site enhancements to follow post BERS.</p> |

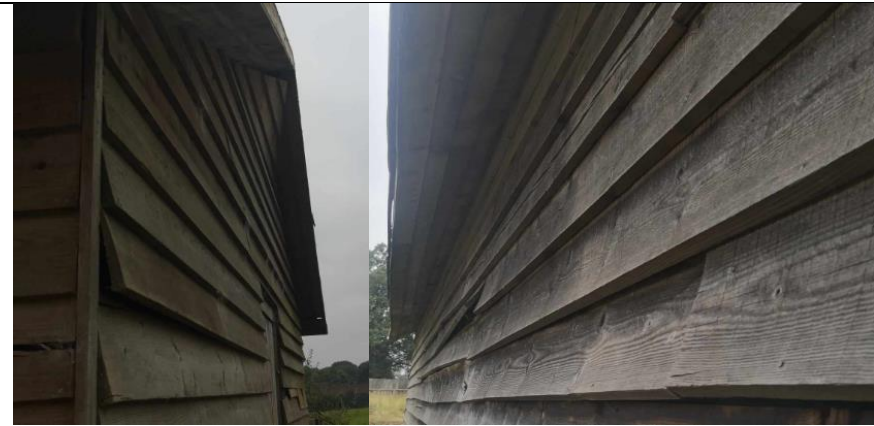
*Figure 3. Two examples of warped exterior cladding, north and west elevations, respectively.*

| Foreseen Impacts | <p>At time of report no formal plans are available.</p> <p><b>Roosting habitat</b></p> <p>To the author's knowledge, <b>B1</b> is to undergo extensive refurbishing to accommodate the repurposing of the building from agricultural to domestic. As the exterior wooden cladding is unfit for purpose, it is likely to be removed during developments. Any bats present within <b>B1</b> at times of works may be disturbed, injured or killed.</p> | |

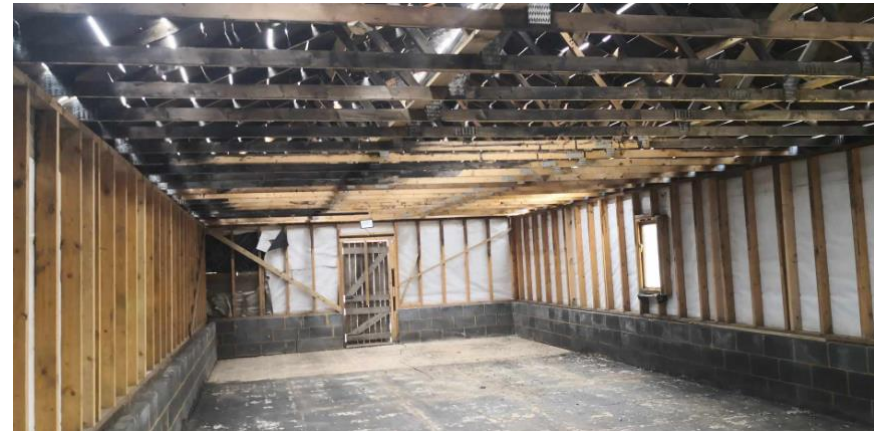
construction beams are visible, as are sheets of damaged building paper. This paper is the only separation from the interior to the exterior timber cladding, with the exception of a section of exposed breathable membrane in the north wall. There are two small windows on the east elevation of **B1**. As such there are very few dark areas of the building and the exposed nature of the interior makes **B1** relatively inhospitable to bats. Nonetheless, it is possible for bats to make use of the interior as a feeding roost; no evidence of such usage was found.

*Figure 4. Interior of **B1**, facing north. Exposed construction paper visible throughout. Breathable membrane visible at left of northern elevation.*

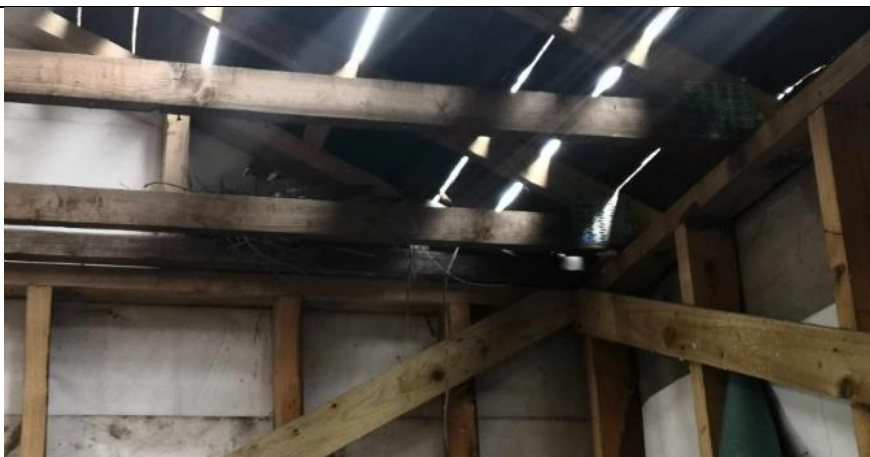
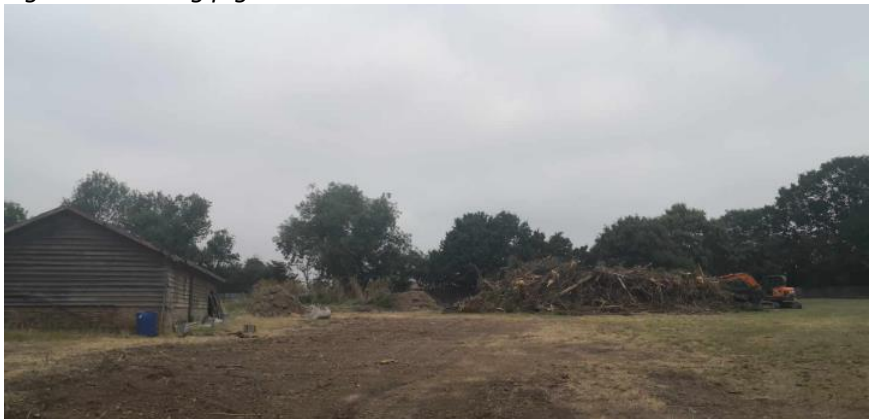
| | <p>leading to the property remain intact.</p> <p>Given the current state of the building, <b>B1</b> is not suitable to host maternity colonies, and it is unlikely that individual bats are using this building for roosting. However, the warped cladding may provide temporary shelter and as such the building is assessed to have <b>low</b> value for roosting bats.</p> | <p>Figure 5. Nesting pigeon.</p> <p>Figure 6. Destroyed vegetation in piles to the north and northeast of <b>B1</b>.</p> |

| Nesting Birds | |
|---|---|
| <i>Recommendations</i> | <p>All active nests to be retained until the young have fledged. As there is an active nest within <b>B1</b> no works may commence until the nest is no longer in use. Following this, any building or vegetation disturbance should be undertaken outside the period 1st March to 31st August. If this timeframe cannot be avoided, a close inspection of the building and nearby vegetation should be undertaken immediately, by a qualified ecologist, prior to the commencement of work.</p> <p>Beyond <b>B1</b>, precautions should be taken with machinery and noise levels when working close to any retained nests so as not to disturb any nearby nesting birds during construction works. At least a 3-5m buffer should be created between any machinery and active nests until the young have fledged.</p> <p>The installation of one bird box on a mature tree on site boundaries or on the redeveloped building will provide additional nesting habitat for birds, e.g. Schwegler No 17 Swift Nest Box (buildings), Bark Boxes Blue Tit 25mm (trees), Woodstone Nest Box (buildings or trees), or a similar alternative brand. Consider a multi-use large bird nest box to provide alternative nesting habitat for wood pigeons.</p> |
