## Old Ramerick Manor

Design and Access Statement  
Hallway and Ensuite Bathroom  
May 2026  
Alison and Kevin Boyle

### Michael Collins Architect Ltd

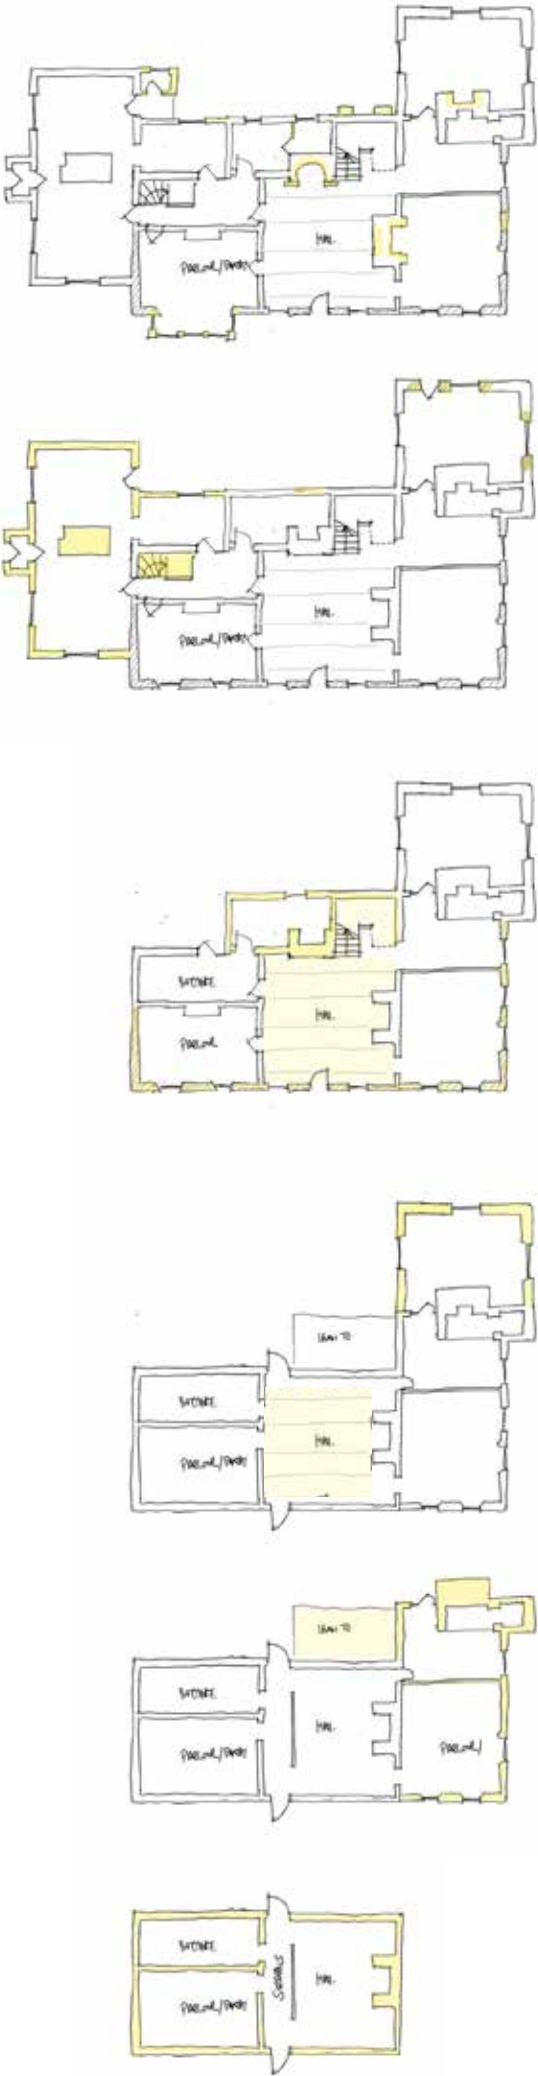
Old Ramerick Manor  
Historic phasing analysis.

Late 19th early 20th Century  
New rear porch, fireplace alterations to the hall, front reception room and rear office. New bay window, rear buttressing and infills.

Early 19th Century  
New service wing, corridor, stairs and alterations to the farm office

Early 18th Century  
Queen Anne agrandissement of the facade, rear stair, fireplace and potential rear lean-to added.

Late 17th Century  
Three storey granary and living extension, hall floored in stages

Late 16th Century  
Two storey Cross wing to the east

14th - 15th Century  
Hall House with 'Solar' to the West

The diagram adjacent illustrates the sequence of alterations from an existing Thatched Hall House which was first recorded on the site in the late 13th Century, it is unclear whether remnants of this exist without detailed dendrochronology, however a visit in 1975 by the Royal Commission of Historic Monuments identified the main entrance hall as being part of a 15th Century timber framed Hall House.

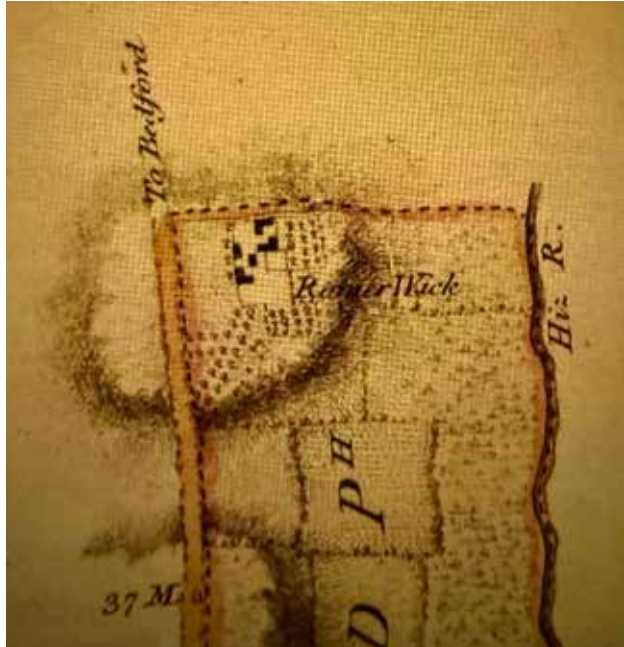
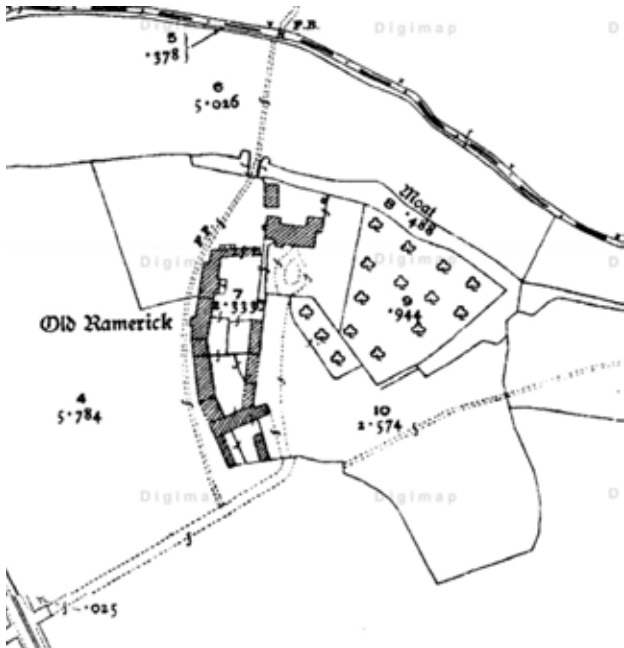
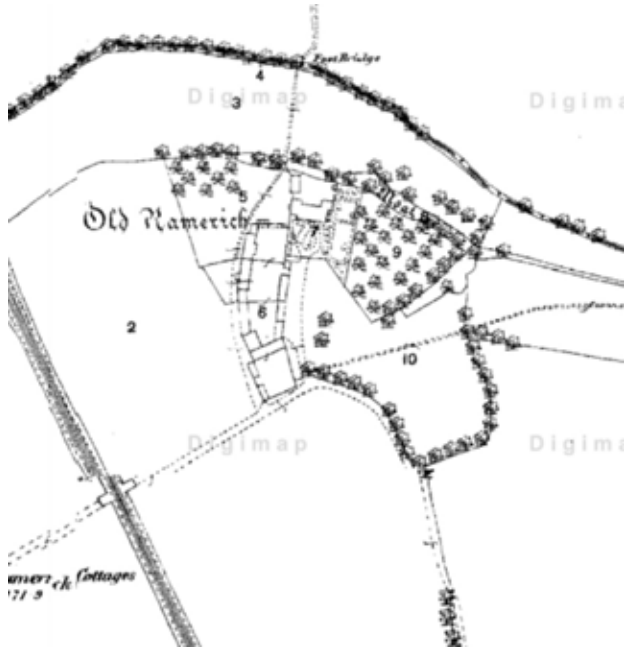
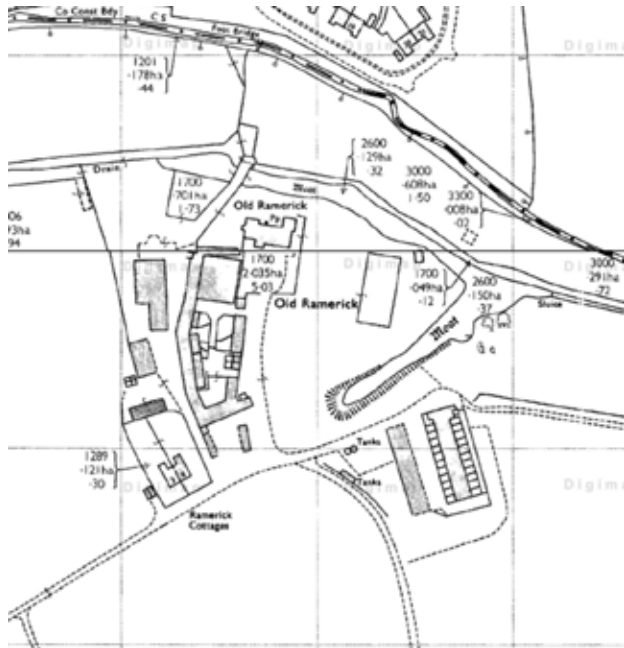
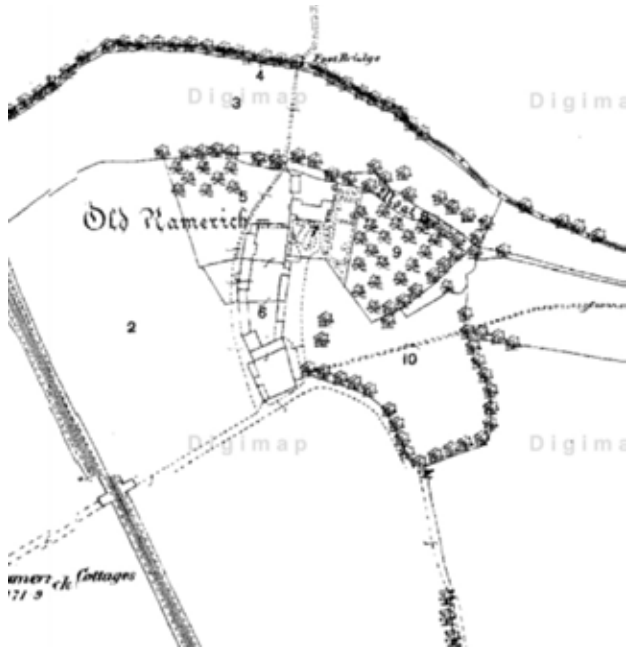
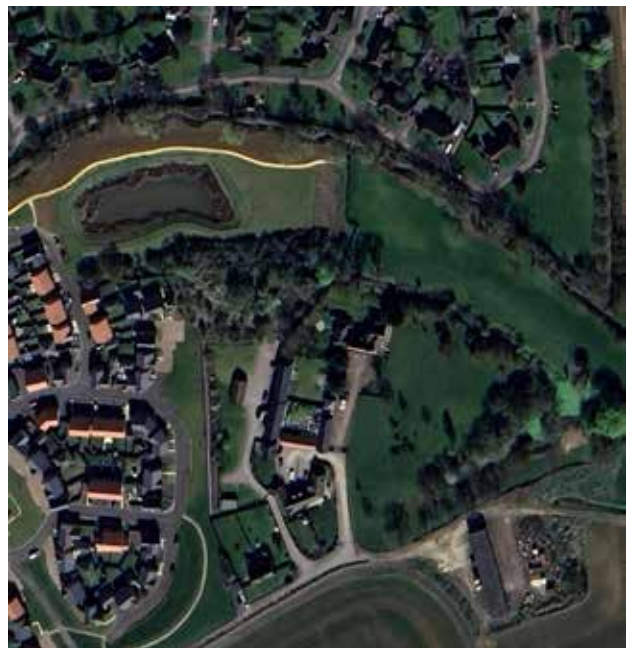
16th Century:  
The eastern cross-wing was built in the late 16th Century to create a kitchen and additional rooms and a further inglenook fireplace currently visible today. There was potentially a rear lean-to evidenced by the precedent set by an existing roof pitch to the north. At this time the property was a large farm-house.

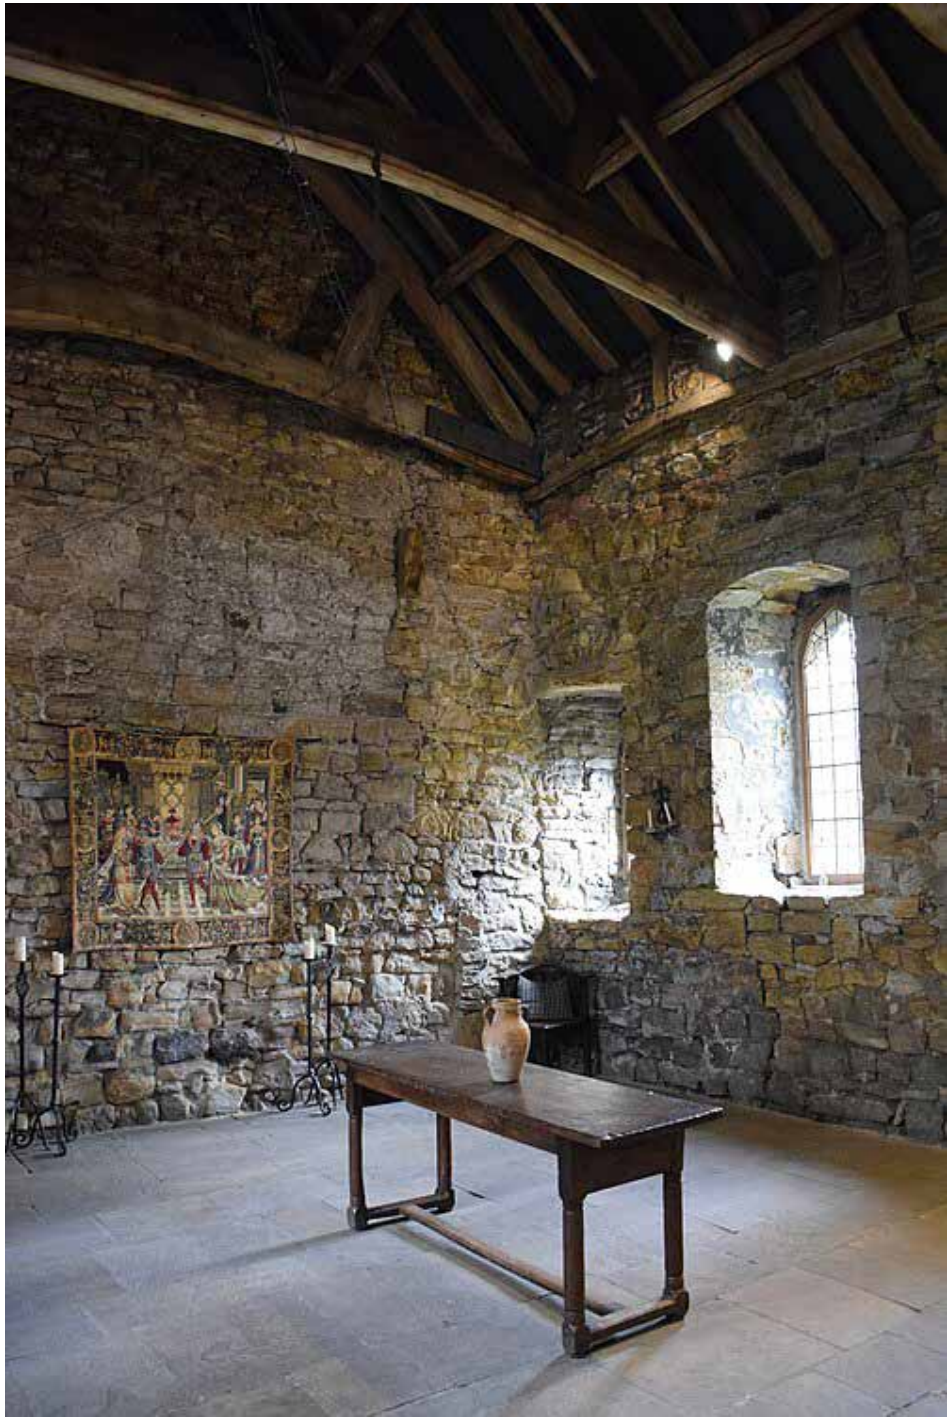
14th century open hall at Crook Hall, Durham

We are considering historic precedents of the floor finish of a Hall House in our proposal to re-lay the entrance hall tile in stone.

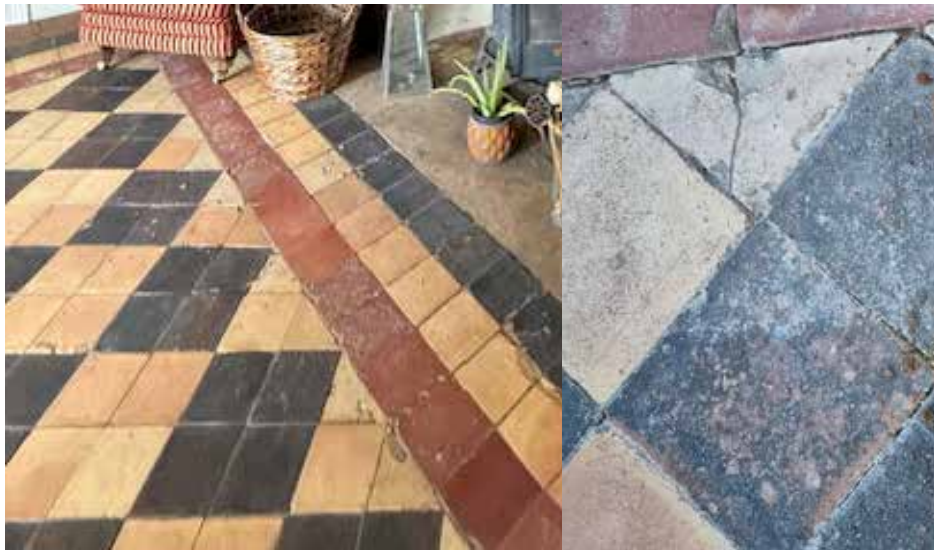
4.2 ENTRANCE HALL CONDITION

The entrance hall floor is subject to loose and cracked tiles, and so is unsuitable for overall repair. Tiles which can be salvaged will be reused to tile the cloakroom and Boot room area, ensuring, as far as possible, the retention of building fabric which could be considered historic.

Mitigation  
The existing floor is crumbling away. It is understood that the piecemeal replacement of it is not feasible and would undermine the historic legibility of the entrance hall. Evidence of crushed brickwork and rubble from the period in which the floor was replaced shows the floor is non-original. Originally the hallhouse would have had an earth floor, but there is evidence of other hall houses with original earth, stone or brick floors. It is proposed that rather than choosing a tile from a partiular era the use of stone as an ancient and timeless material can act as a mediator to make reference to the historic Hall House, the building’s Queen Anne origins, and provide a more neutral palette to allow the historic fabric to be better read. A new floor will provide durability in the name of future proofing and protecting the building from damp and other issues. We acknowledge that reversability is low, but no less reversible than the Edwardian tiles currently in situ, and will be constructed to have minimal impact on the rest of the buidling fabric.

Compensation  
The current floor will be carefully recorded before dismantling and the remaining tiles in good condition will be reused in the boot room and cloakroom areas.

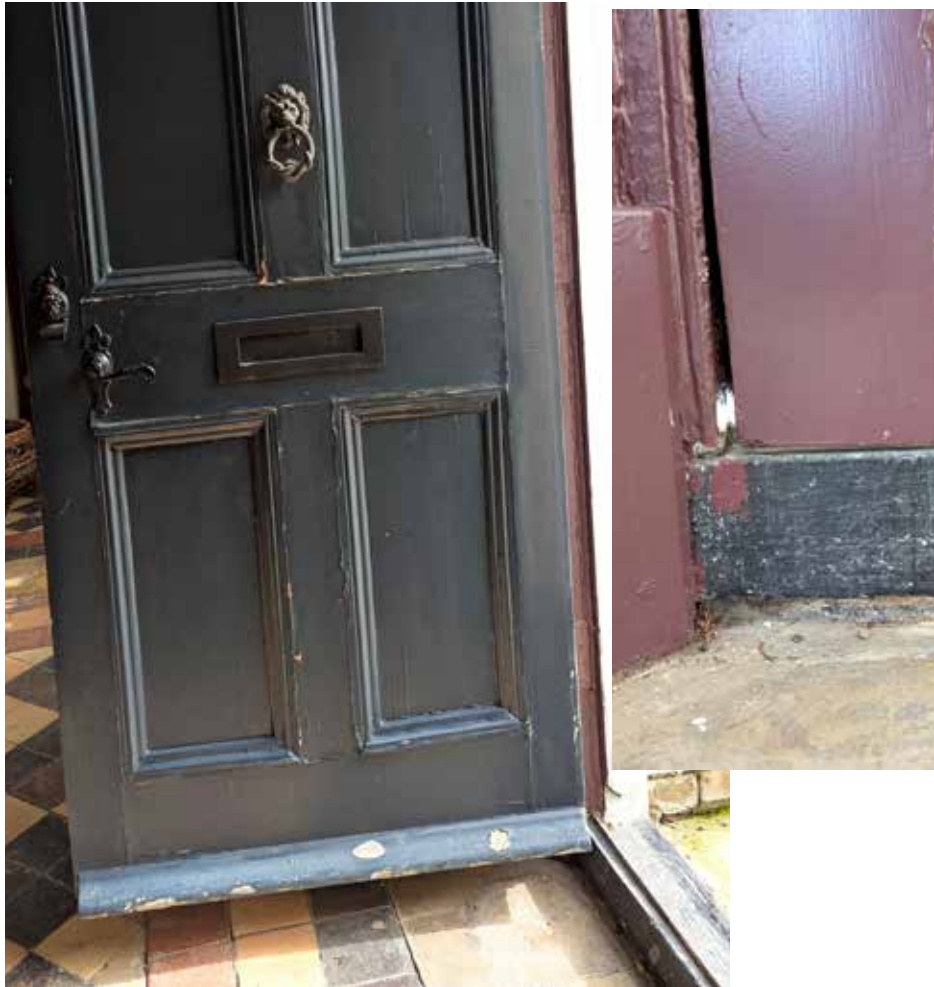
The front door is in very poor condition and unsuitable for weatherproofing the hall.

Impact - low  
The front door is not orginal, and is in poor condition, crumbling, with large air gaps

Mitigation  
The door will be replaced like-for-like so no change will be observable from an aesthetic standpoint

Compensation  
A replacement door will provide better security and weather tightness to protect the building fabric.

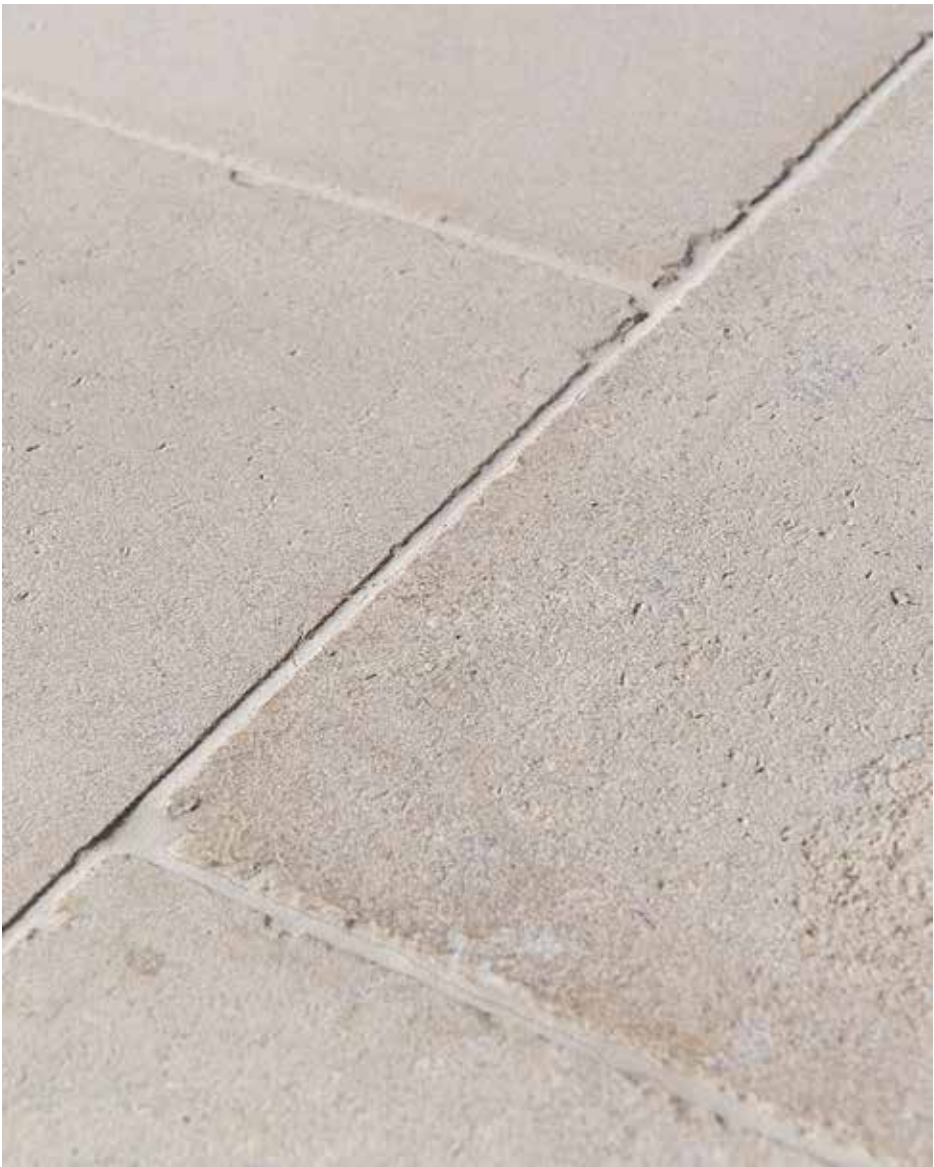
4.3 ENTRANCE HALL MATERIAL

We propose a natural stone tile such as Versailles Softly Aged Limestone Tiles from Quorn Stone

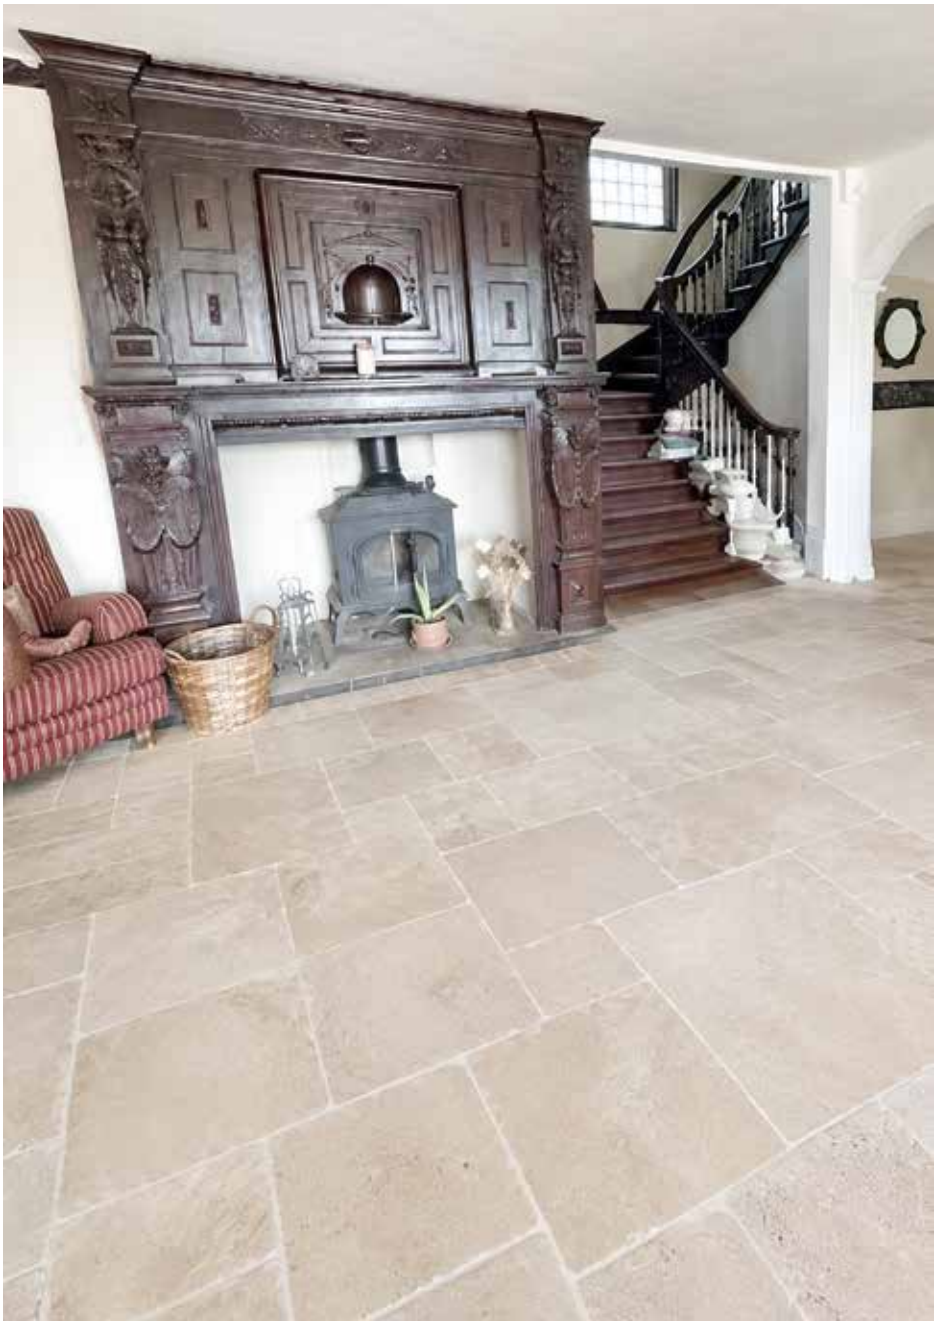
Please note: Visual of stone paved floor indicative - exact tile arrangement TBC

Due to the condition of the existing floor tiles we propose a new floor for the purposes of future proofing the space, improving its durability and protecting the building from damp and other issues.

As seen in the precedents to the right, rather than attempting to repair the existing, or choosing a ceramic tile from a partiular era which risks a pastiche appearance, we propose the use of stone as an ancient and timeless material. The stone acts as a mediator to make reference to the historic Hall-House, the building’s Queen Anne origins, and provides a more neutral palette to allow the historic fabric to be better read.

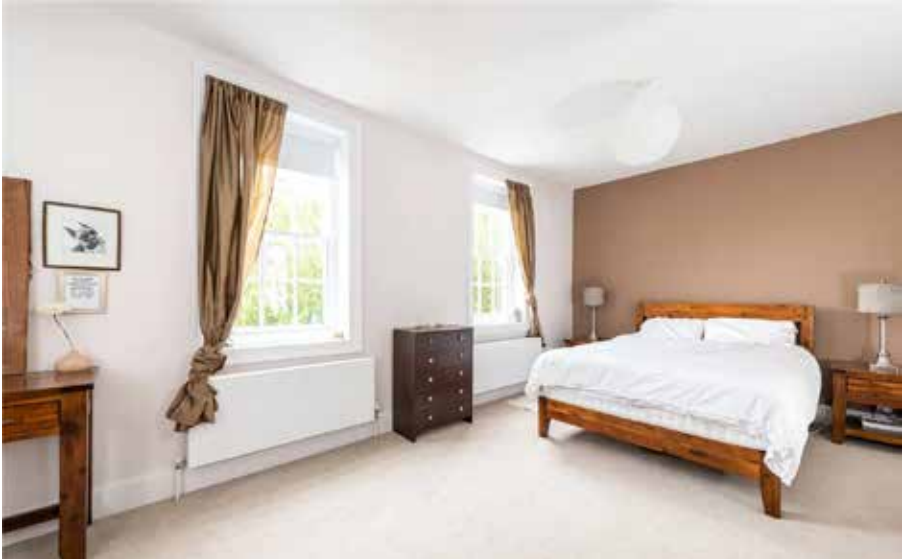
EXISTING

This bedroom has very long and narrow proportions in comparison to the bedrooms on the east face of the house in the maltings.

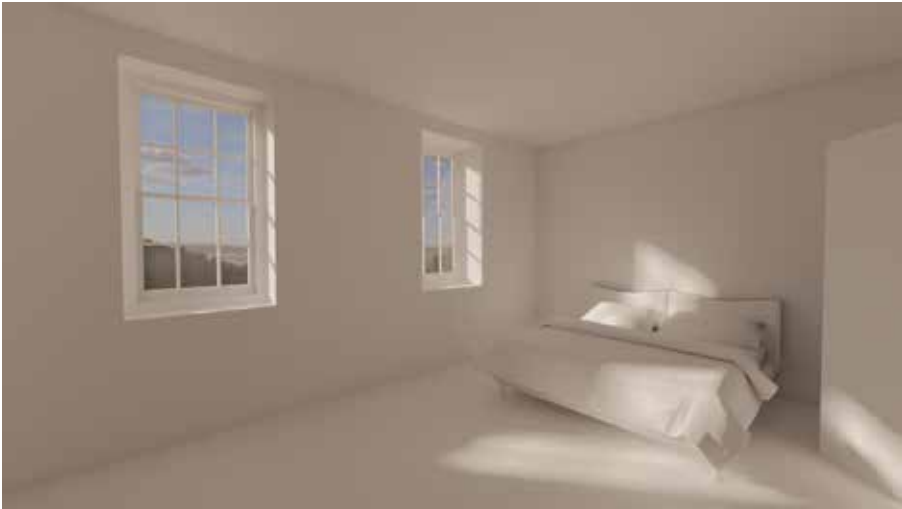
PROPOSED

An ensuite has been proposed to be as narrow as possible and designed to read as one continuous joinery unit with the storage within the entry. This will bring the internal proportions closer to those of the East bedrooms, and bring the room up to the standards of a C21st manor house.

Please note all cornicing and decorative features to the bedroom are to be retained - this visual is illustrative only

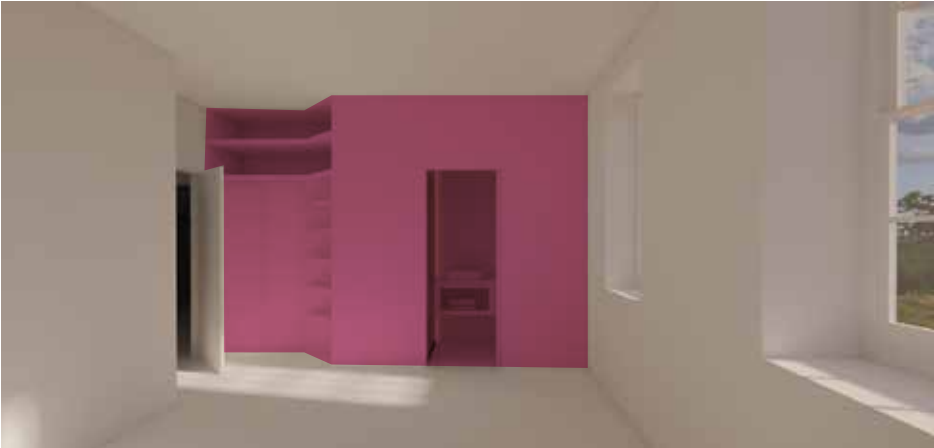
Visually distinct

The ensuite is designed to read as one continuous joinery unit and will be clad in a way that demarcates it from the historic building fabric. Please note the colour is diagrammatic not proposed.

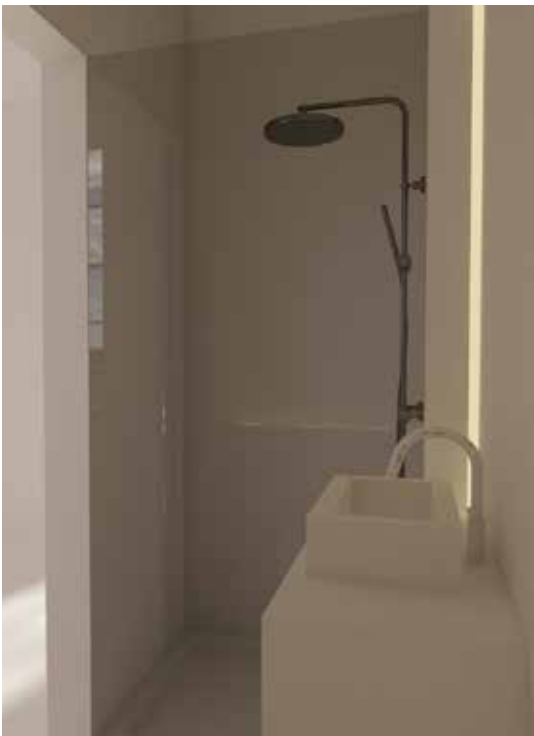
Careful placement and arrangement

The ensuite has been positioned in order to drain through existing boxing in in the dining room below. Ventilation and mechanical extraction will discharge onto the rear roof through concealed tile vents to ensure the notable chevron tiled front roof is undisturbed.

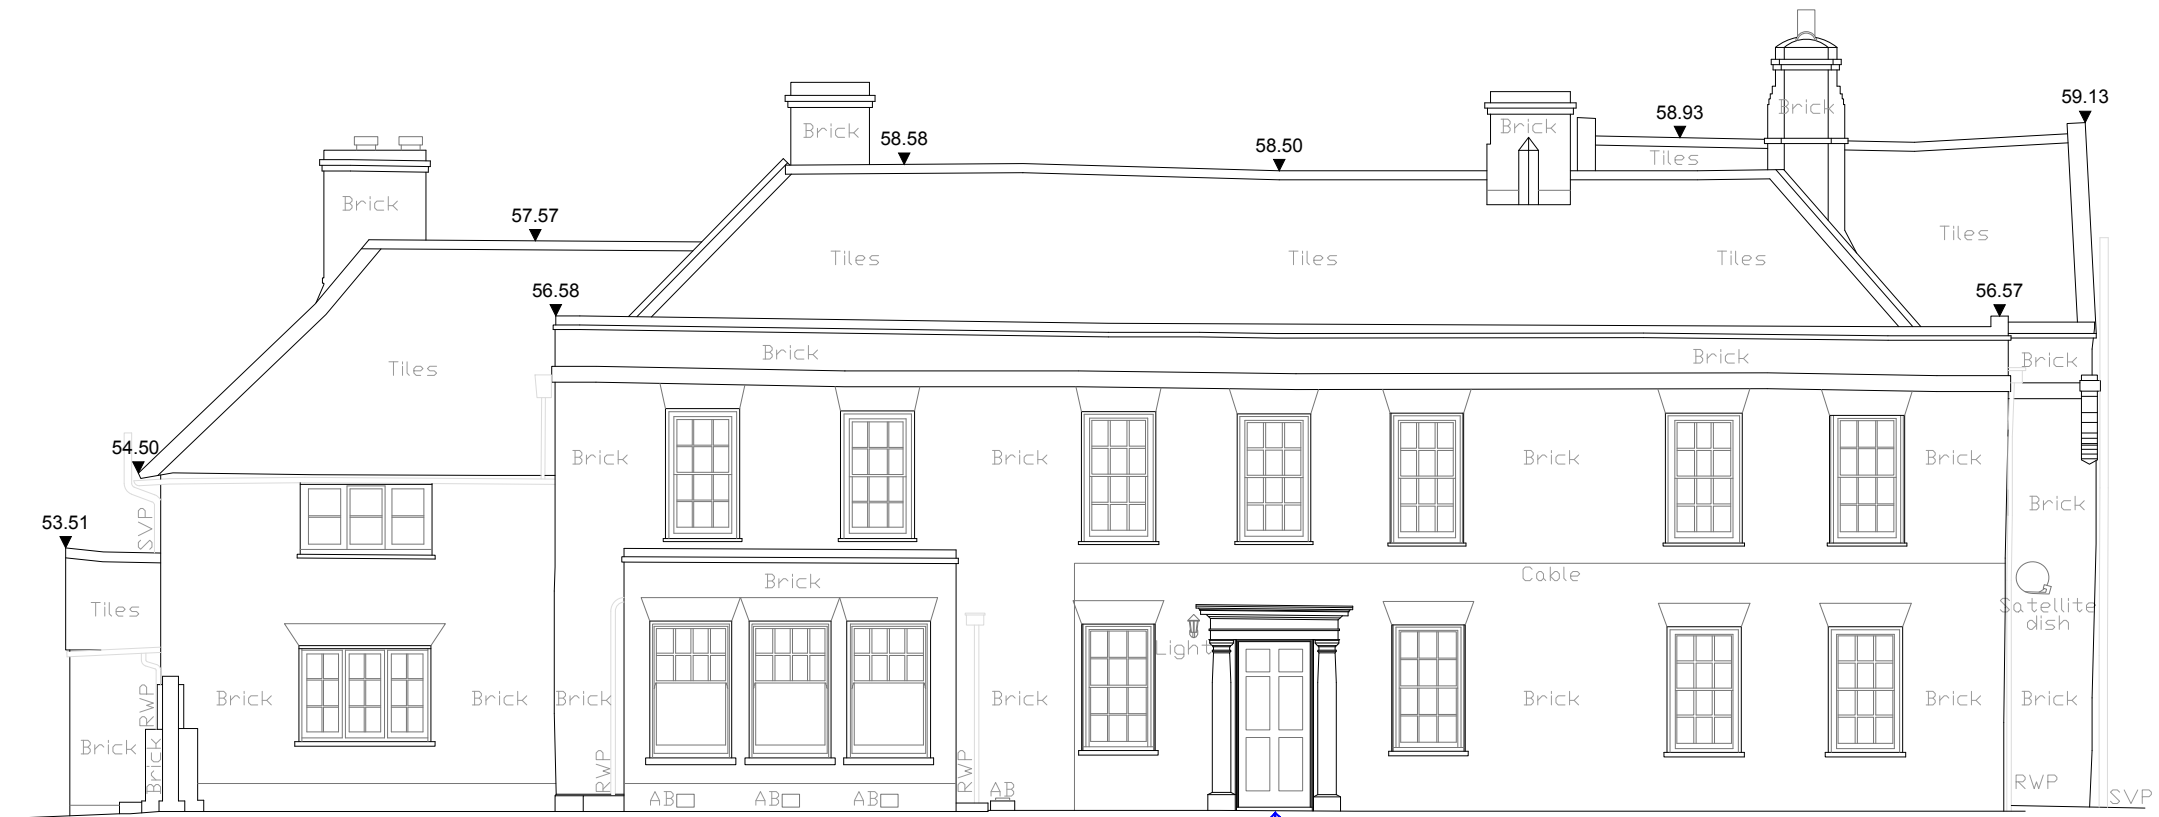
SOUTH ELEVATION

Front door to be replaced like for like

We also propose a new door for weather tightness and improved security, which will be replaced like-for-like to avoid any impact on the South Elevation of the building.
