## **Flood Risk Assessment and Surface Water Drainage Strategy**

**Wymondley Battery Energy Storage System**

# Soakage Report

**Project Name:** Little Wymondley

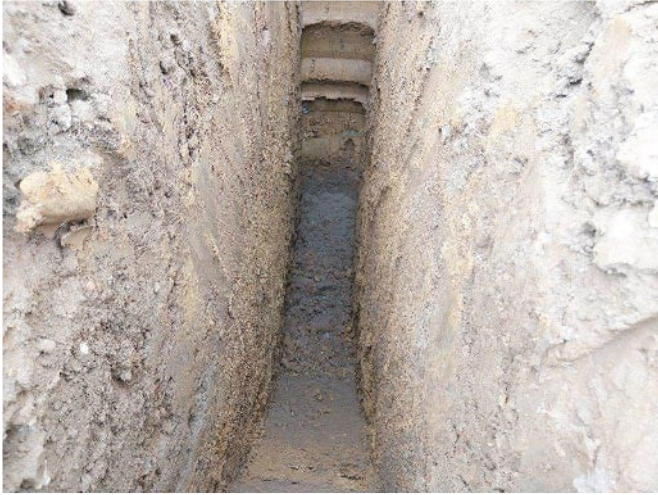
Photograph 1 - Looking down within TP01.

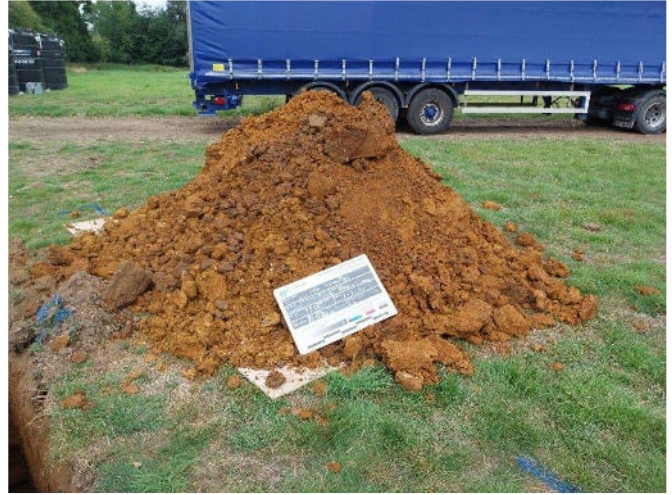
Photograph 2 - TP01 subsoil arisings.

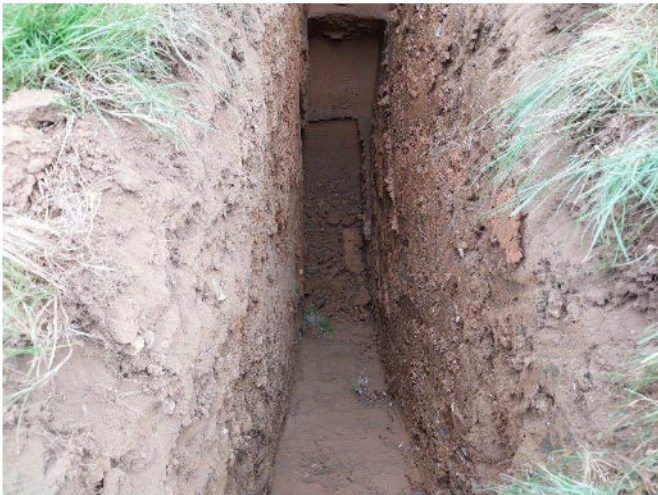
Photograph 3 - Looking down within TP02.

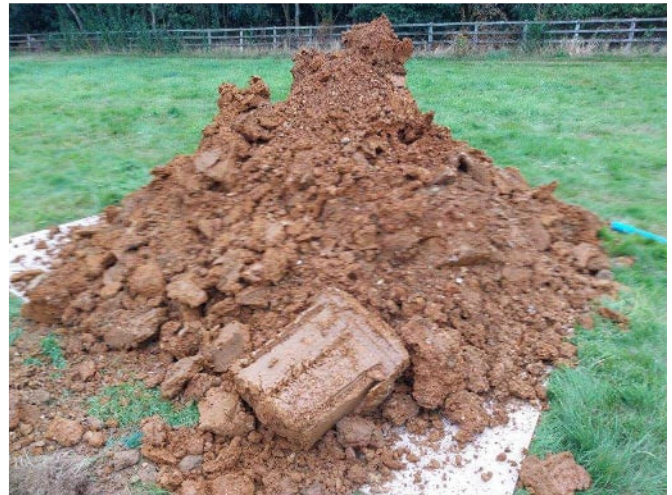
Photograph 4 - TP02 subsoil arisings.

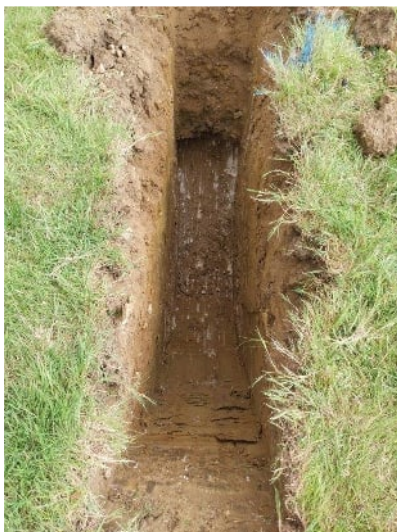
Photograph 5 - Looking down within TP03.

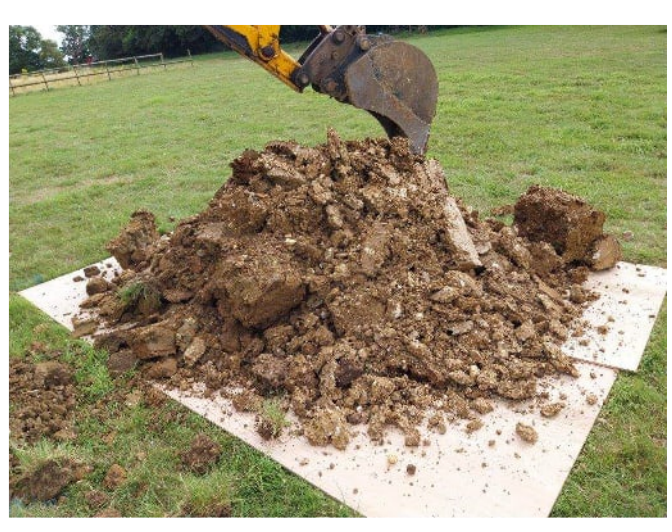
Photograph 6 - TP03 subsoil arisings.

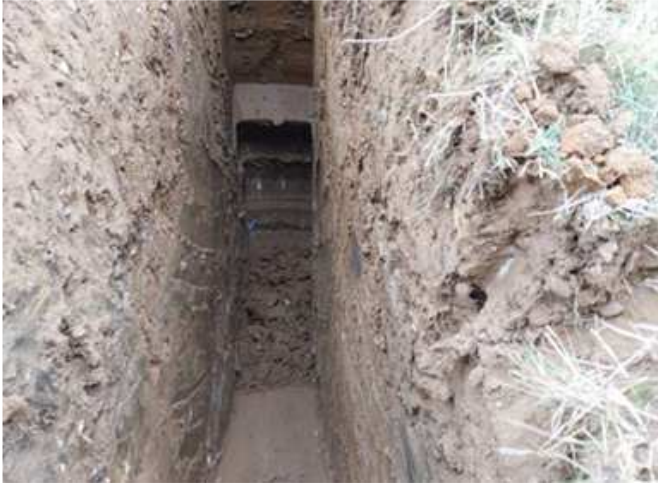
Photograph 7 - Looking down within TP04.

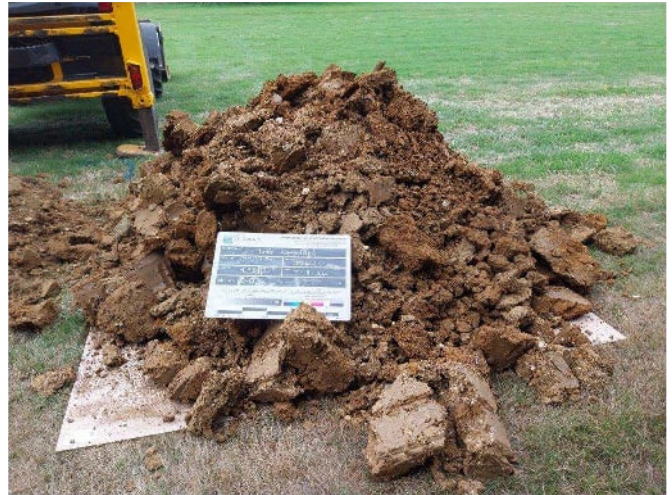
Photograph 8 - TP04 subsoil arisings.

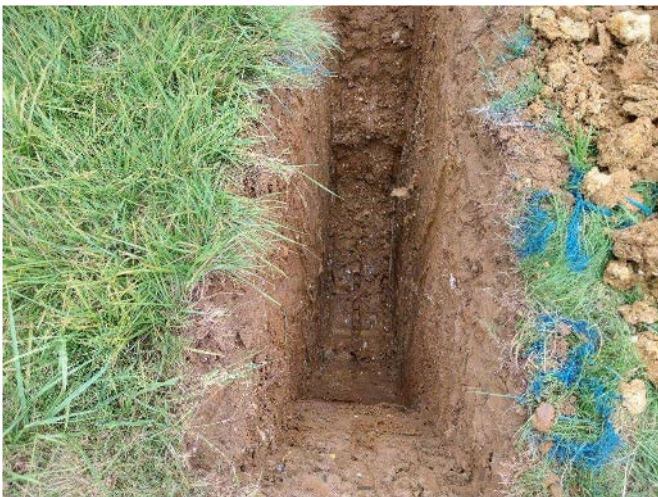
Photograph 9 - Looking down within TP04A.

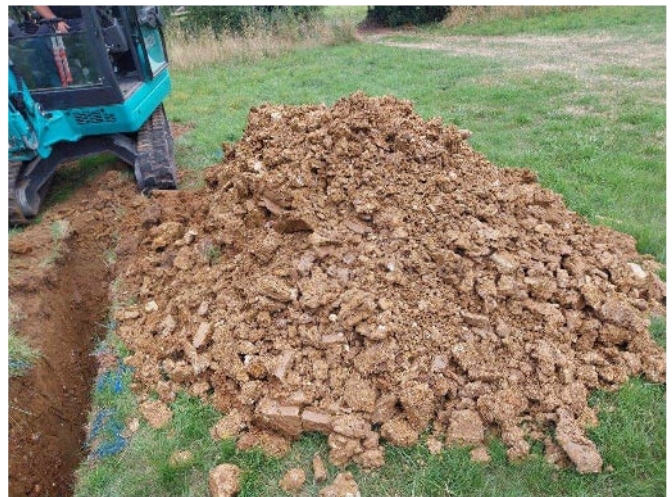
Photograph 10 - TP04A subsoil arisings.
