Dice  
Environmental

Glencoe Villa

Phase I & II Geo-Environmental Report

Site                      Glencoe Villa,  
                                 Ickleford,  
                                 Hitchin,  
                                 SG5 3TR

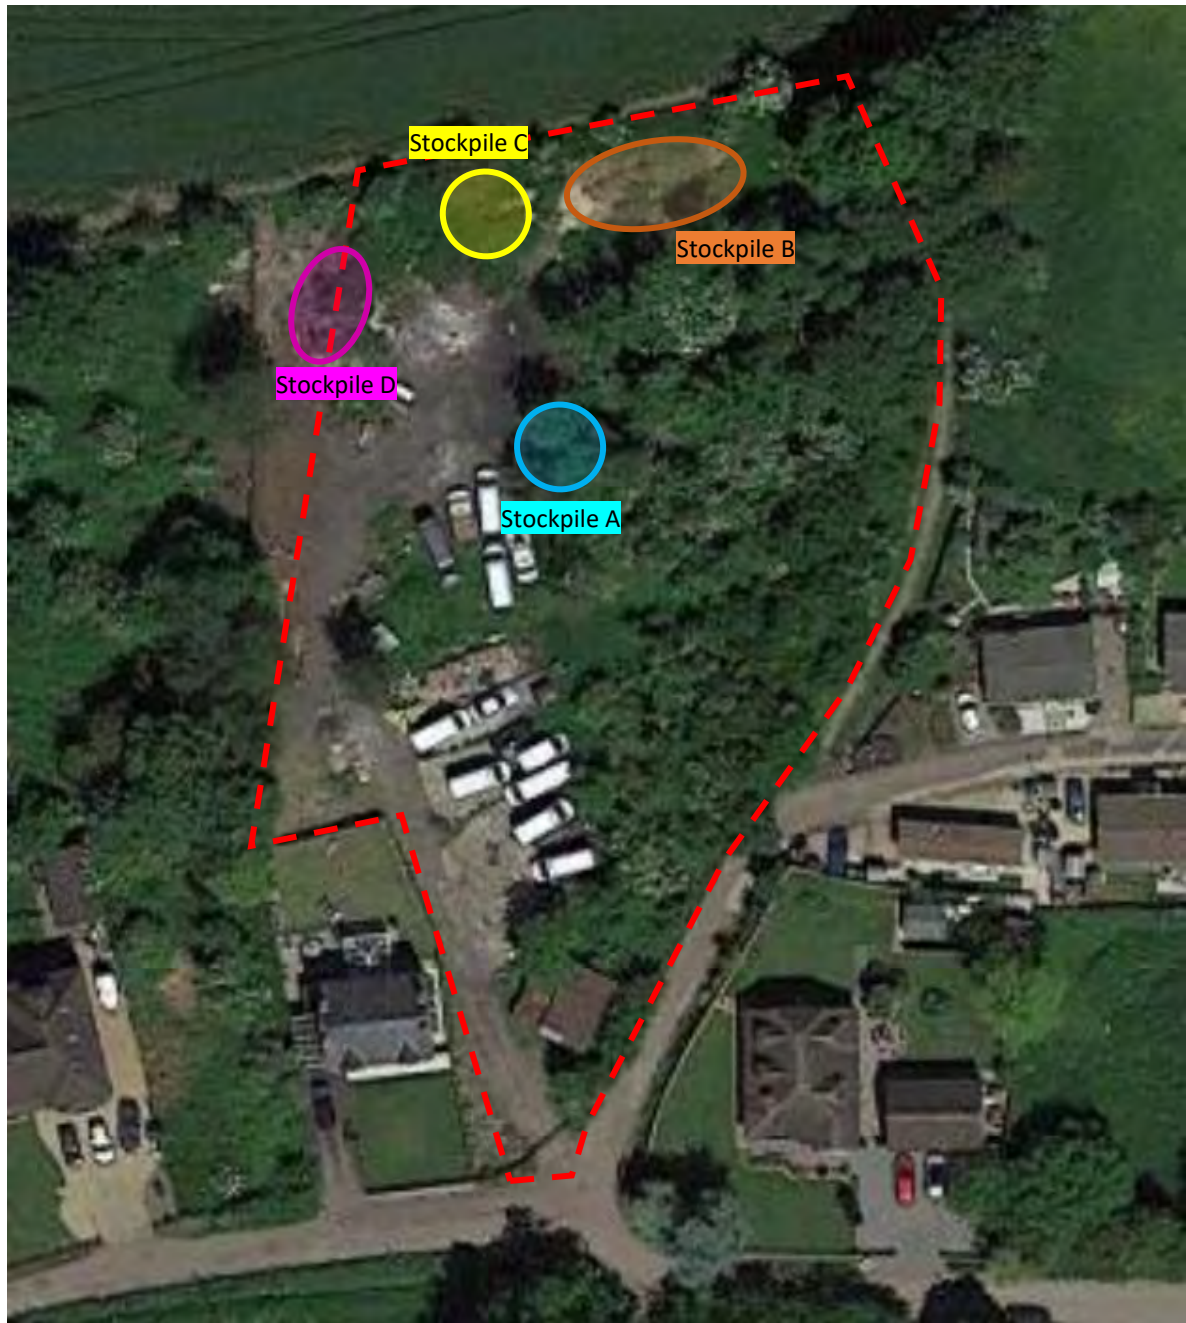
Title  
Approximate Stockpile Locations

4No. stockpiles (Stockpiles A to D) were identified around the site, predominantly in the north of the site. Stockpiles predominantly comprised gravelly sand with brick, coal, plastic and concrete fragments. Stockpile B also contained metal, ash, burned materials, wood chippings and shells.

Multiple stockpiles were identified surrounding this patch of hardstanding, predominantly in the north of the site. The stockpiles contained burned materials, timber and wood chippings, metal, concrete and brick. The more established stockpiles were also covered in vegetation. The approximate locations of the identified stockpiles are included within Appendix A.

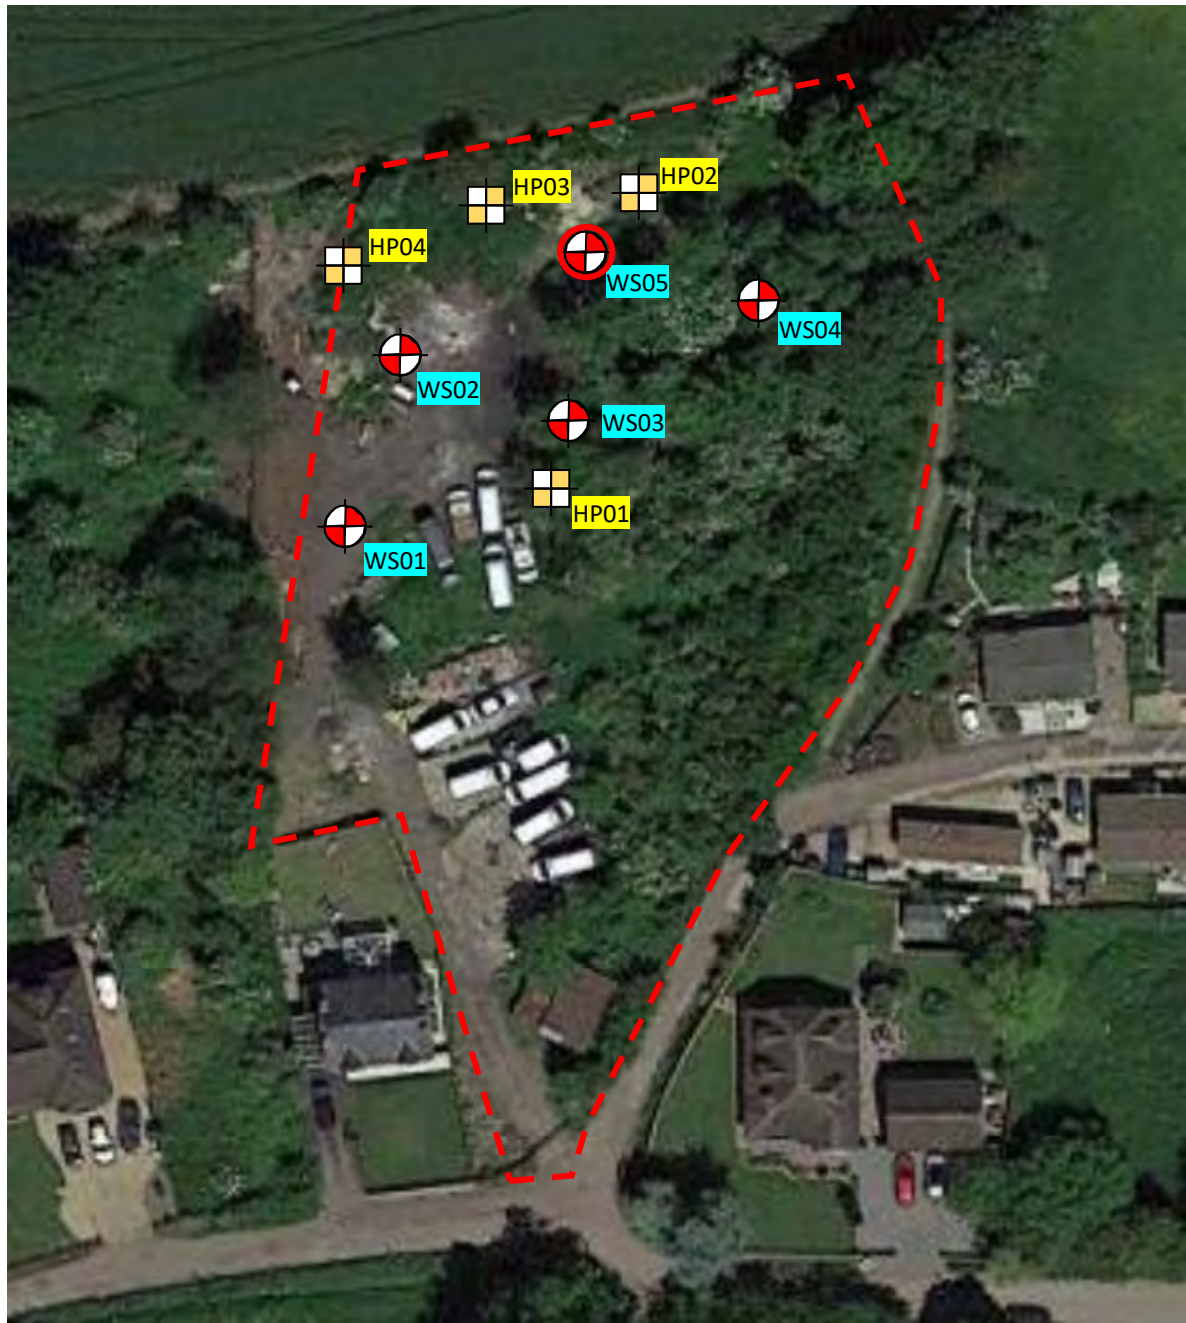
Title  
SI Plan

In all exploratory locations, holes were advanced through any made ground onto underlying natural soils, soils were logged and any visual or olfactory evidence of contamination noted.

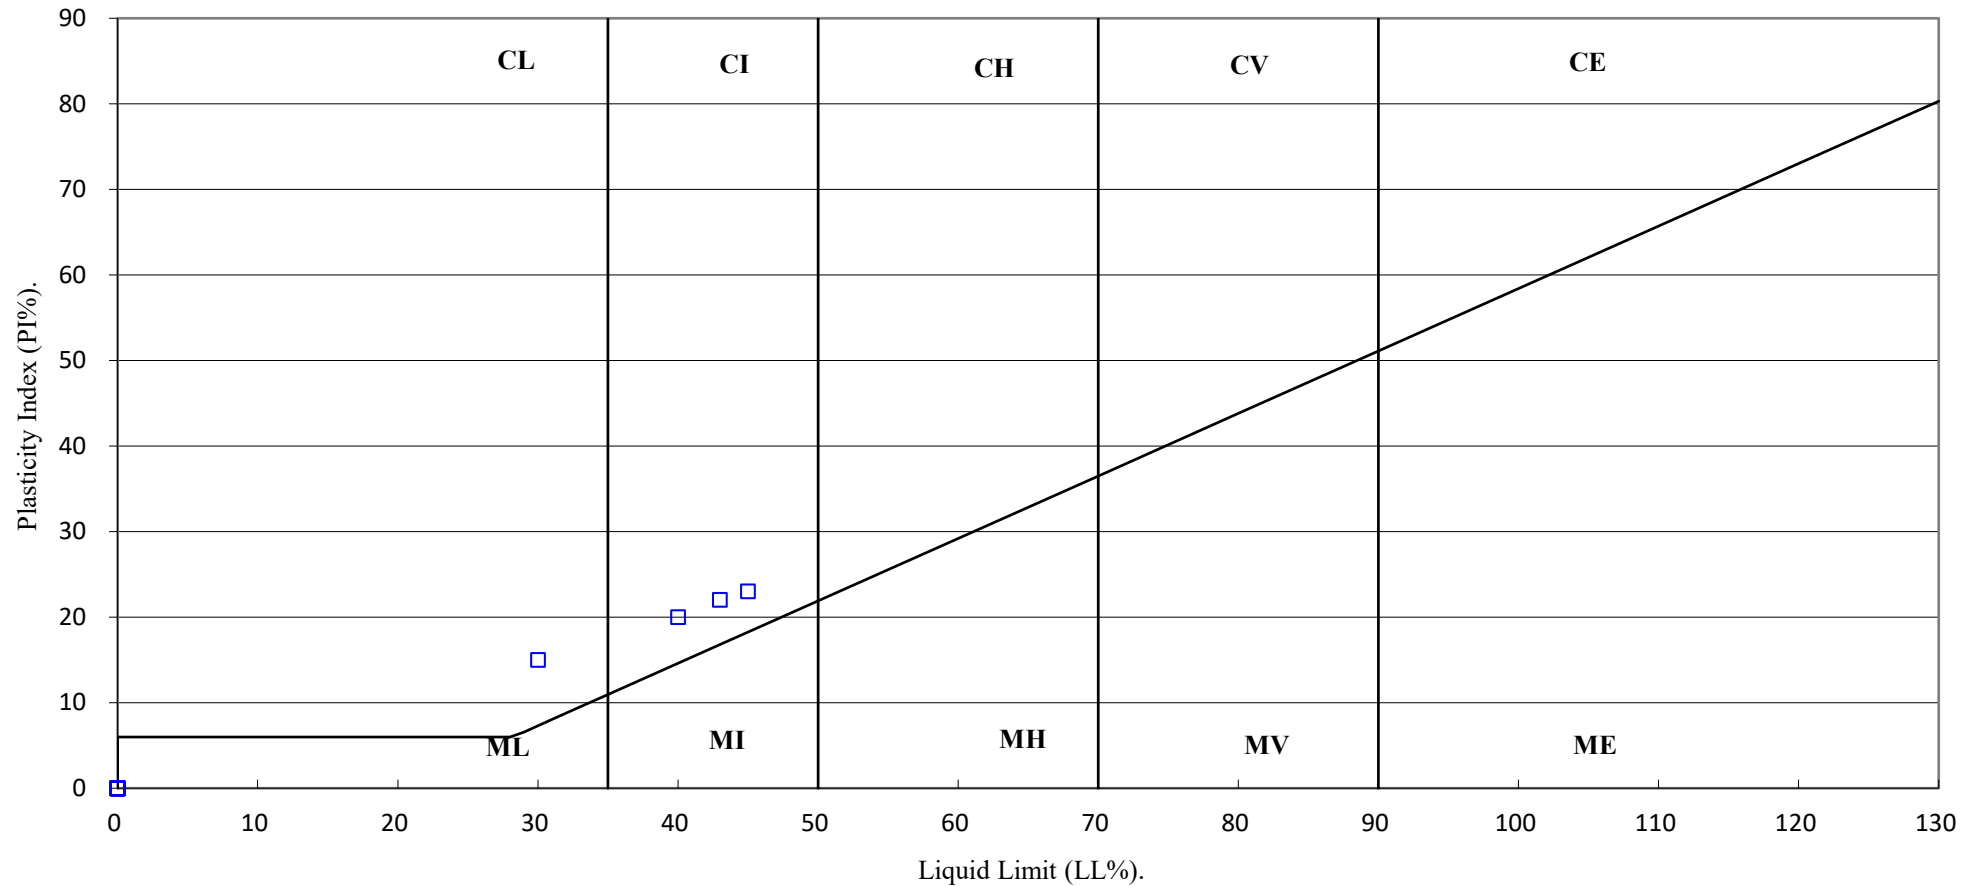
# PLASTICITY CHART FOR CASAGRANDE CLASSIFICATION.

| Geo-Technical | <p>Cohesive strata was identified to be of predominantly intermediate plasticity. Therefore, within the influencing zone of trees, foundations within cohesive soils should be deepened in these areas in accordance with NHBC Guidance Chapter 4.2 – Building Near Trees. An arboricultural survey may be required to identify the influencing zones of trees, to assist with refining foundation design.</p> |

Cohesive strata was identified to be of predominantly intermediate plasticity. Therefore, within the influencing zone of trees, foundations within cohesive soils should be deepened in these areas in accordance with NHBC Guidance Chapter 4.2 – Building Near Trees. An arboricultural survey may be required to identify the influencing zones of trees, to assist with refining foundation design.
