For the Site of: The White House, Valley Rise, Royston, SG8 9GH

# Ecological Appraisal (EA)

The following report details the findings and recommendations for the site of The White House, Valley Rise, Royston, SG8 9GH.

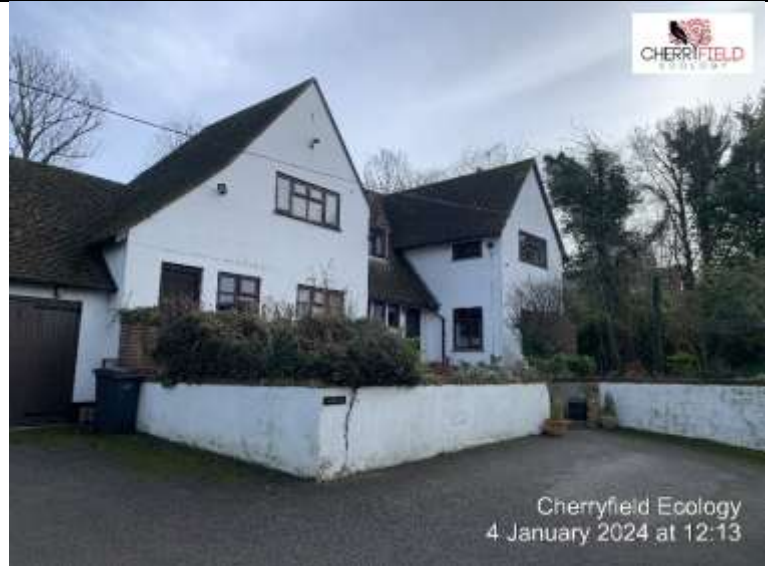
| Habitat Features | | | |
|---|---|---|---|
| Buildings | Developed<br>Land; Sealed<br>Surface | B1 | <p><b>External</b></p> <p>B1 is a detached, brick-built two-storey dwelling (Figure 3). The roof to the main section of B1 follows a T-shaped structure with opposite gable-ends and a hip on the long section. A further gable-end crosses into the hip and another extends out from the middle at the rear (Figure 4). Dormers, clad with waney boarding, are present at the front and the rear in the middle sections.</p> <p>Attached to B1 is a double garage and single-storey extension which was previously used as a veterinary practice (Figure 5 - 6). The garage has a hipped roof and joins at the hip on the main section, whilst the roof of the extension is flat. The main section and garage are both covered with clay tiles, and the extension is mostly covered with bitumen felt (with a small section of clay tile at the front). There are two chimney stacks protruding from the main section, both with associated lead flashing. The window frames are made from uPVC and the doors (including the garage doors) are wooden.</p> |

Figure 3: Front view of B1.

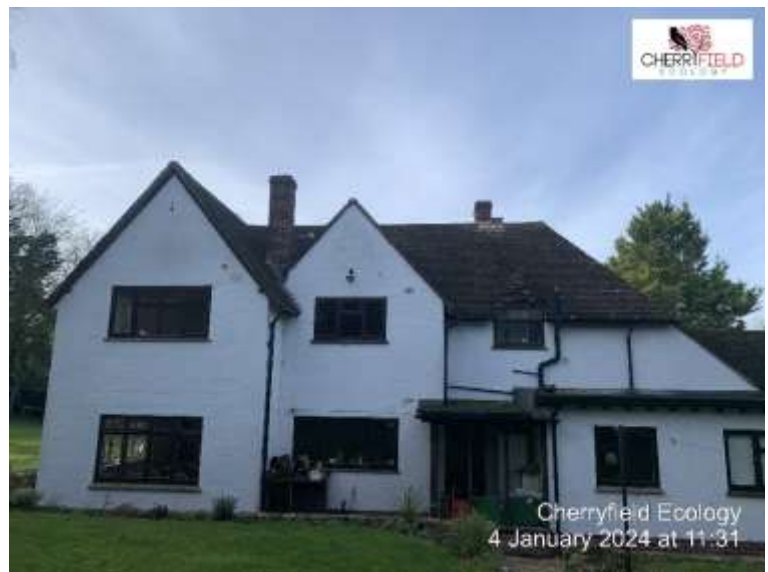
Figure 4: Rear view of B1.

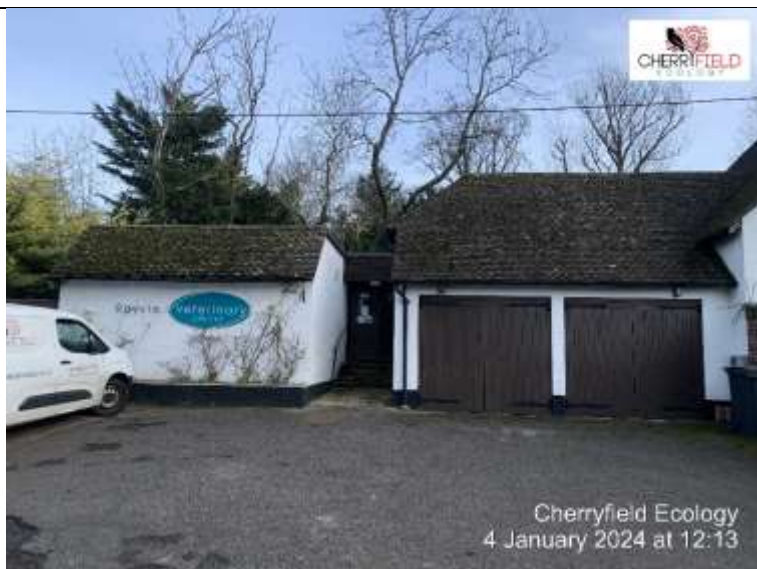
Figure 5: Front view of garage and extension to B1.

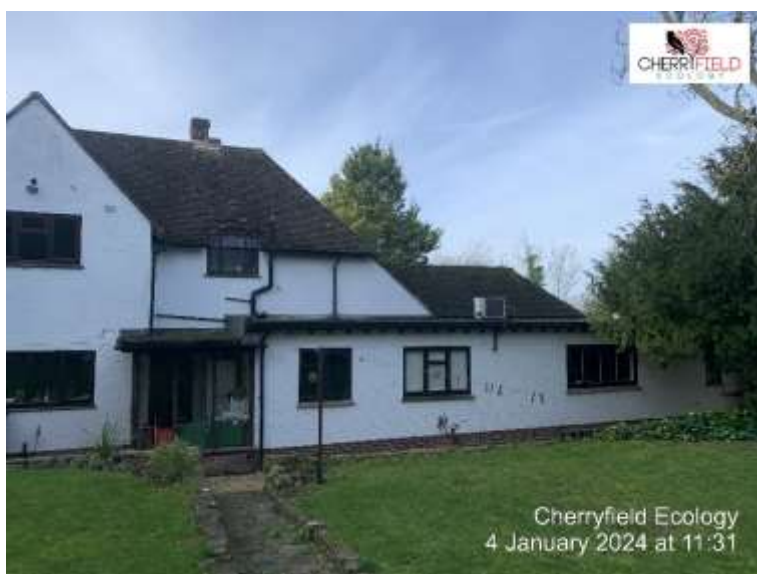
Figure 6: Rear view of garage and extension to B1.

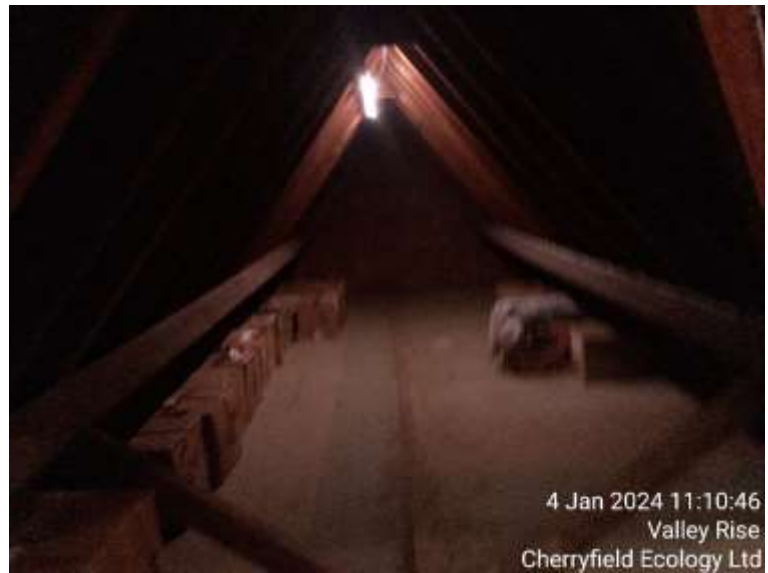
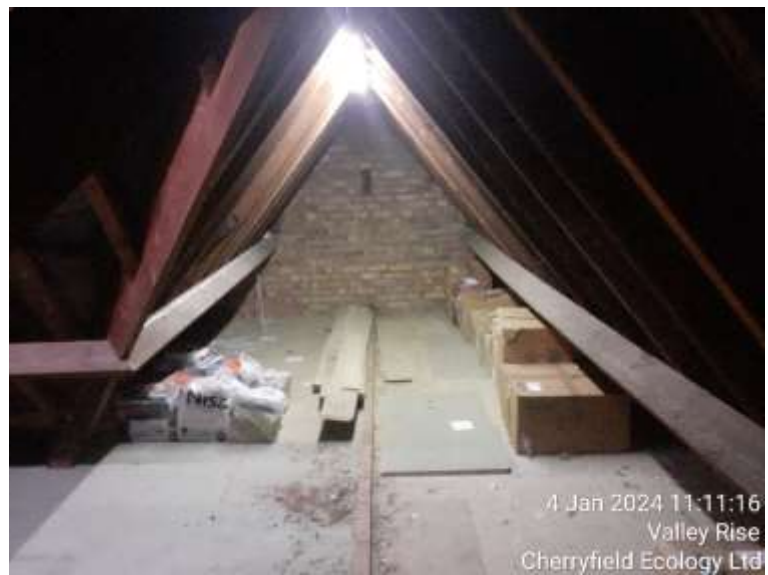
The main section of B1 has a loft void at the which follows the T-shaped layout of B1 (Figure 7 - 8). It is fully boarded and has a timber frame. The roof is lined internally with bitumen felt.

Figure 7: Example of loft within B1.

Figure 8: Another example of loft within B1.

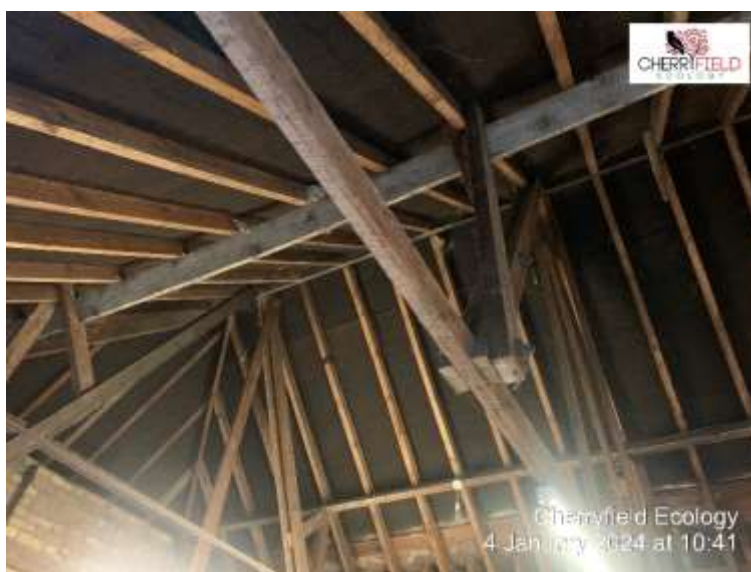
The garage section is open plan and has a timber king post and fink frame (Figure 9 - 10). The roof is internally lined with bitumen felt, and the walls are unlined.

Figure 9: Example of the interior of the garage attached to B1.

Figure 10: Another example of the interior of the garage attached to B1.

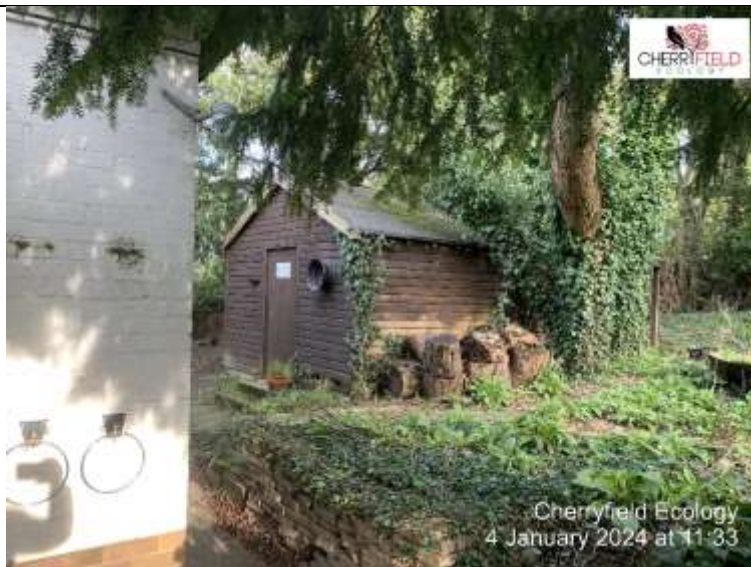
B2 is a gable-ended storage shed with a wooden construction (Figure 11). The roof is lined with bitumen felt and there is an awning with timber support posts at the rear (Figure 12).

Figure 11: Front view of B2.

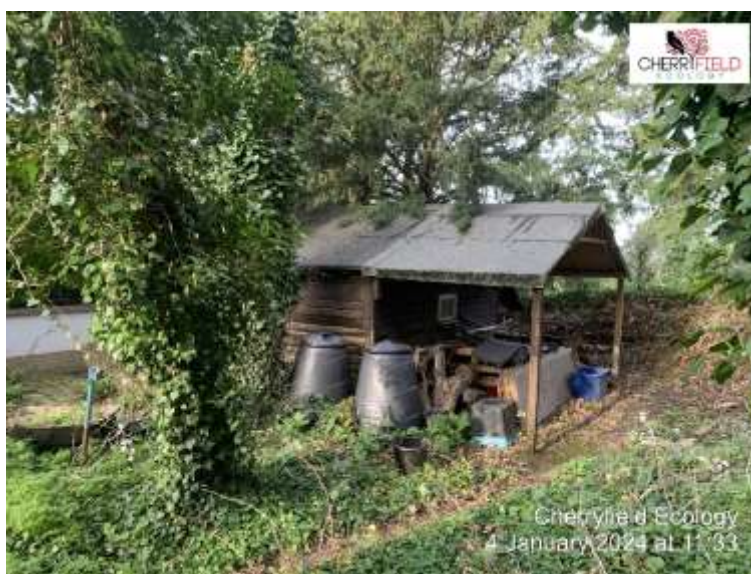
Figure 12: Rear view of B2.

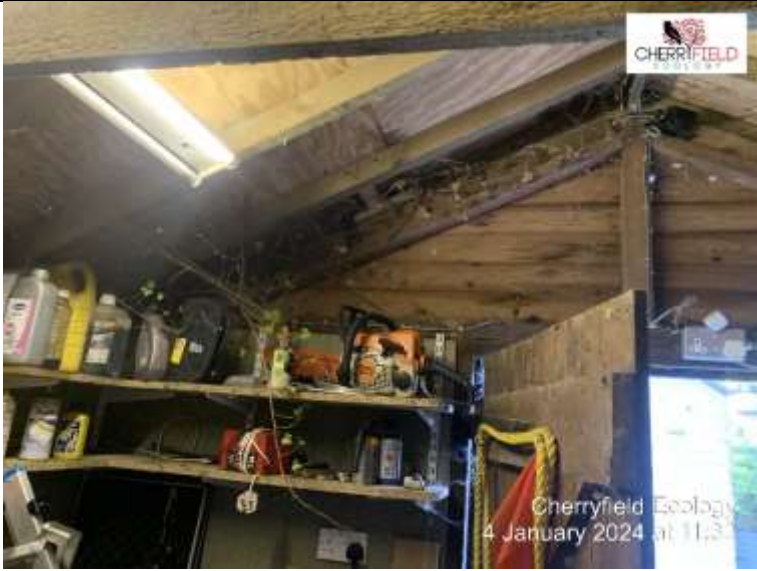
The interior of B2 is unlined and follows the structure of the exterior (Figure 13).

| | | <p>Figure 14: Example of interior of B2.</p> |

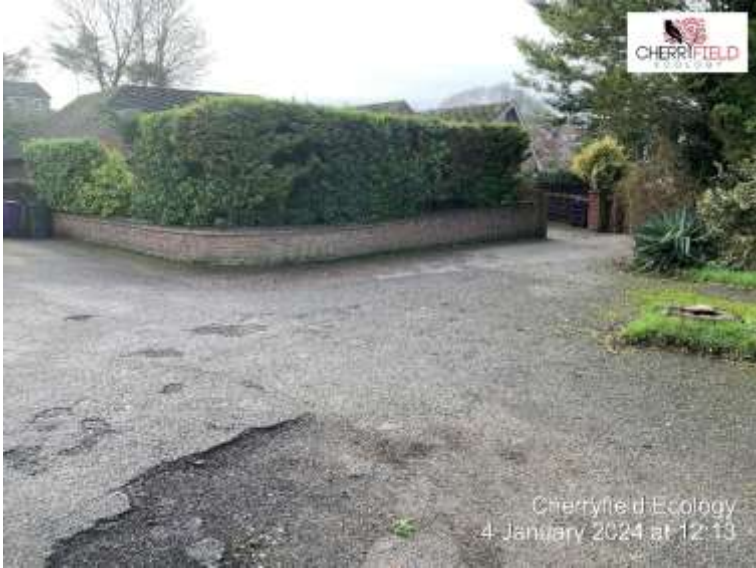
| Hardstanding | Developed Land; Sealed Surface | <p>There is a tarmacked driveway and parking area at the front of B1 (Figure 15), concrete steps and path at the entrance to B1, and a paved pathway around the sides and rear of B1 and leading to B2 (Figure 16).</p> <p>Figure 15: Tarmacked driveway and parking area at the front of B1.</p> |

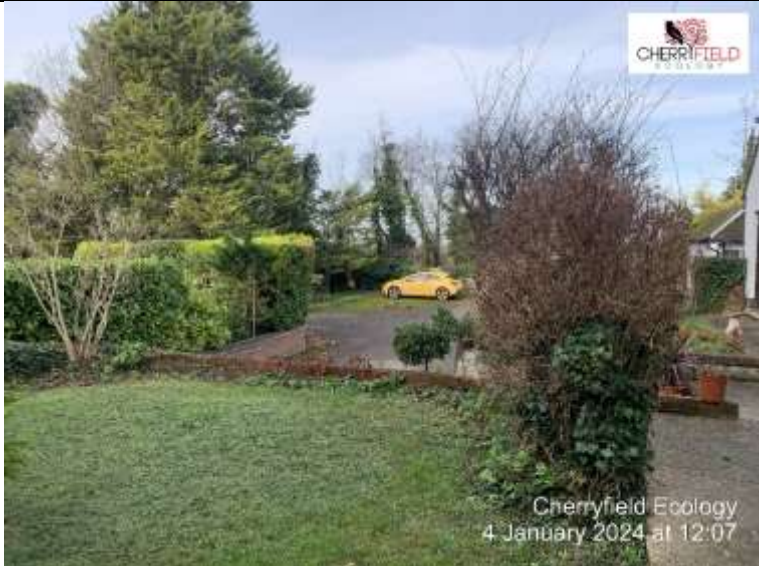
| | | <p>Figure 16: Concrete steps and path at the entrance to B1 (visible on the right).</p> |

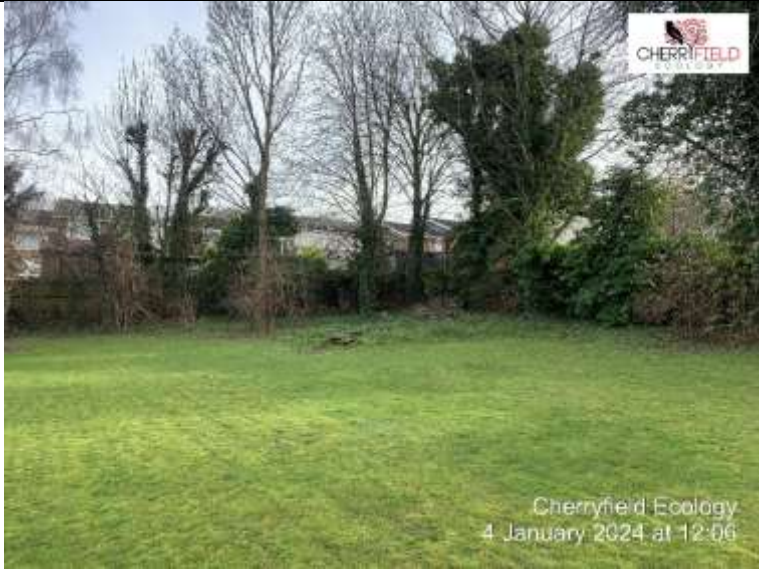
| Amenity Grassland | Vegetated Garden | <p>The majority of the garden at the rear of B1, as well as a small area at the front (see Figure 16) is comprised of amenity grassland dominated by Perennial Rye-Grass <i>Lolium perenne</i> with abundant Daisy <i>Bellis perennis</i> and Bristly Oxtongue <i>Picris echioides</i> (Figure 18).</p> |

| | | <p>Figure 18: Example of amenity grassland on-site.</p> |

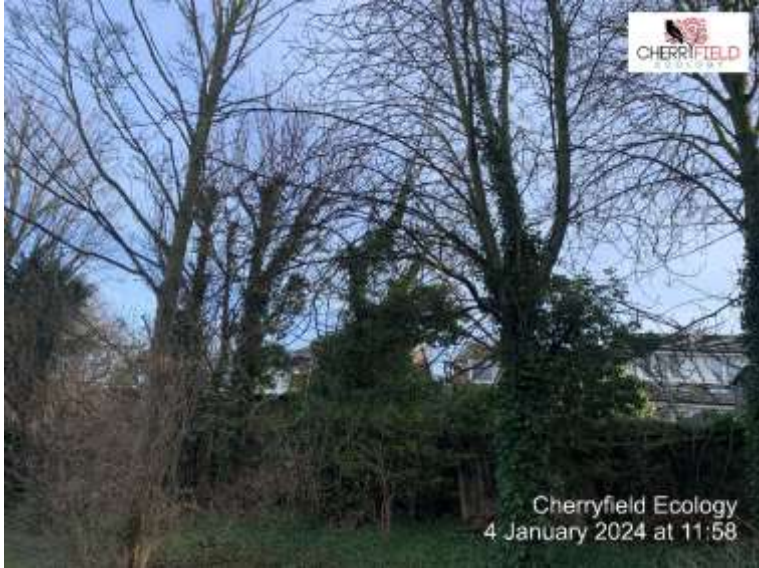
| Scattered Trees | Urban Tree/Rural Tree | <p>Scattered Hawthorn <i>Crataegus monogyna</i>, Yew <i>Taxus baccata</i>, Silver Birch <i>Betula pendula</i>, Horse Chestnut <i>Aesculus hippocastanum</i>, Sycamore <i>Acer pseudoplatanus</i>, and Apple <i>Malus</i> sp. are present throughout the site (Figure 19).</p> <p>Figure 19: Example of scattered trees on-site.</p> |

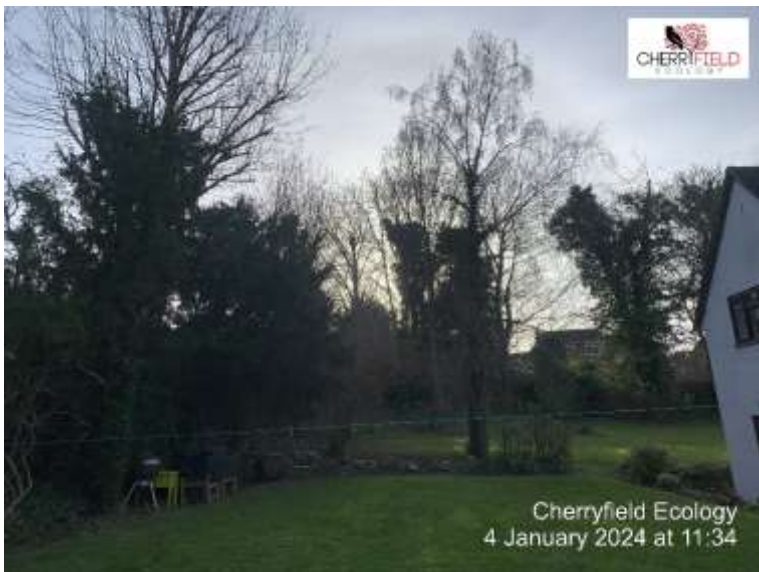
| Trees | Line of Trees (Ecologically Valuable) | Lines of trees are present along the eastern and southern site boundaries, and are comprised of Elder <i>Sambucus nigra</i> , Holly <i>Ilex</i> |

| | | <p><i>aquifolium</i>, Lawson's Cypress <i>Chamaecyparis lawsoniana</i>, and Ash <i>Fraxinus excelsior</i> (Figure 20).</p> <p>Figure 20: Example of line of trees on-site.</p> |

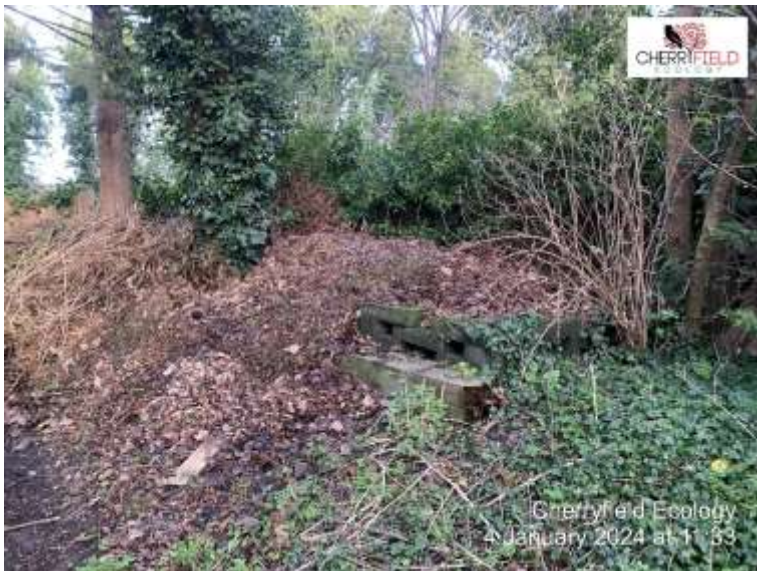
| Target Note | Description |
|---|---|
| T1 | <p>Compost heap and brush pile with stacked concrete blocks providing gaps to enter that could provide habitat for various species (Figure 21).</p> <p>Figure 21: Compost heap and brush pile with stacked concrete blocks (T1).</p> |

**Great Crested Newt (GCN)** - No further survey is necessary; however, a qualified ecologist will need to supervise the clearance of any compost heaps/timber piles on-site via a destructive search. If GCN are found on site, all works must stop, and advice sought.

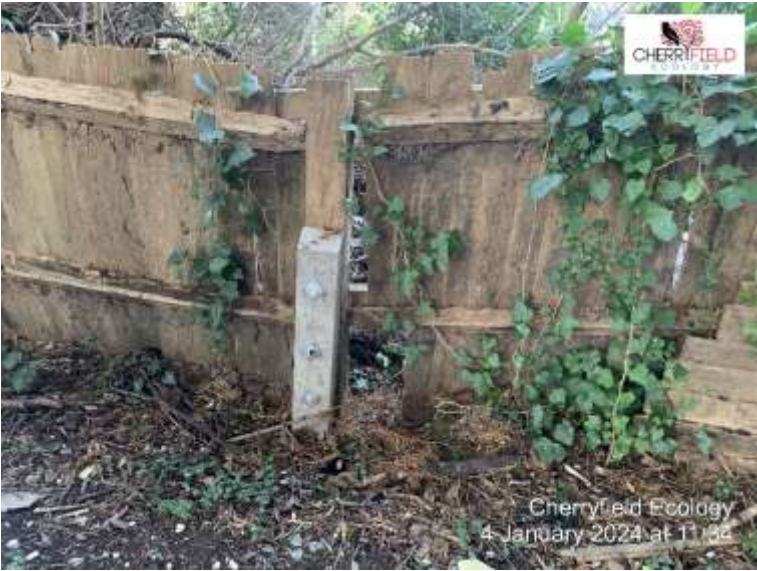
| T2 | <p>Gap in wooden fence that could provide site access for various species (Figure 22).</p> <p>Figure 22: Gap in wooden fence (T2).</p> |

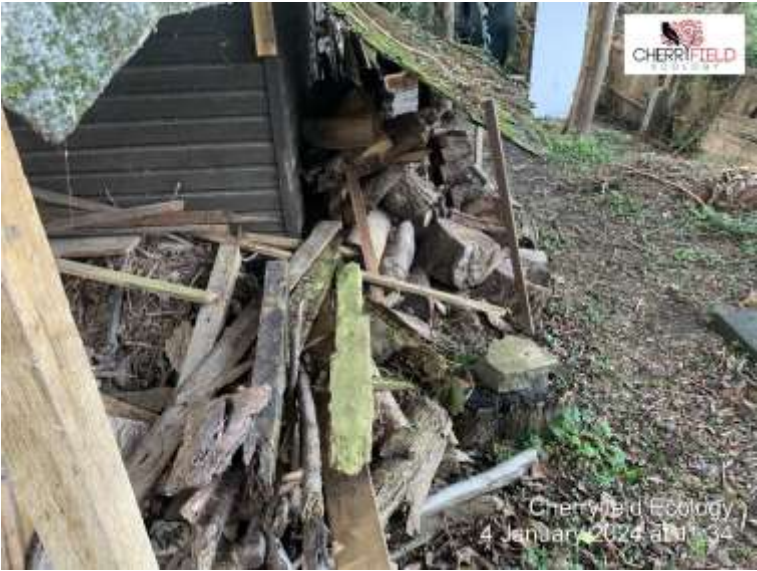
| T3 & T4 | <p>Timber piles by B2 that could provide habitat for various species (Figure 23 - 24).</p> <p>Figure 23: Timber pile by B2 (T3).</p> |

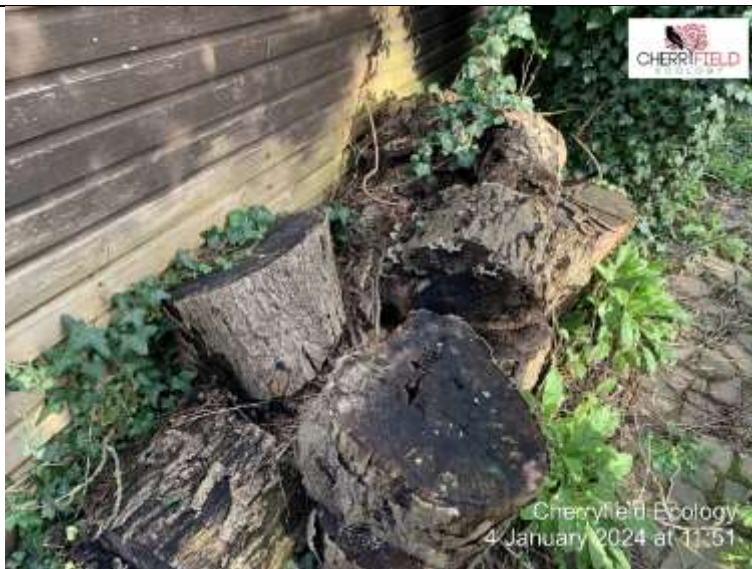
Figure 24: Timber pile by B2 (T4).

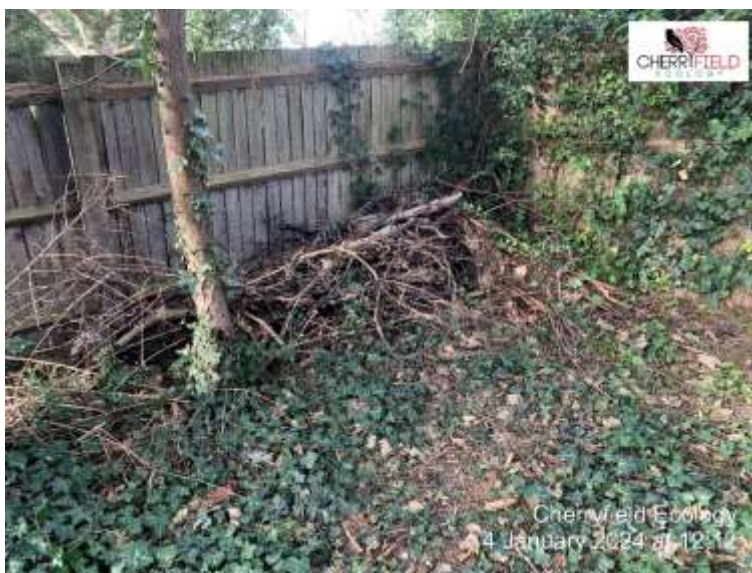
Brush piles within amenity grassland area by the site entrance that could provide habitat for various species (Figure 25 - 26).

Figure 25: Brush pile near site entrance (T5)

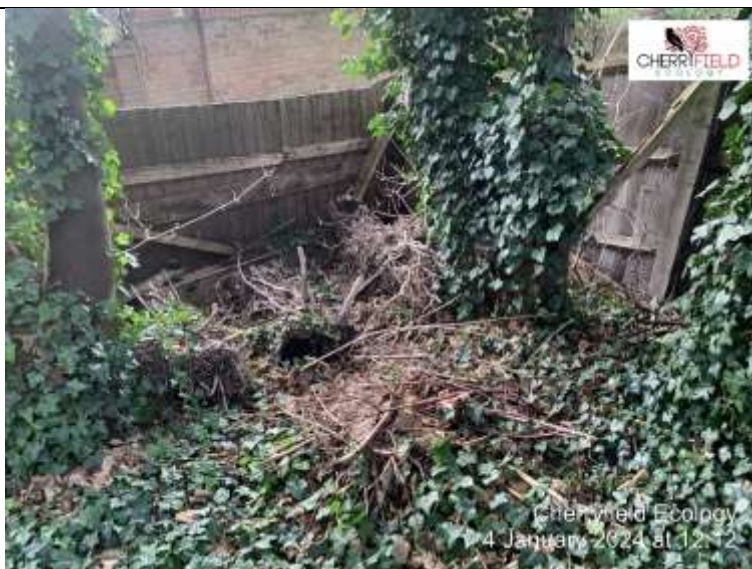
Figure 26: Brush pile near site entrance (T6).

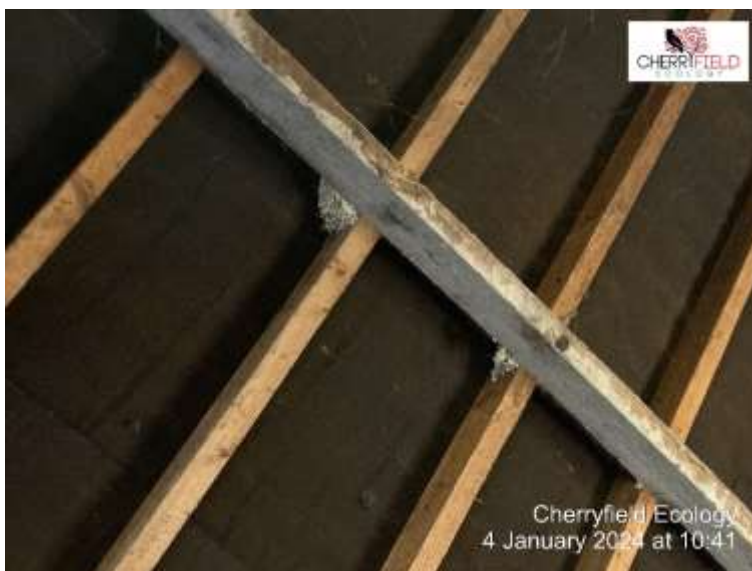
Disused Swallow *Hirundo rustica* nests found within the garage attached to B1.

Figure 27: Disused Swallow nests within the garage attached to B1.

**Breeding Birds** - No further surveys are recommended; however, the development should take place outside the nesting season (March to August). If this is not possible, it is recommended that a qualified ecologist is on-site to ensure the building/vegetation is not occupied by breeding birds, prior to demolition/clearance. Should an occupied nest be found, a buffer zone would need to be created until the nest is no longer in use.

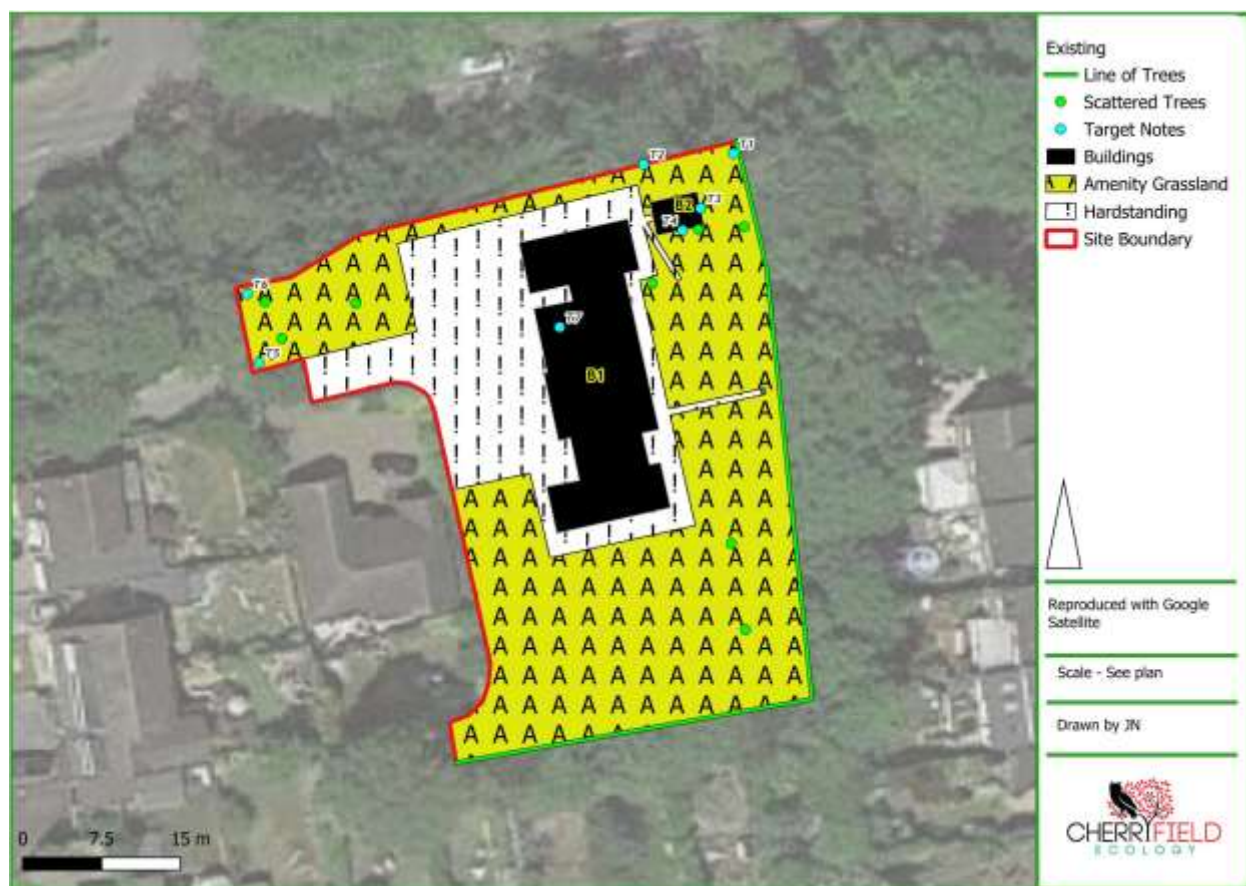
Figure 28: Site Plan

This section details the structures/habitat reference and descriptions (see Figure 28 for Site Plan).

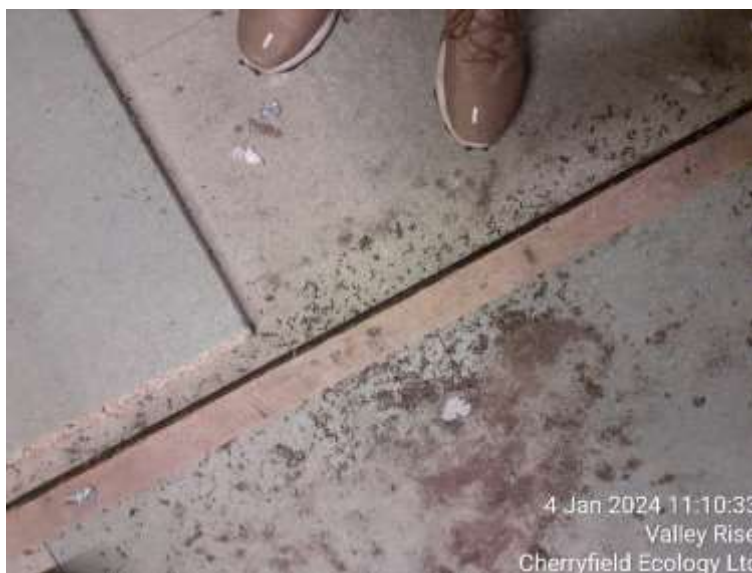
B1 is a **confirmed** bat roost as evidence of bats (droppings) were found within the loft.

B1 is **confirmed** as a bat roost as bat droppings were found within the loft (Figure 29). It otherwise provides **moderate** potential for roosting bats. There are lifted tiles above the garage (Figure 30) which could potentially be used as a roosting feature by crevice-dwelling species, along with the waney boarding on the dormers. The droppings were found on the floor beneath the internal ridges, indicating a likely Brown Long-Eared *Plecotus auritus* roost. The unlined brick wall and bitumen felt could be used as an internal roosting feature. It is possible that bats have accessed the loft via the air brick (Figure 31). Disused Swallow *H. rustica* nests were found within the garage attached to B1 (T7), indicating birds have been able to access the garage in the past. No points of entry to the garage were visible, however, and there was no evidence of use by bats found in this section of the building.

Figure 29: Bat droppings found within the loft in the main section on B1.

**Bats** - **Presence/likely absence surveys** (moderate) will be required (two surveys, three weeks apart), with two surveyors to cover the building B1; these must be undertaken between May to August. These are required to establish whether bats are accessing the loft void via the north-facing hip above the garage (where works are proposed). One of these surveys should be undertaken pre-dawn due to the potential presence of Brown Long-Eared Bats.

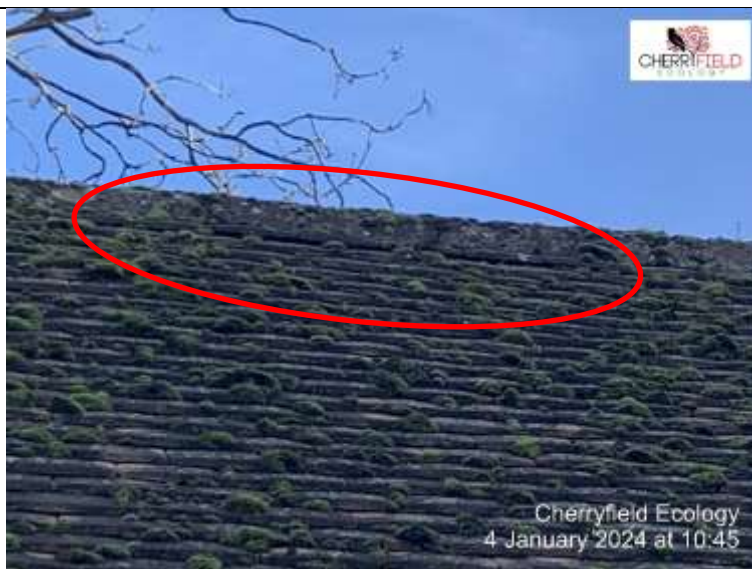
Figure 30: Lifted clay tiles above garage attached to B1.

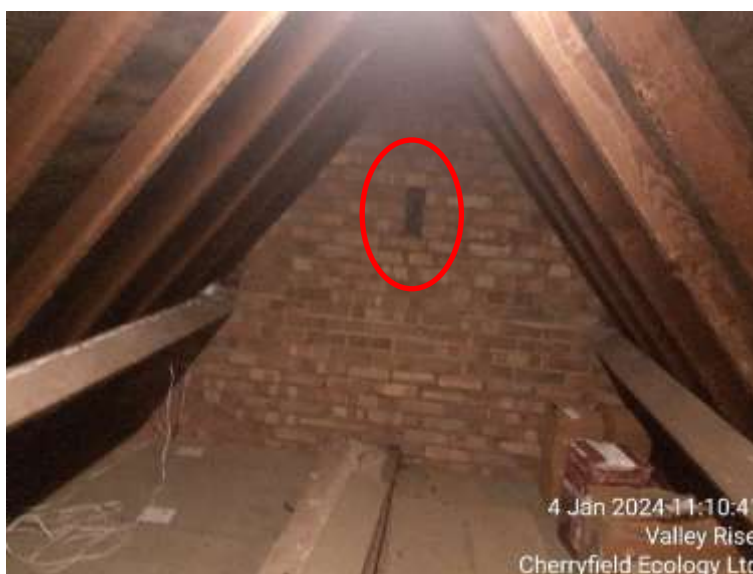
Figure 31: Air brick within the loft in the main section of B1.

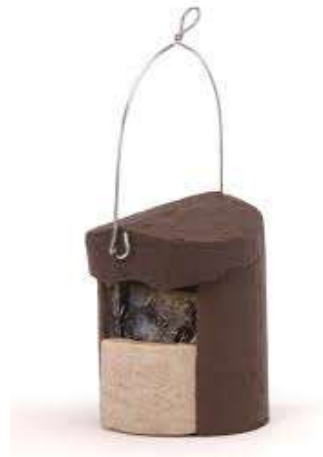
Figure 33: Robin box

A selection of open-fronted boxes and songbird boxes can be installed (Figure 33 and Figure 34); it is recommended that a minimum of two of each of the boxes are installed. These will be installed at a minimum of 2m high and ideally face north to east.

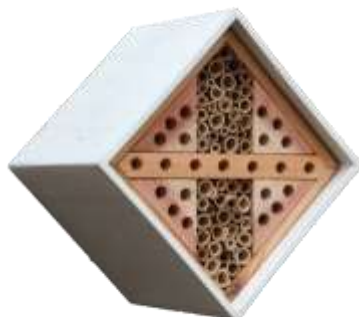
Figure 35: Urban bee nesting box, used for solitary bees and wasps.

A variety of insect boxes can be installed in the area; a minimum of one box is recommended (Figure 35 and Figure 36).

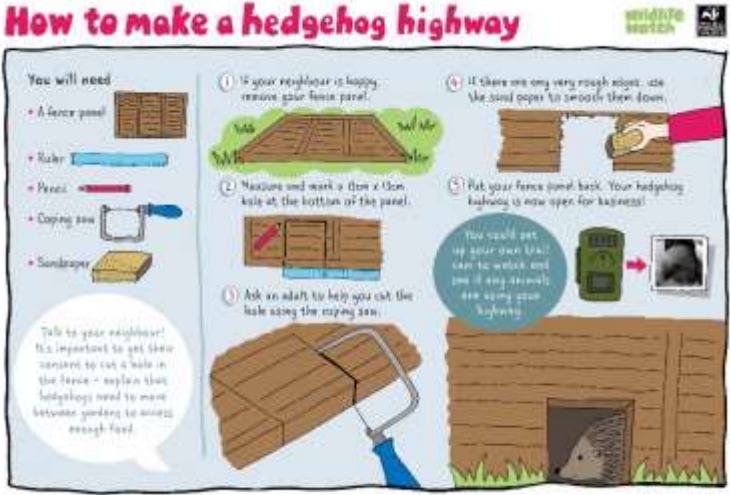
- A 13cm-by-13cm is sufficient for any hedgehog to pass through. This will be too small for nearly all pets (Figure 37).
- Remove a brick from the bottom of the wall, creating a 13cm-by-13cm hole.
- Cut a small hole in your fence if there are no gaps (the existing gap in the fence [T2] can be retained).
- Dig a channel underneath your wall, fence or gate.
- Ideally, rather than walls or fences, a hedge will provide foraging, shelter and a route along as well as through the site.

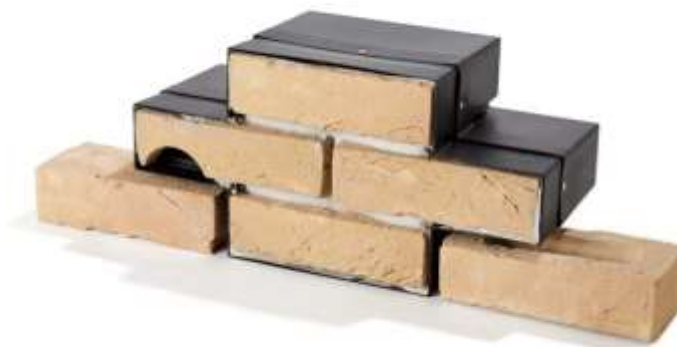
Figure 38: Example of swift bricks, that can be built into a dwelling, Source: <https://www.birdbrickhouses.co.uk/brick-nesting-boxes/>

| <p>Swifts <i>Apus apus</i></p> | <p>Swift nest bricks are recommended due to the increased lack of nesting opportunities swifts are finding in modern-built dwelling homes.</p> <p>Information is adapted from the RSPB <a href="https://www.rspb.org.uk/our-work/rspb-news/news/stories/swift-advice-for-ecologists/">https://www.rspb.org.uk/our-work/rspb-news/news/stories/swift-advice-for-ecologists/</a> and <a href="http://actionforswifts.blogspot.com">http://actionforswifts.blogspot.com</a></p> <p>The following will be undertaken:</p> <ul style="list-style-type: none"> <li>Wherever possible, swift bricks will be installed into new or restored buildings to increase the overall availability of nest sites for swifts and other species. Birds such as house sparrows can use swift bricks, but swifts cannot use house sparrow nest bricks.</li> <li>Integral swift bricks are the preferred option for new housing developments. These should be fitted in clusters of 2 to 4 on gable ends and near the roofline where swifts would naturally look for a potential nest site.</li> <li>Try to ensure swift bricks have a minimum of 5m clearance beneath and in front. Always avoid locating them above doors and windows to help prevent a disturbance issue to both the birds and human owners.</li> </ul> |

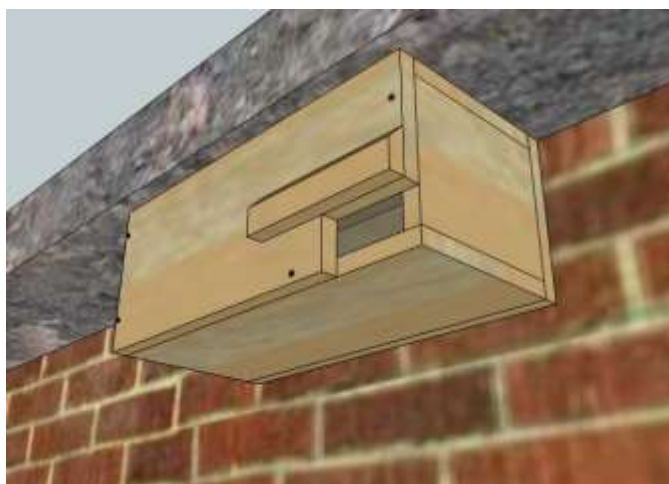
Figure 39: Swift box, source: <http://actionforswifts.blogspot.com/p/diy-swift-box-designs.html>

- Alternatively, swift boxes can be placed on the external walls of a building where the installation of swift bricks is not possible.
