Glencoe Villa

Phase I & II Geo-Environmental Report

Ref: 101320

Site                      Glencoe Villa,  
                                 Ickleford,  
                                 Hitchin,  
                                 SG5 3TR

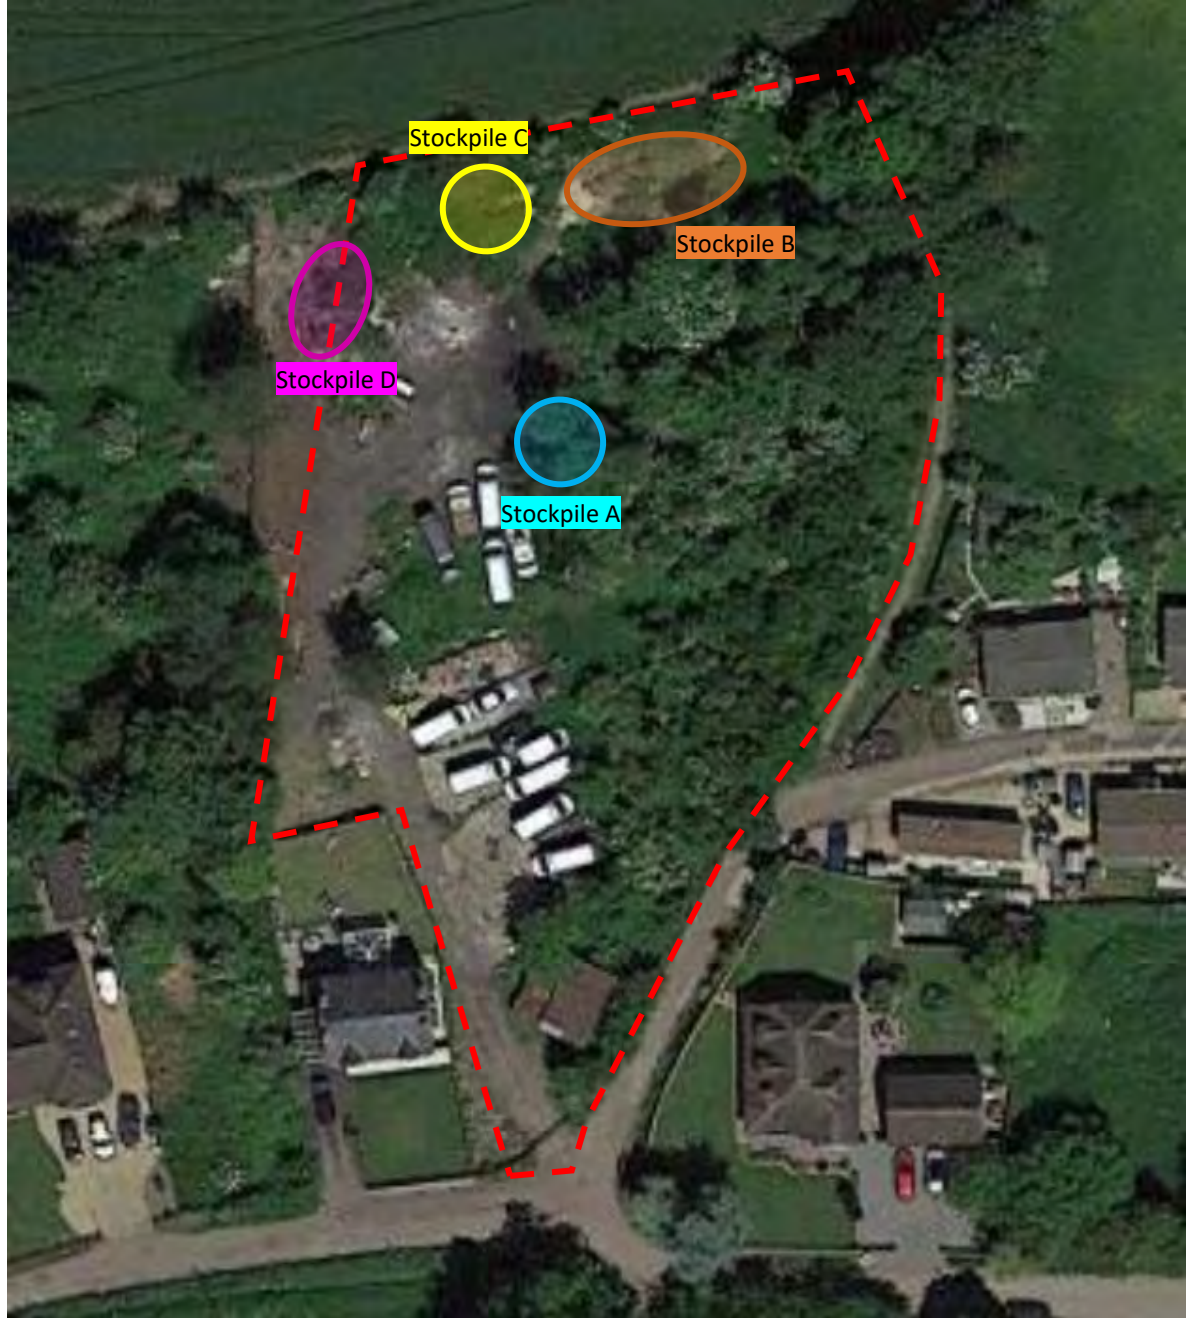
Title  
Approximate Stockpile Locations

Multiple stockpiles were identified surrounding this patch of hardstanding, predominantly in the north of the site. The stockpiles contained burned materials, timber and wood chippings, metal, concrete and brick. The more established stockpiles were also covered in vegetation. The approximate locations of the identified stockpiles are included within Appendix A.

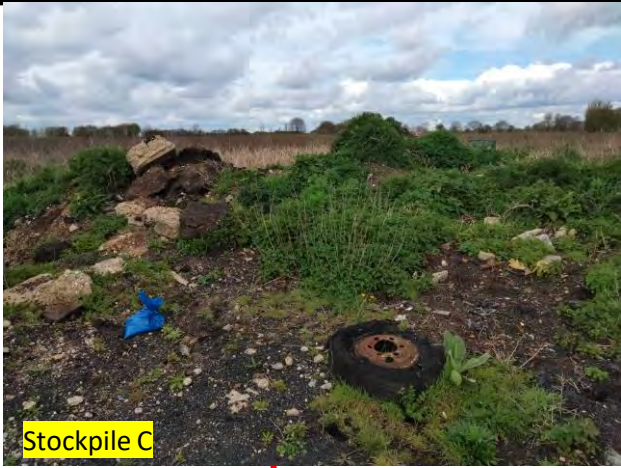
Stockpile C

4No. stockpiles (Stockpiles A to D) were identified around the site, predominantly in the north of the site. Stockpiles predominantly comprised gravelly sand with brick, coal, plastic and concrete fragments. Stockpile B also contained metal, ash, burned materials, wood chippings and shells.
