| Title: | Plot of Particle Size Distribution | | | | Project: | Starwood House, Letchworth | |

## **Annex B: Site Photographs**

## Photograph Log

| Client: | | Site Location: | Project No.: |
|---|---|---|---|
| Letchworth Investment LLP | | Starwood House, Letchworth, SG6 2TT | 631621.0000.0001 |

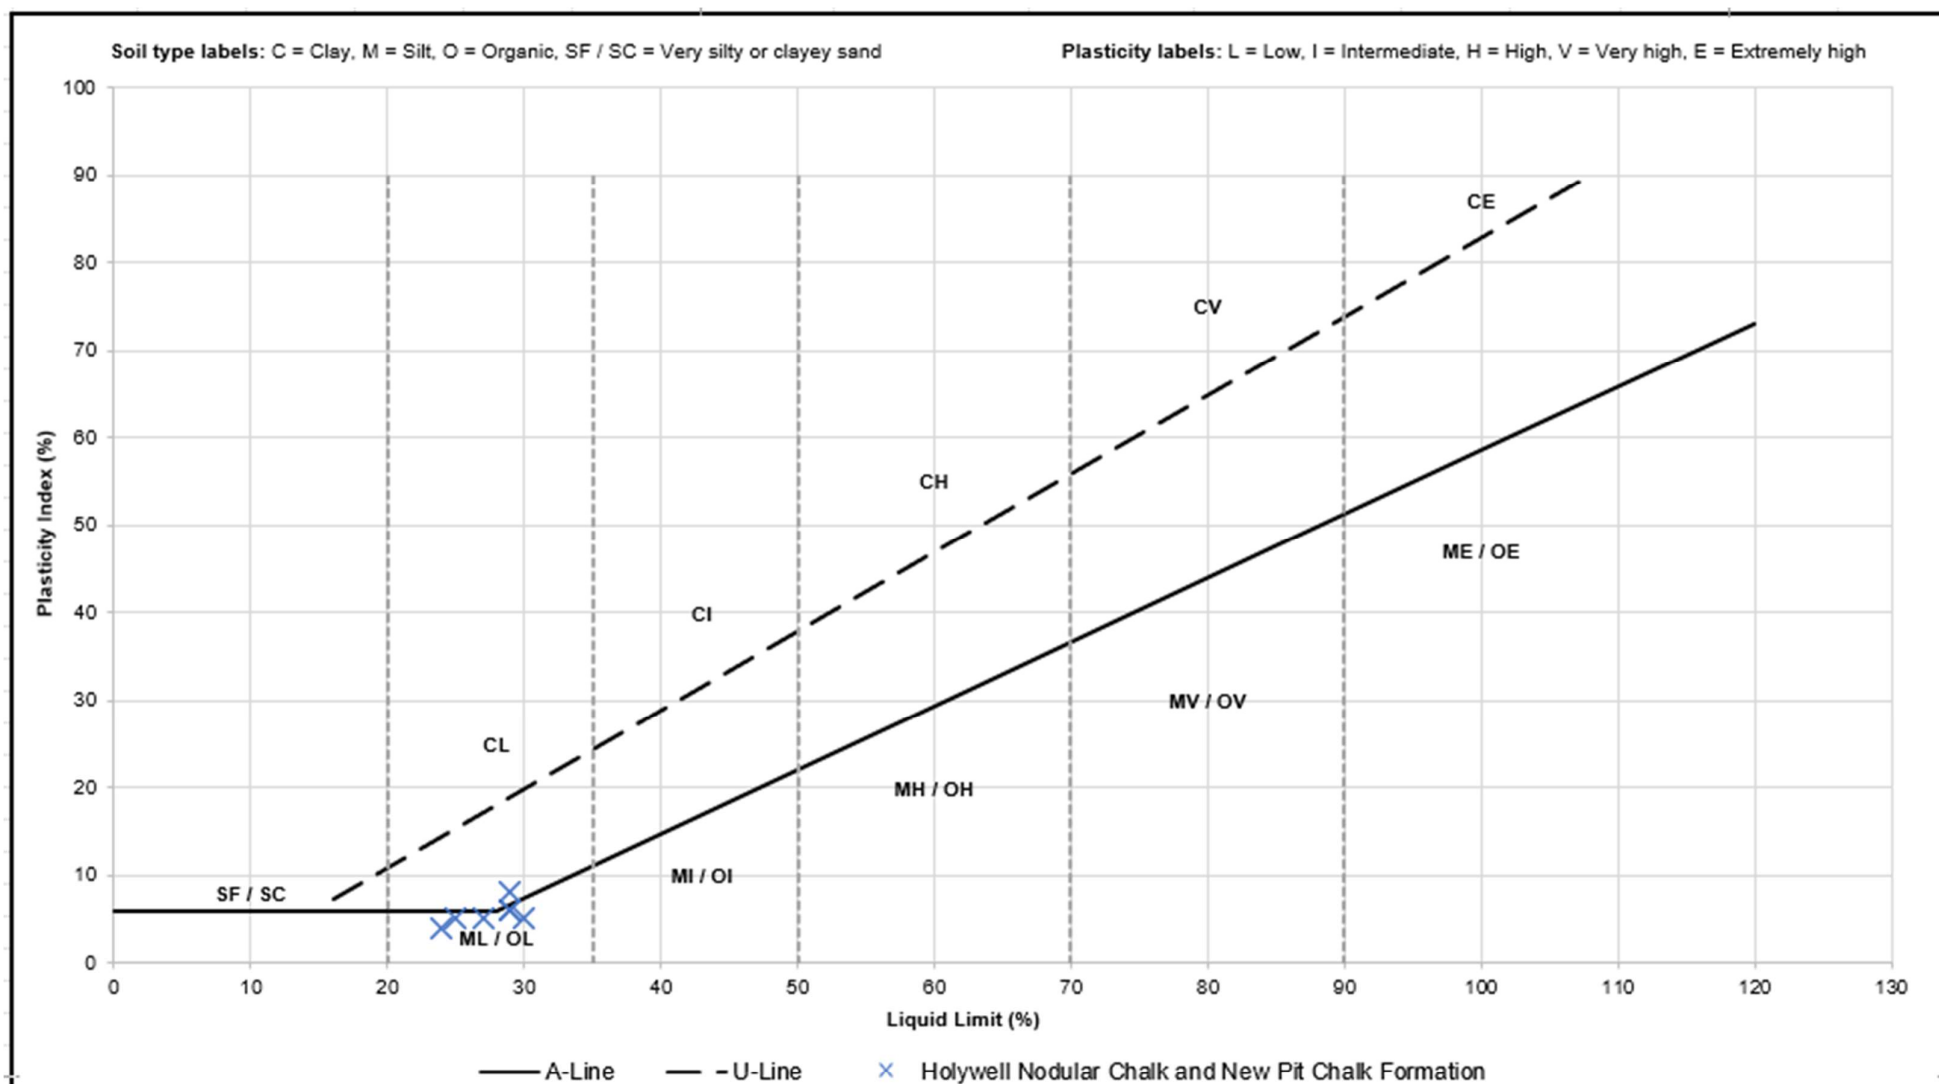
| Figure No.: | | 7 | Author: | JE | Date: | 28/08/2025 | Location: | | Starwood House, Letchworth, SG6 2TS | |

| Title: | | Plot of Plasticity by Geology | | | | Project: | | Starwood House, Letchworth | | |

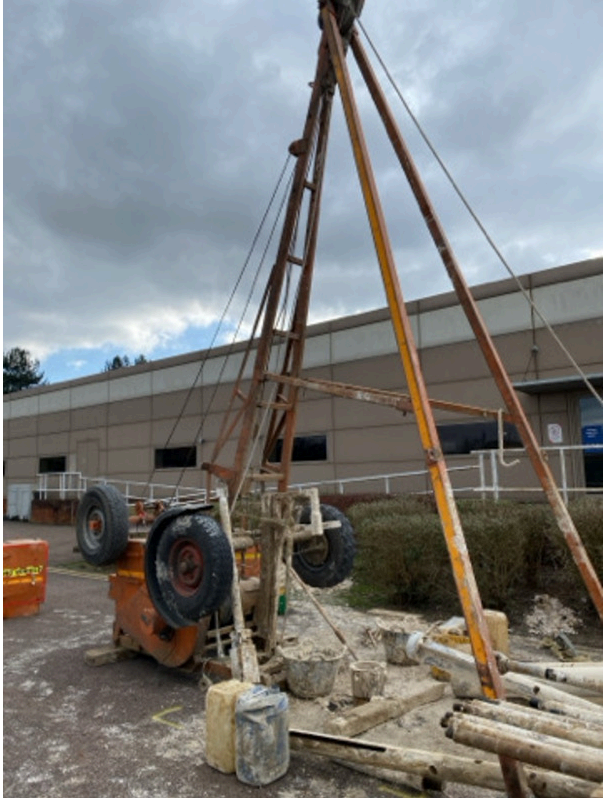
| Client: | | Site Location: | Project No.: |
|---|---|---|---|
| 1 | 17/03/25<br>- 20/03/25 | | |

| Client: | | Site Location: | Project No.: |
|---|---|---|---|
| CP101 Location | | | |

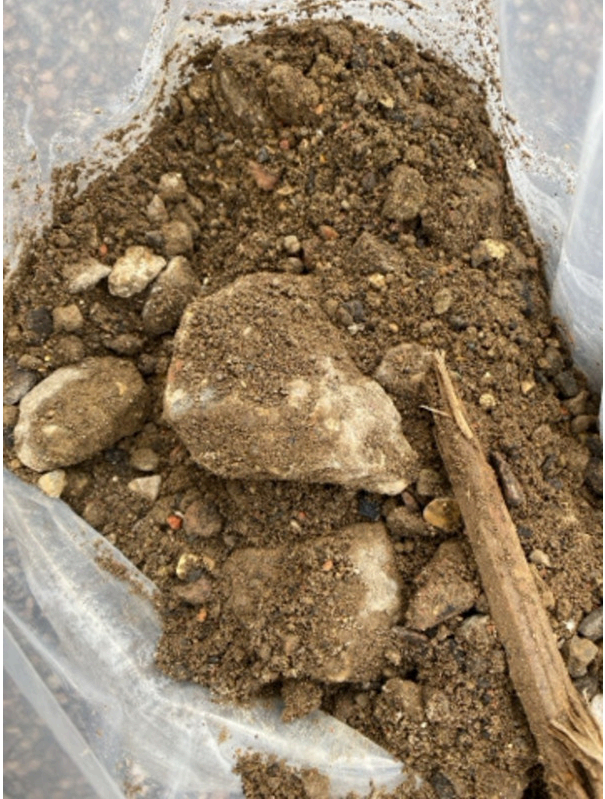
| Photo No. | Date | | |
|---|---|---|--|
| 2 | 17/03/25<br>- 20/03/25 | | |

| Photo No. | Date | | |
|---|---|---|--|
| CP101 - Arisings at 0.3m bgl | | | |

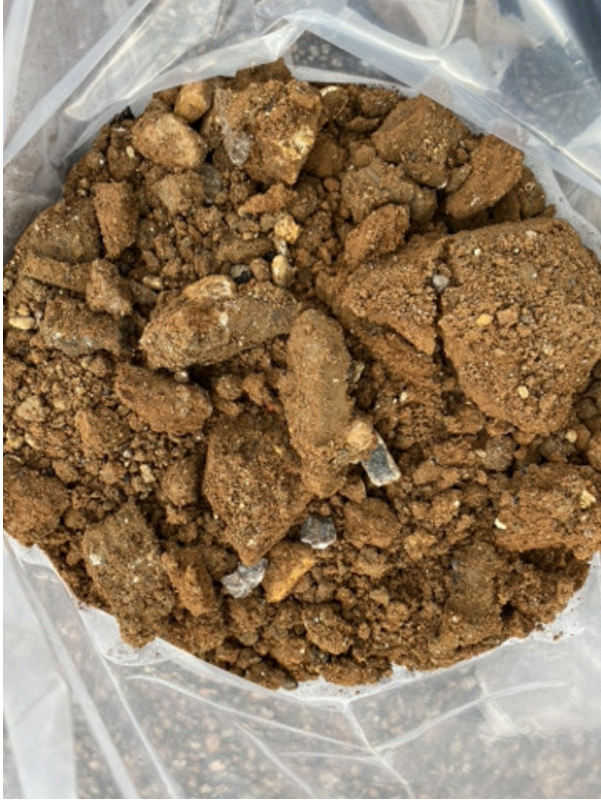
| Client: | | Site Location: | Project No.: |
|---|---|---|---|
| 3 | 17/03/25<br>- 20/03/25 | | |

| Client: | | Site Location: | Project No.: |
|---|---|---|---|
| <b>Description</b><br>CP101 - Arisings at 0.6m bgl | | | |

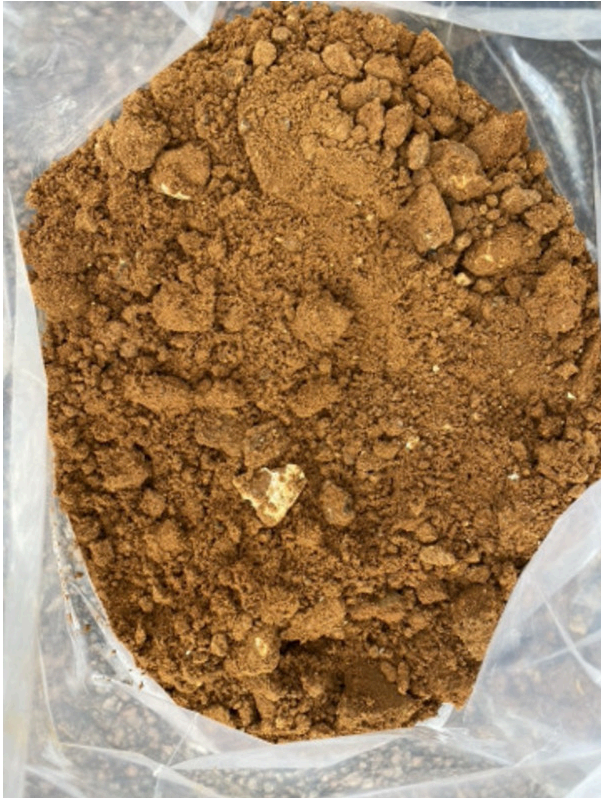
| Photo No. | Date | | |
|---|---|---|--|
| 4 | 17/03/25<br>- 20/03/25 | | |

| Photo No. | Date | | |
|---|---|---|--|
| <b>Description</b><br>CP101 - Arisings at 1m bgl | | | |

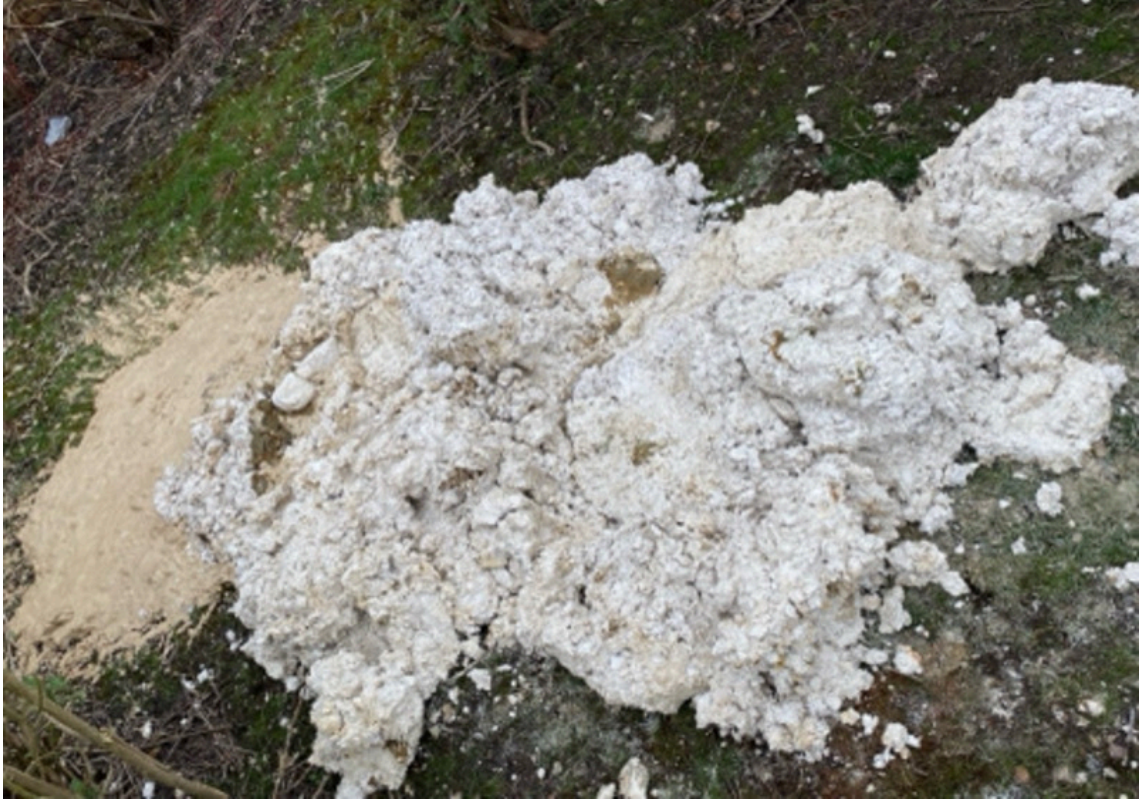
| Client: | | Site Location: | Project No.: |
|---|---|---|---|
| 5 | 17/03/25<br>- 20/03/25 | | |

| Client: | | Site Location: | Project No.: |
|---|---|---|---|
| <b>Description</b><br>CP101 - Chalk arisings between 2m and 10m bgl | | | |

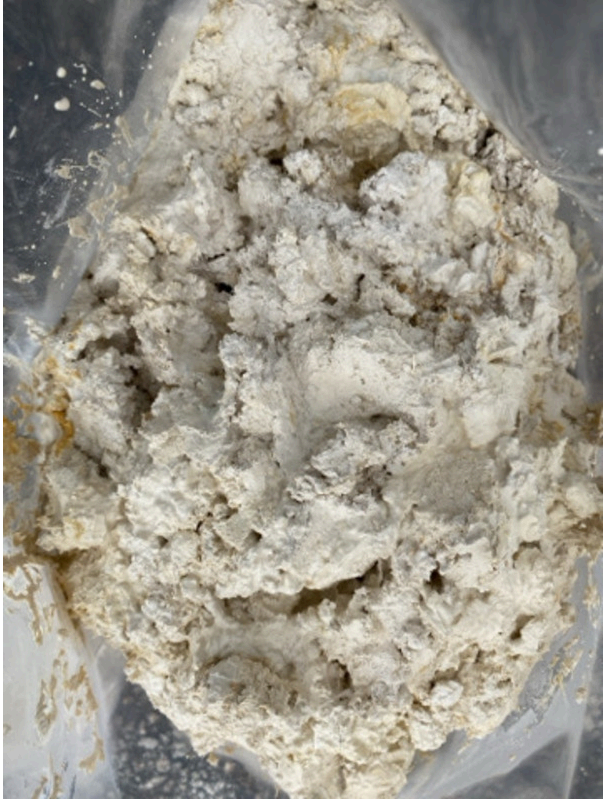
| Photo No. | Date | | |
|---|---|---|--|
| 6 | 17/03/25<br>- 20/03/25 | | |

| Photo No. | Date | | |
|---|---|---|--|
| <b>Description</b><br>CP101 - Arisings at 11m bgl | | | |

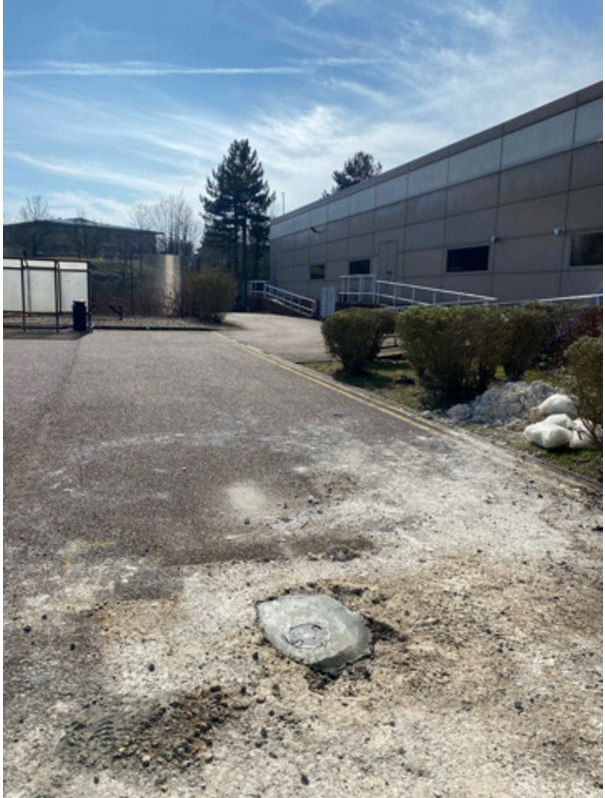
| Client: | | Site Location: | Project No.: |
|---|---|---|---|
| 7 | 17/03/25<br>- 20/03/25 | | |

| Client: | | Site Location: | Project No.: |
|---|---|---|---|
| CP101 Installation | | | |
