# Highover Farm, Hitchin, SG4 0QW

Phase 2 Geo-environmental and Geotechnical Site  
Investigation

340110-R01 (01)

JANUARY 2020

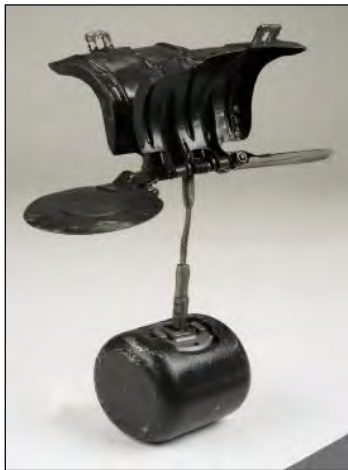
Parachute Mine (Luftmine B / LMB)

| Bomb Weight | Approx. 990kg (2176lb) | | |
| Remarks | Deployed a parachute when dropped in order to control its descent. Had the potential to cause extensive damage in a 100m radius. | | |

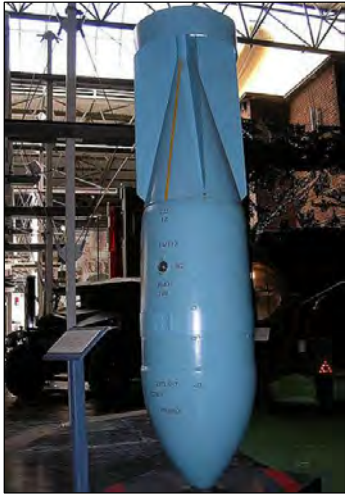
SC 1000kg

| Bomb Weight | Approx. 993-1027kg (2,189-2,264lb) | | |
| Explosive Weight | Approx. 530-620kg (1168-1367lb) | | |
| Fuze Type | Electrical impact/mechanical time delay fuze. | | |

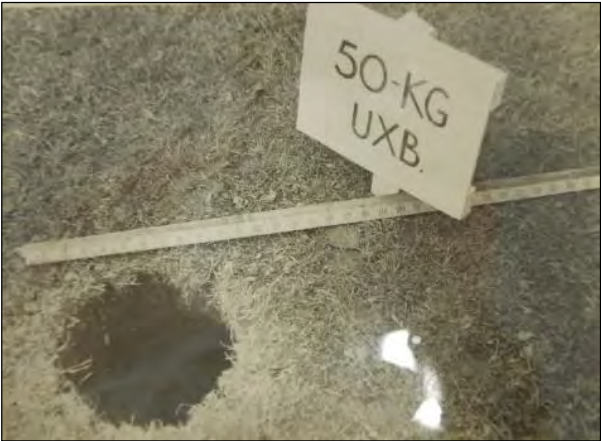
One of the most common scenarios for UXO going unnoticed was when a UXB fell into a 'bomb site' (such as the area shown **Top Left**), the entry hole of the bomb obscured by any debris and rubble present. Note that the entry hole of a 50kg UXB could be as little as 20cm in diameter (**Left**).

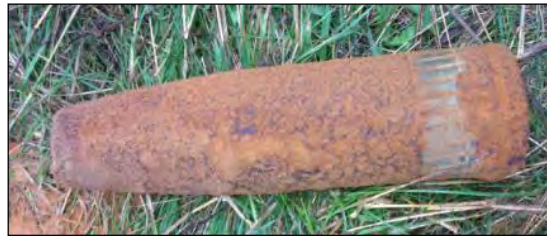
| Use | The 3.7in AA Mks 1-3 were the standard Heavy Anti-Aircraft guns of the British Army. |
| Ceiling | 30,000ft to 59,000ft |

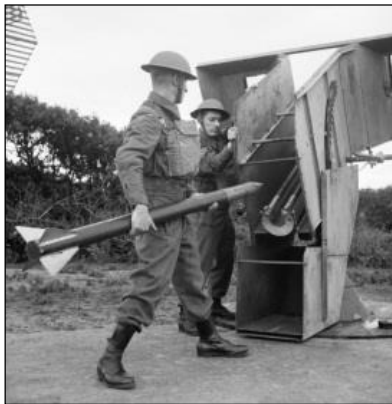
3in Unrotated Projectile (UP) Anti-Aircraft Rocket ("Z" Battery)

| HE Projectile Weight | 3.4kg (7.6lb) |
| Dimensions of projectile | 236 x 83mm (9.29 x 3.25in) |
| Remarks | As a short range rocket-firing anti-aircraft weapon developed for the Royal Navy. It was used extensively by British ships during the early days of World War II. The UP was also used in ground-based single and 128-round launchers known as Z Batteries. Shell consists of a steel cylinder reduced in diameter at the base and threaded externally to screw into the shell ring of the rocket motor |
