Report prepared for: Samuel Pollock

For the Site of: 56 Ickleford Rd, Hitchin, SG5 1TS

# Preliminary Roost Assessment (PRA)

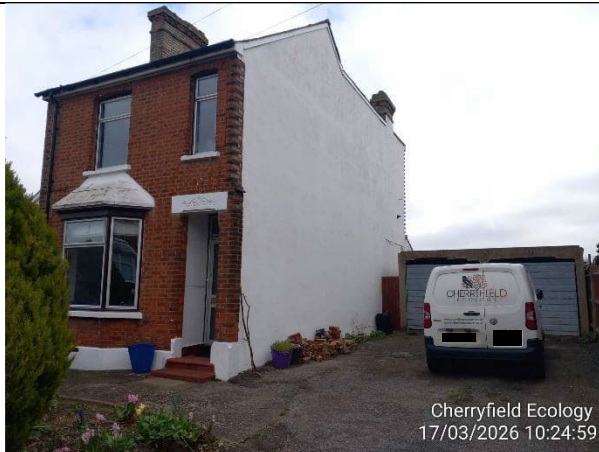
Figure 2: Example of B1's front exterior

| Building/Tree/Structure Number | Description |
|---|---|
| B1 | <p><b>External</b></p> <p>B1 is a brick built, two storey residential dwelling. The roof is in a cross gabled structure with slate roofing tiles. A UPVC soffit box surrounds the eaves of the building, as well as some plastic guttering. Two chimneys are present on the roof. A single storey extension is present to the rear of the building, this is mono-pitched with concrete interlocking roofing tiles. All the doors and windows are UPVC framed.</p> |

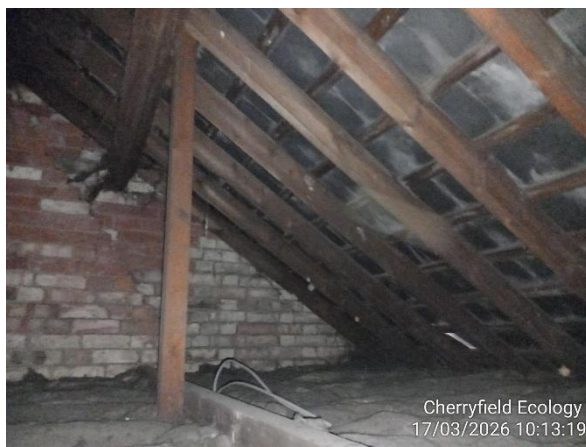
Figure 4: Example of B1's interior

Internally, one loft void can be found above the second storey of the building. The loft is in a gable ended structure with timber framing and timber lined roofing tiles.

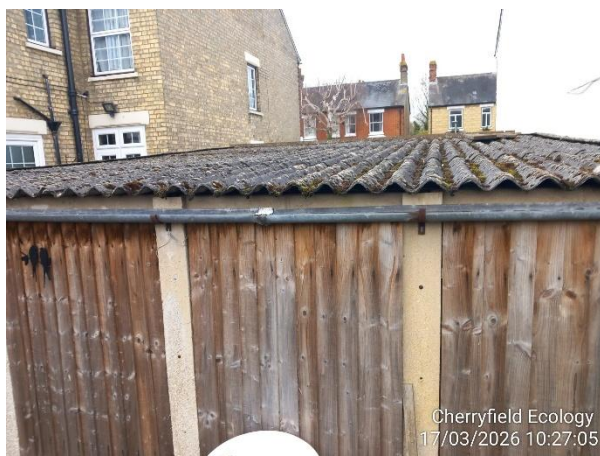
Figure 6: Example of B2's exterior

B2 is a concrete detached garage with a mono-pitched corrugated asbestos-type roof. There are two metal garage doors at the front of the building. The rear and some of the side exterior of the garage are covered by timber. A section of guttering is found to the rear of the garage.

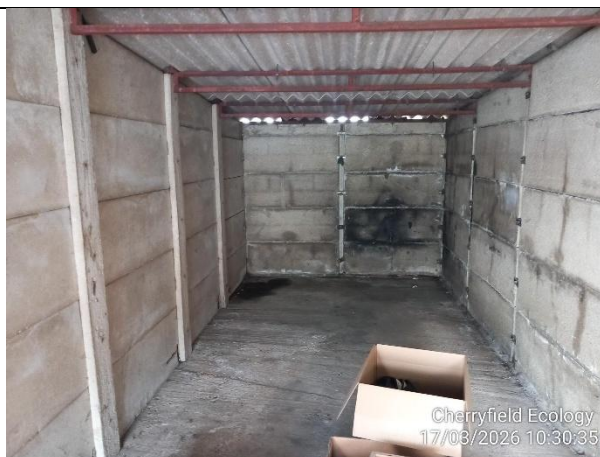
Figure 7: Example of B2's interior

B2 is split into two internal sections, both of which are framed with metal and used for storage.

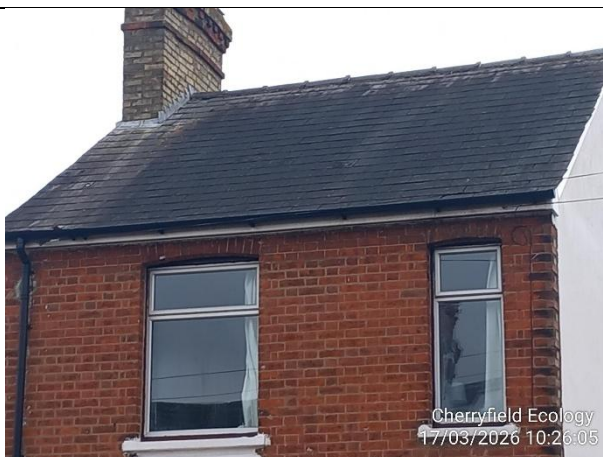
| Potential for bat use | Buildings:<br>Level of likelihood of roosting presence -<br>B2 - Negligible<br>B1 - Negligible<br>B1 provides negligible potential for roosting bats due to the lack of gaps within the roofing tiles, mortar, lead flashing and soffit box. There are also no internal access points found within the loft void. |

Figure 9: Example of the tightly fit slate roofing tiles

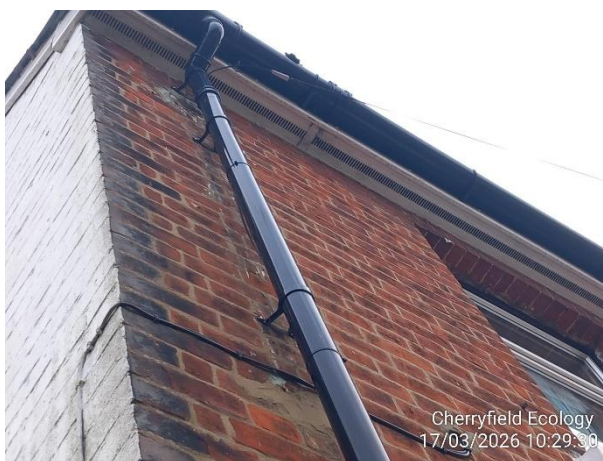
Figure 10: Example of the tightly fit soffit box
