Natrix Ecological Limited

## Preliminary Roost Assessment (PRA)

The Lodge, Preston Road, Gosmore, Hitchin

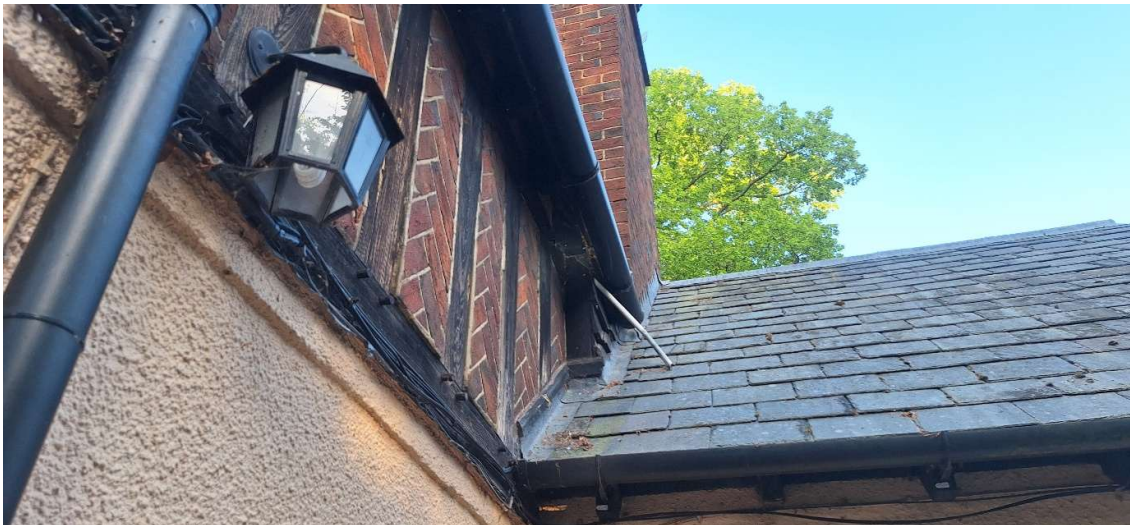
**Photograph 2.** Building B showing herringbone brickwork, lead flashing, slate tiles and render. Note overall good repair.

The upper storey exhibits more original features including exposed wood and traditional herringbone brickwork. The brickwork also appears damaged in places. The ground floor appears to have undergone much more recent renovation, with painted rendering in

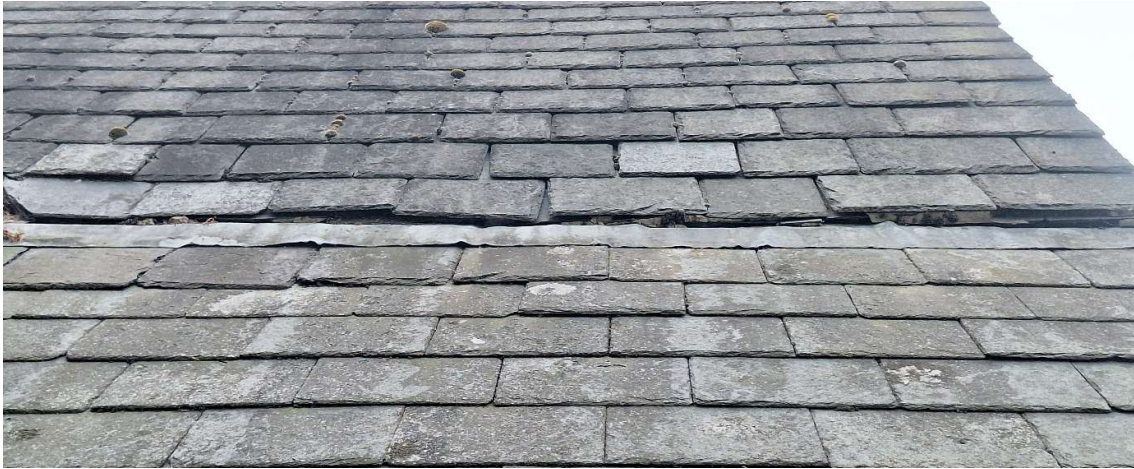
**Photograph 9:** Example of lifted slate tiles, sufficient to provide roost space for bats. Eastern aspect, Building A.

Building A possesses several features which mean it has **low** roost potential for bats. These are the lifted tiles, ageing window frames (1<sup>st</sup> floor) and holes in the brickwork. These will require an emergence survey to be undertaken to ascertain whether these features are utilised by bats. In accordance with BCT guidelines (2023), it is therefore necessary to undertake one survey, due to the assessed potential. However, should bat activity be noted in relation to the structure, further surveys will be required.

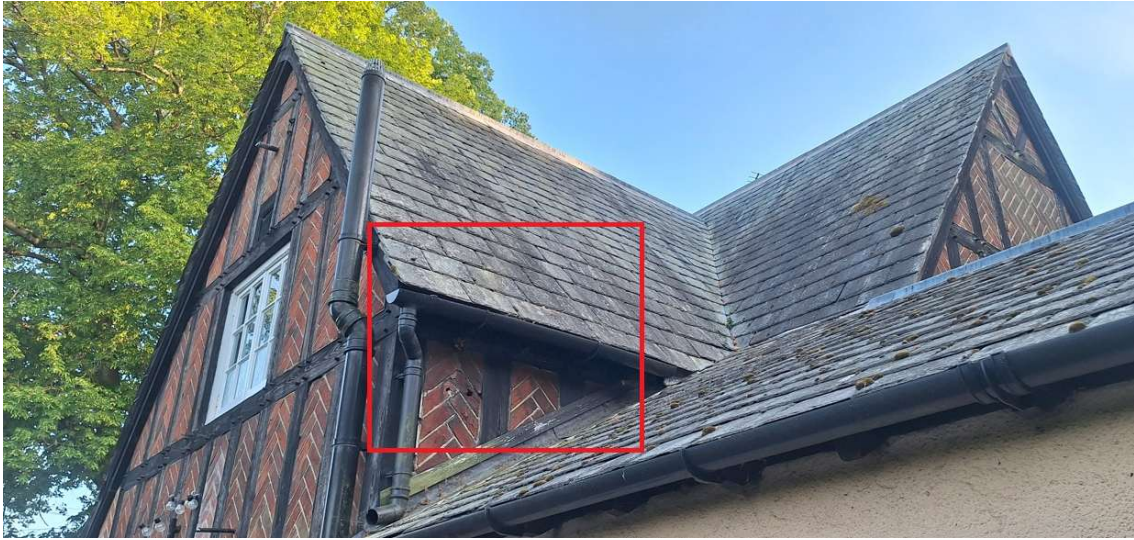
**Photograph 12:** Hole in brickwork on the northern aspect of the upper storey.  
Recommended view for survey.

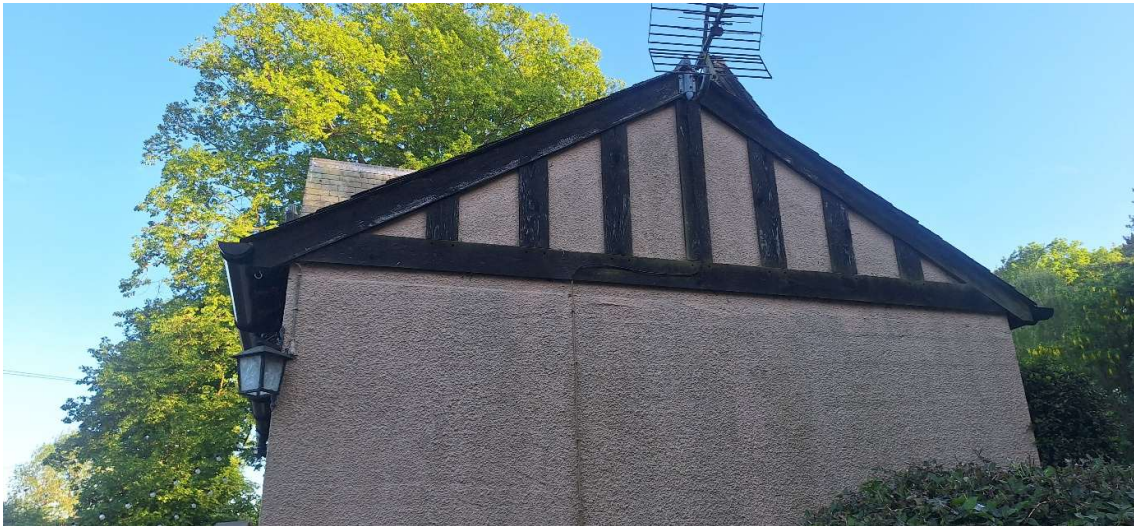
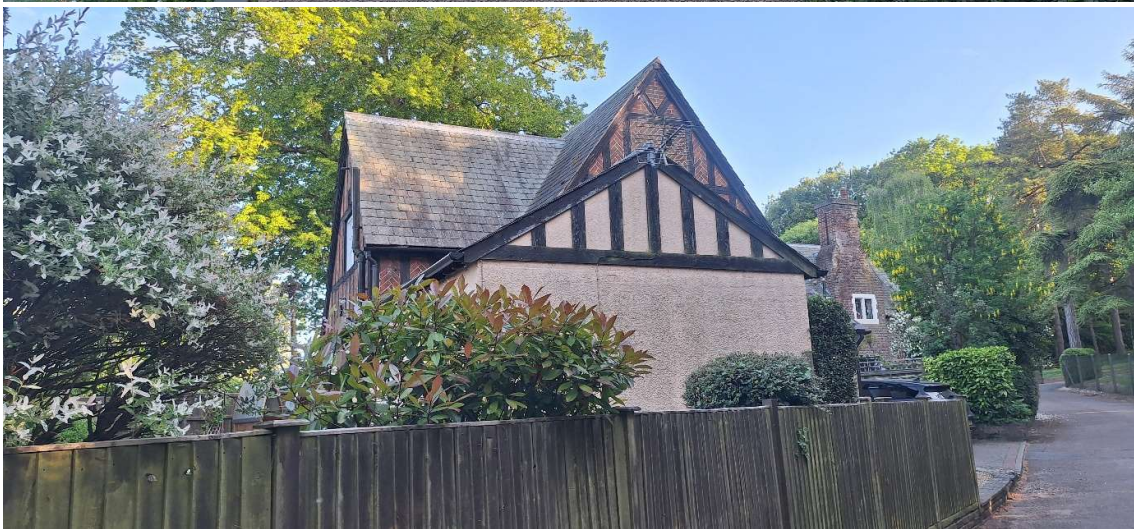
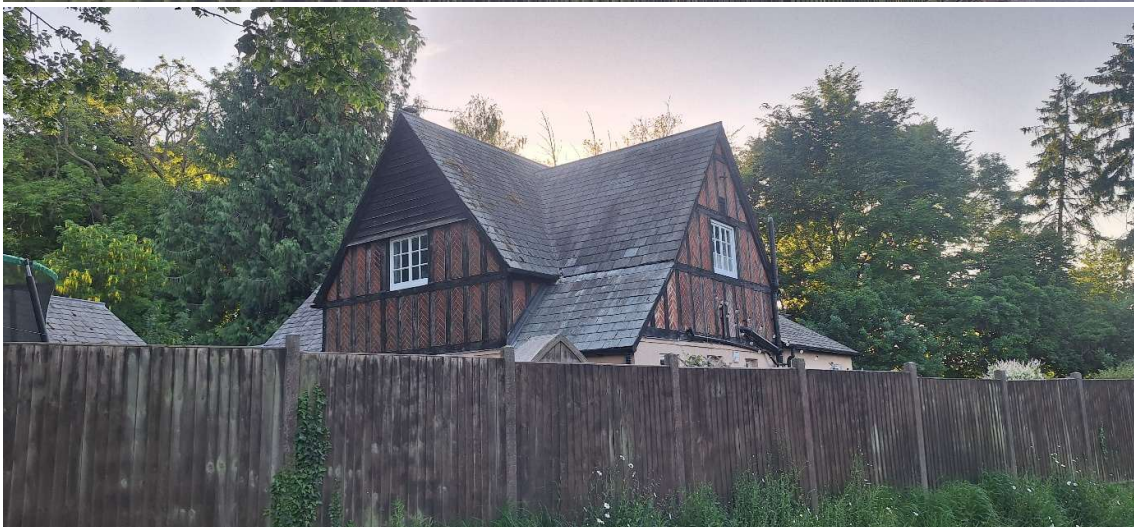
**Photographs 15, 16 & 17.** North and easterly aspects of Building A, with indication of surrounding habitat.
