# **Hill Residential Ltd**

## **Ground Investigation**

**Lucas Lane  
HITCHIN  
Hertfordshire  
SG5 2HS**

**Report Ref: 16.07.021c  
March 2025**

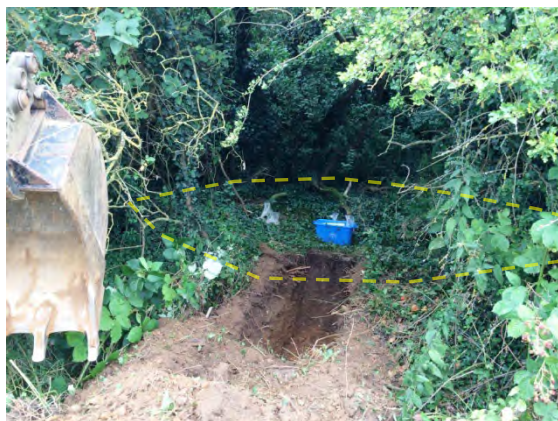
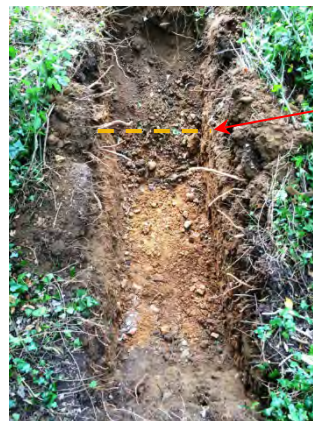
Circular depression (difficult to see from photographs and very approximately highlighted) from edge of TP 8 – and shallow Made Ground at surface within that pit

No visual or olfactory signs of contamination were noted during the fieldwork, other than the metallic and glass artefacts within the Made Ground from TP8 on the edge of the former farmer's pit in the densely vegetated area. Whilst these artefacts are not necessarily contaminative in themselves, they do confirm the anecdotal evidence for the presence of the pit.

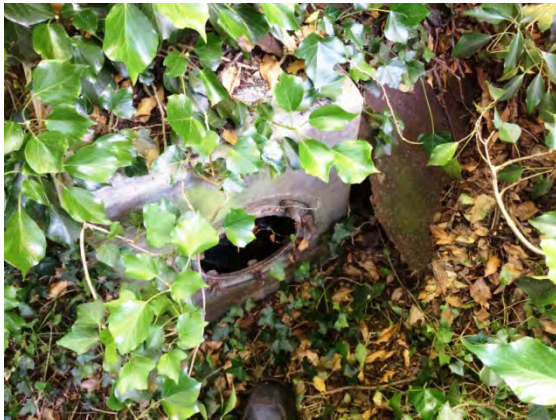
Metal tanks within the wooded area

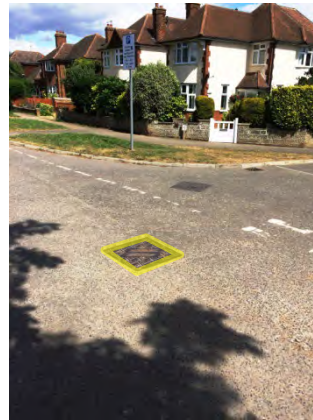
Manhole, on Lucas Lane, used as survey datum

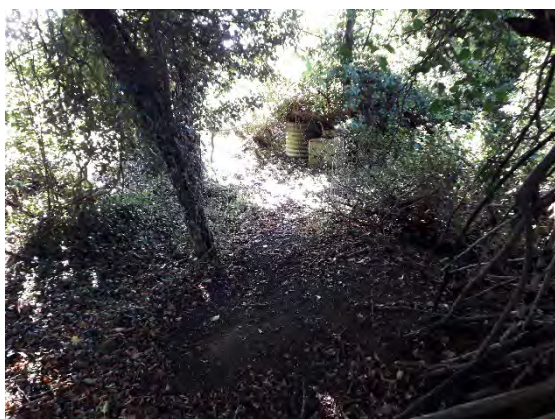
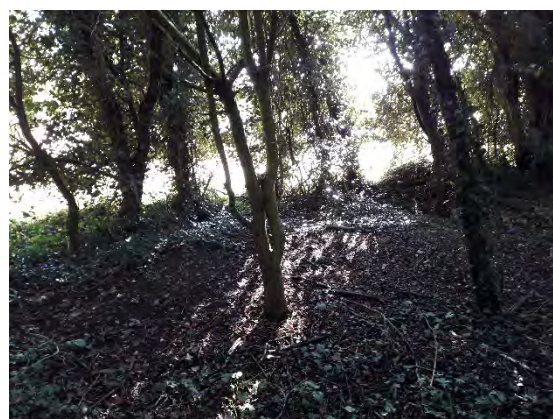
Dense vegetation within the wooded area of the site and (on the left-hand image) the two galvanised metal containers evident from the first walkover

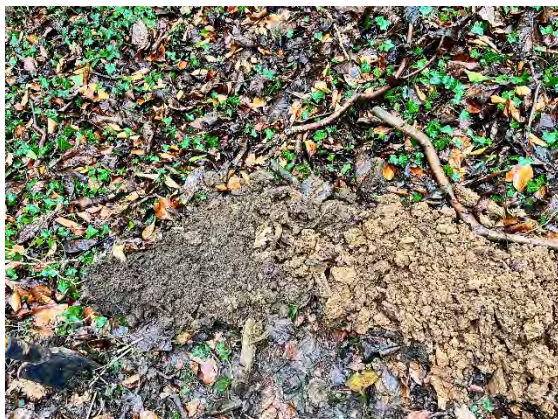
Showing shallow Made Ground soils
