# whitworth

MILL END COTTAGE, MILL END, BUNTINGFORD, HERTS, SG9 0RN  
(HERITAGE STATEMENT)

June 2024  
MS/7179

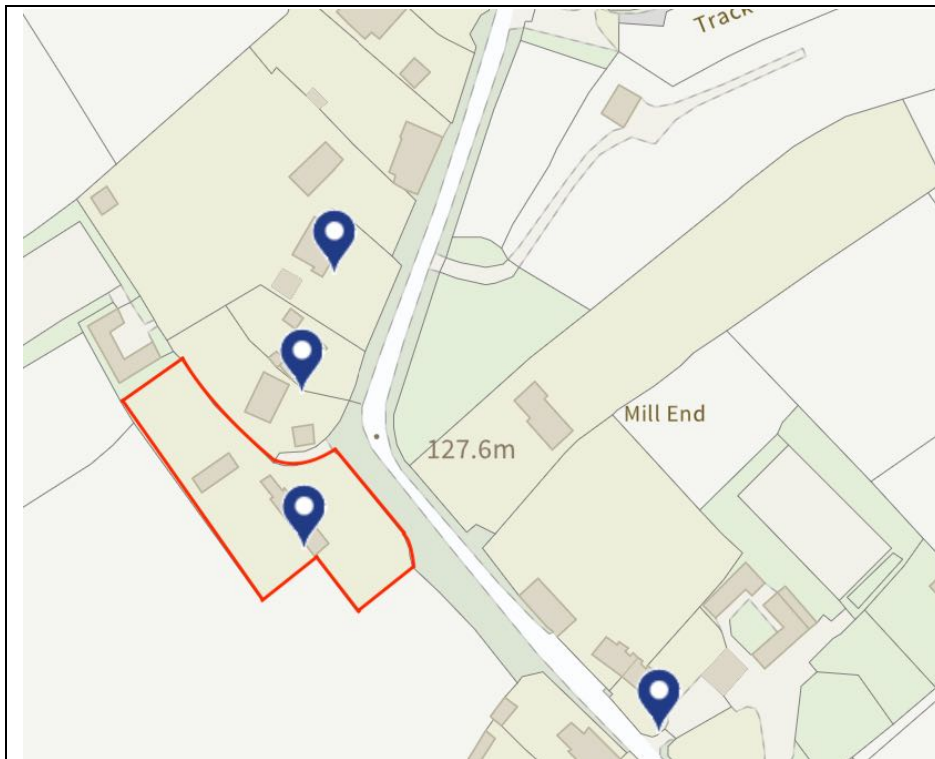
Site plan

The property is situated in the small hamlet of Mill End with open countryside to the south and west of the site.

The area is characterised by the properties being in a linear development along road with generous plot sizes. There are listed buildings to both the north and east of the property as noted on the site plan. The property sits within the centre of the plot and there are limited views of the property from the road.

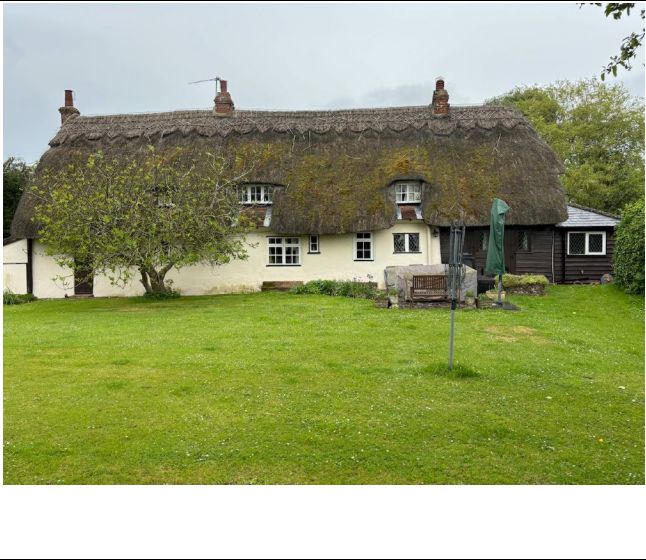
| A photograph showing the south west elevation of Mill End Cottage. The house is a two-story building with a thick thatched roof and three chimneys. The walls are white with dark window frames. A large green lawn is in the foreground, and a small tree is on the left. | A photograph showing the north west elevation of Mill End Cottage. The house has a steep thatched roof and a small dormer window. A dark wooden shed is in the foreground, and a yellow flowering bush is on the right. A car is partially visible on the left. |

The original property has rendered elevations under a thatched roof. There have been single storey extensions added to both ends of the property under tiled roofs.

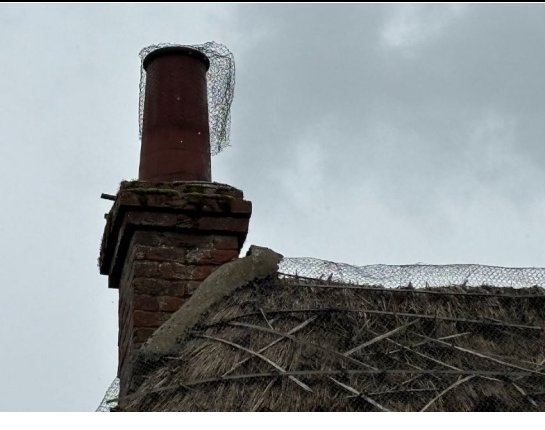
| i | A close-up photograph of a brick chimney on a thatched roof. The chimney is made of red brick and has a metal mesh cage around the top. The thatch is made of straw and is visible below the chimney. | <p>To northern chimney, take down top 3 courses of brickwork and raise height of chimney to 1.8m above ridge of thatch and install class 1 flue liner as detailed in the schedule of works.</p> |

The proposed works are necessary to protect the property from fire damage and decay. The chimneys are not of sufficient height to allow sparks to fall away from the building before burning out. The current situation compromises the owners ability to secure building insurance. At the present height there is a very

real chance of sparks falling on the thatch and causing a fire. The existing cement render on the gable does not allow the fabric of the building to breath, this in turn is likely to cause decay to the historic timber frame.

| | | Mitigation | The existing chimneys are not high enough to prevent sparks from the fire places from falling on to the thatch. Although there is no photographic evidence, the chimneys are not of a height typically found on similar listed buildings. The proposal to raise the height of the chimneys will reduce the risk of fire to the thatch. |

The chimneys will be raised using handmade bricks to match the existing bricks used on the chimneys laid in 1:2 NHL 3.5 Lime : sharp sand. The gable will be re rendered in chalk render on sawn oak laths with sheeps wool insulation used to fill any voids and finished with 3 coats of limewash coloured to match the existing walls.

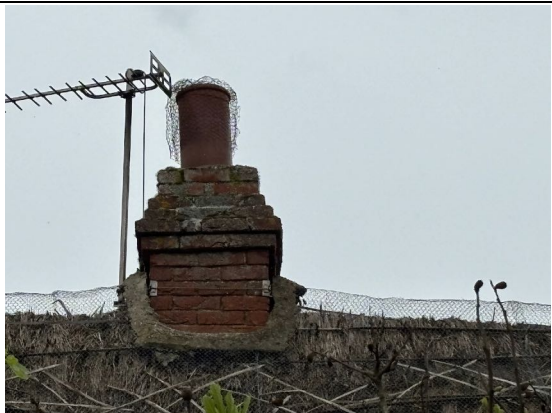
| ii | A close-up photograph of a brick chimney on a thatched roof. The chimney is made of red bricks and has a metal mesh cage around its top. A television antenna is visible to the left of the chimney. | <p>To central chimney, take down top 6 courses of brickwork and raise height of chimney to 1.8m above ridge of thatch and install class 1 flue liner as detailed in the schedule of works.</p> |

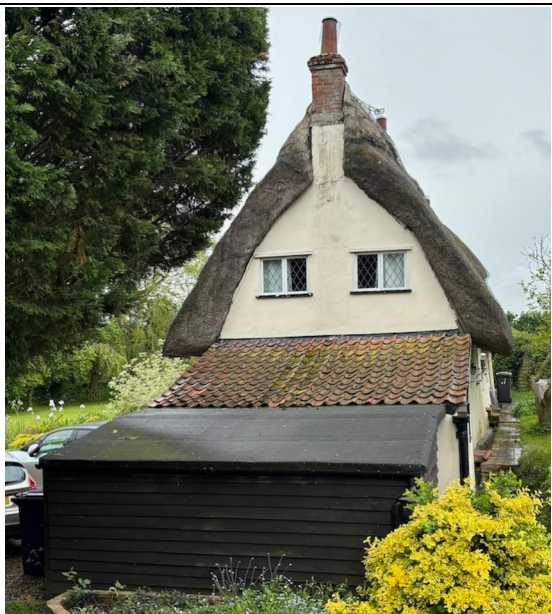
| iii | A photograph of the exterior of Mill End Cottage. The house has a thatched roof and a small dormer window. A dark wooden outbuilding is attached to the side of the house. Yellow flowers are in the foreground. | <p>To north west gable, strip existing cement render and re finish with Lime render on timber lath</p> |

| | | Mitigation | The gable is rendered with a cement based render which does not allow the fabric of the listed building to breathe and is likely to cause decay of the historic timber frame. Replacing the render in a traditional lime render with limewash finish will return the fabric to the original breathable fabric and prevent any further decay |

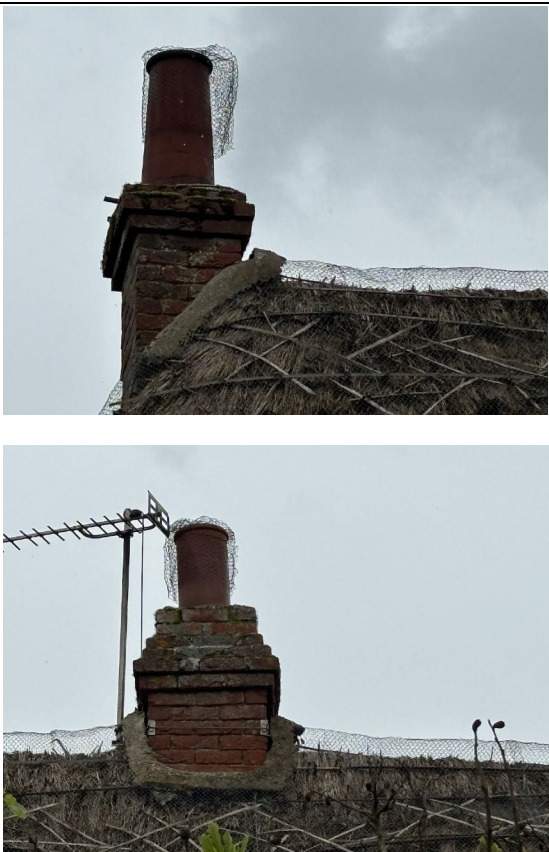
| 1 | | Item | Raising 2 no. chimneys |

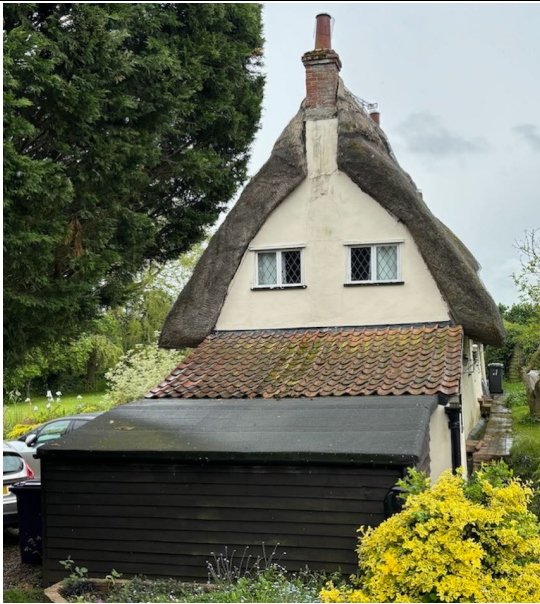
| 2 | | Item | Re rendering north west gable |
