Report prepared for: James Gran

For the Site of: The Generator Building, Hexton Manor, Hexton, Hitchin, Hertfordshire  
SG5 3JH

# Emergence and Activity Bat Survey (EBS)

The survey was conducted on 22/05/2024.

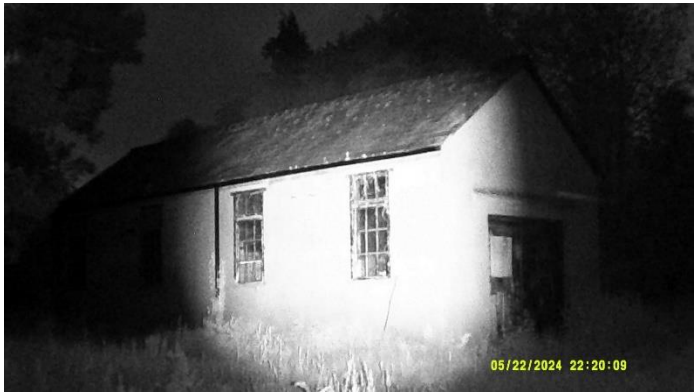
| Surveyor | Building, Tree or Structure | Dates, Times and Survey Type | Bat Activity Observed |
|---|---|---|---|
| JW | B1 | 22/05/2024<br>20:40 to 22:30<br>SS: 21:00 | A Common Pipistrelle ( <i>Pipistrellus pipistrellus</i> ) was heard but not seen at 21:22. Foraging activity was then recorded at 21:30 with continuous foraging activity until 21:44. All bat calls were heard but not seen during the survey. No bats were observed emerging. |

| | | | <p>Figure 2: Surveyor IR image of elevation.</p> |

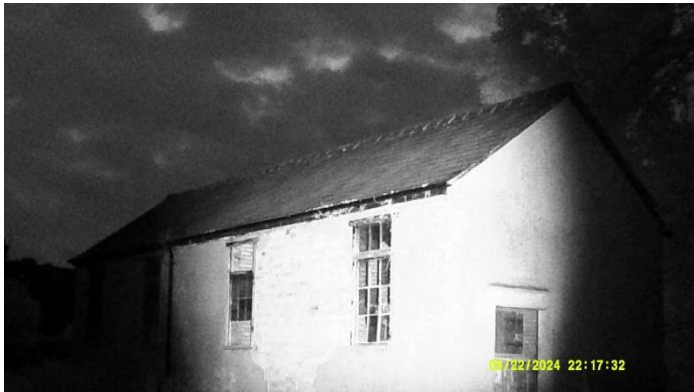
| ES | B1 | As above | <p>A Common Pipistrelle was recorded passing at 21:38. A Myotis species was heard but not seen at 21:47.</p> <p>Figure 3: Surveyor IR image.</p> |

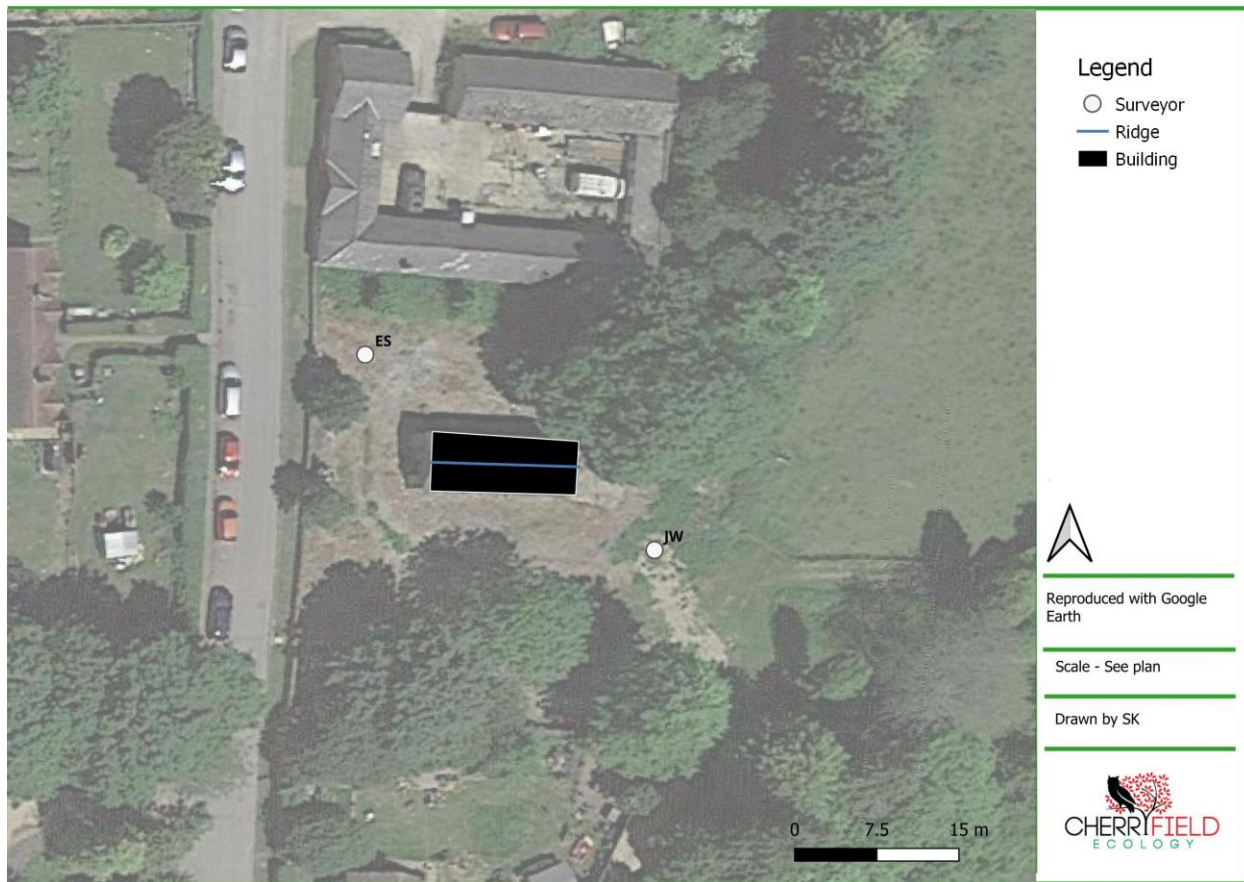
Figure 4: Site Plan

The following section details the structure(s) reference, bats located, evidence located and observed emergence/re-entry (see Figure 4 for Site Plan).
