KDK ARCHAEOLOGY LTD

## Archaeological Monitoring and Recording Report

Colt House,  
Southern Green,  
Rushden,  
Hertfordshire

Event/Accession No: RUS/CHSG '24

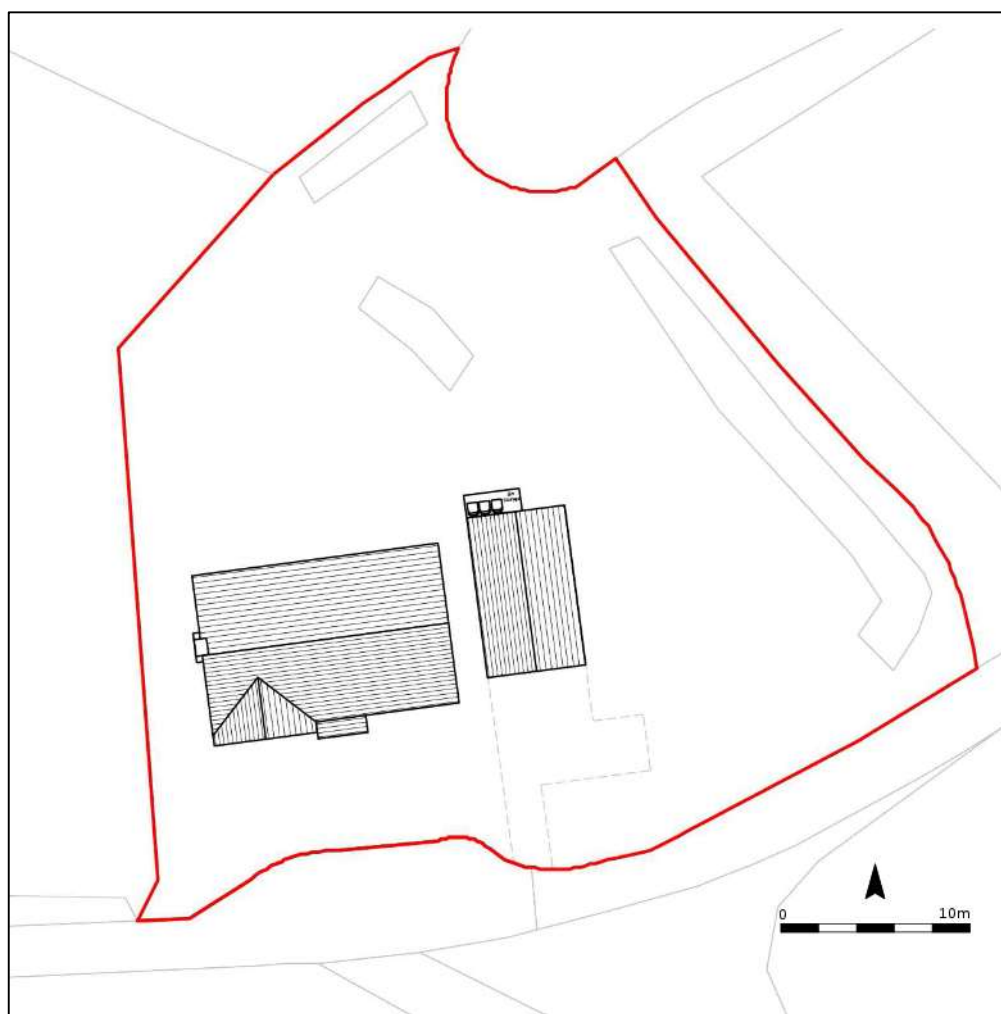
**Figure 3:** Development plan (scale 1:400)

The development entailed the erection of one 4-bed dwelling with associated outbuilding and landscaping following demolition of existing detached dwelling and outbuilding (Fig. 3).

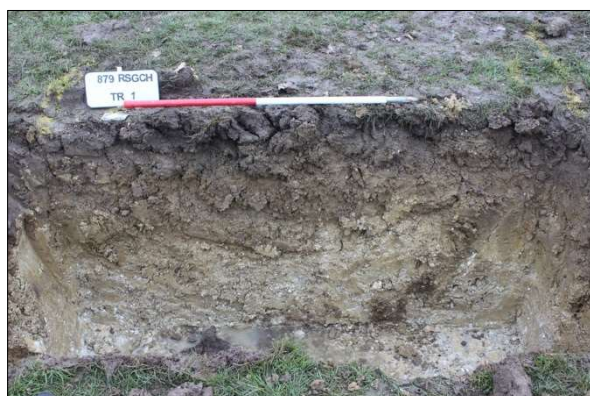
**Plate 1:** Representative stratigraphy in Trench 1

The stratigraphy was uniform in all excavations and was represented in Footings Trench 1 (Plate 1, Fig. 10). It consisted of mid greyish brown silty clay topsoil, generally c. 0.1m deep. Below this was a layer of light greyish brown silty clay subsoil measuring around 0.25m deep. This overlay the natural geology, which was mid orangey brown clay with large chalk inclusions, becoming grey chalky clay as it extended deeper.

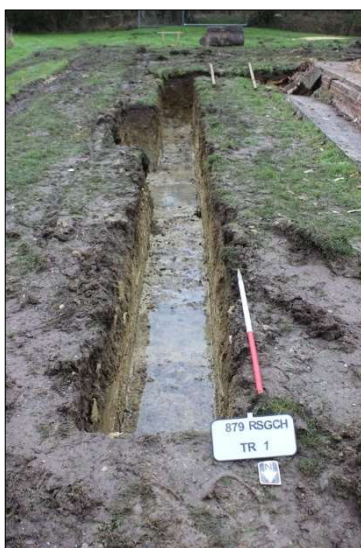
**Plate 2:** Trench 1, looking north

The footings of the new dwelling, represented by Trenches 1 – 8, were arranged in a footprint measuring 13.5m long by 9.7m wide including four large perimeter trenches and four interior trenches (Plates 2 – 9). Trenches 9 – 12 were located to the east and were for the new garage, arranged in a footprint measuring 8.5m long by 5.4m wide (Plates 10 – 13). All footings trenches were 0.6m wide and 1.1m deep. An area immediately to the south of the house measuring 10.2m long by 8.6m wide was reduced to a depth of 0.3m. This did not breach the subsoil and therefore did not reach the archaeological horizon (Plate 14). The septic tank was excavated to the north of the house and measured 3.2m long by 2.4m wide. It reached a depth of 2.2m (Plate 15). No evidence of archaeological finds or features were identified in any of the excavations (Fig. 11).

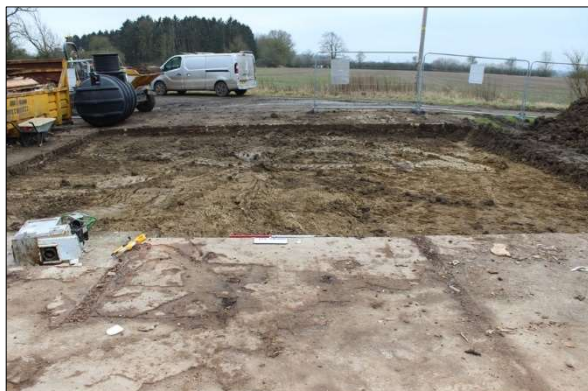
**Plate 14:** Stripped area, looking south

The project required the excavation of twelve footings trenches, eight for the new dwelling and four for the new garage. Limited ground reduction took place on the southern side of the site, as well as the excavation of a septic tank. The work was carried out using a 5-tonne tracked excavator fitted with 0.9m and 0.4m wide toothless buckets.

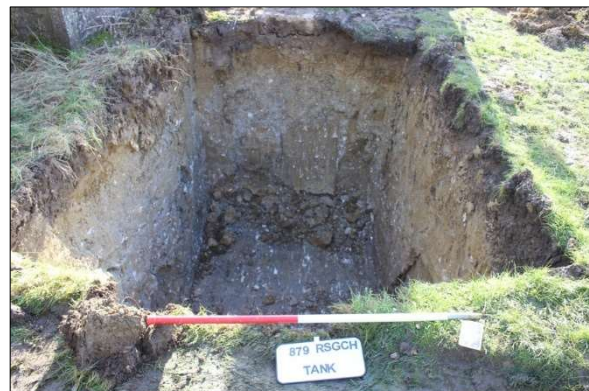
**Plate 15:** Septic tank, looking south-southeast

This project required the monitoring of twelve footings trenches, as well as the excavation of a septic tank to the north and shallow ground reduction to the south. A planning condition was applied due in part to the proximity of the development to the large medieval moated complex located immediately to the northeast of the site, with the west arm of the moat running through the site.
