**Holborn Barn, Therfield, Hertfordshire**

**Phase II Site Investigation**

**March 2026**

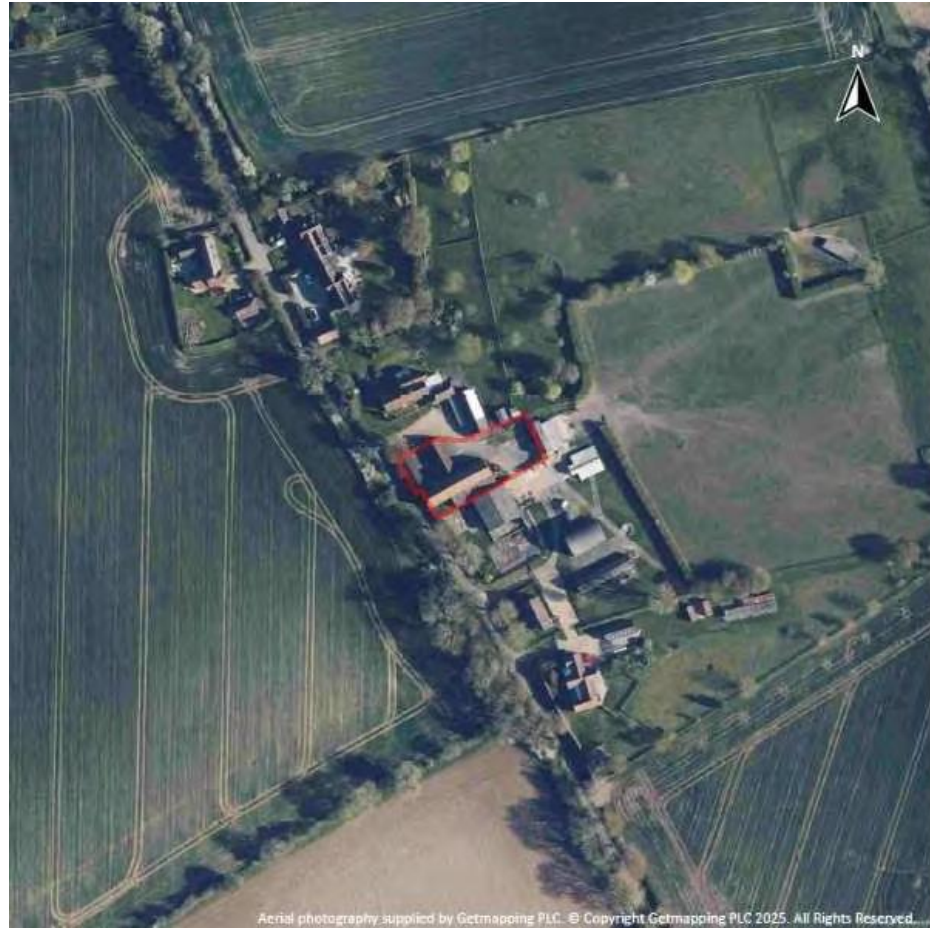
**FIGURE 2 – TRIAL PIT LOCATIONS**

The site investigation was undertaken on Wednesday 11<sup>th</sup> February 2026. Trial pits logs are provided in Appendix A and selected photos from the site work are provided in Appendix C. The investigation locations are shown in Figure 2.

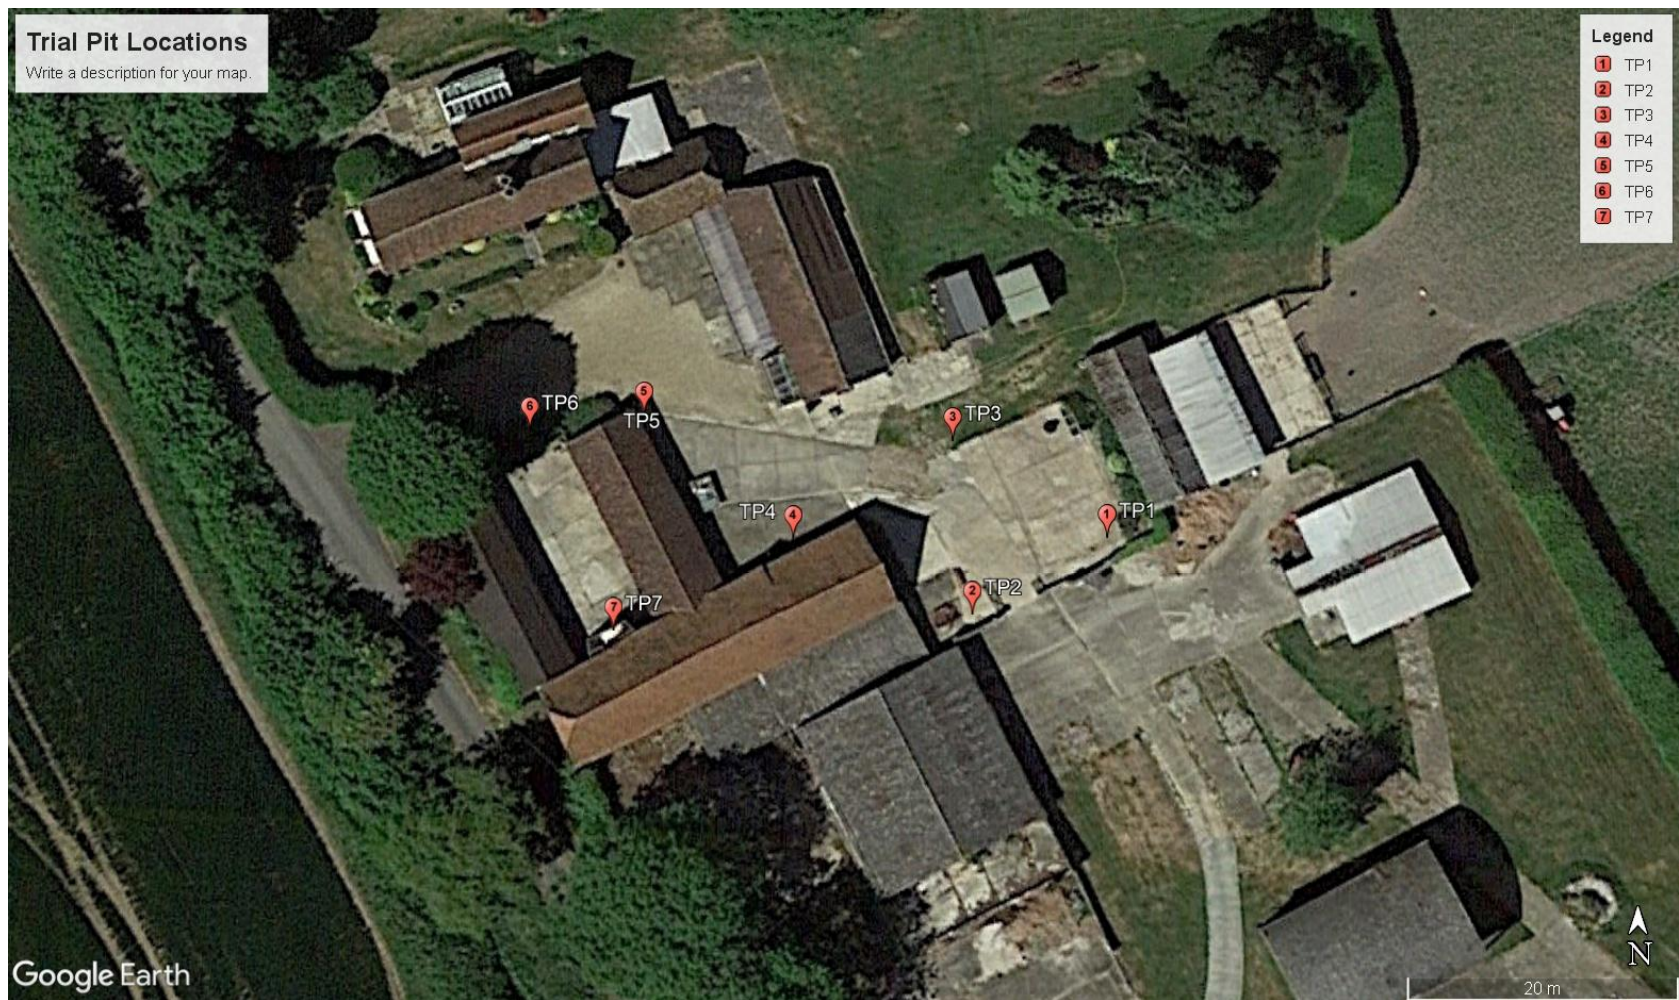
As an infilled pond was identified in the Phase I Desk Study as being present in the northeast corner of the Site, an investigation location is located there (TP1). The remaining investigation locations are then well spread across the Site.

The investigation locations were selected to be located in the northeast corner (to target the infilled pond) and then evenly across the Site.

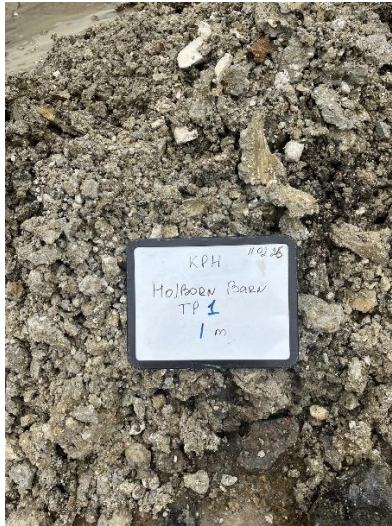
Photo 1: TP1 Spoil

| TP | Depth, m | Description | Samples | Notes |
|---|---|---|---|---|
| 1 | 0 - 0.1 | MG: Concrete slab | S1 0-0.5m | |
| | 0.1 - 0.3 | MG: Type 1 | | |
| | 0.3 - 0.5 | MG: Gravelly CLAY | S2 0.5 - 1m | |
| | 0.5 - 1m | Calcareous CLAY (NG) | | |

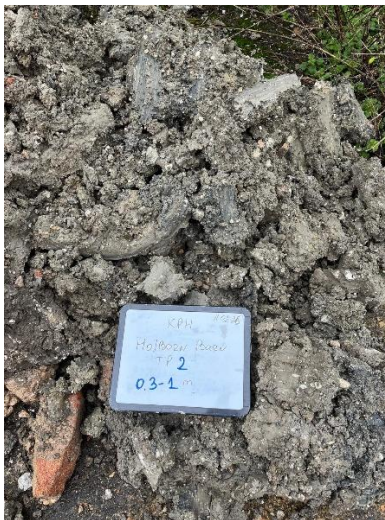
Photo 2: TP2 Spoil

| TP | Depth, m | Description | Samples | Notes |
|---|---|---|---|---|
| 2 | 0 - 0.1 | MG: Concrete slab | S1 0.25-0.5m | |
| | 0.1 - 0.25 | MG: Type 1 | S2 0.5 - 1m | |
| | 0.25 - 0.6 | MG: Gravelly CLAY | | |
| | 0.6 - 1m | Calcareous CLAY (NG) | | |

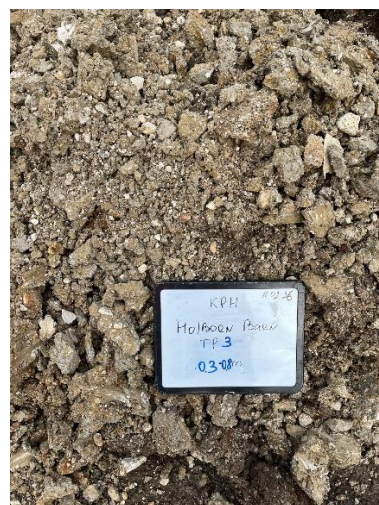
Photo 3: TP3 Spoil

| TP | Depth, m | Description | Samples | Notes |
|---|---|---|---|---|
| 3 | 0 - 0.3 | MG: Topsoil | S1 0-0.3m | |
| | 0.6 - 1m | Calcareous CLAY (NG) | S2 0.3 - 0.8m | |

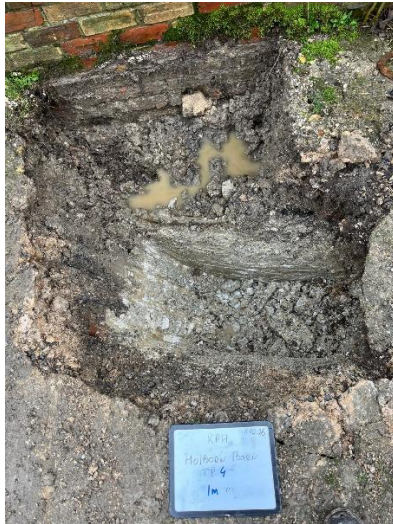
Photo 4: TP4 excavation

| TP | Depth, m | Description | Samples | Notes |
|---|---|---|---|---|
| 4 | 0 - 0.1 | MG: Concrete slab | S1 0.1-0.5m | TP is adjacent to the barn. Cable in metal casing runs W-E at 0.5m |
| | 0.1 - 0.5 | MG: Type 1 | S2 0.5 - 1m | |
| | 0.6 - 1m | Calcareous CLAY (NG) | | |

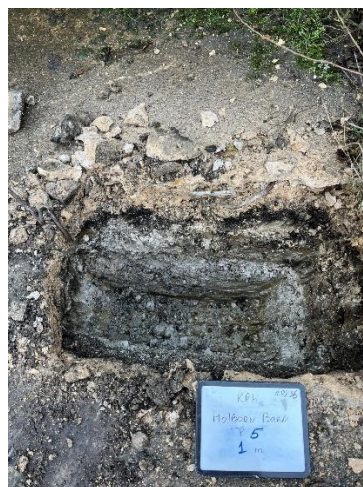
Photo 6: TP5 Excavation

The Arsenic detected in TP5 at shallow depth coincides with the ash layer that was visually identified in the trial pit. Ash-derived materials are a commonly recognised source of elevated arsenic concentrations and are frequently encountered within historical made ground.

| TP | Depth, m | Description | Samples | Notes |
|---|---|---|---|---|
| 5 | 0 - 0.1 | MG: Concrete slab | S1 0.15-0.45m | Metal rods below concrete |
| | 0.15 - 0.18 | MG: Ash | | |

- During the redevelopment works, ground excavations in the location of TP5, vigilance should be maintained and works undertaken slowly and the area damped down to avoid air-borne ash occurring. Disposal of the ash material should be undertaken by a registered waste contractor with the soil sample test results provided to the waste disposal site in advance of the waste being transported to ensure the correct disposal route. As an alternative, the localised ash material could be reused beneath hardstanding areas, subject to suitable materials management procedures.
- During the redevelopment works, if any unexpected contamination is identified, work must be stopped and a suitably qualified contaminated land specialist must be called to the Site to advise further.

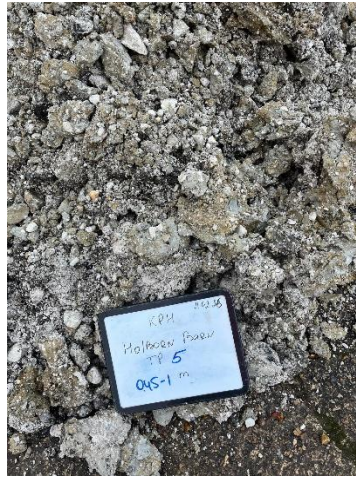
Photo 7: TP5 Spoil

The soil samples were analysed for a wide range of potential contaminants. Apart from an isolated exceedance of Arsenic in TP5 at 0.15 – 0.45m bgl, all of the determinands tested for, both organic and inorganic, were either below detection or at concentrations well below the appropriate screening level.

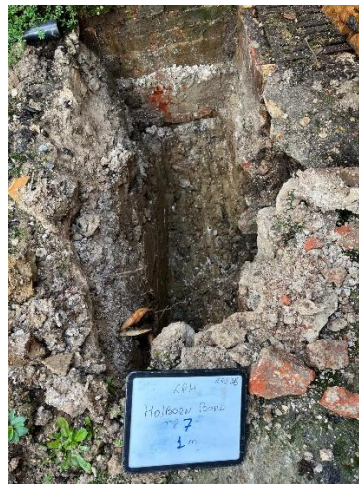
Photo 8: TP7 excavation

| TP | Depth, m | Description | Samples | Notes |
|---|---|---|---|---|
| 7 | 0 - 0.1 | MG: Concrete slab | S1 0.-0.3m | TP is adjacent to the barn. Pocket of coarse rubble on E side. |
| | 0.1 - 0.3 | MG: Type 1 | | |
| | 0.3 - 0.6 | MG: Gravelly CLAY(NG) | S2 0.3 - 0.8m | |
