| REVISIONS | | | | |
|---|---|---|---|---|
| PROJECT | | 19.14 Maydencroft Manor | | |
| TITLE | | West Elevation<br>Conservation Works Record | | |
| DRAWING<br>NUMBER | | 19.14.04.57 | | |

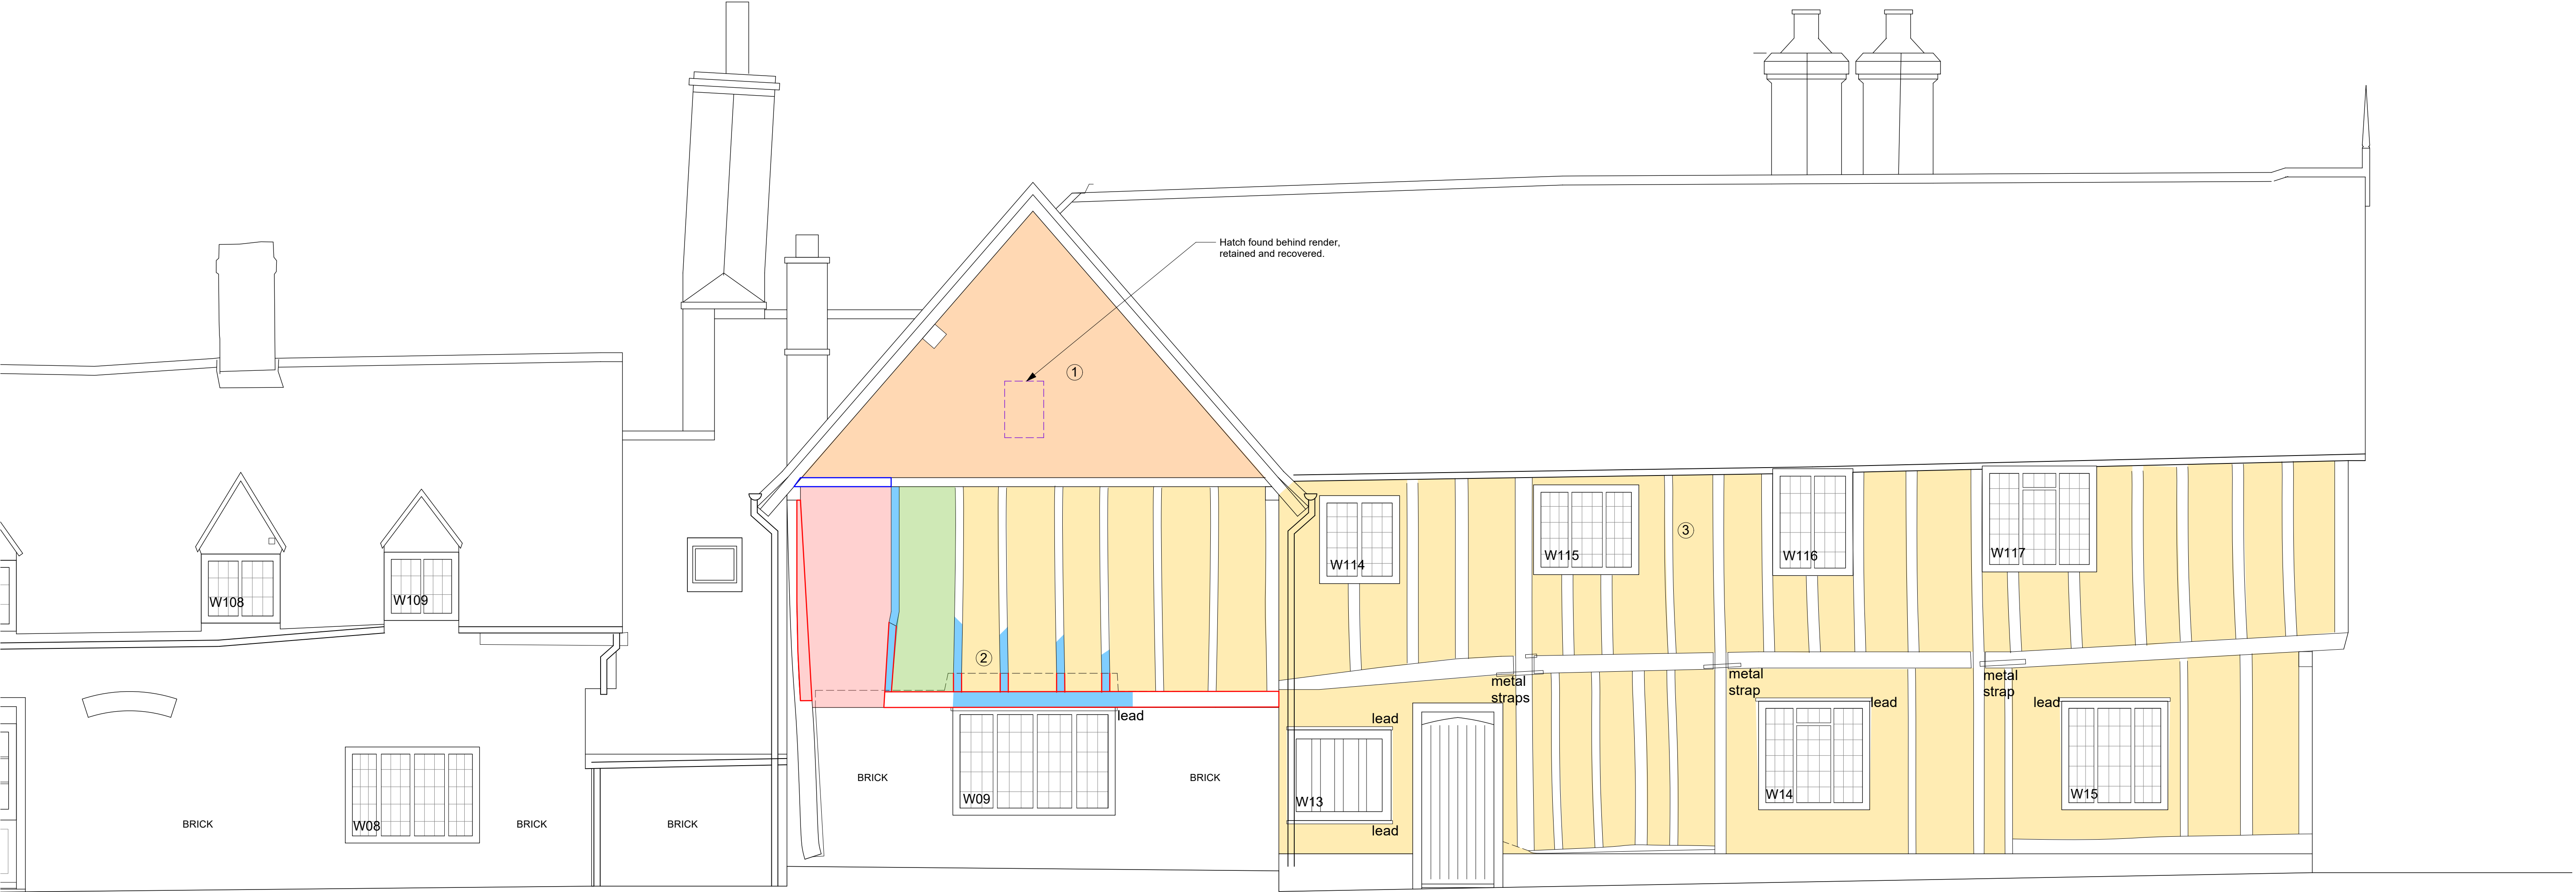
- Cement render removed, substrate found: outer wall modern boards & EML with thin mineral wool insulation, inner wall of laths behind.  
Works: Thin sheeps wool where depth permits, Woodwool carrier board, lime render finish with mineral paint finish in Ochre.
- Cement render removed, substrate found: outer wall modern boards. No inner wall (loft space)  
Works: Woodwool carrier board, lime render finish with mineral paint finish in Ochre
- Cement render removed, substrate found: outer wall modern lath broken and rotting in places. Inner wall mix of lath and brick.  
Works: Woodwool carrier board, lime render finish with mineral paint finish in Ochre
- Cement render removed, substrate found: outer wall modern boards, inner wall brick  
Works: Thin sheeps wool, Woodwool carrier board, Lime render finish with mineral paint finish in Ochre

- Timber replacement/ scarf repairs
- Timber frame previously buried/partially buried in cement now exposed.
- Timber frame previously partially visible now covered by lime render.
