# ROAVR | GROUP

**Project:** 25\_PEA\_BNG\_03\_58  
**Site:** Kirby Manor Barns, Northfield Road, Ashwell, SG7 5JQ  
**Client:** Sam Shepphard

| Report Type: | Preliminary Ecological Appraisal Report (PEAR) |
| Site Address: | Kirby Manor Barns, Northfield Road, Ashwell, SG7 5JQ |

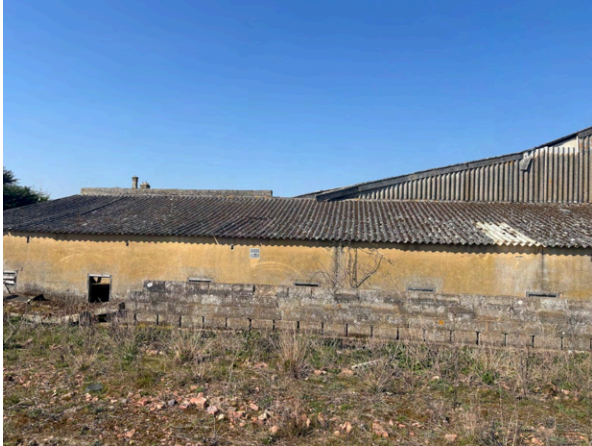
| Habitats and Target Notes | Description | Supporting Photo |
|---|---|---|
| <p>Habitat 1 - U1b: Developed land – sealed surface</p> | <p>This habitat encompasses the majority of the site footprint, including extensive areas of hardstanding and all existing buildings. Surfaces are predominantly comprised of concrete, with some localised sections of tarmac and compacted hardcore evident across the central and southern portions of the plot. The substrate is impermeable and largely devoid of vegetation, consistent with prolonged agricultural and vehicular use. Small accumulations of debris and organic matter along wall bases and cracks support limited pioneer species such as dandelion (<i>Taraxacum officinale</i>), annual meadow-grass (<i>Poa annua</i>), and mosses (<i>Bryophyta</i> spp.), though cover is minimal and discontinuous.</p> <p>The buildings within this habitat are vacant and in varying states of structural degradation, with substantial ecological function confined primarily to bat and bird access opportunities within structural voids rather than within the hard surfaces themselves. The habitat provides negligible ecological value in terms of floristic diversity or invertebrate interest, though it may offer functional connectivity and foraging space for edge-dwelling species such as pied wagtail (<i>Motacilla alba</i>) or small mammals. As a habitat type, its condition is assessed as Poor due to absence of vegetation cover, lack of substrate permeability, and zero capacity to support</p> | <p>Photo 1</p> |

hydrological or soil-based ecosystem functions.

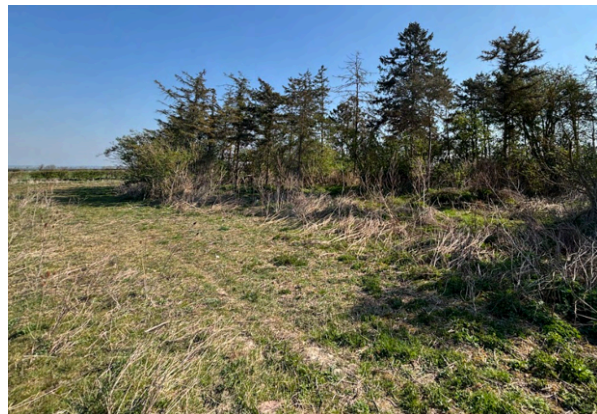
| Habitat 2 - g3c: Other neutral grassland | <p>This habitat is restricted to narrow marginal strips along the northern and eastern boundaries of the site, forming a transitional zone between the sealed surface areas and adjacent hedgerows or tree lines. The sward is uneven and unmanaged, indicative of sporadic disturbance and low-intensity use, consistent with a poor condition classification under UK Habitat Condition Assessment criteria (Score: 2/5). Species composition is limited but typical of nutrient-enriched soils, dominated by perennial ryegrass (<i>Lolium perenne</i>), creeping buttercup (<i>Ranunculus repens</i>), and broad-leaved dock (<i>Rumex obtusifolius</i>). Occasional individuals of common nettle (<i>Urtica dioica</i>), ribwort plantain (<i>Plantago lanceolata</i>), and cow parsley (<i>Anthriscus sylvestris</i>) were also noted.</p> <p>Floral diversity is low, with cover dominated by competitive grasses and ruderal species, and there is minimal evidence of structured zonation</p> | <p>Photo 5</p> |

| | <p>or indicator species associated with higher-quality neutral grassland. The habitat presents limited ecological function but may offer incidental nectar resources for generalist pollinators such as buff-tailed bumblebee (<i>Bombus terrestris</i>) and additional cover for small mammals. No notable invertebrate or botanical interest was identified, and there is no evidence of management to enhance sward condition. The current structure and limited floristic value confirm a degraded state consistent with low ecological importance in the context of local habitat networks.</p> | |

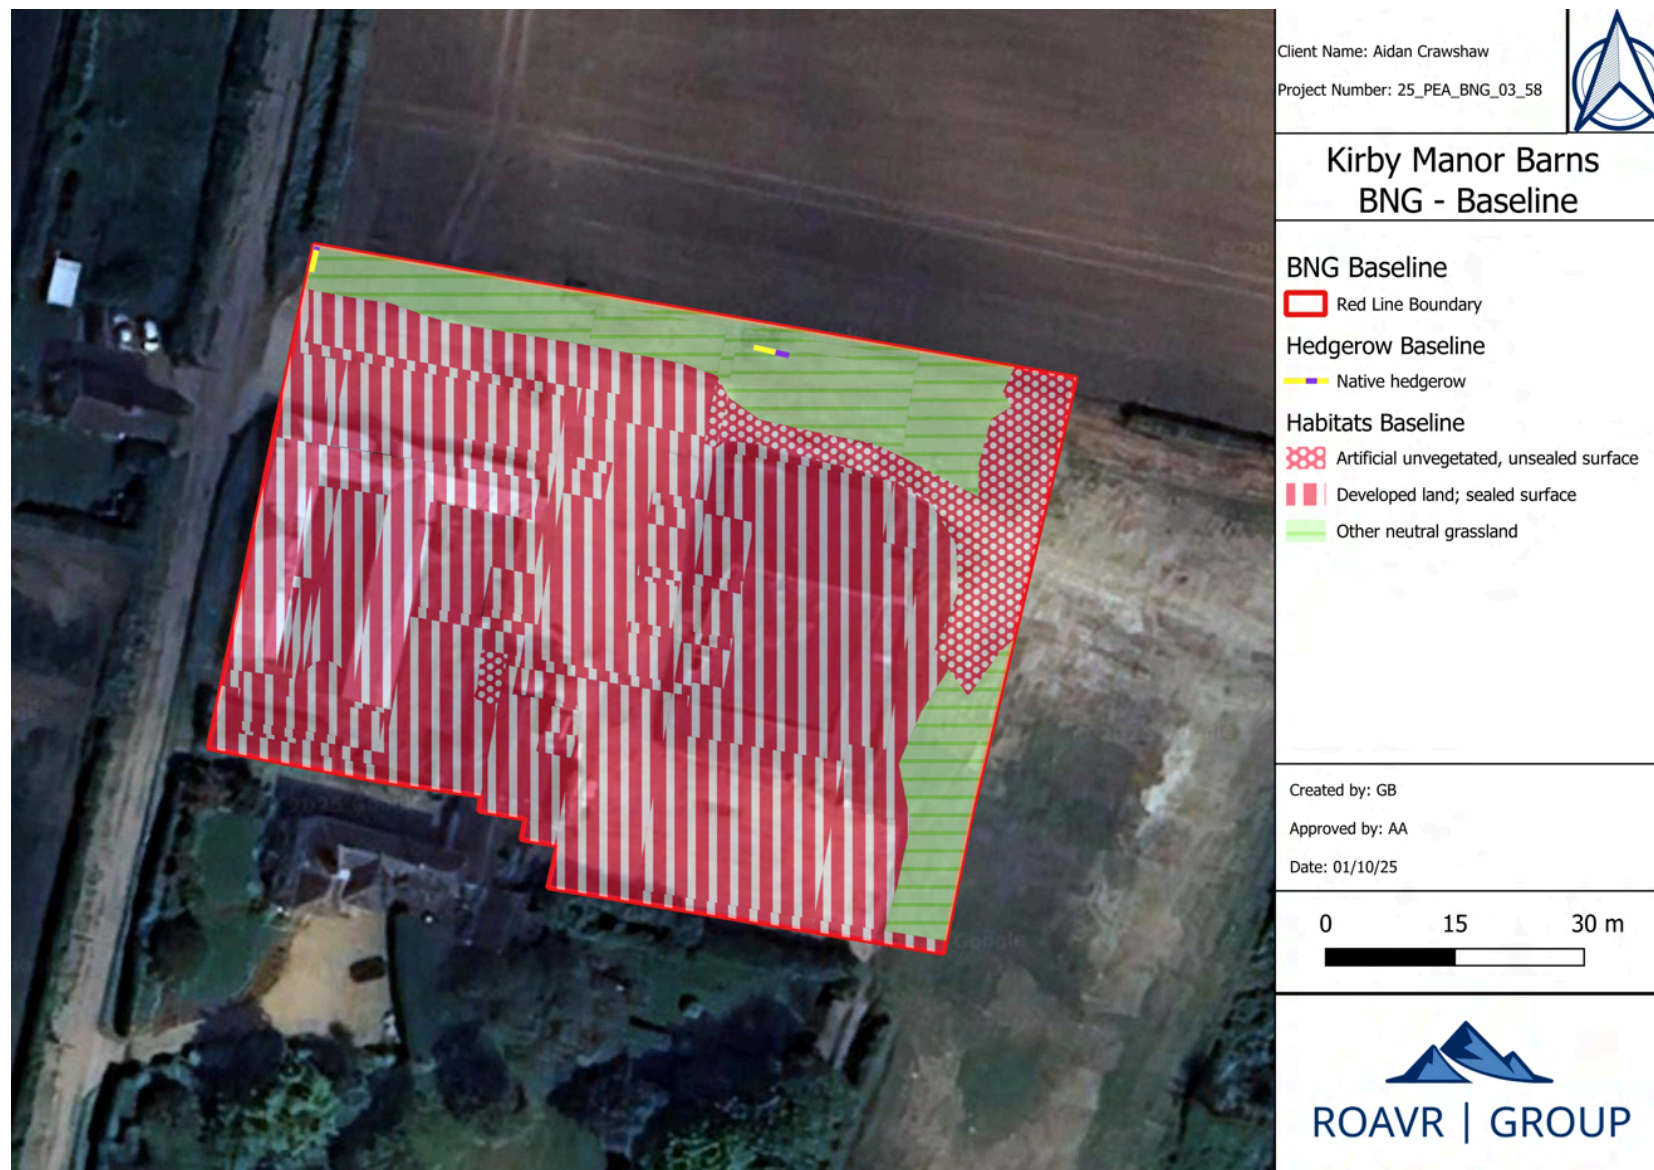
A3.1 The Site Habitat Map was produced in accordance with the UK Habitat Classification Manual (Butcher et al., 2020).
