# Maydencroft Manor Loft Conversion

## Design & Access Statement Incorporating Heritage Statement

October 2025  
Rev B

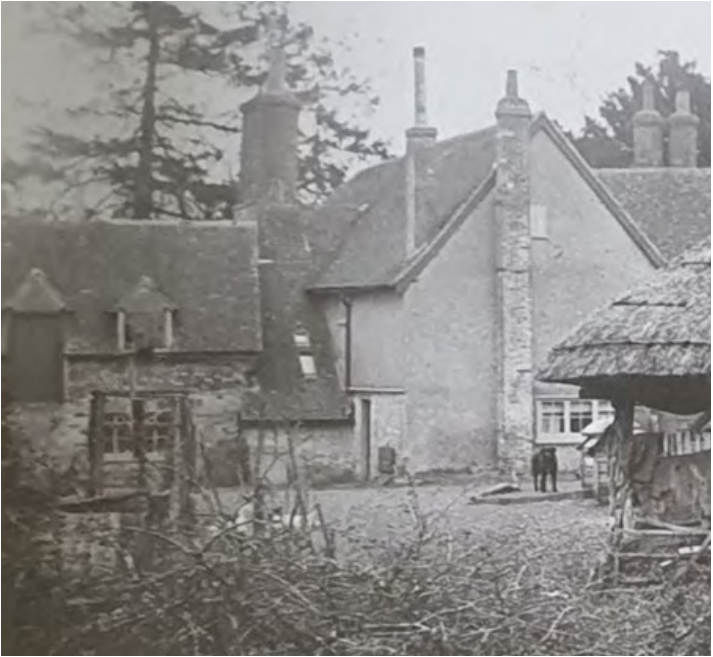
Photo 1908 facing the west end of the east-west gable range, chimney on the face of the gable no longer exists, GF window is now bigger and central. The render/brick exposed has changed over time. Hatch at loft level adjacent to chimney present.

14. Re-open historic hatch to external side and install fixed timber framed glazed light to opening. The hatch within the end gable was present in the early 1900's (see photo on page 5) and still is visible internally to the loft space. The frame of the hatch will be retained and utilised for the framing of a new timber framed fixed glazed light/window. The size and location and outer framing (visible internally) are all historic so reusing it has a low impact on the heritage of the building; the low impact of glazing the opening for modern day use is offset by recreating a feature from the past which helps to tell the history of the house.

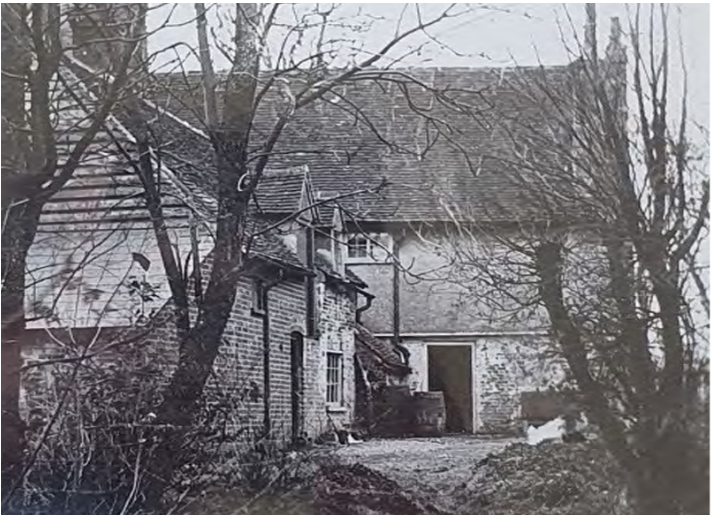
Photo 1908 facing the north side of the east-west gable range, door has since been bricked up

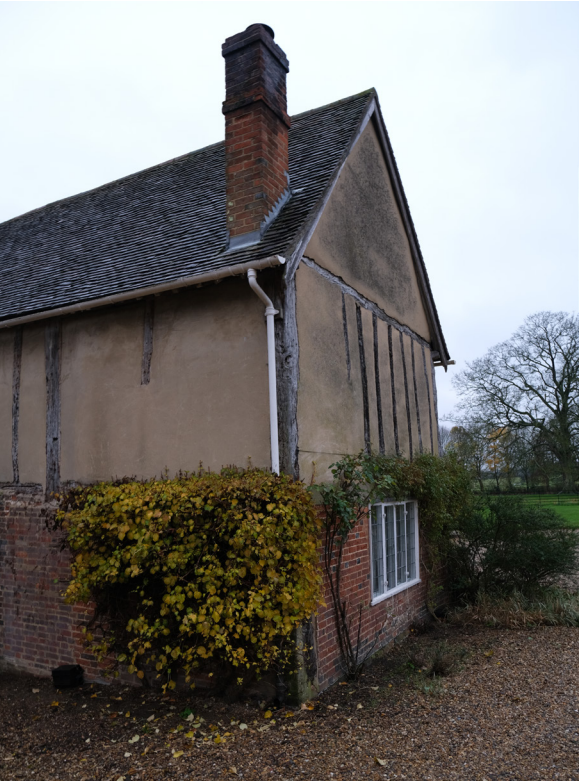
Photo 2020 north-west end of the east-west gable range (prior to conservation repairs of external fabric) showing changes since the 1908 photos.

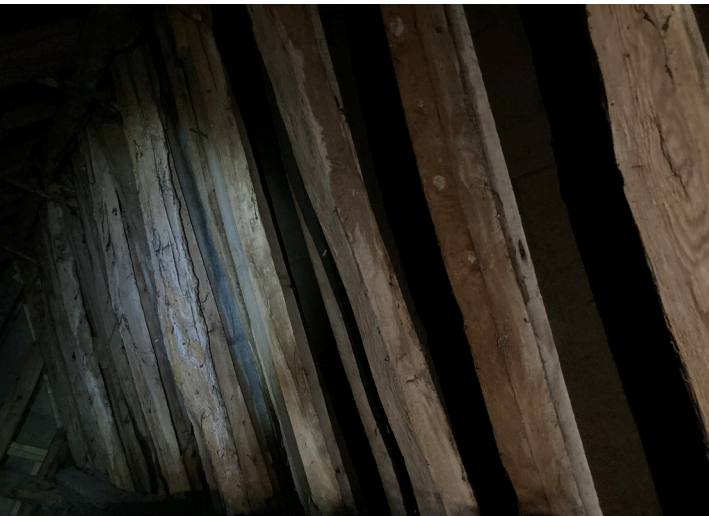
Photo 2025 showing historic rafters with modern rafters overlaid, likely done when the house was re-roofed in the 1980's. (Loft space of east west range of house).

The original timber rafters throughout the loft space predominantly have been preserved, during the 1980’s re-roofing instead of replacing them they were overlaid with new rafters so the originals with their deflection are very visible within the loft space.

8. New breathable insulation to underside of roof with historic rafters left visible. As detailed above, the historic rafters will be predominantly visible due to the overlaying of new rafters at the time of the re-roofing in the 1980's therefore the insulation layer will sit between the new rafters at the upper level. It is considered that this will therefore have no impact on the heritage. A detail has been provided.

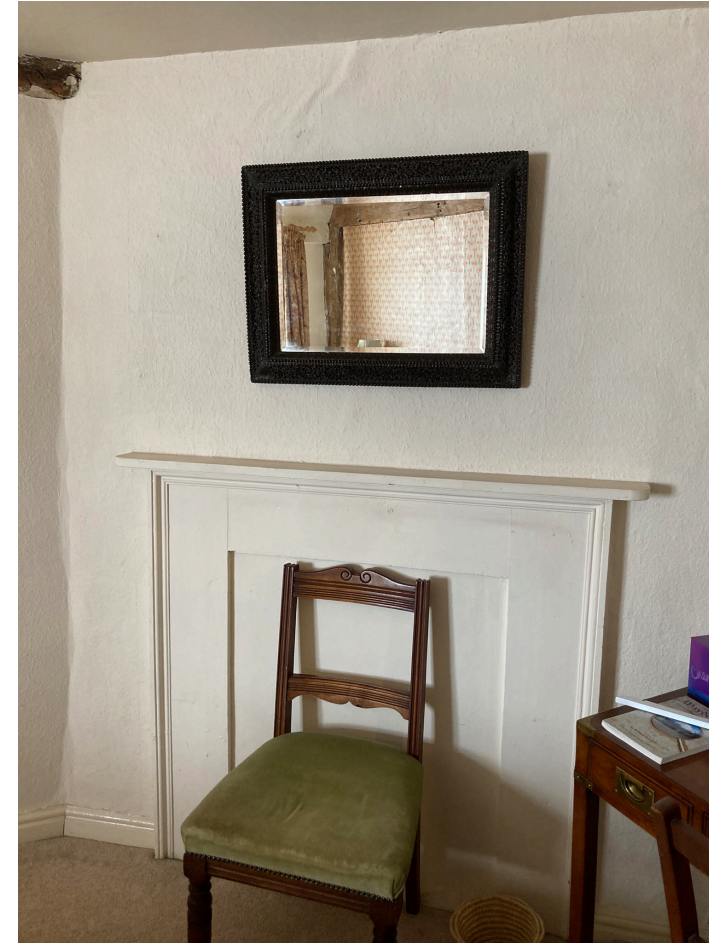
Photo of the 20th C chimney breast diagonally across the corner of Bedroom 6 with modern surround and blocked up opening. (North east corner of the gabled range).

The chimney in the far north east corner of the north wing is a 20th Century insertion, seen above roof level and then internally with a chimney breast diagonally across the corner of the room at both ground and first floor level. At first floor a modern fireplace surround is fixed to the surface of the wall with the opening blocked up, this may have always been a ‘dummy’ fireplace at first floor level as it is directly above the wood burning stove installed at ground floor level or it was installed for use at first floor level only and later altered to serve the ground floor when the adjacent external chimney on the end of the gable was removed to widen the ground floor window, later in the 20th Century. Its significance is relatively low in the heritage of the house but does hold some clues of to 20th Century changes to the house so has a low historic value.

1. Removal of the chimney breast at first floor level back to a stack around the flue servicing the ground floor log burner. Retaining external appearance of chimney. Loss of 20th Century fabric, mock fireplace at first floor cannot be operational, with fireplace retained at ground floor level and the chimney externally, the changes to the chimney at first floor level have a very low impact on the heritage.

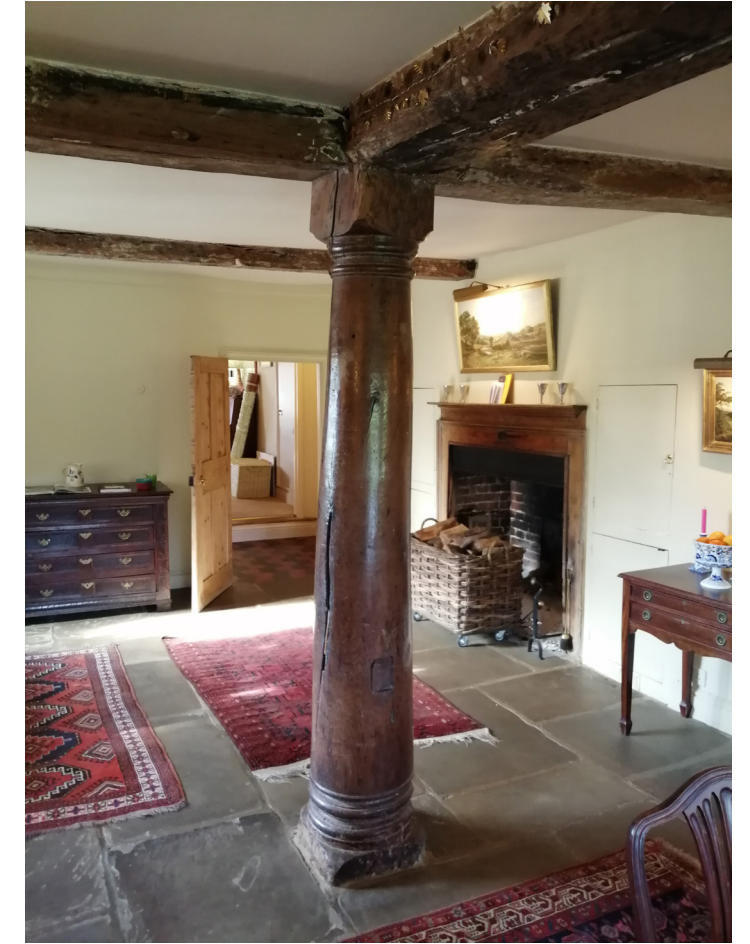
Photo looking at the ground floor area of the 15th Century Medieval Hall with the later extension east, removal of the wall and insertion of the round column in place of the wall. Fireplace is a 17th/18th Century addition, referred to as the north fireplace in the extracts from the Jon Lowe Heritage Report.

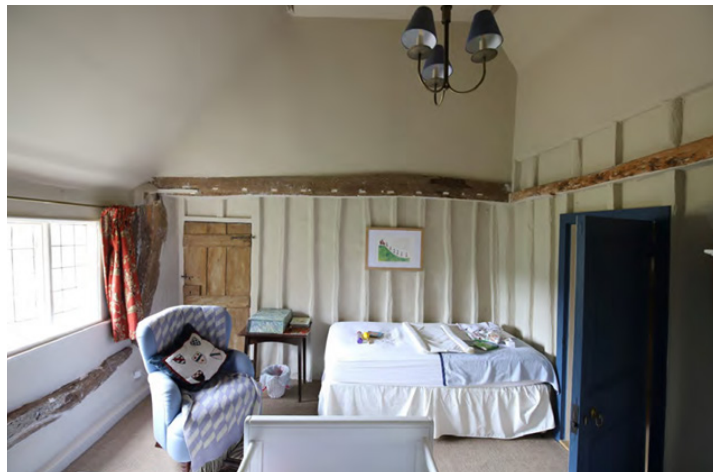
Photo of Bedroom 4 (looking west) in location of original 15th Century Medieval Hall, first floor insertion later addition. Small void above apex visible in loft space.

Blackened timbers in this roof space mostly over Bedroom 4 within the void above the higher ceiling level and what looks to be some fading out into the space above bedroom 5/the ensuite are signs of the original Hall house where fires would have been lit in the centre of the floor before the introduction of the chimneys and fireplaces. This is of significant evidential value.

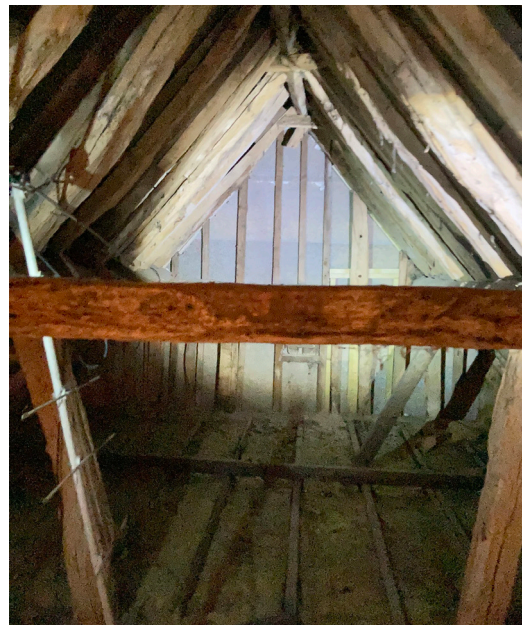
Photo of loft space over bedroom 5&6 looking north towards end gable. New breathable render carrier board visible between the end timber studs.

The end gable has been restored externally and the new breathable render carrier boards are visible internally, these would be rendered internally too with lime plaster/ insulated lime plaster, leaving the face and some depth of the wall studs visible.

9. Lime render internal face of new render carrier boards on end gable, leaving timber studs visible. The studs will remain visible, the rear side of the render carrier boards will be lime rendered, this wall will look like the internal walls on the first floor. This has no impact on the heritage.

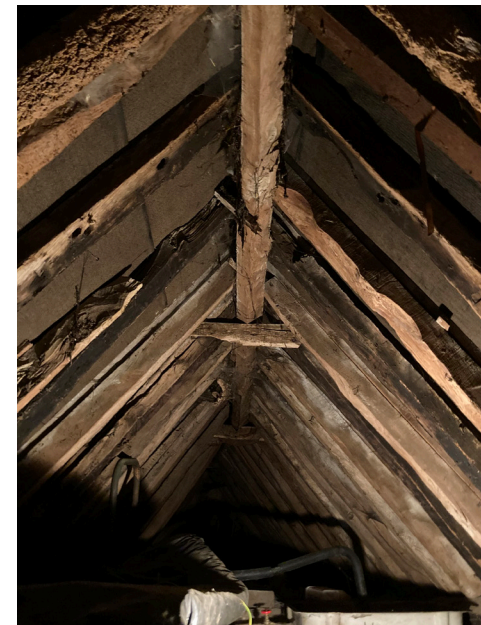
Photo of loft space over bedroom 5 looking south into the void over the ceiling above Bedroom 4 (15th Century Medieval Hall House)

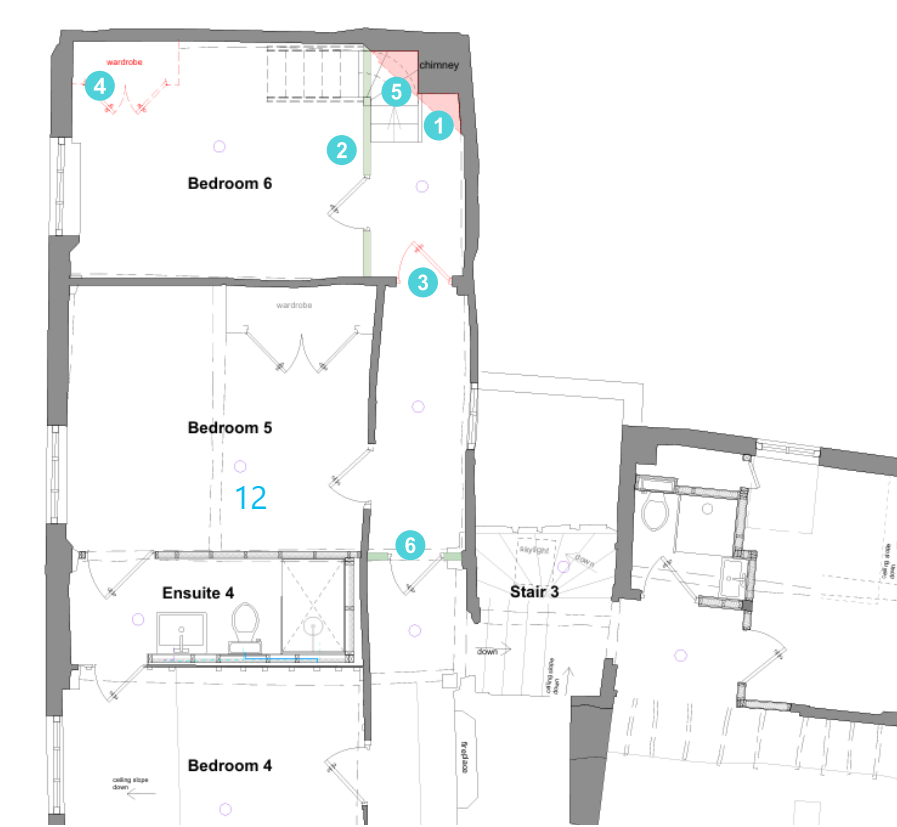
Proposed Plan First Floor Level (Part Plan North wing)

1. Removal of the chimney breast at first floor level back to a stack around the flue servicing the ground floor log burner. Retaining external appearance of chimney.

2. New partition wall in Bedroom 6 making a smaller bedroom and extended hallway for locating stairs to the loft space.
3. Move existing door into bedroom 6 to the new partition wall, essentially retaining the existing entrance door to the bedroom but in a new location.

4. Removal of built in wardrobe in Bedroom 6.
5. New timber staircase to loft space.
6. New door opening placed in hallway at first floor level to provide fire escape protection, use of salvaged hardwood door (which is in storage on site) and matches style of some other first floor doors.

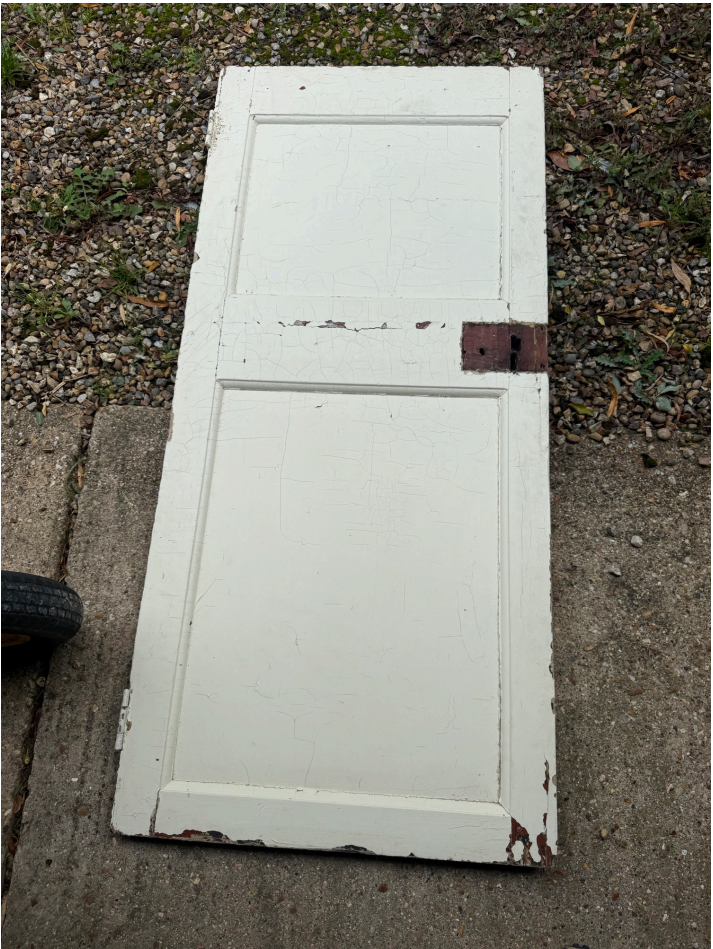
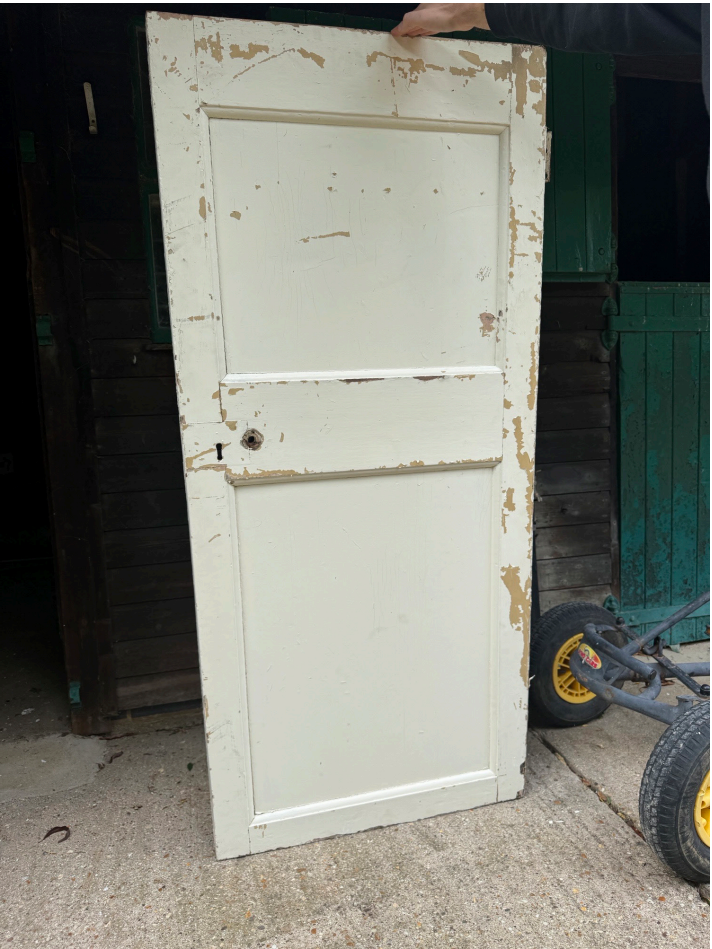
Photos of the salvaged hardwood door for use in the hallway

At First Floor Level: One existing door to be relocated into the adjacent new partition and one ‘new’ door to be installed to the hallway for which a salvaged hardwood door of a similar style is proposed for use (photos opposite), this is in storage on site and likely came out of the house. At Attic Level, new door into bathroom to match style of exisitng on site in this part of the house.

6. New door opening placed in hallway at first floor level to provide fire escape protection, use of salvaged hardwood door (which is in storage on site) and matches style of some other first floor doors. The door is likely to have come out of the house and is of a similar style to those on the first floor, so there is benefit in reinstating historic material (although not to an original location, this is unknown). The new doorway doesn't require any loss of fabric, its partitioning of the hallway is considered to have a very low impact on the heritage.
