Job Title  
19 Roxley Cottages  
Willian  
Letchworth Garden City  
SG6 2AX

Drawing Title  
Existing Front Elevation -  
(with photograph)

DRAWING NO:  
24-02033- EX-001

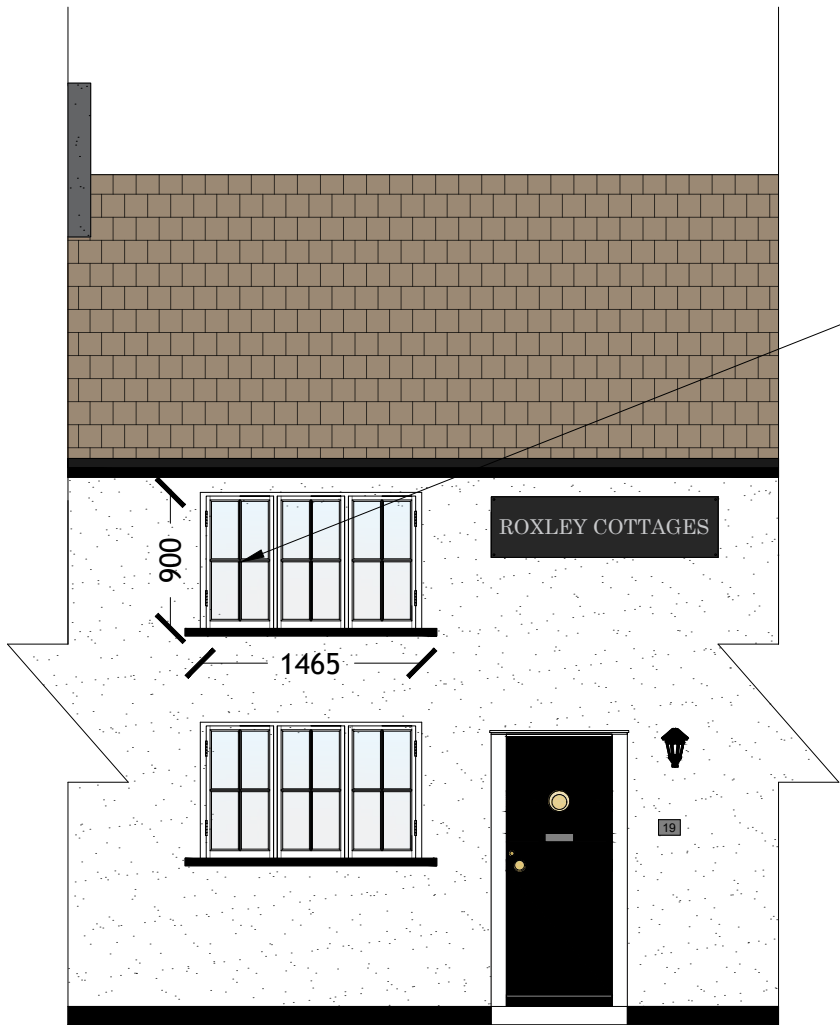
# A - Existing Front Elevation

First floor, existing  
single single glazed,  
timber casement  
windows are damaged  
and beyond repair.
