## Preliminary Roost Assessment (PRA)

The Lodge, Preston Road, Gosmore, Hitchin

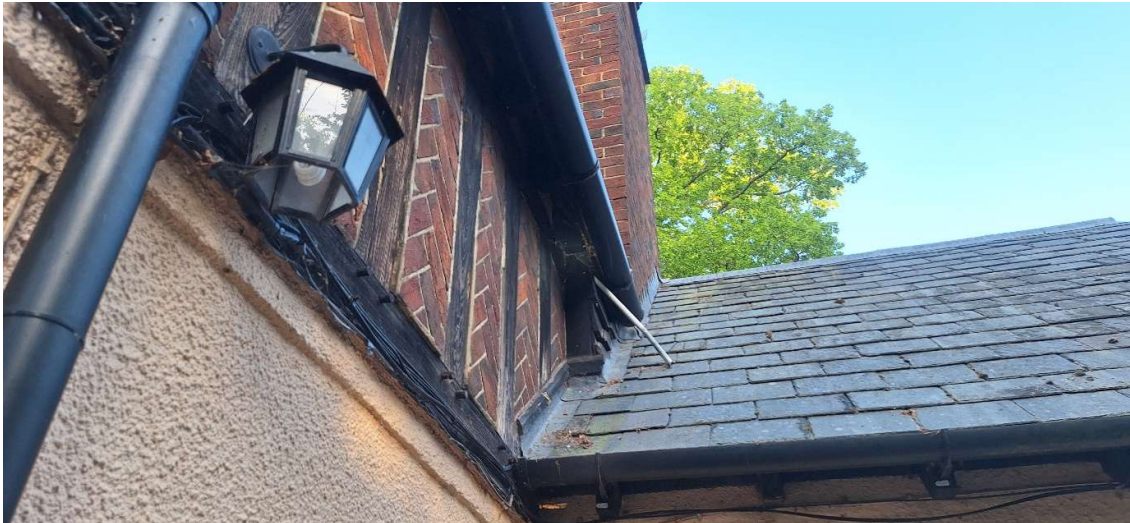
**Photograph 2.** Building B showing herringbone brickwork, lead flashing, slate tiles and render. Note overall good repair.

The upper storey exhibits more original features including exposed wood and traditional herringbone brickwork. The brickwork also appears damaged in places. The ground floor appears to have undergone much more recent renovation, with painted rendering in

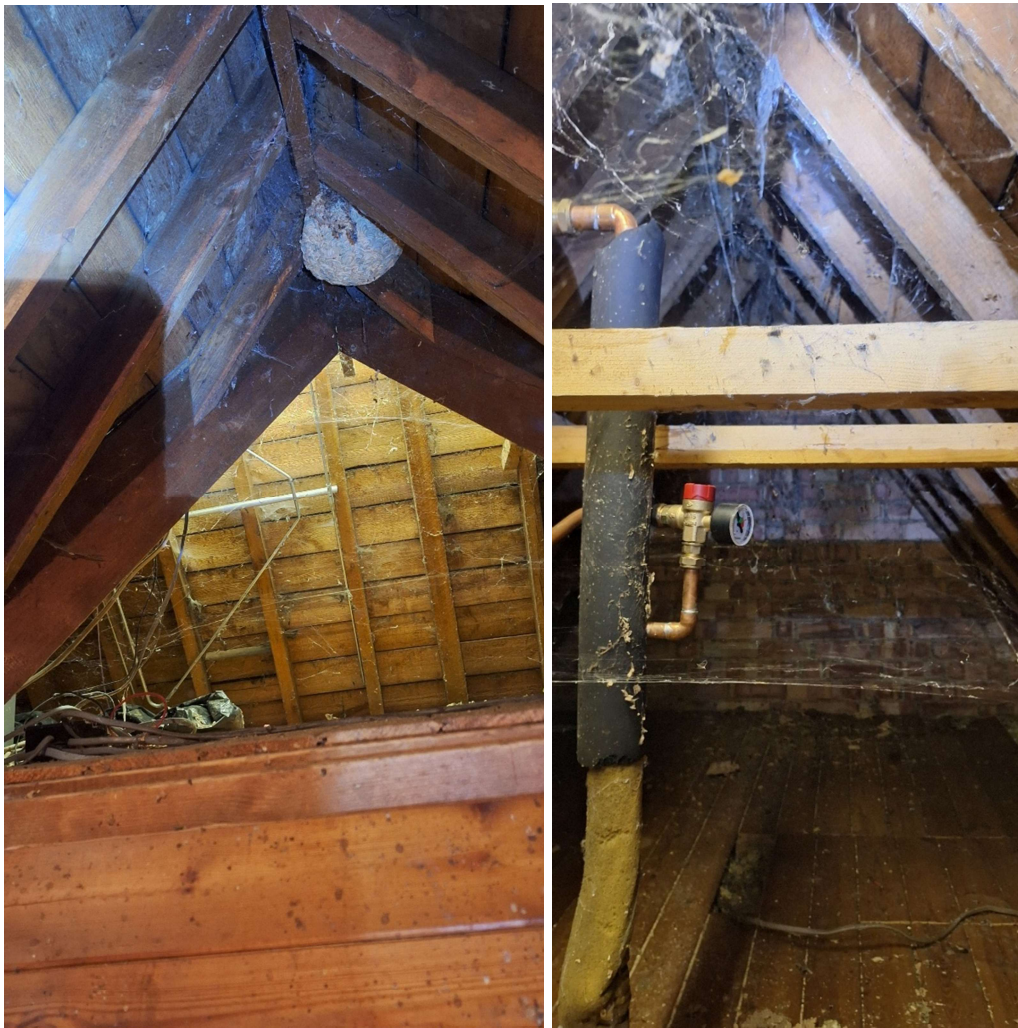
The roof trusses and boarding are in good condition, with the internal space being well-sealed. Several disused common wasp nests were found. These had been subject to chemical extermination treatment the previous year (2024). There were no indications of habitation by any bat species. For example, there were no droppings found. There was a significant amount of accumulated spiderweb hanging in the loft space which did not appear to have been disturbed through bat activity.

**Photographs 3 & 4.** Interior of loft space, Building A. Note webs, wasp nest and good state of repair.

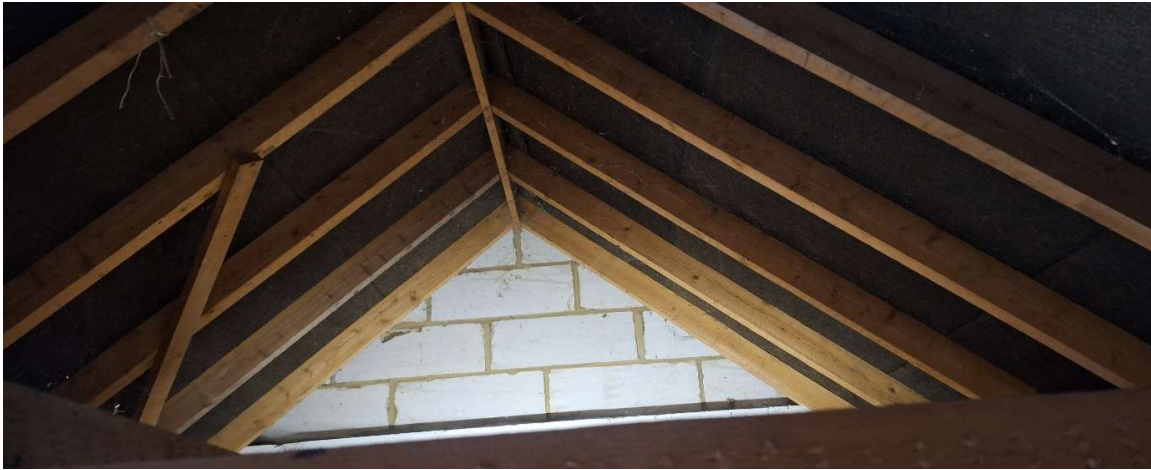
Building B is a single-storey garage of modern construction with a single-pitch roof. The interior is well sealed. There is a single-pane, wooden-framed window on ground floor. The roof space was visible from the ground floor. There is no indication of any bird, bat or insect mammal activity in the roof space. A small number of rodent droppings were present on the windowsill. The building is currently used for storage and is in regular use.

**Photograph 5:** Interior of the roof space, Building B

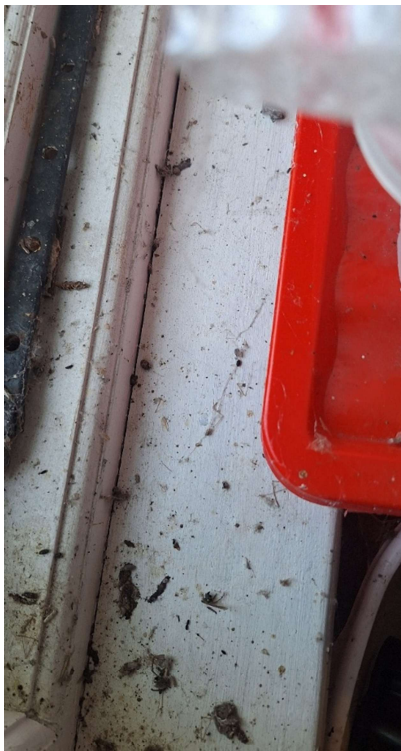
**Photographs 6.** Mouse droppings, Building B

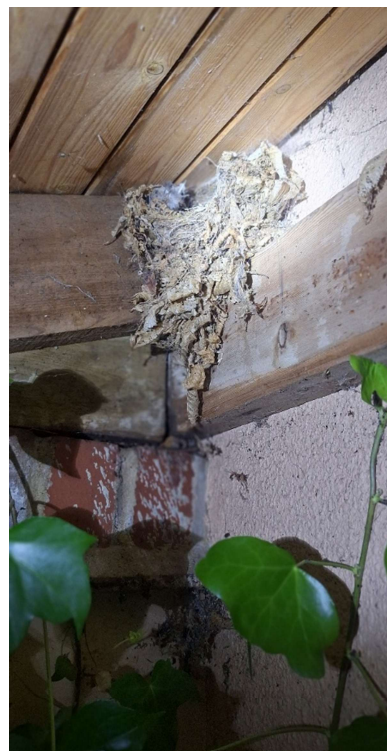
**Photograph 7.** Bird nest, Building B

Building B is of **negligible** potential for bat roost features. Care should be taken to avoid disturbing any nesting birds. One nest was found under the lean-to. However, change of use without significant works and on-site noise, nocturnal lighting and other disturbance is unlikely to cause harm to resident bats or their habitat.

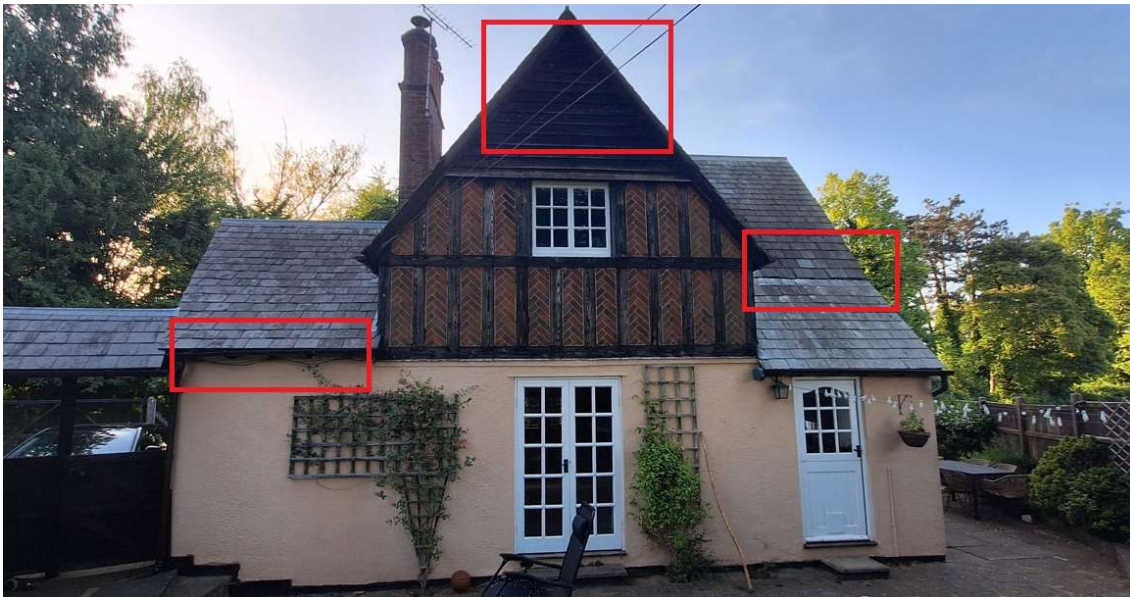
Building A is a two-storey building of brick and timber construction. As noted above, the age of the building (>100 years) increases the likelihood of potential roosting features. The slate-tiled roof is hipped with joints to widow eaves. Lead flashing has been used to seal hip joints. Roof is in good condition, with minor lifting of tiles noted on eastern aspect (Photograph 8).

**Photograph 8:** Potential roost features identified on the eastern aspect, Building A.  
Recommended view for survey.

Building A possesses several features which mean it has **low** roost potential for bats. These are the lifted tiles, ageing window frames (1<sup>st</sup> floor) and holes in the brickwork. These will require an emergence survey to be undertaken to ascertain whether these features are utilised by bats. In accordance with BCT guidelines (2023), it is therefore necessary to undertake one survey, due to the assessed potential. However, should bat activity be noted in relation to the structure, further surveys will be required.

This will require **2-3 surveyors** to allow all roost features to be viewed during the survey.

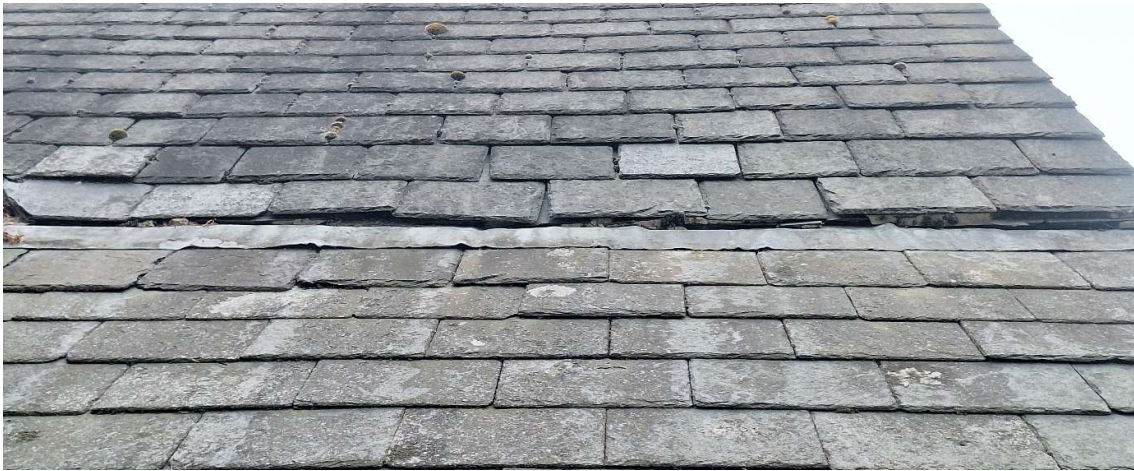
**Photograph 9:** Example of lifted slate tiles, sufficient to provide roost space for bats. Eastern aspect, Building A.

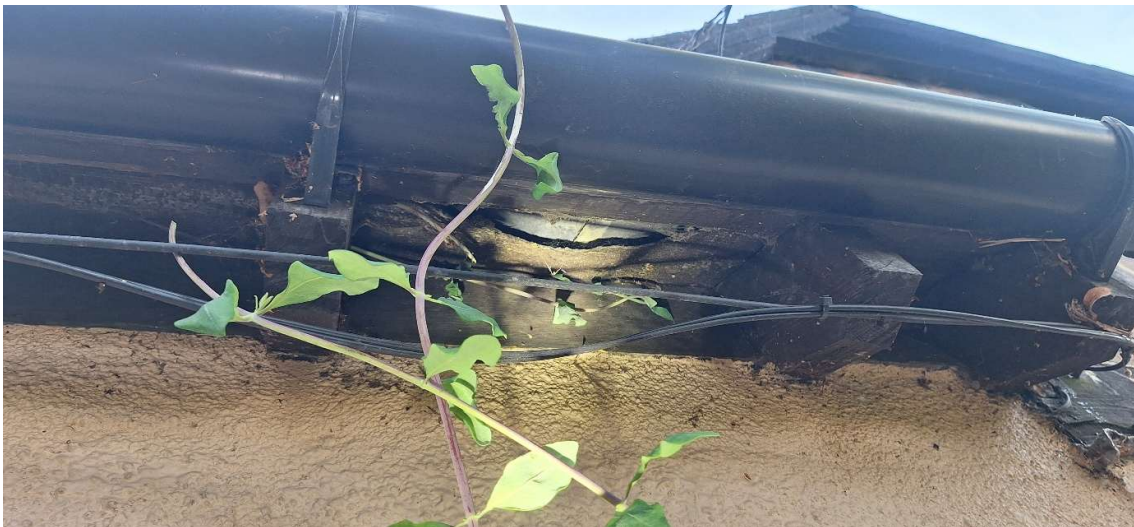
**Photograph 10:** Holes in soffits, eastern aspect of Building A

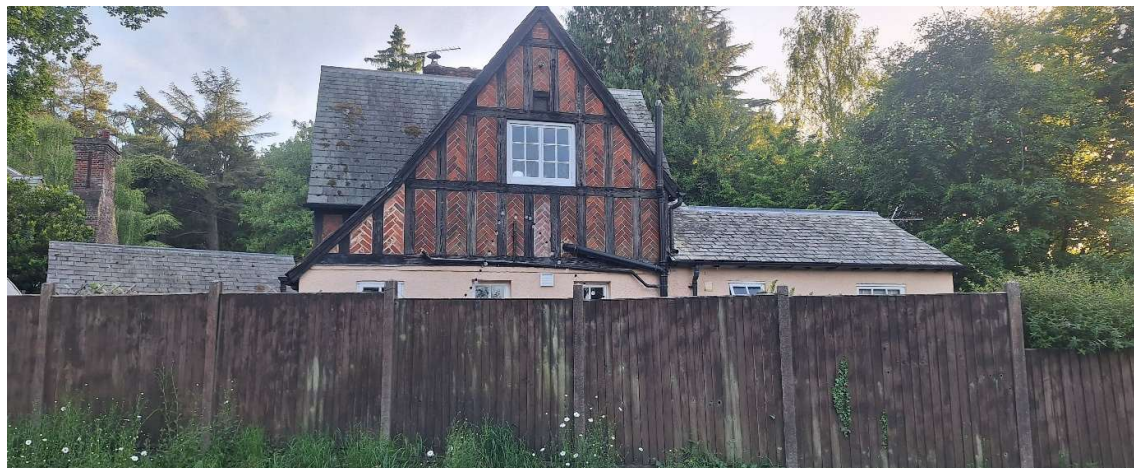
**Photograph 11:** View from opposite side of Preston Road. Potential survey location.

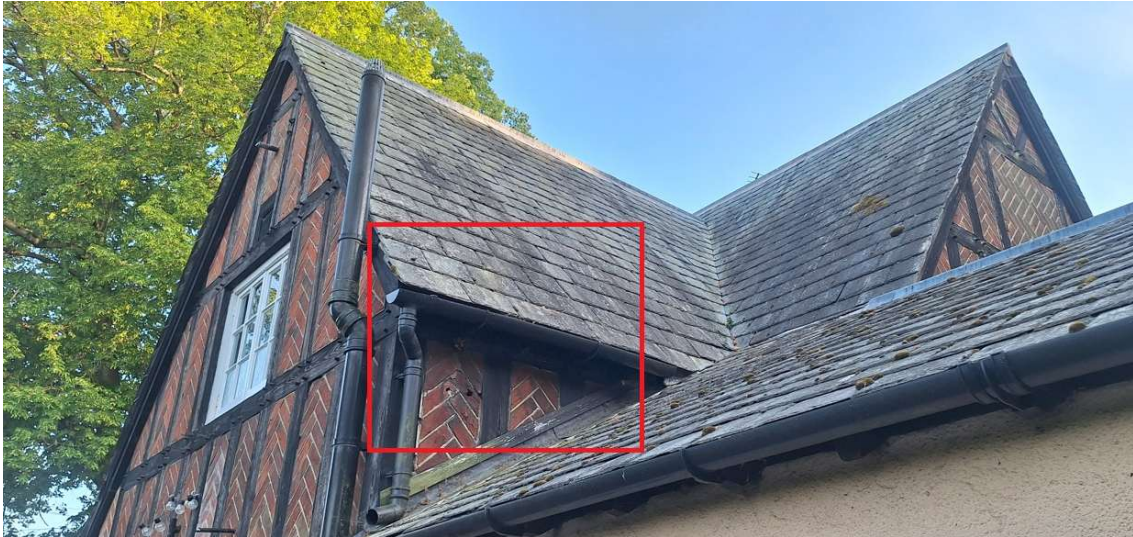
**Photograph 12:** Hole in brickwork on the northern aspect of the upper storey.  
Recommended view for survey.

It is noted that few of the potential roost features appeared to offer access to sufficient internal voids for roosting. This would nonetheless require confirmation through an emergence survey.

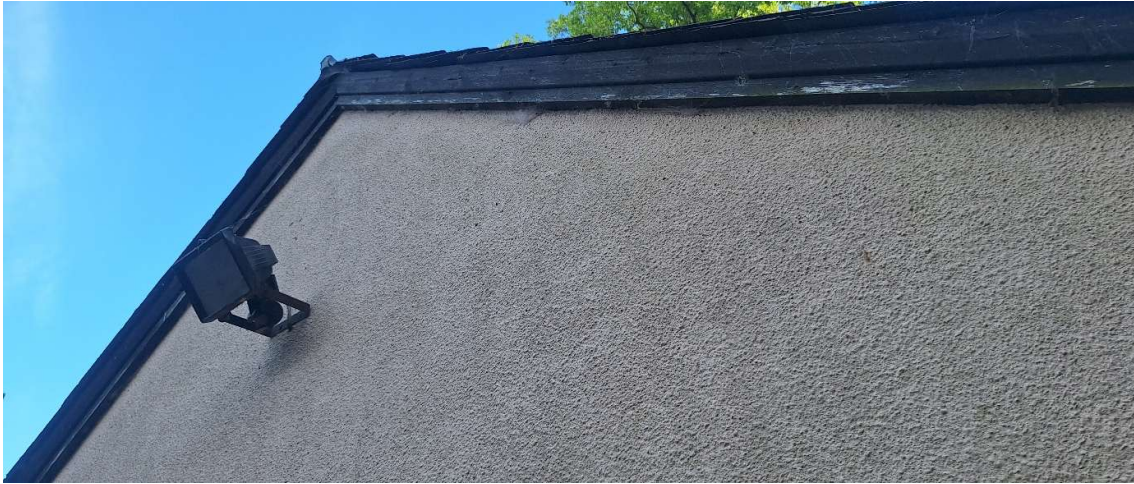
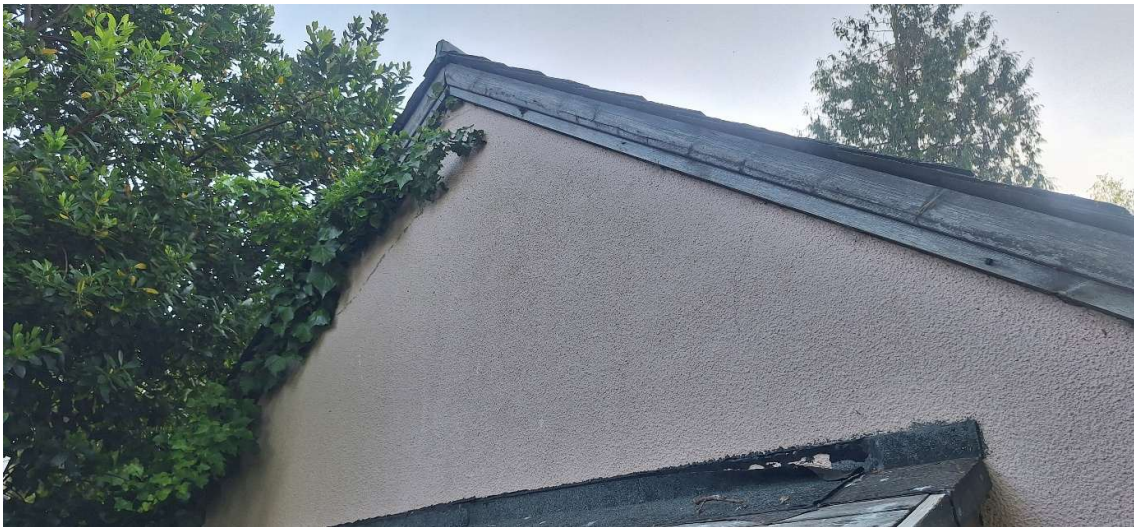
**Photographs 13&14.** Rendering and eaves with negligible roost potential, Building A
