**Highover Farm, Highover Way, Hitchin, Hertfordshire  
HG4 0QR**

**Heritage statement: assessment of significance in  
respect of application for listed building consent for  
conversion of threshing barn to two separate  
residential dwellings**

**May 2025**

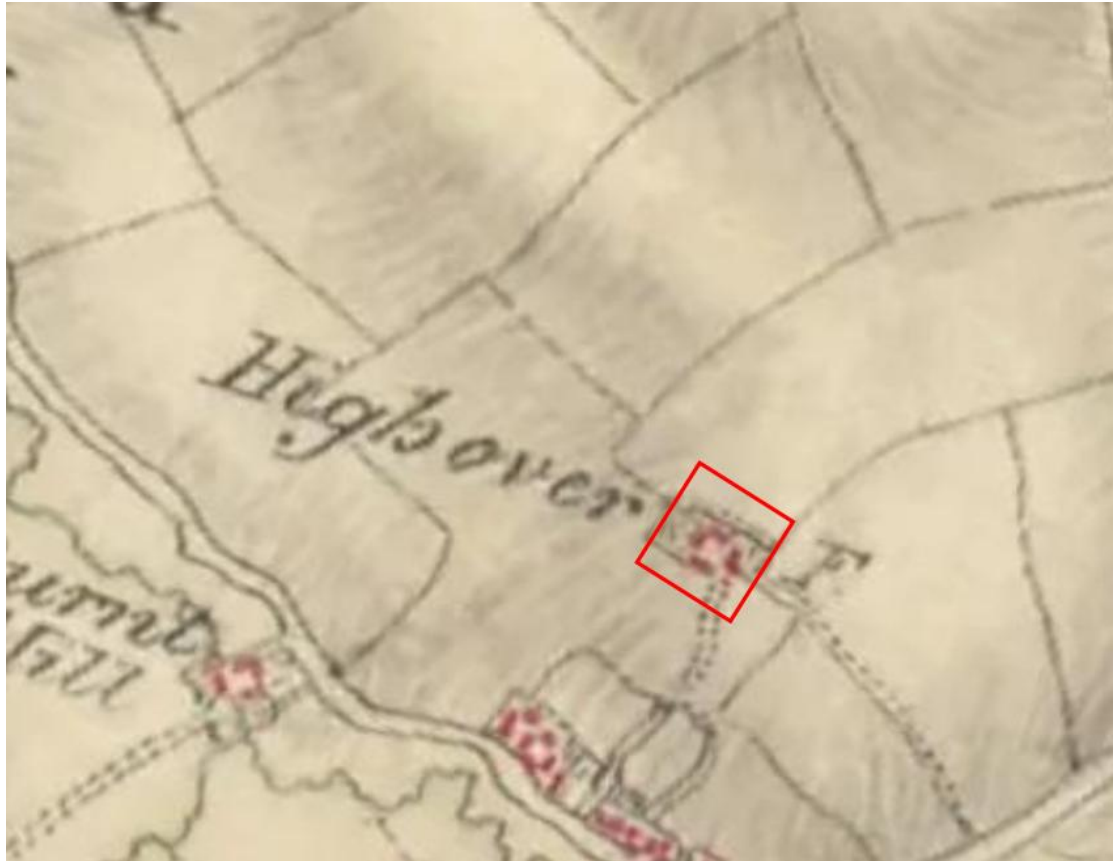
**1804 – the farm and context (our red and blue notations added throughout)**

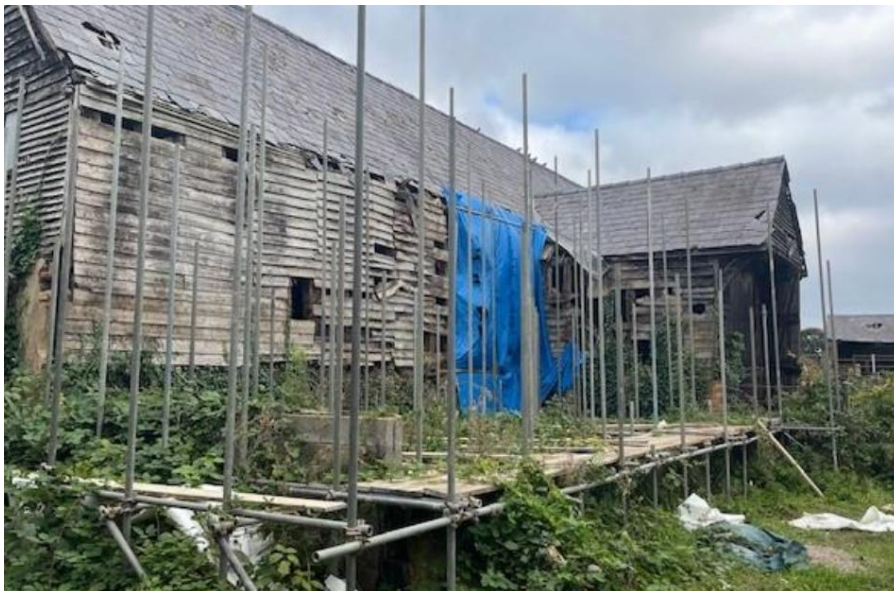
### Closer view: signs of neglect and dereliction

46. In essence the threshing barn will be subdivided into 2 separate dwellings with external changes as shown.
47. The residential use is the optimum viable use consistent with its conservation. The building is in a state of disrepair and shortly (whether under the terms of this application subject to timings or via an informal agreement with the local planning authority) the slates will need to be taken down and stored and plastic sheeting placed over the structure.

48. The need for an urgent solution is clear and is reflected in the images shown.
49. The barn has not been used for many years and it is understood that whilst the farm use ceased in 2022 it is not clear when the threshing barn was put to any meaningful agricultural operation at that point (or in recent times prior to that date).

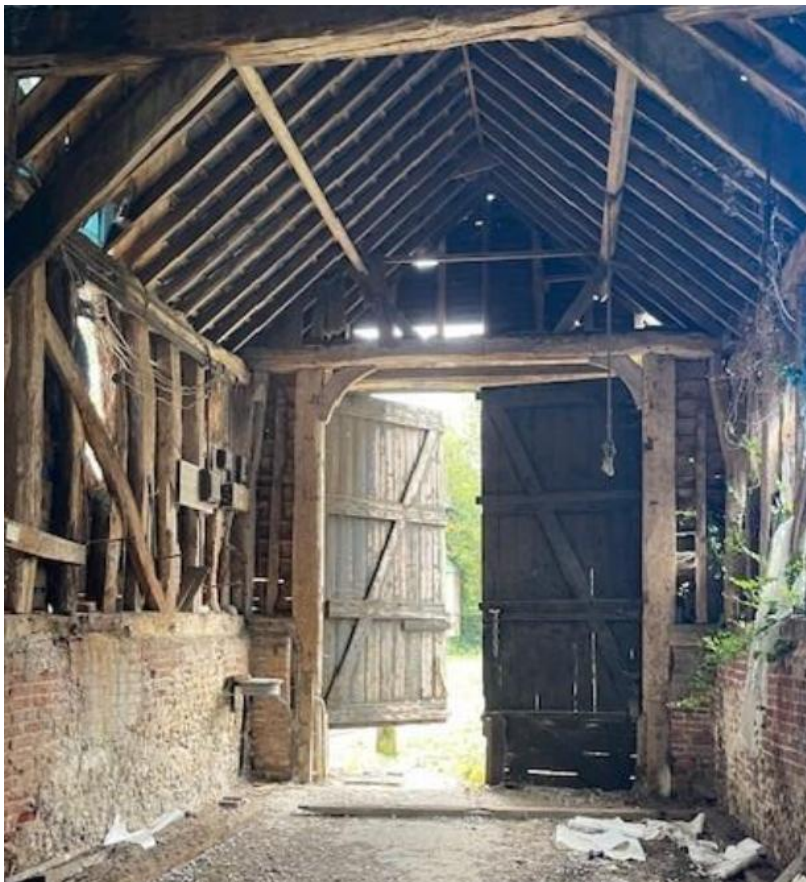
Internal view central gable

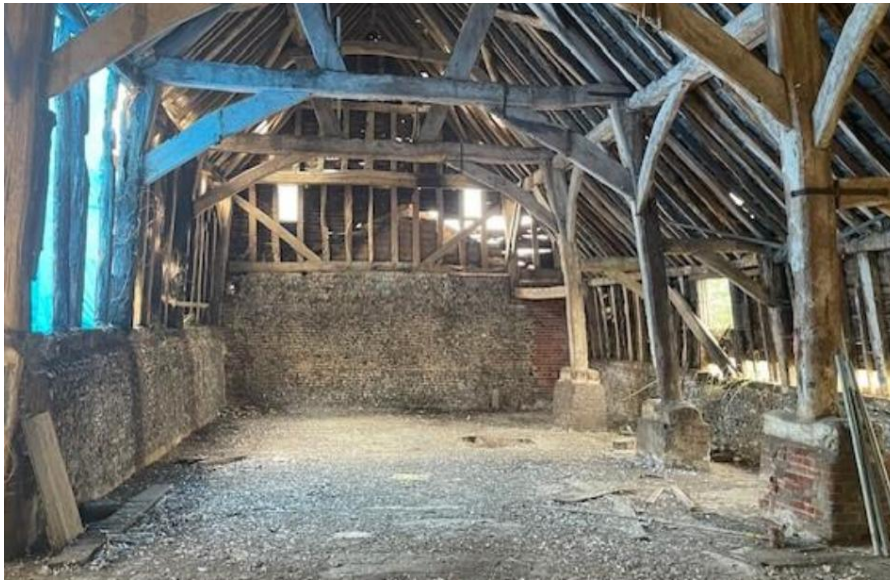
Internal view facing north-west

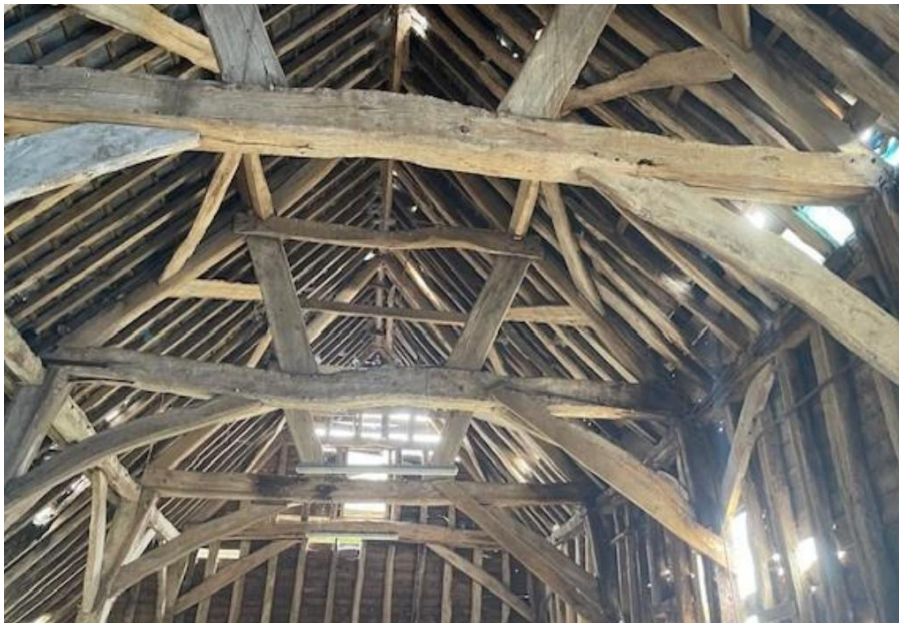
And internal view in opposing direction.
