## **GEOENVIRONMENTAL DESK STUDY REPORT**

### **Westfield Energy Conservation Park Hertfordshire**

**6437-JPG-XX-XX-RP-G-0601-S2-P02**

**26 February 2025**

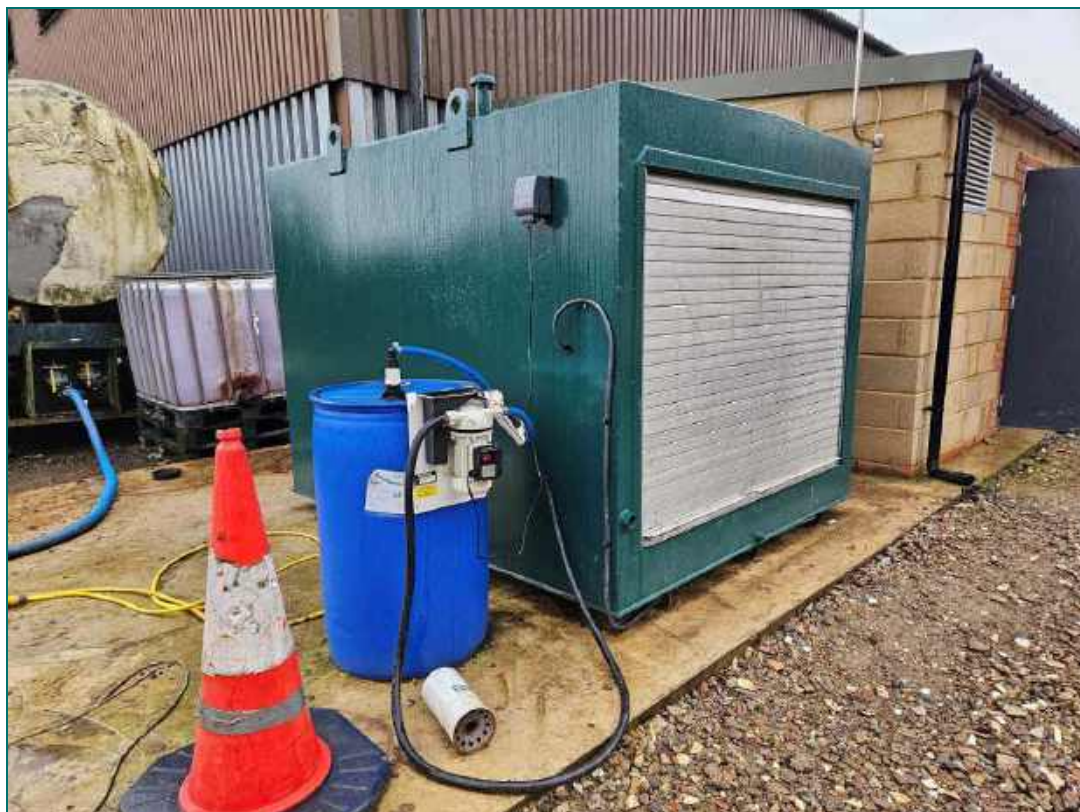
**Photograph 5: Fuelling Facility at Munches Farm.**

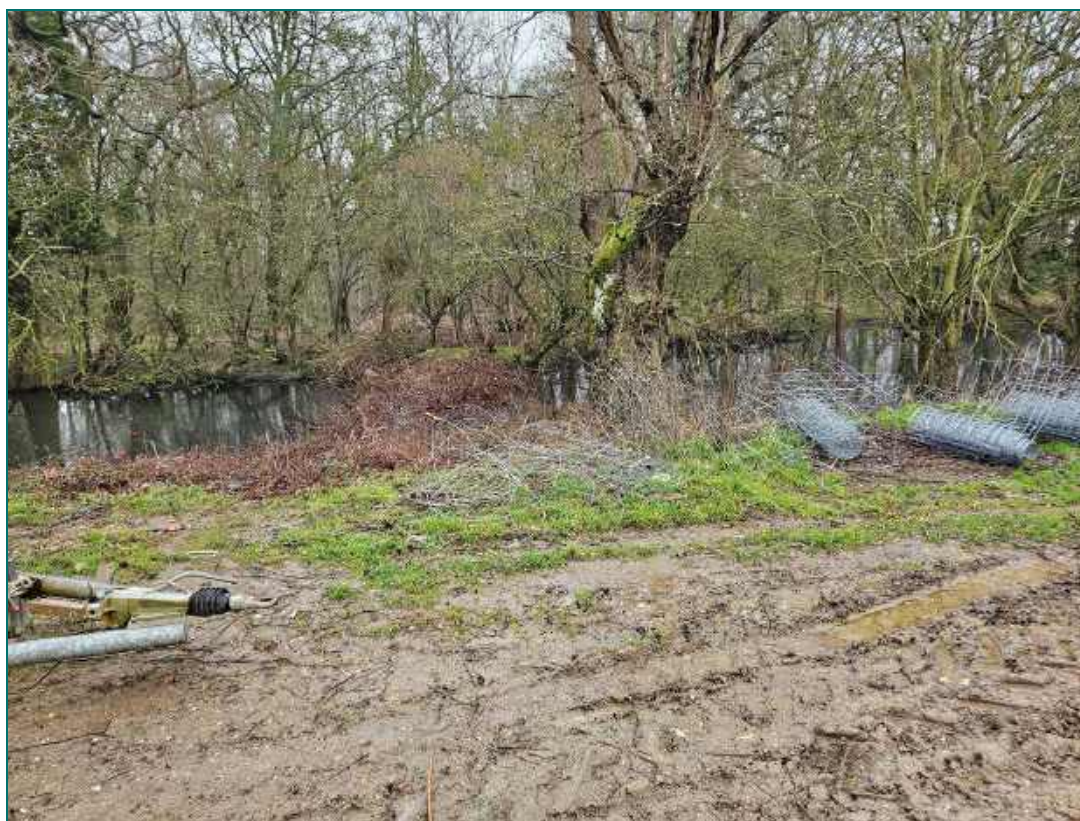
**Photograph 6: Pond at Munches Farm.**

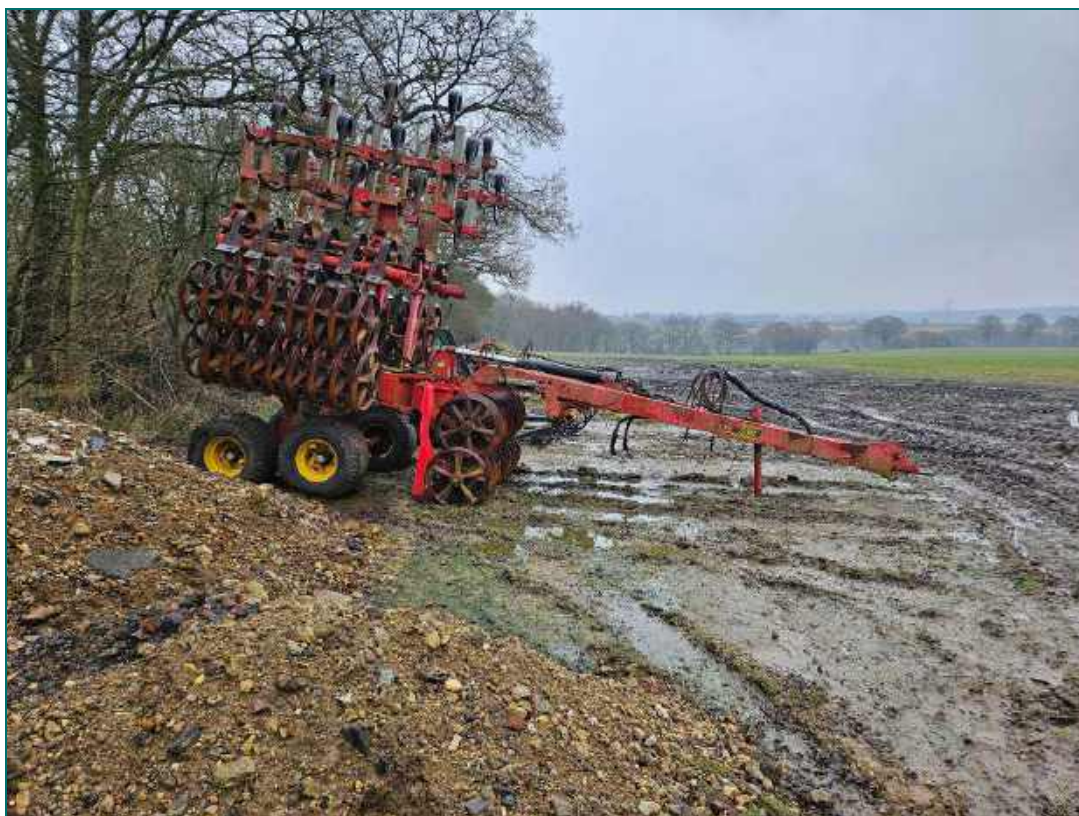
**Photograph 11: Farm Equipment in West of Field 12  
with Small Stockpiles of Soil Arisings.**
