Barns at Radwell Grange  
Phase 1 Geo-Environmental Report  
March 2025  
Project Ref: 101723  
Document Ref: RAD-DEL-XX-XX-RP-GE-0001  
Revision P01

Site                      Barns at Radwell Grange,  
                             Baldock,  
                             SG7 5EU

Client                      Peter George Town Planning

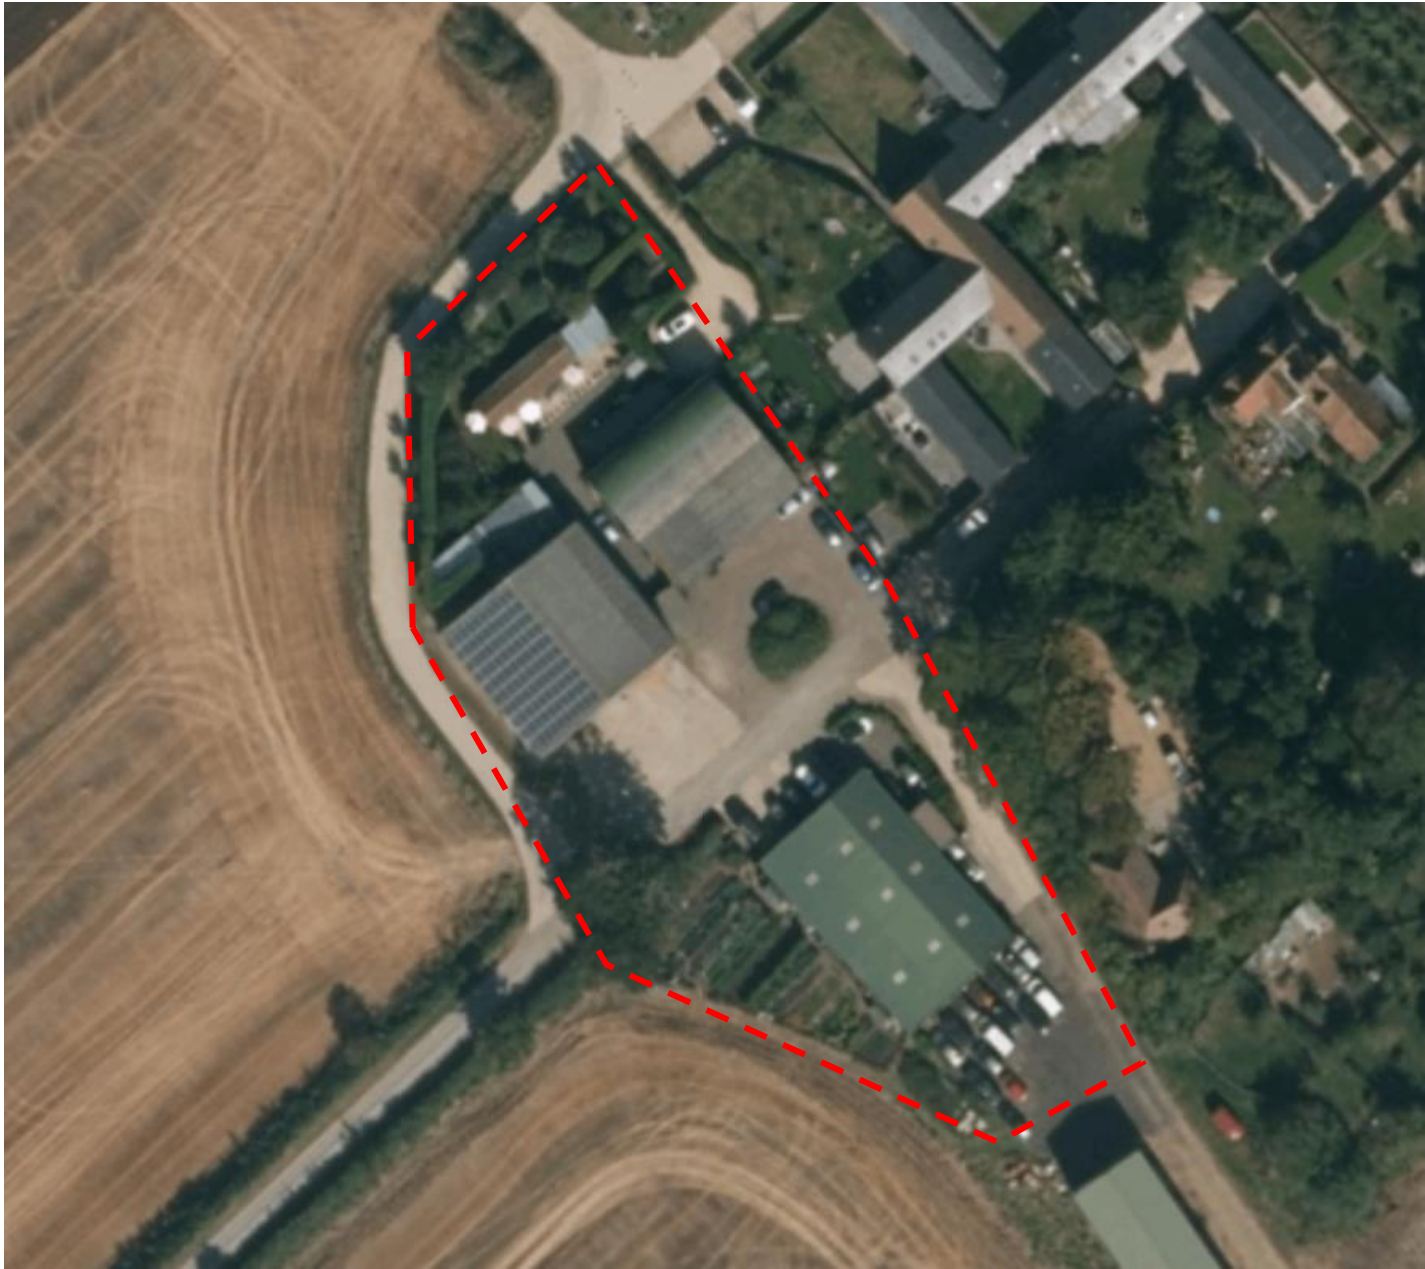
Figure Number  
Fig.2

Title  
Site Layout

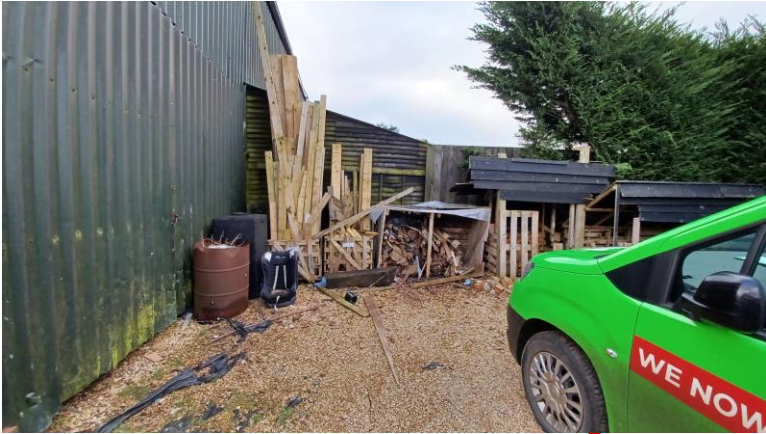
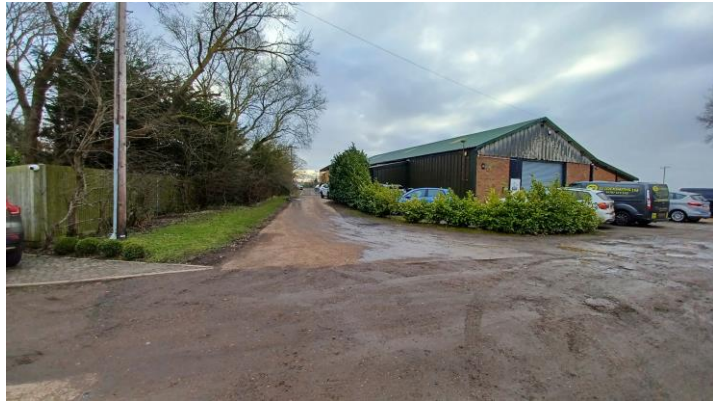
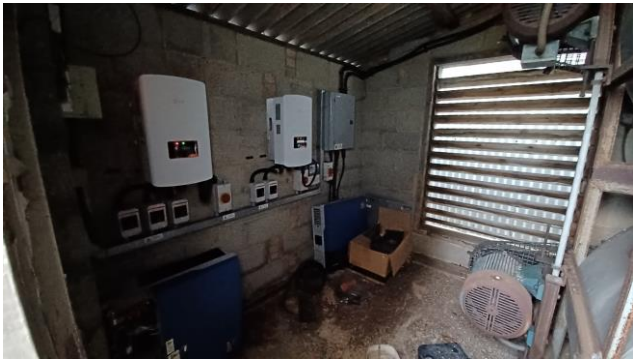
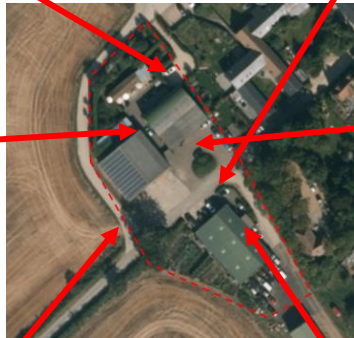
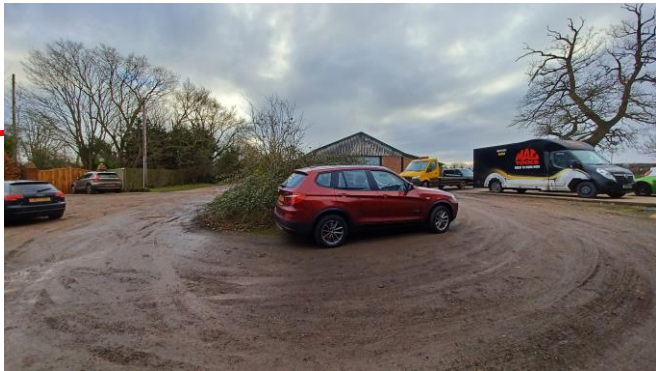
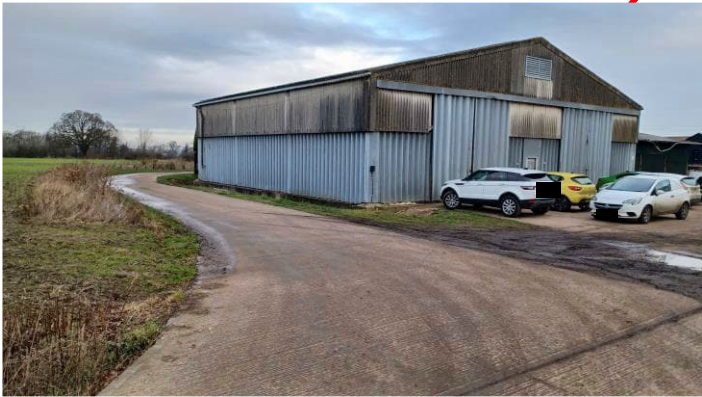
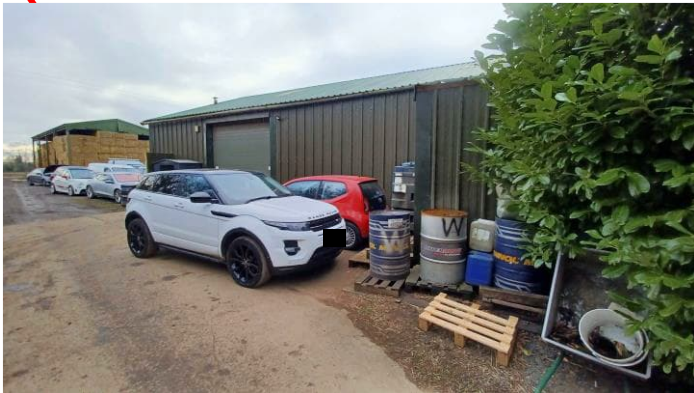
Figure Number  
Fig.3

The site comprises a plot of land occupied by 3 main barns, a small assumed residential property and various smaller structures. The three main barns are identified as Barn A and Barn B in the north of the site, both identified as agricultural storage barns, and Barn C in the south of the site, which is identified as Herts & Beds Transmissions Ltd, a vehicle components store/garage. Barns A and B are currently understood to be in use as storage overflow for the garage. A residential property exists adjacent north of Barn A and Barn B and it is accessible via a locked gate between the two buildings.

On the eastern side of Barn C, oil drums and a large above-ground plastic storage tank, assumed to contain oil, were identified. These were predominantly placed in hardstanding areas and raised up off the ground on wooden pallets.

Beyond the presence of Made Ground, no significant visual or olfactory evidence of contamination was observed.

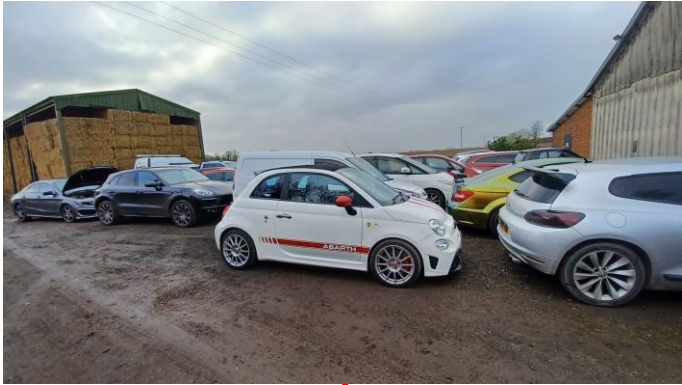
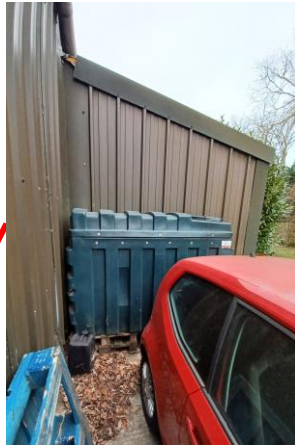
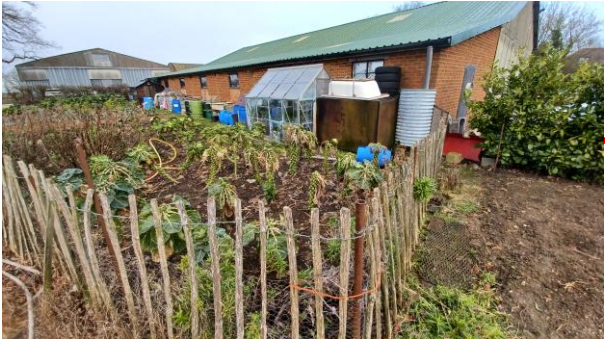
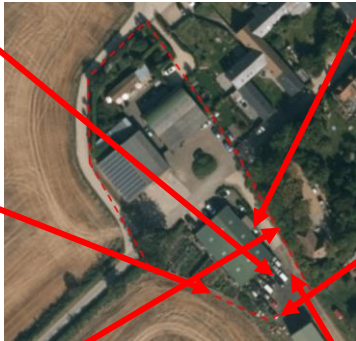
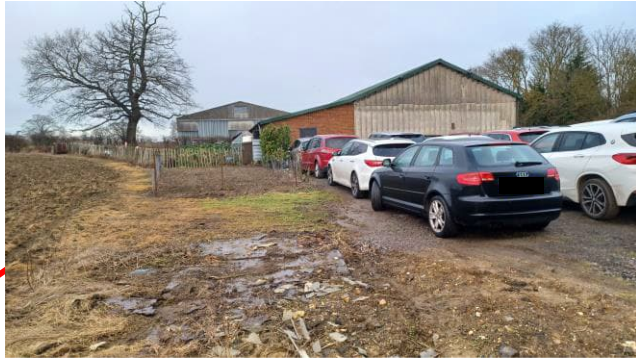
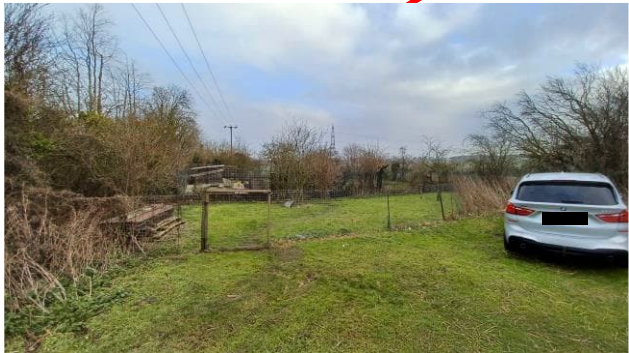
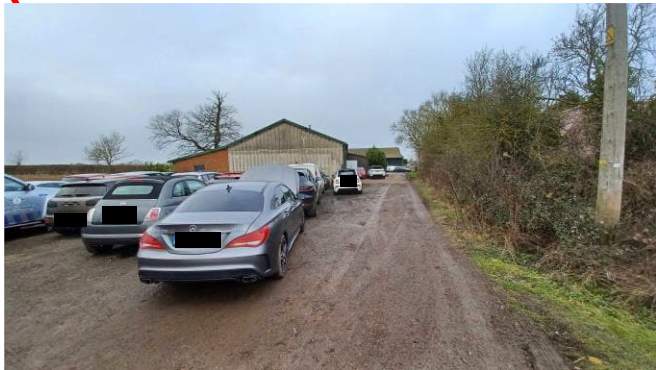
Whilst much of the site comprised hardstanding surfacing, some parts of the site comprised soft landscaping, including short grasses, shrubs and semi-mature/mature trees. In the south-west of the site, to the west of Barn C, a fenced-off allotment area was present, with various plants being grown. Within this area, unspecified small containers were also present alongside a greenhouse and a small wooden shed.
