**Land to the rear of 83 Whitehill Road,  
Hitchin  
Hertfordshire  
SG4 9HP**

**Phase 2 Contamination Risk Assessment**

**On behalf of Soil Investigation (Eastern) Ltd**

**Document Reference: 12248**

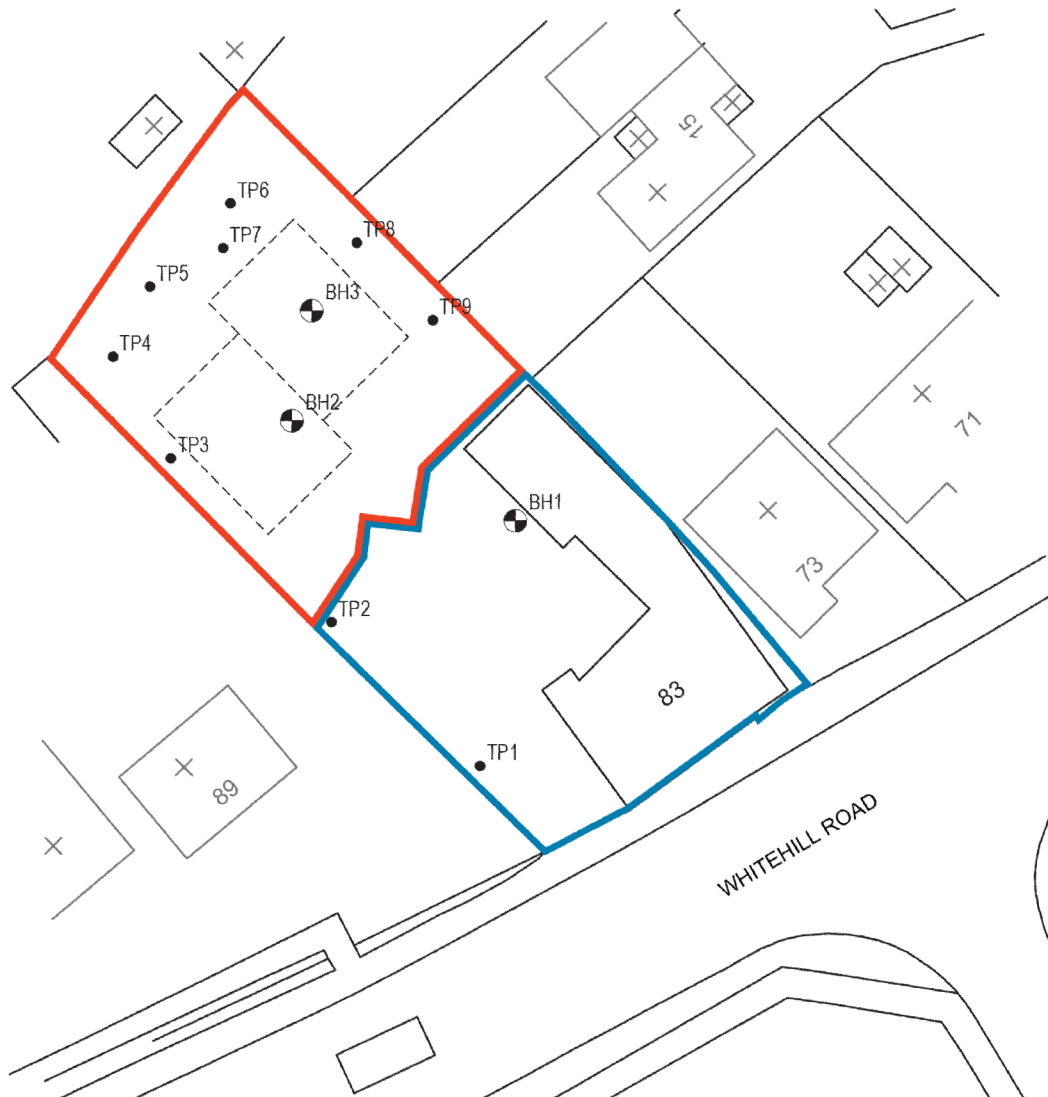
Site: 83 Whitehill Road, Hitchin.

The positions of the above works on the site are indicated on Figure 1, Site Location Plan.

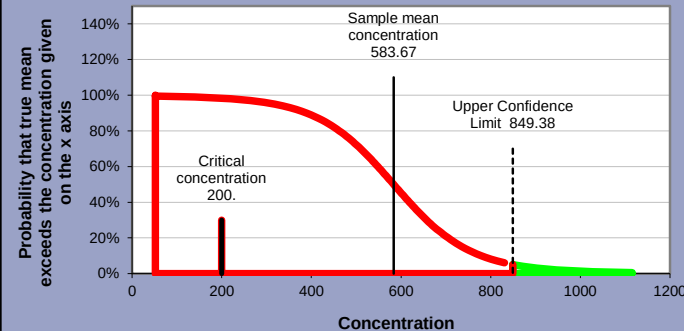
Planning: is true mean lower than critical concentration ( $\mu < C_c$ )?

Null hypothesis: The true mean concentration is equal to or greater than the critical concentration:  $\mu \geq C_c$

Alternative hypothesis: The true mean concentration is less than the critical concentration:  $\mu < C_c$

Evidence against Null hypothesis:

2%
