# Growing Baldock

Appendix 11.4 Nocturnal Bat Survey Report

# LAND TO THE EAST AND SOUTH OF BALDOCK

**BMD.21.0045.RPE-P2.808**

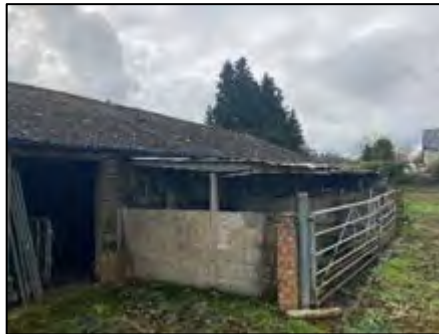
| Buildin<br>g no. | Description | Value | Survey |
|---|---|---|---|
| 6 | <p>Building assessment recorded a single storey elongated barn structure consisting of timber panelling on a brick base, with a pitched corrugated likely asbestos roof. Timber fascia boards and window frames were present (although some window panes missing) and a flat roofed blockwork/brick section extended from the northern aspect.</p> <p>The building showed signs of wear and tear, with gaps between the timber wall panels, damaged windows and gaps under the likely asbestos sheeting provide access/egress.</p> <p>Small clusters of feeding remains were noted throughout the building.</p> | Low | |

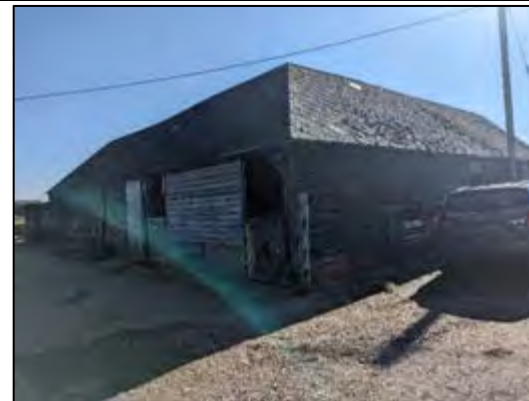
| 14 | <p>Building assessment recorded a single storey stable which consisted of a brick structure clad in timber panels. Two timber extensions were also located on the south-eastern aspect. The main roof was pitched and formed from likely asbestos tiling on top of tight boarding. The extensions included single pitch corrugated likely asbestos sheeting roofs.</p> <p>The building showed signs of wear and tear, with gaps between the timber wall panels, and open doorways provide access/egress. Internally numerous access points and opportunities were noted with bat droppings recorded within the south of the stable block.</p> | Moderate | | |

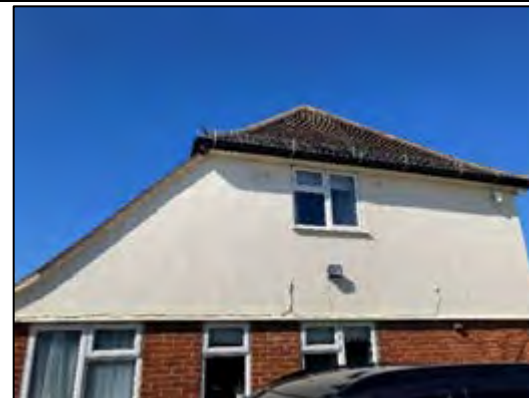
| 17 | <p>Building assessment recorded a two-storey residential structure which consisted of brick walls, with white render on the first floor and a clay tiled hipped roof. A timber framed conservatory protruded from the southern edge of the building. Timber soffit boxes and a chimney stack were also recorded. Overall, the building was in a good state of repair; however, slipped tiles were recorded on the southern aspect of the roof. Inspection on the day of survey showed no change to these external features.</p> <p>House sparrows were utilising gaps at roof edges above the guttering at northeast elevation. Internal inspection conducted within loft void (5-6 m in height with wooden struts and beams). Loft space was extremely dirty, cobwebbed and unlined with no void at rafters. No signs of bats were identified during the inspection.</p> | Low | | |

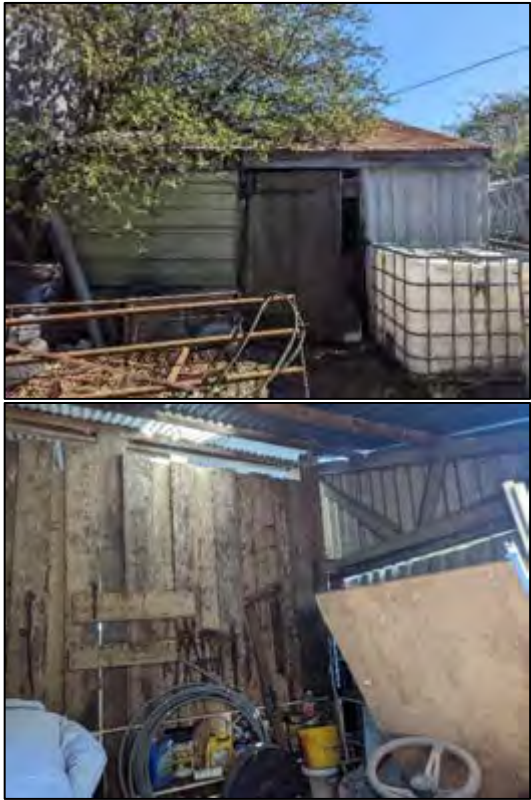
| 35 | <p>Building assessment recorded a small shed structure which consisted of timber/corrugated metal walls. The pitched metal roof included timber barge boards. The building showed signs of wear and had been constructed in a non-uniform fashion.</p> <p>Multiple large access points to interior via roof breaks, gaps in wooden walls, rafters and fascia board. Elder tree is present between B35 &amp; B36. Interior quite drafty, multiple historic and active bird nests are present within the build including confirmed wren. One historic bat dropping was present on the floor of interior.</p> | Low | |

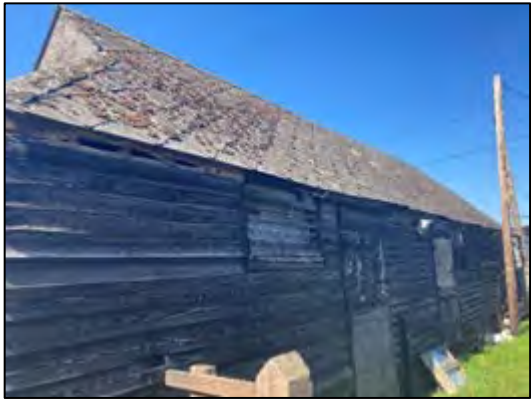
| 39 | <p>Building assessment recorded a single storey C shaped stable in constant use which consisted of a brick and blockwork structure clad in timber panels. The system of roofs comprised pitched sections formed from likely asbestos tiles and corrugated sheeting.</p> <p>The building showed signs of wear and tear, with gaps between the timber wall panels, damaged windows and gaps under the likely asbestos sheeting progress access/egress.</p> | Moderate | |

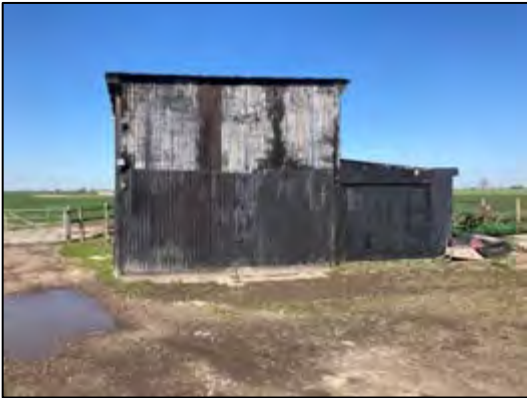
| 40 | <p>Building assessment recorded a shed structure which consisted of corrugated metal sheets on a timber structure, with part flat, part single-pitch corrugated metal roof. Timber fascia boards and skirting was also present surrounding the side-hinged doors on the southern aspect.</p> <p>In places the building was in a poor state of repair; however, openings around the joints in the frame or roof lead to possible entry and roosting opportunities. Due to no internal access and possible opportunities within the interior that could not be assessed the building is recorded to have low opportunity.</p> | Low | |

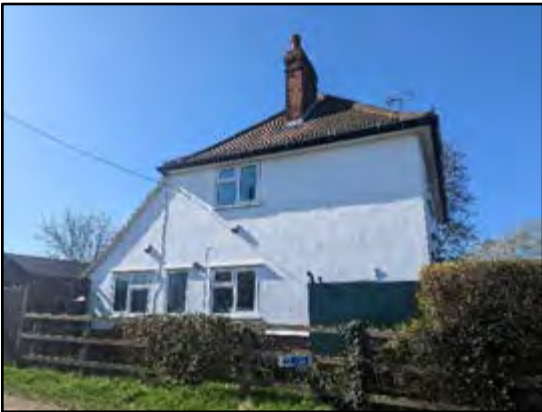
| 45 | <p>Building assessment recorded a two-storey residential structure which consisted of brick walls and a clay tiled pitched roof. Overall, the building was in a good state of repair although a number of tiles were missing on the eastern elevation creating potential entry points.</p> <p>Internally the loft void is unlined and a couple of historic bat droppings were present within the loft space.</p> | Moderate | |

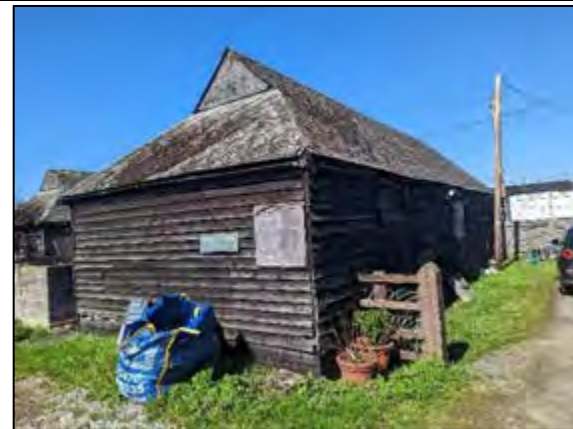
| 48 | <p>Building assessment recorded a single storey C shaped barn in constant use which consisted of a brick and blockwork structure clad in timber panels. The system of roofs comprised pitched sections formed from likely asbestos tiles and wooden boards on the apex's.</p> <p>The building showed signs of wear and tear, with gaps between the timber wall panels, damaged windows and gaps under the likely asbestos sheeting progress access/egress. A number of nests were recorded on the exterior and interior likely swallow and wren.</p> | Moderate | |

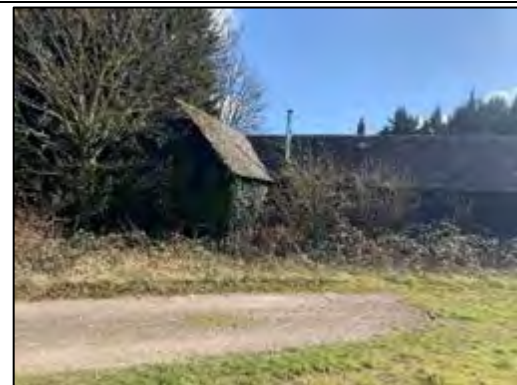
| 53 | <p>Previous survey assessment recorded a building which consisted of timber panelling. The roof is pitched and consists of likely asbestos cement roofing tiles. Some tiles were missing, but no cavities available as a result. There was a number of gaps under lifting weatherboarding which create possible roosting opportunities specifically at the gable/apex of the building.</p> | Low | |

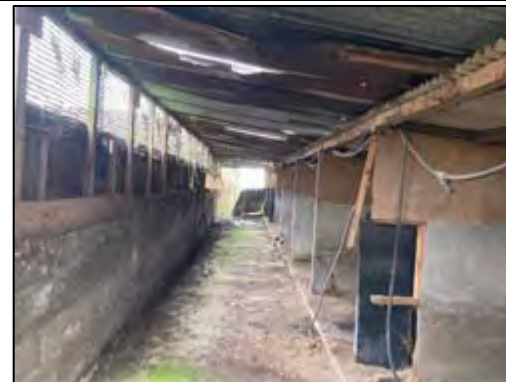
| 55 | <p>Building assessment recorded a former pig shed. Constructed of a flat tin roof, open on all sides to the elements although the centre is well covered. Internally, a number of crevices within the boardings of the walls were recorded and other roosting opportunities internally that were suitable to support roosting bats. The structure was damp in many places and dilapidated.</p> | Low | |

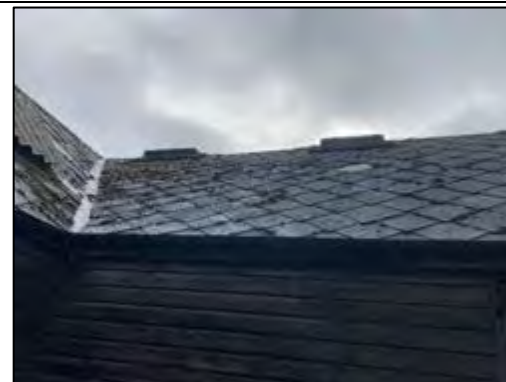
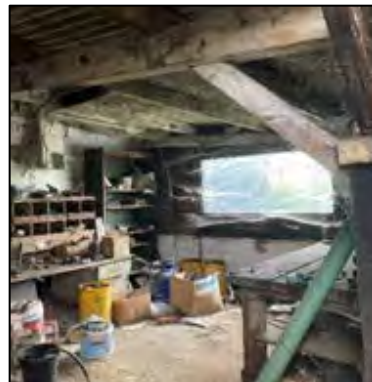
| 56 | <p>Building assessment recorded a C shaped building used as a stable block and storage barns. The structure consisted of timber panelling. The roof was pitched and consisted of tiles on a single lined timber panelling with likely asbestos tiles. A number of gaps were noted externally including lifted weatherboarding and gaps under the eaves allowing access internally.</p> <p>Internally the structure was free of evidence of bats, cobwebs present and dirty throughout the storage barns. Gaps from missing mortar under the stable vents allow opportunity for roosting bats as well as other external features.</p> | Moderate | |

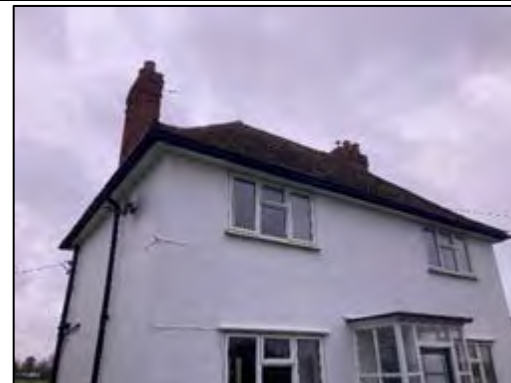
| 59 | Building assessment recorded a two-storey residential structure which consisted of brick walls and a clay tiled pitched roof. Overall, the building was in a good state of repair. A number of tiles on the south western elevation had slipped allowing access for roosting bats between the tiles and mortar. Internally the loft void is unlined and no evidence was recorded. | Low | |

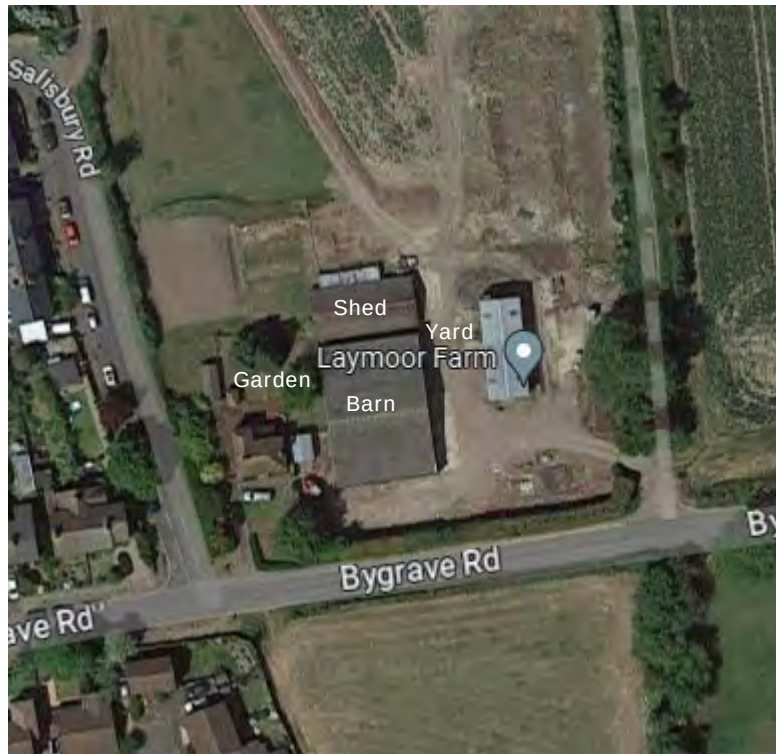
## Bat Emergence/Re-entry Survey Recording Form - B6

| Name of Site: Baldock (Building 6) – 21.0045 | | Surveyor's position: Southeast elevation of shed and northeast of Barn (Building 6) |

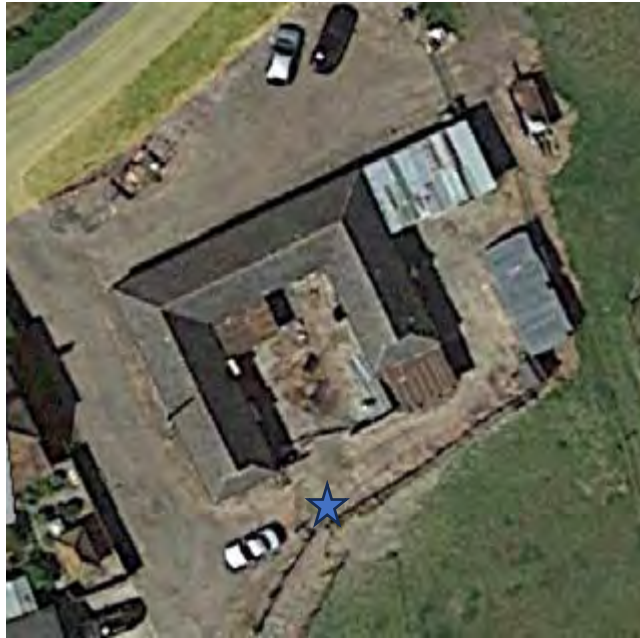
### Bat Emergence/Re-entry Survey Recording Form - B14

| Name of Site: Baldock (Building 14) – 21.0045 | | Surveyor's position: KD - south east & centre of stables | |
| 22:10 | BLE passed through in front of building | | |
| 22:17 | 3x Leisler's contact – unseen detected only. | | |

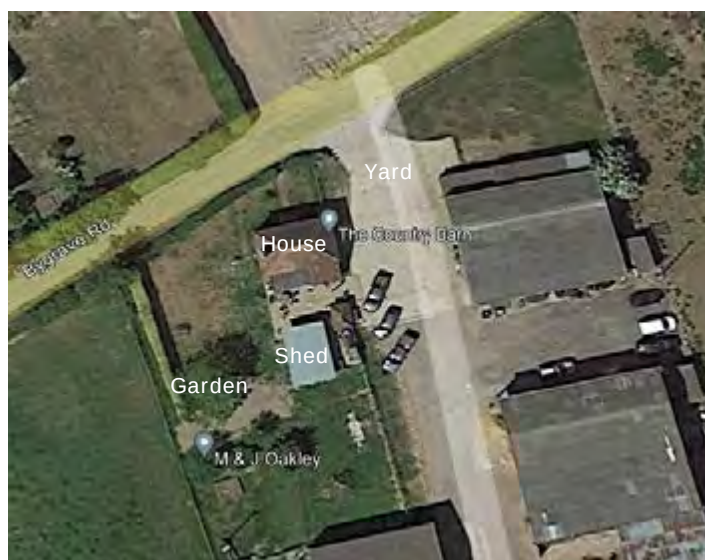
## Bat Emergence/Re-entry Survey Recording Form – B17

| Name of Site: Baldock (Building 17) – 21.0045 | | Surveyor's position: Western elevation of B17, situated in the garden | |

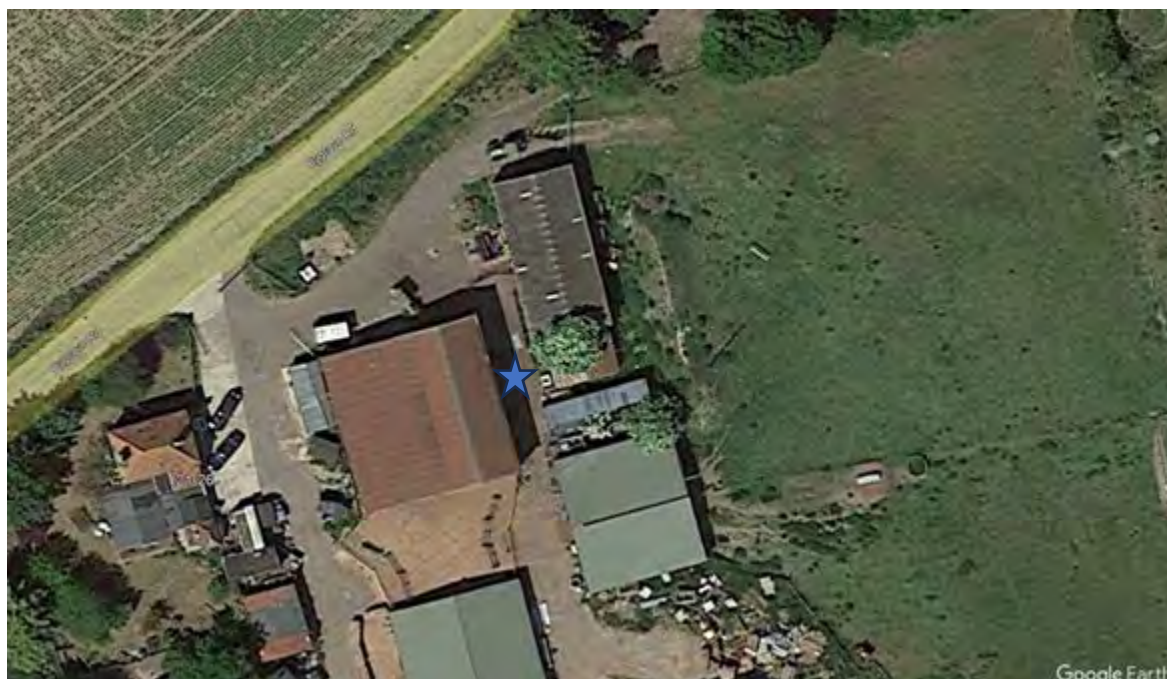
## Bat Emergence/Re-entry Survey Recording Form – B35

| Name of Site: Baldock (Building 35) – 21.0045 | | Surveyor's position: Western elevation of B35, situated by the door. | |

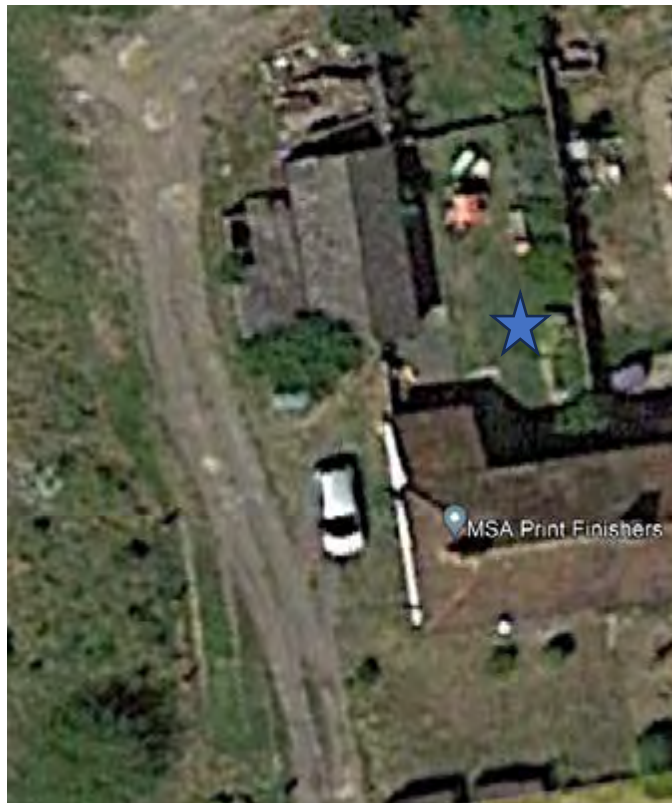
### Bat Emergence/Re-entry Survey Recording Form – B44

| Name of Site: Baldock (44) – 21.0045 | | Surveyor's position: KD – south and eastern elevation. | |
| 21:54 | Common pip fly by heading south - seen | | |
| 22:19 | Common pip contact – unseen | | |

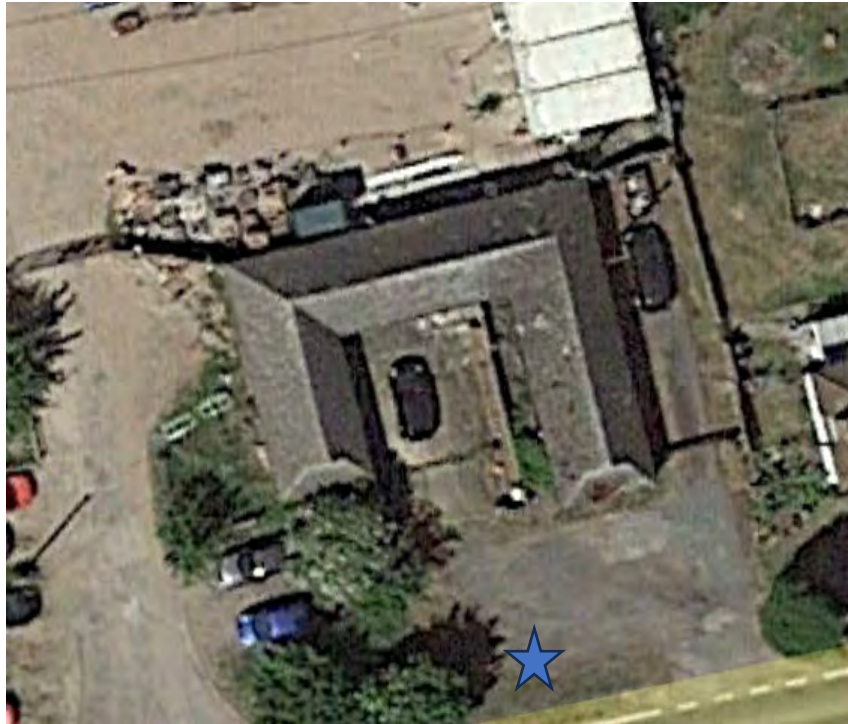
### Bat Emergence/Re-entry Survey Recording Form – B48

| Name of Site: Baldock (48) – 21.0045 | | Surveyor's position: KD – south covering centre courtyard. | |
| 21:53 | Leisler's contact – unseen detected only. | | |
| 22:14 | Leisler's contact – unseen detected only. | | |

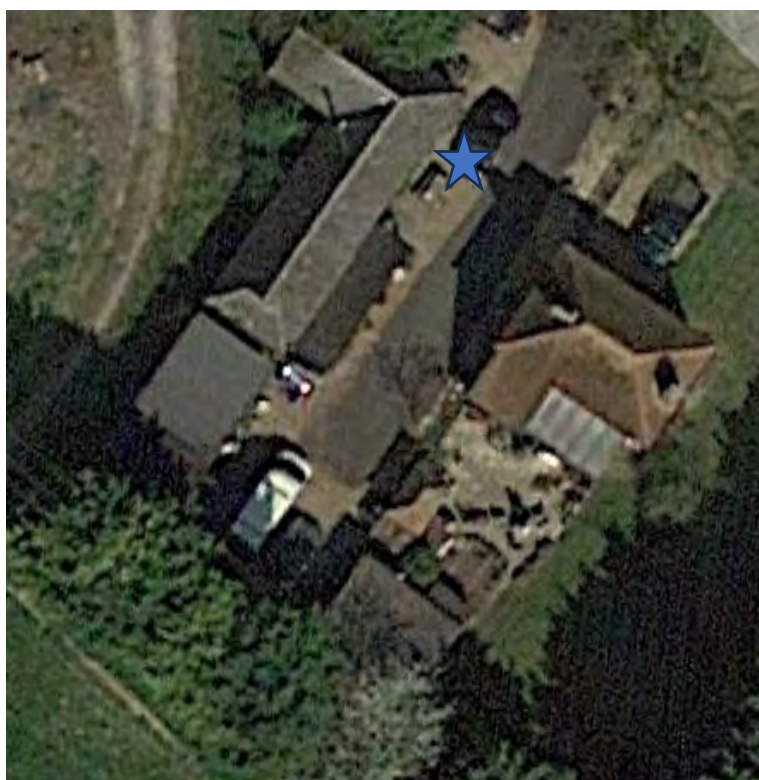
## Bat Emergence/Re-entry Survey Recording Form – B53

| Name of Site: Baldock (B53) – 21.0045 | | Surveyor's position: B53 – north western elevation | |
| 21:34 | 45 pip contact seen fly by | | |

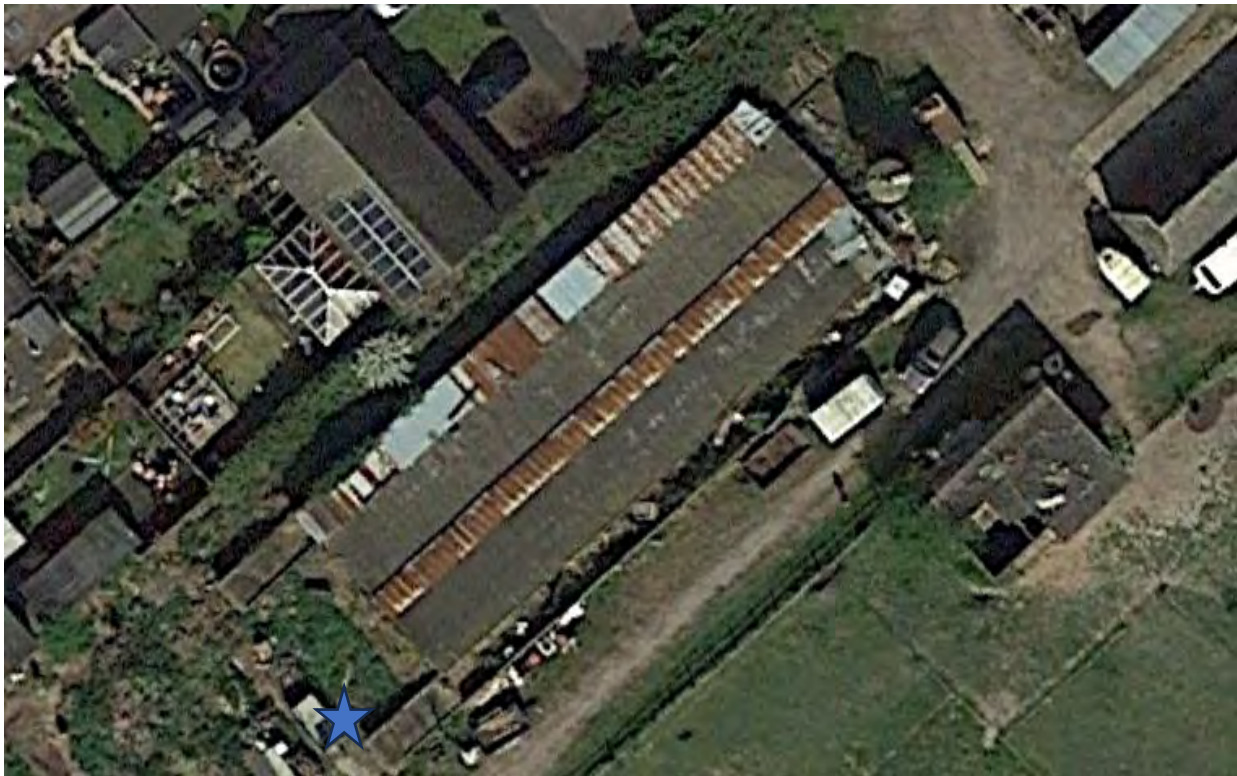
## Bat Emergence/Re-entry Survey Recording Form – B55

| Name of Site: Baldock (55) – 21.0045 | | Surveyor's position: KD –south west elevation within courtyard | |
| 20:43 | Leisler contact – unseen | | |

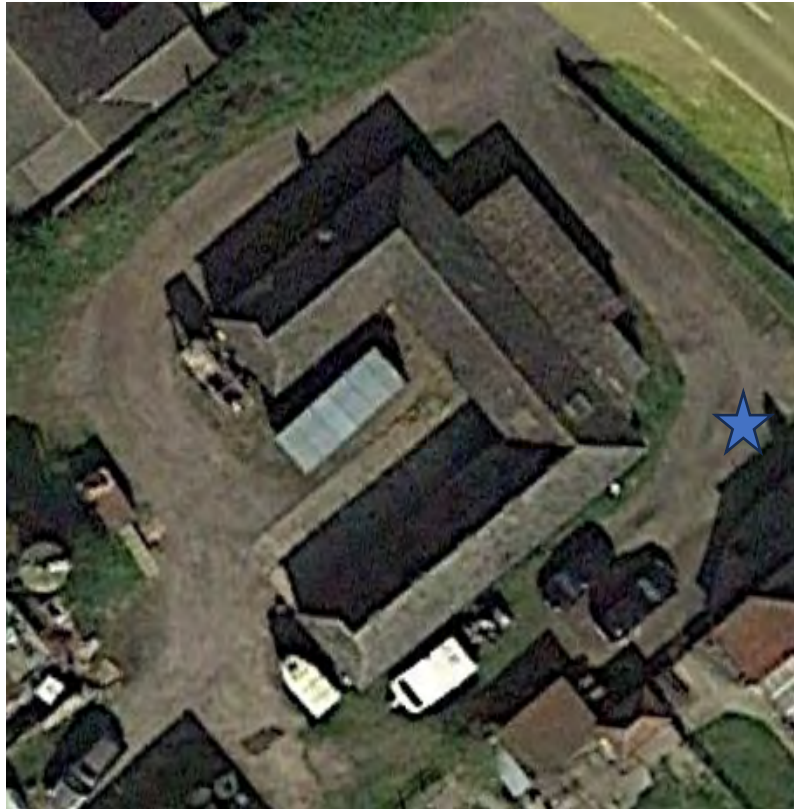
### Bat Emergence/Re-entry Survey Recording Form – B56

| Name of Site: Baldock (56) – 21.0045 | | Surveyor's position: HR –Northen eastern corner of stable block | |
| 21:35 | Leisler's noctule flyby east to west | | |

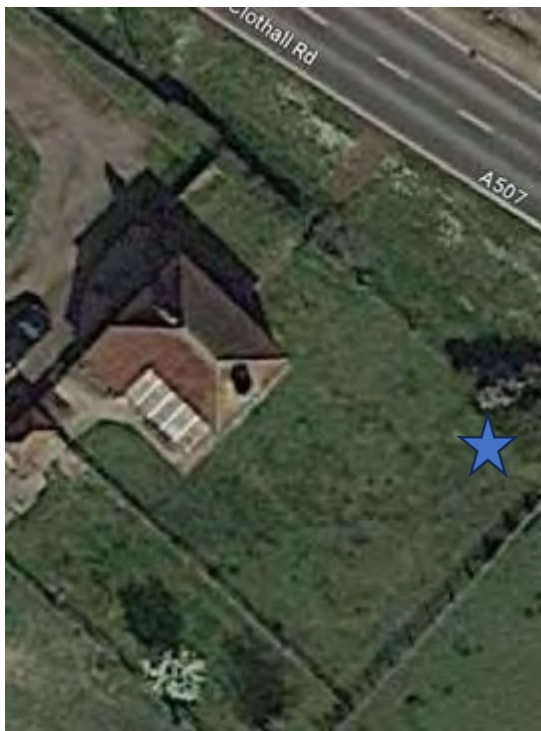
## Bat Emergence/Re-entry Survey Recording Form – B59

| Name of Site: Baldock (59) – 21.0045 | | Surveyor's position: HR – North eastern elevation | |

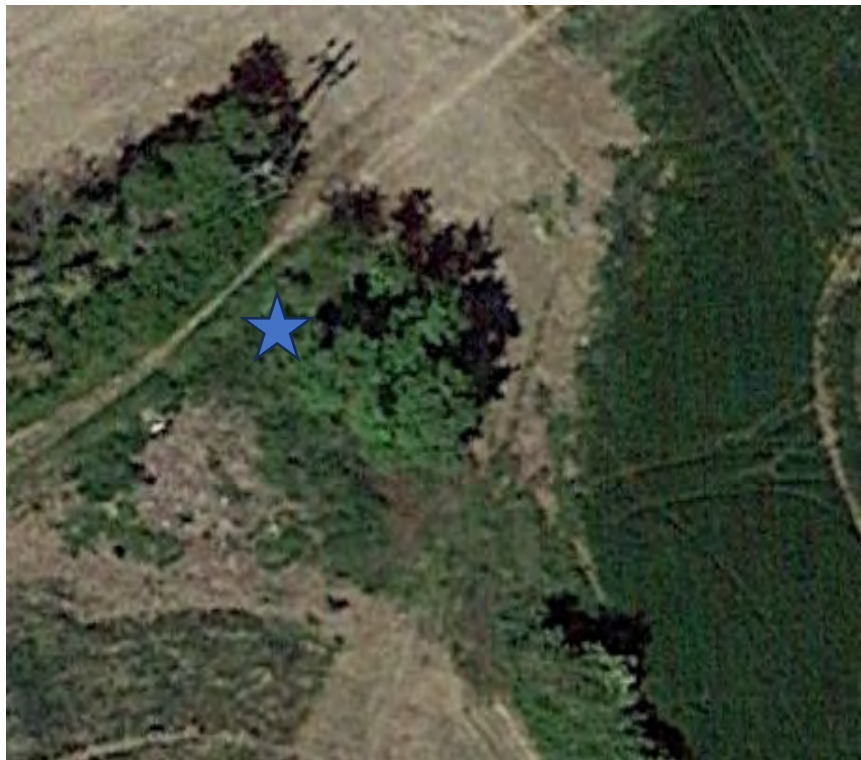
### Bat Emergence/Re-entry Survey Recording Form – TN17

| Name of Site: Baldock (TN17 Field Maple) – 21.0045 | | Surveyor's position: KD – north west of tree | |

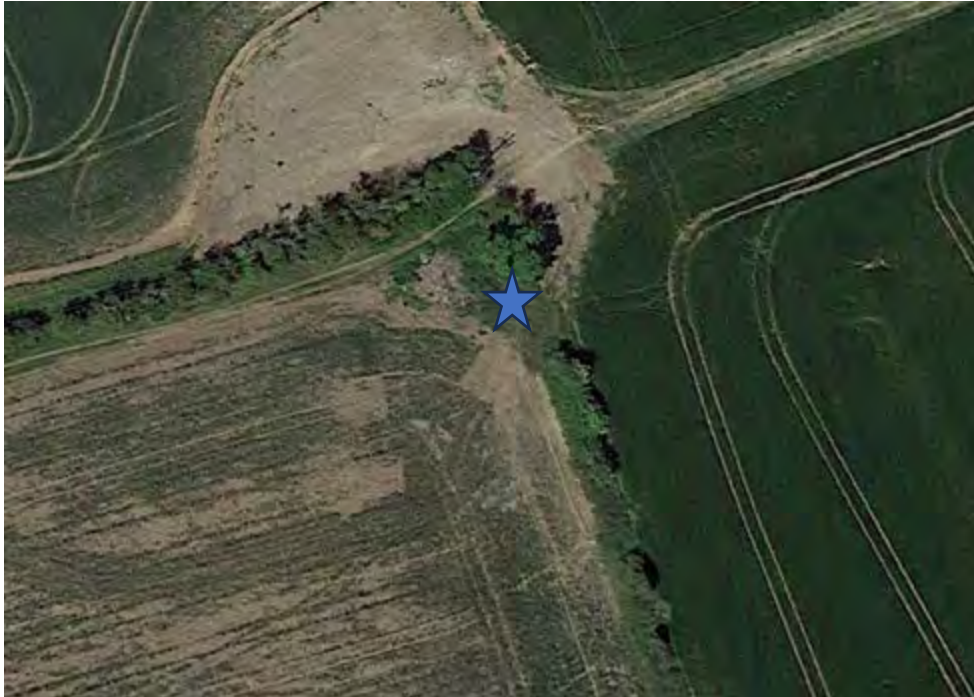
## Bat Emergence/Re-entry Survey Recording Form – TN17

| Name of Site: Baldock (TN17) – 21.0045 | | Surveyor's position: Field maple | |
| Date: 05/07/2023 | | Weather conditions: Sunny, Clear, rain earlier in the day | |

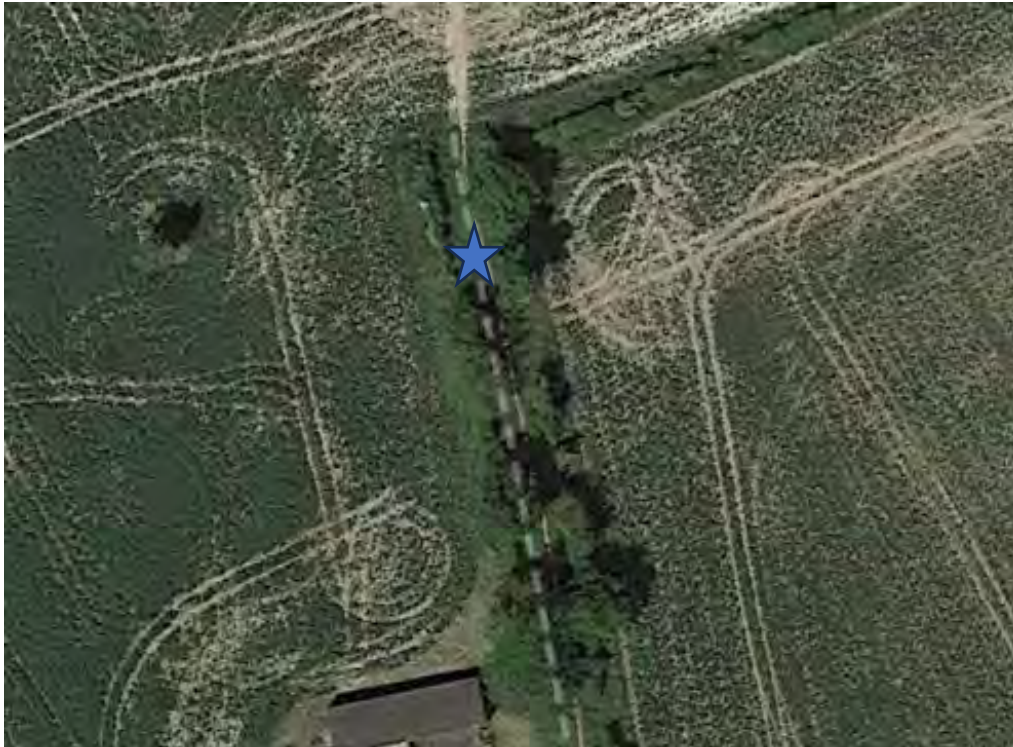
## Bat Emergence/Re-entry Survey Recording Form – TN39

## **TN39 – MATURE ELDER**

| Name of Site: Baldock (TN39) – 21.0045 | | Surveyor's position: Mature elder |
