## Tudor House, Preston (257)

Listed Building Consent **Part 1/2**

Minor Works  
June 2025

**Michael Collins Architect LLP**

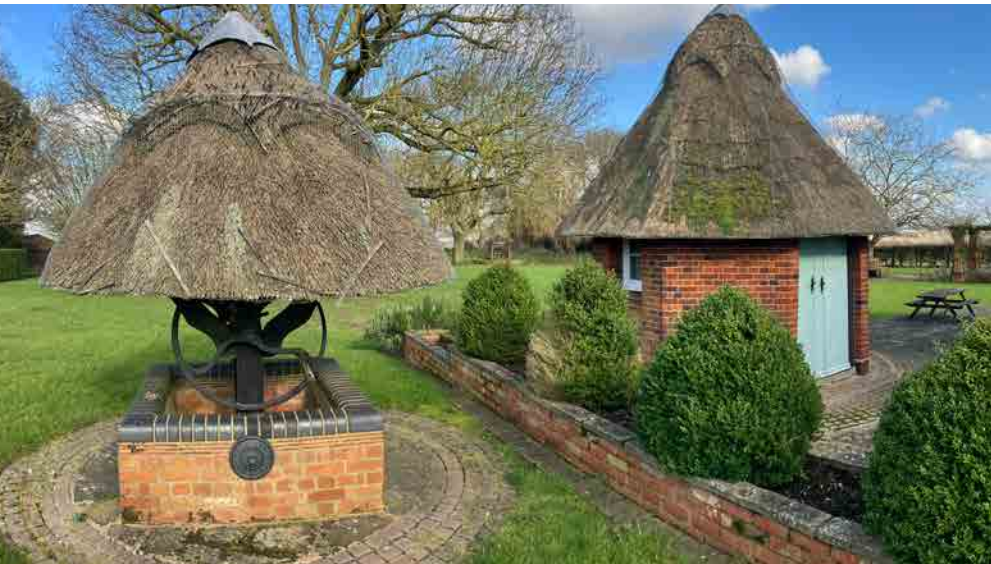
Octagonal dairy near North West corner of Tudor House, Preston Poynders End. Early C19. Red brick with steep pointed roof now covered in felt. A small single-storey octagonal dairy near NW corner of house facing S. Deeply recessed small windows to rear (N), and double doors on S side. Interior white tiled. Very steep faceted roof now crowned by a cowl. Included for group value.

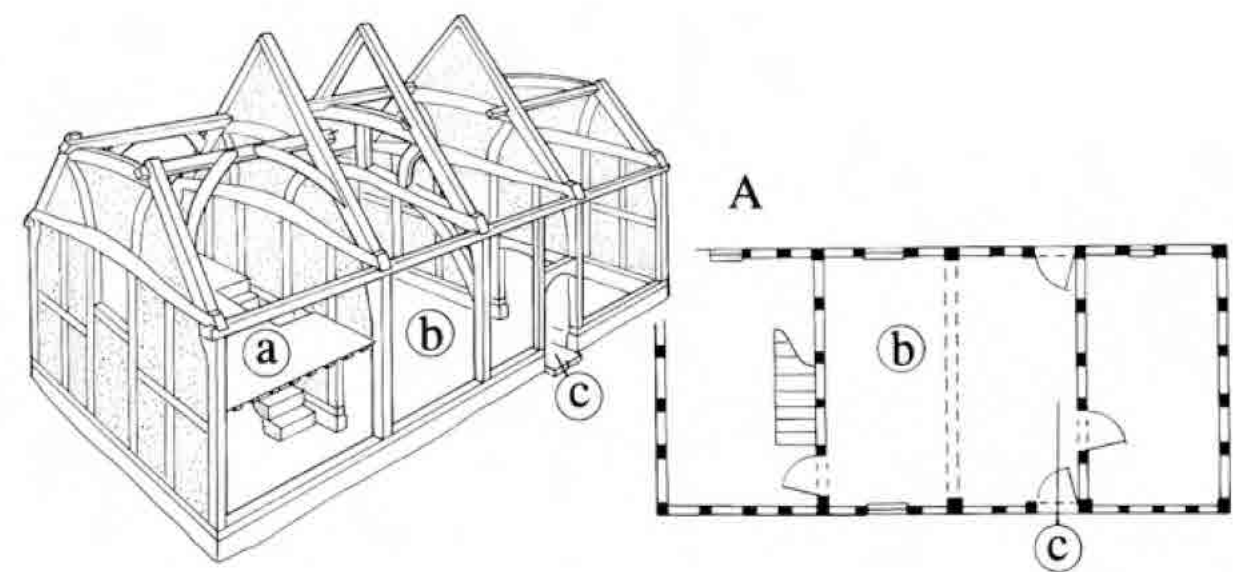
A Four-bay three-cell house

- a) Solar
- b) Two-bay open hall with open truss
- c) Cross-entry

Tudor house is a noteworthy exemplar of an English hall house, exhibiting a historical timber truss structure. The ground floor is subdivided into three cells, conforming to a hall-and-crossing layout. The upper storey is characterised by an overhanging roof.

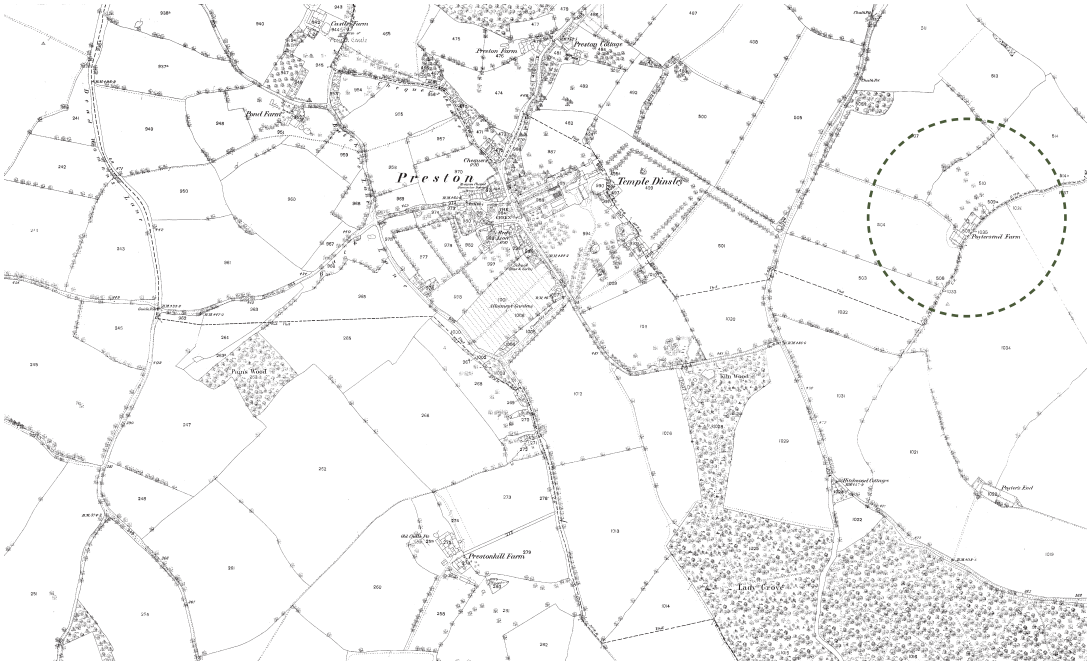
1850s

The cartographic document from the 1880s clearly indicates that Poydersend Farm was a single edifice, clearly delineated as an agricultural holding on a large plot of land.

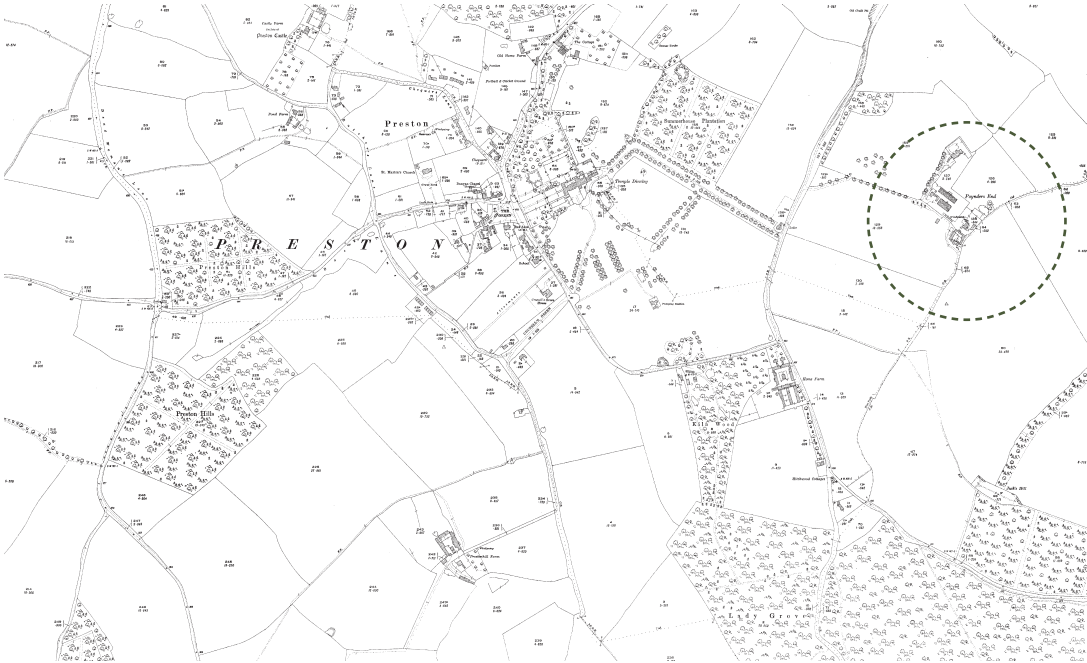
1900s

Following a period of fifty years, the context underwent significant modification, following the construction of five new edifices situated to the north-west of the Tudor House, later designated as The Barn at Tudor House, as per planning application records indicated in 2008 (please refer to planning application 070 2942).

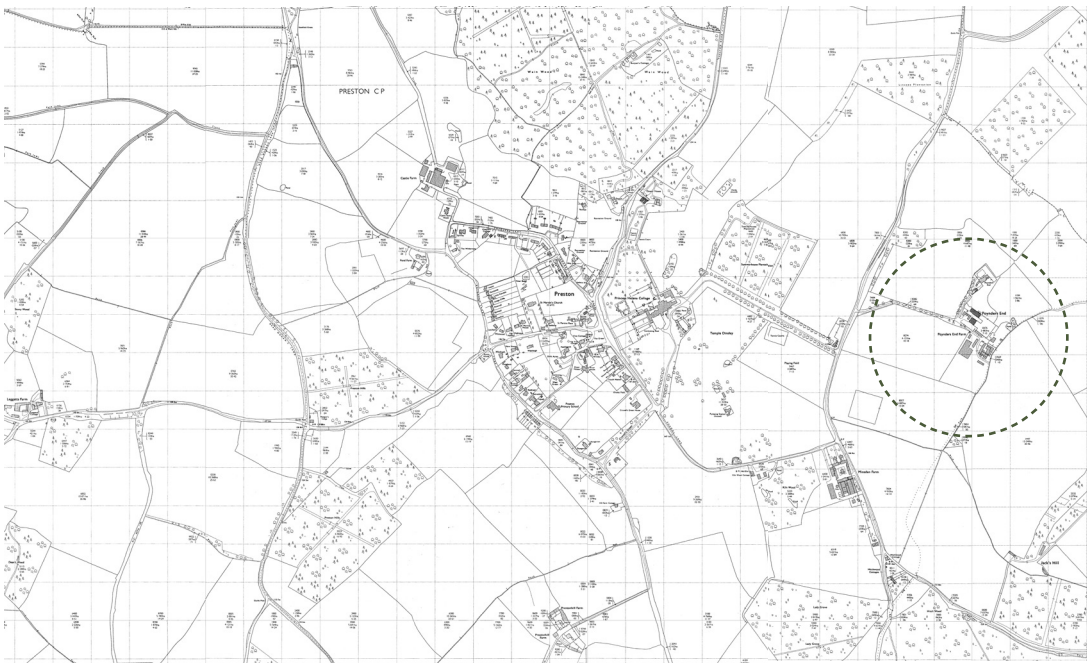
1950s

In the early 20th century, the construction of additional barns was initiated on the southwestern periphery of the site, reflecting the current situation of the area. It is unclear when Poynders End / Tudor House stopped serving as a farm, but the latest agricultural activity found was in 1901.
