# Phase II Geo-Environmental Assessment

Site: Land at Lower Road, Breachwood Green, SG4 8NS

Project reference: UK26.7955b

**Title:** Phase II Geo-Environmental Assessment  
Land at Lower Road, Breachwood Green, SG4 8NS

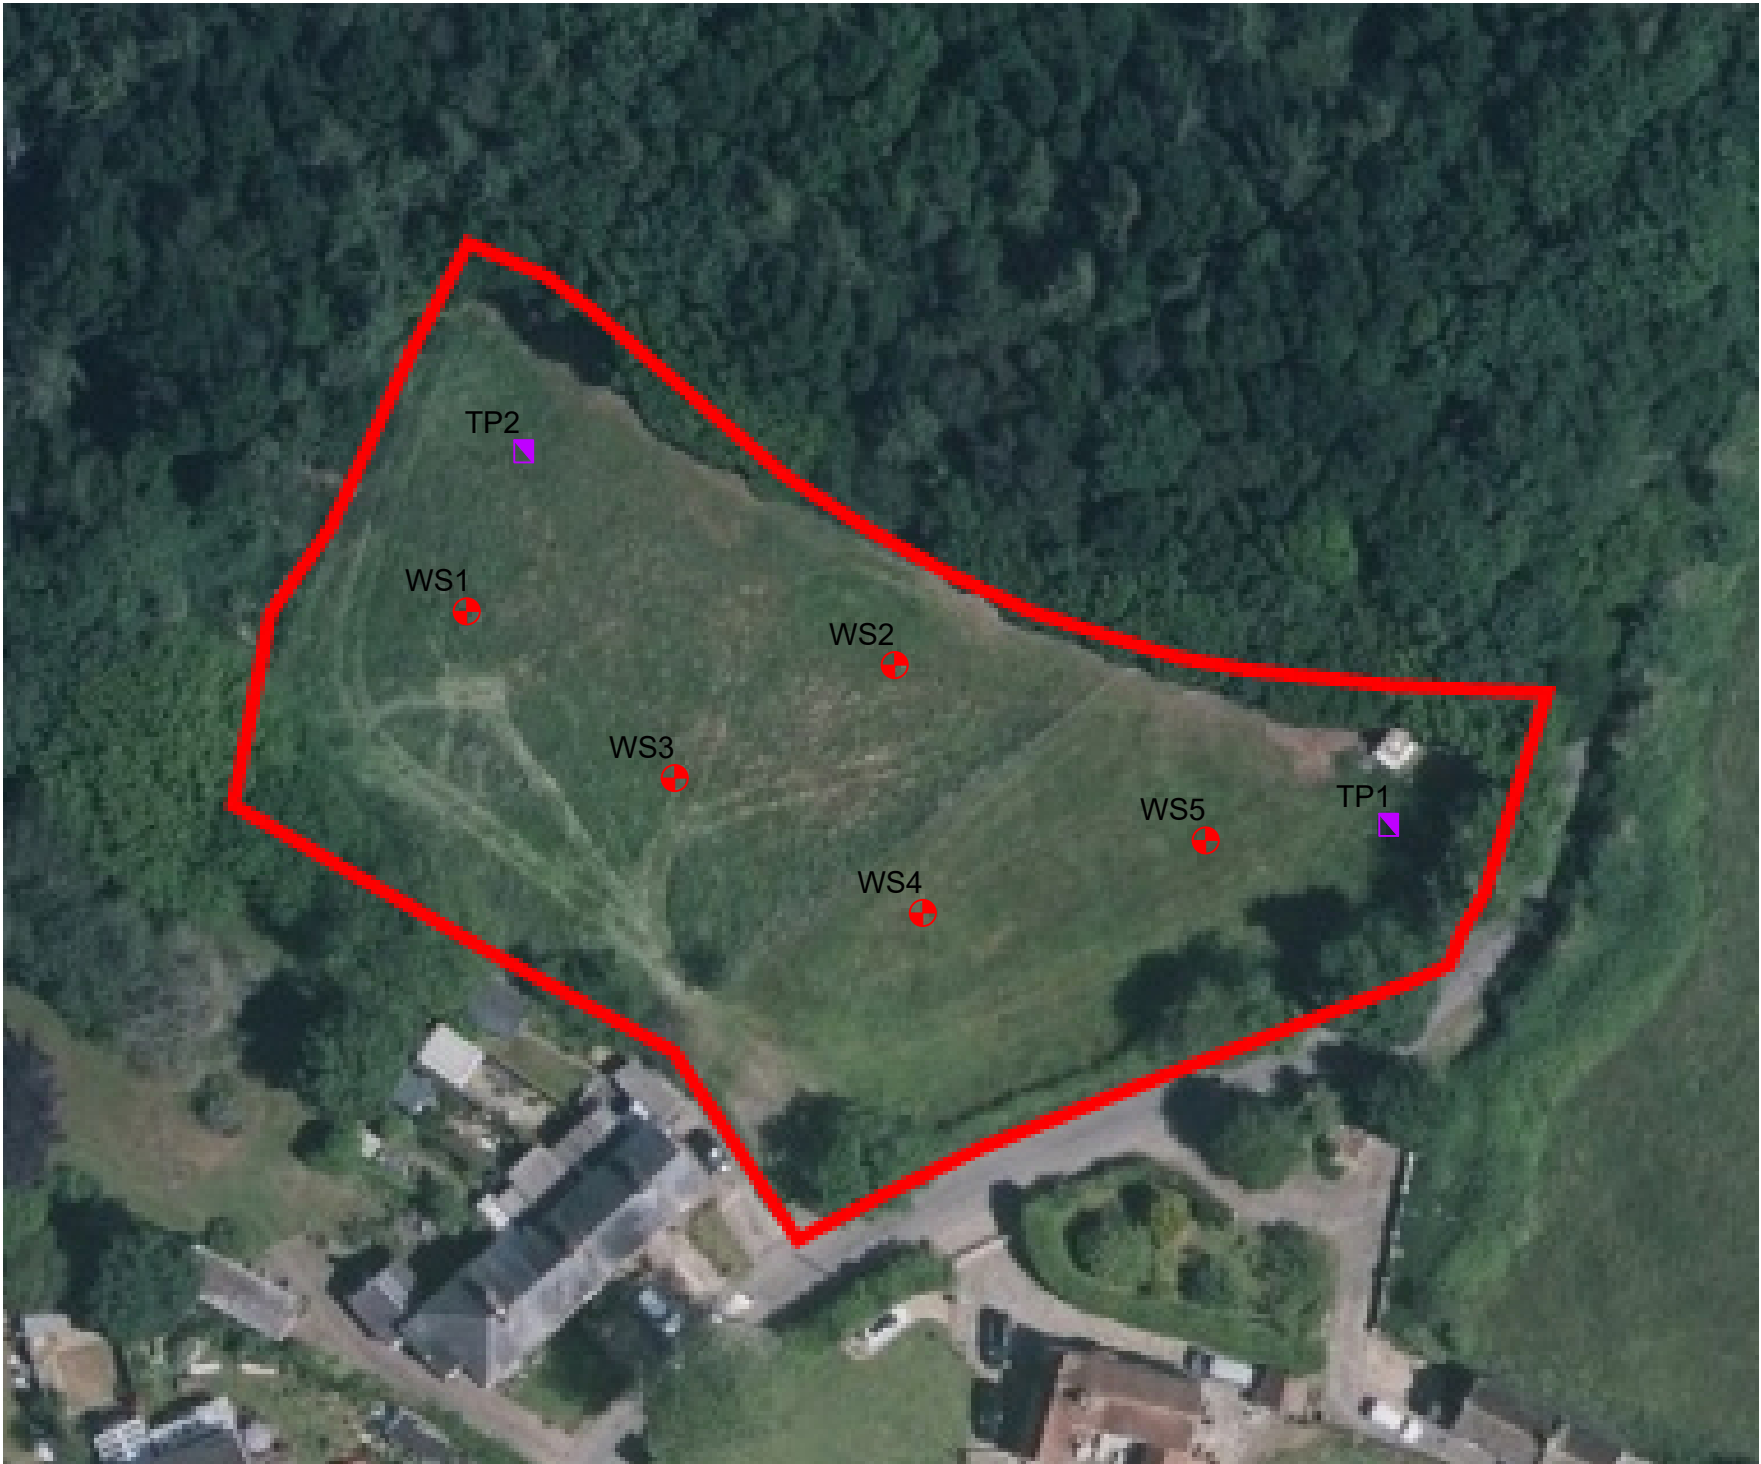
- KEY:
- APPROX. SITE BOUNDARY
  - APPROX. WINDOW SAMPLE BOREHOLE LOCATION
  - APPROX. TRIAL PIT LOCATION WITH INFILTRATION TESTING

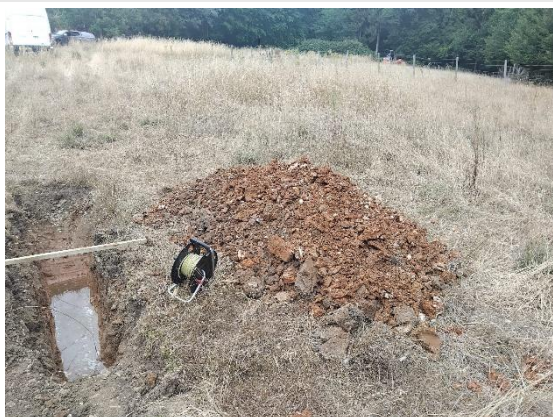
Photo 1: Infiltration testing undertaken at TP1.

Infiltration tests were attempted within the shallow soils at the two trial pit locations (TP1 & TP2), progressing to depths of up to 1.7m bgl, and in general accordance with '*BRE Digest 365 – Soakaway Design*'.

Both tests were run over a 2-day period and in the time available, only around 25% of the water in each pit drained away. A minimum of 75% is typically required in order to be able to calculate accurate infiltration rates, and therefore these results are considered to represent 'practically impermeable' drainage conditions for the soils present to this depth beneath the site.

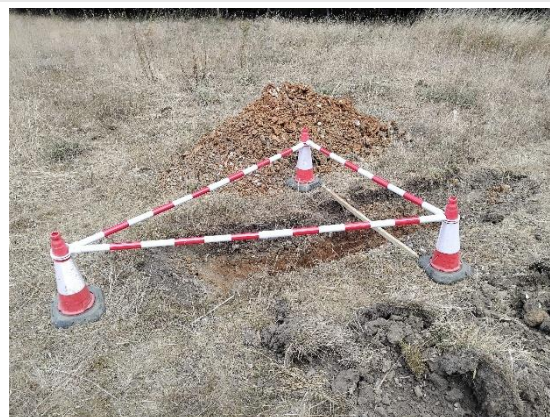
Photo 2: Trial pit and spoil heap at TP2.

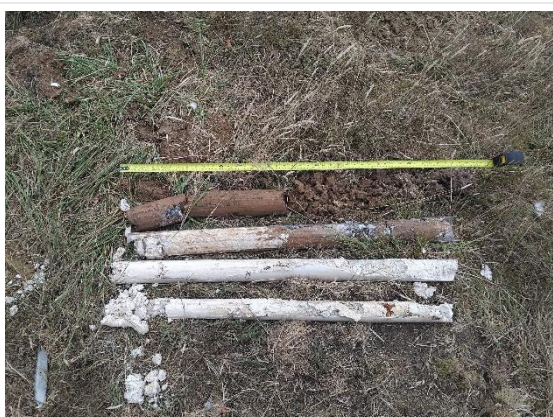
Photo 3: Materials recovered from WS2.

Where the Clay-with-Flints Formation was fully proven, it was found to be underlain by bedrock of the Lewes Nodular Chalk Formation (Chalk). This was encountered at a depth of 3.2m bgl in WS5 but as high as around 1.7m bgl in WS1 and WS2, and was generally recovered as a crumbly white structureless chalk composed almost entirely of a silt matrix, with rare gravel of fine to medium flint and intact chalk fragments, extending to beyond the depth of each of the boreholes.

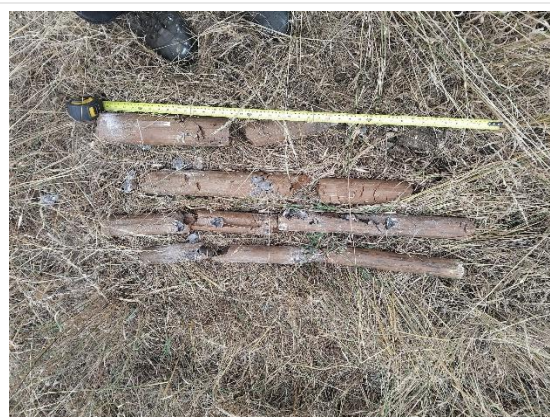
Photo 4: Materials recovered from WS4.

was noted to contain frequent decayed organic material in WS3, WS4 and WS5, and was also noted to exhibit occasional very flint-rich horizons between around 1.5m and 4.0m.
