Report prepared for: Victoria Carter

For the Site of: Black Barn, Deadman's Hill, Sandon, Herts SG9 0RJ

# Preliminary Roost Assessment (PRA) and Emergence & Activity Bat Survey (EBS)

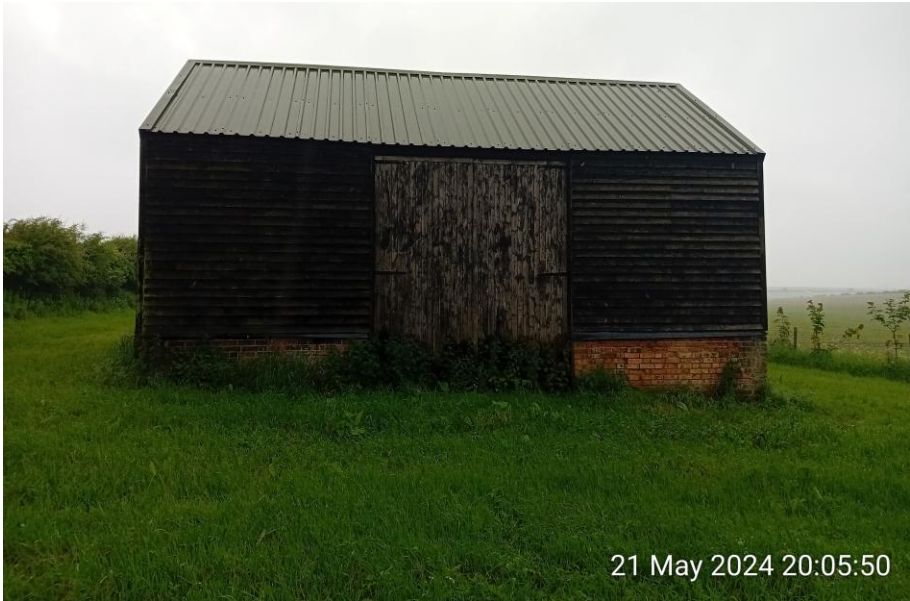
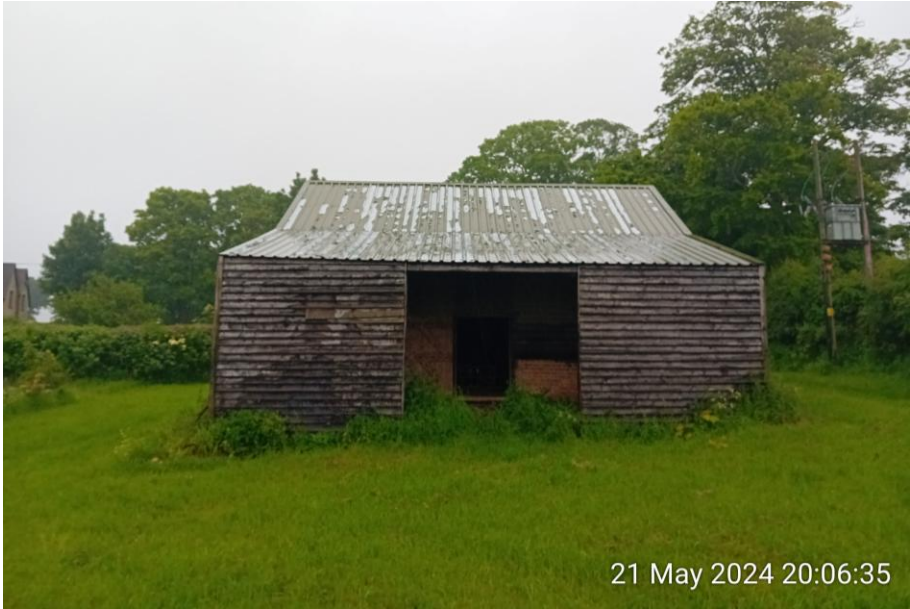
| Building/Tree/Structure Number | Description |
|---|---|
| B1 | <p><b>External</b></p> <p>B1 is a timber built, two-storey barn, with a brick plinth. The roof is gable ended and pitched with metal roofing sheets covering it. The rear of the barn is open access.</p> <p>21 May 2024 20:05:50</p> <p>Figure 2: Front of B1.</p> <p>21 May 2024 20:06:35</p> <p>Figure 3: Rear of B1.</p> |

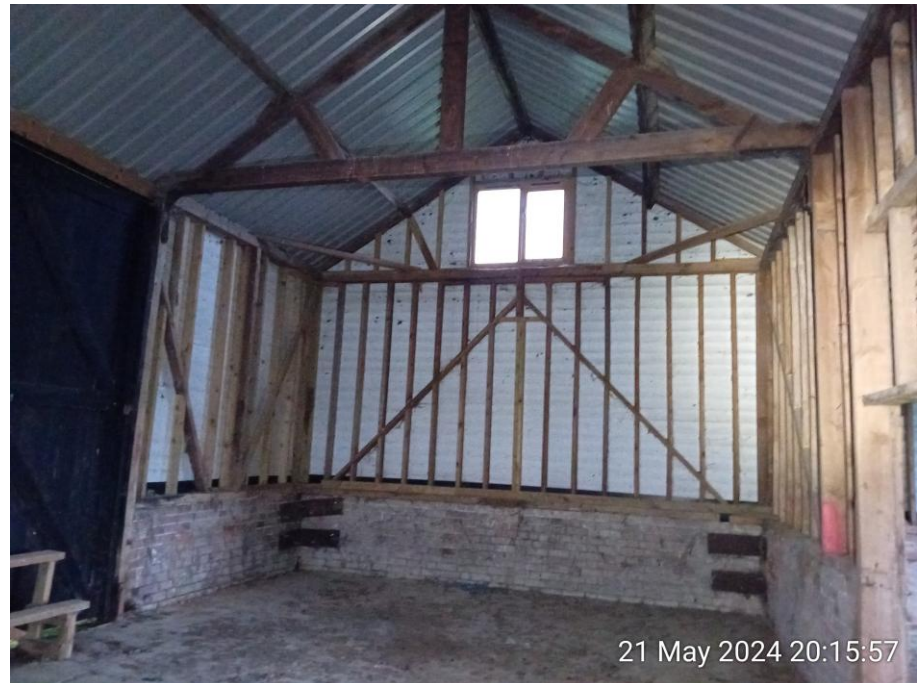
Figure 4: Example of interior.

The barn has a vaulted ceiling with a king post truss beam structure. The walls are unlined, exposing the timber cladding internally.

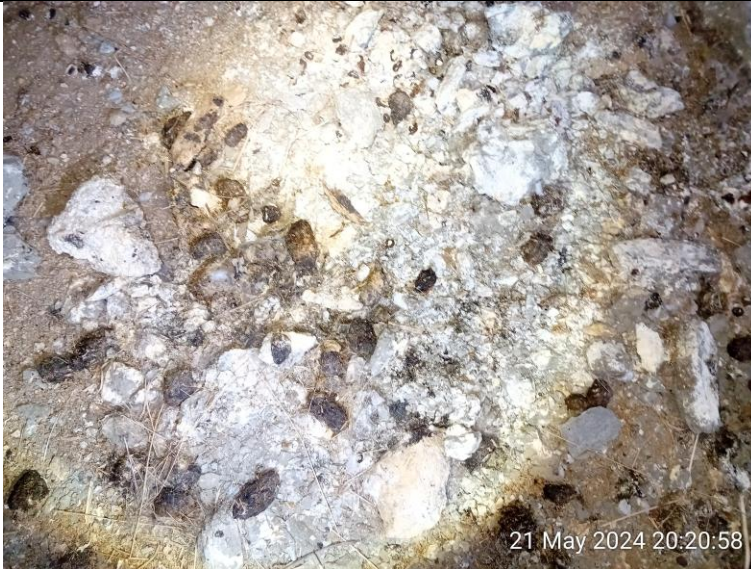
Figure 6: Barn owl pellets.

The site consists of a timber-built disused barn (B1). The Preliminary Roost Assessment (PRA) has been conducted as part of a single nighttime survey. One emergence survey has been carried out. The dusk emergence survey found no evidence of bats roosting in B1. However, ~50 barn owl, *Tyto alba*, pellets were found within B1.

**A barn owl mitigation plan** is required prior to planning permission being granted.

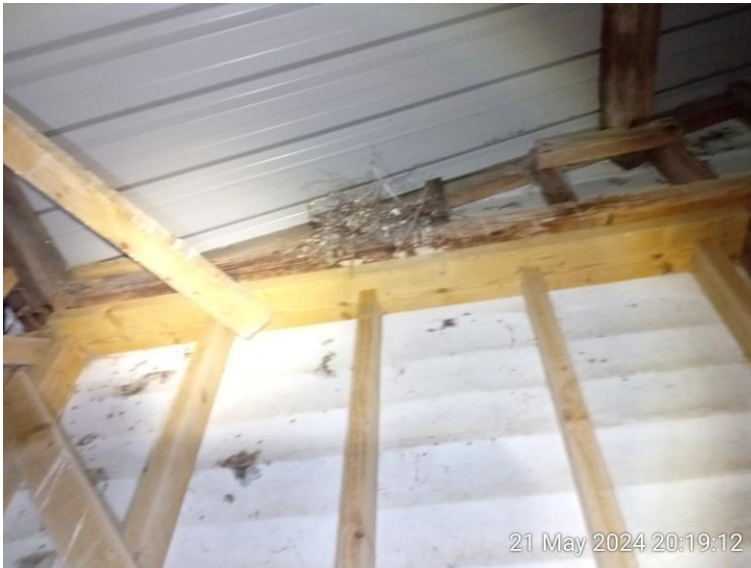
Figure 7: Barn owl nest.

| Impact | A barn owl nest will be lost in the development. |
| Characterisation of unmitigated impact on the feature | A barn owl nest will be destroyed when works are carried out resulting in a low-level loss/impact at a local level. |
| Effect without mitigation | Without mitigation, individual barn owl could be killed, injured or trapped during the works. |

| Significance of effects of residual impacts (after mitigation) | If a Barn Owl Mitigation Plan is followed, the effects would be negligible. |

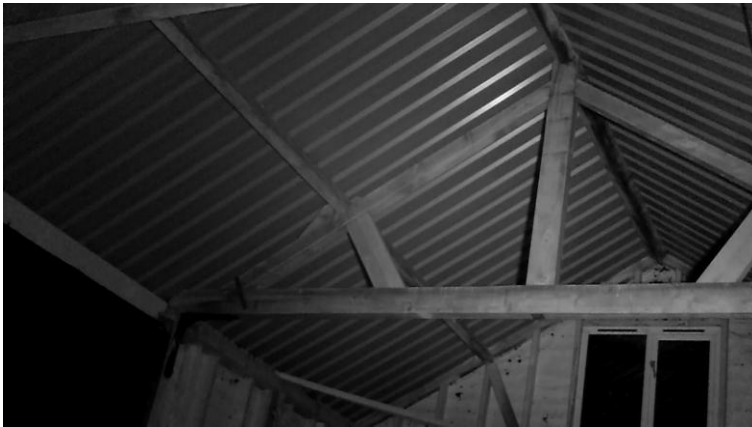
Figure 8: Darkest point of the interior.

IR at the darkest point:

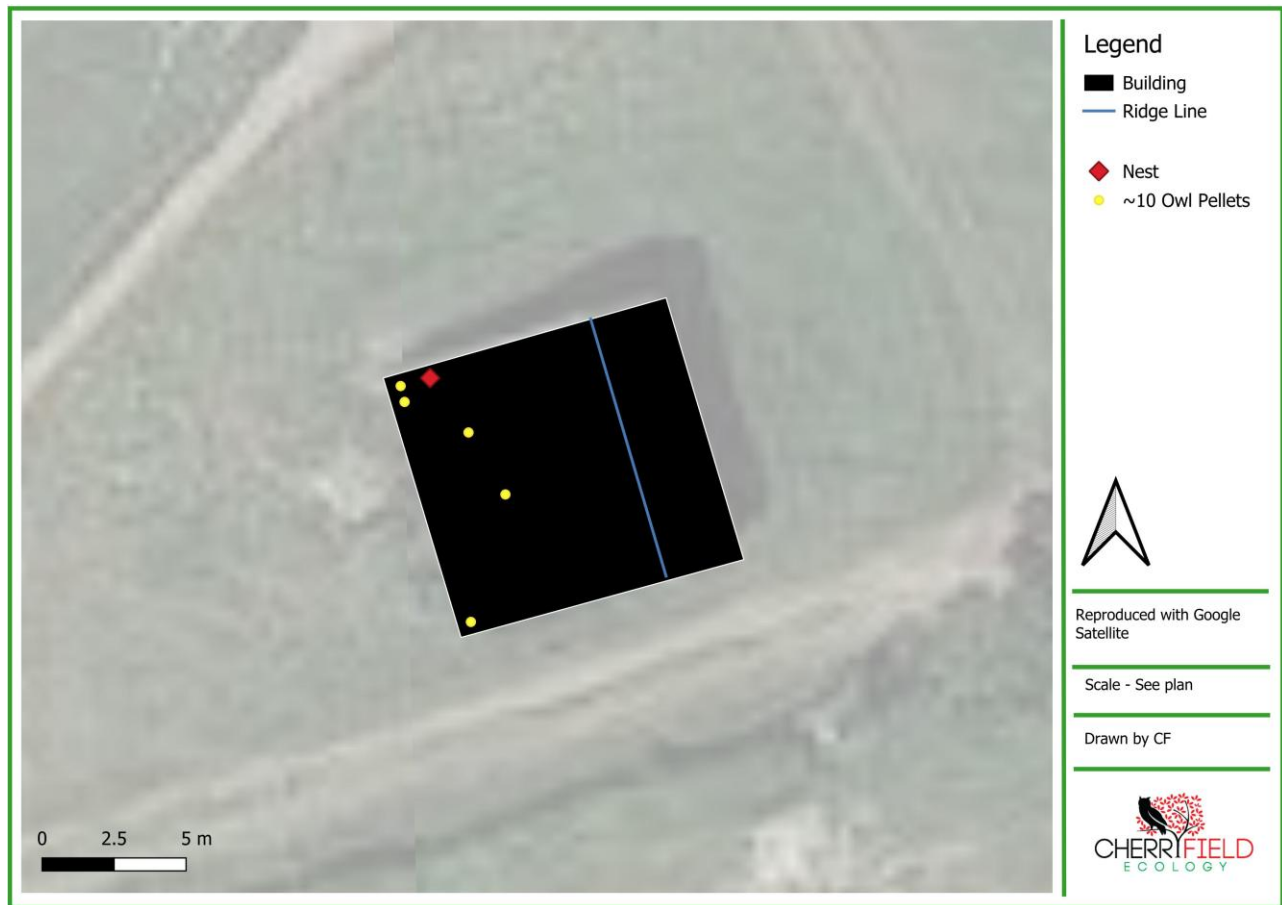
Figure 11: PRA and EBS Site Plan

| Surveyor | Building, Tree or Structure | Dates, Times and Survey Type | Bat Activity Observed |
|---|---|---|---|
| CF | B1 | 20:42 to 22:27<br>SS:20:57 | A single common pipistrelle was observed commuting along the hedgerow to the Southeast at 21:53. |
| SD | B1 | 20:42 to 22:27<br>SS:20:57 | Two noctules were heard passing but not seen. These occurred at 21:29 and 21:54. |

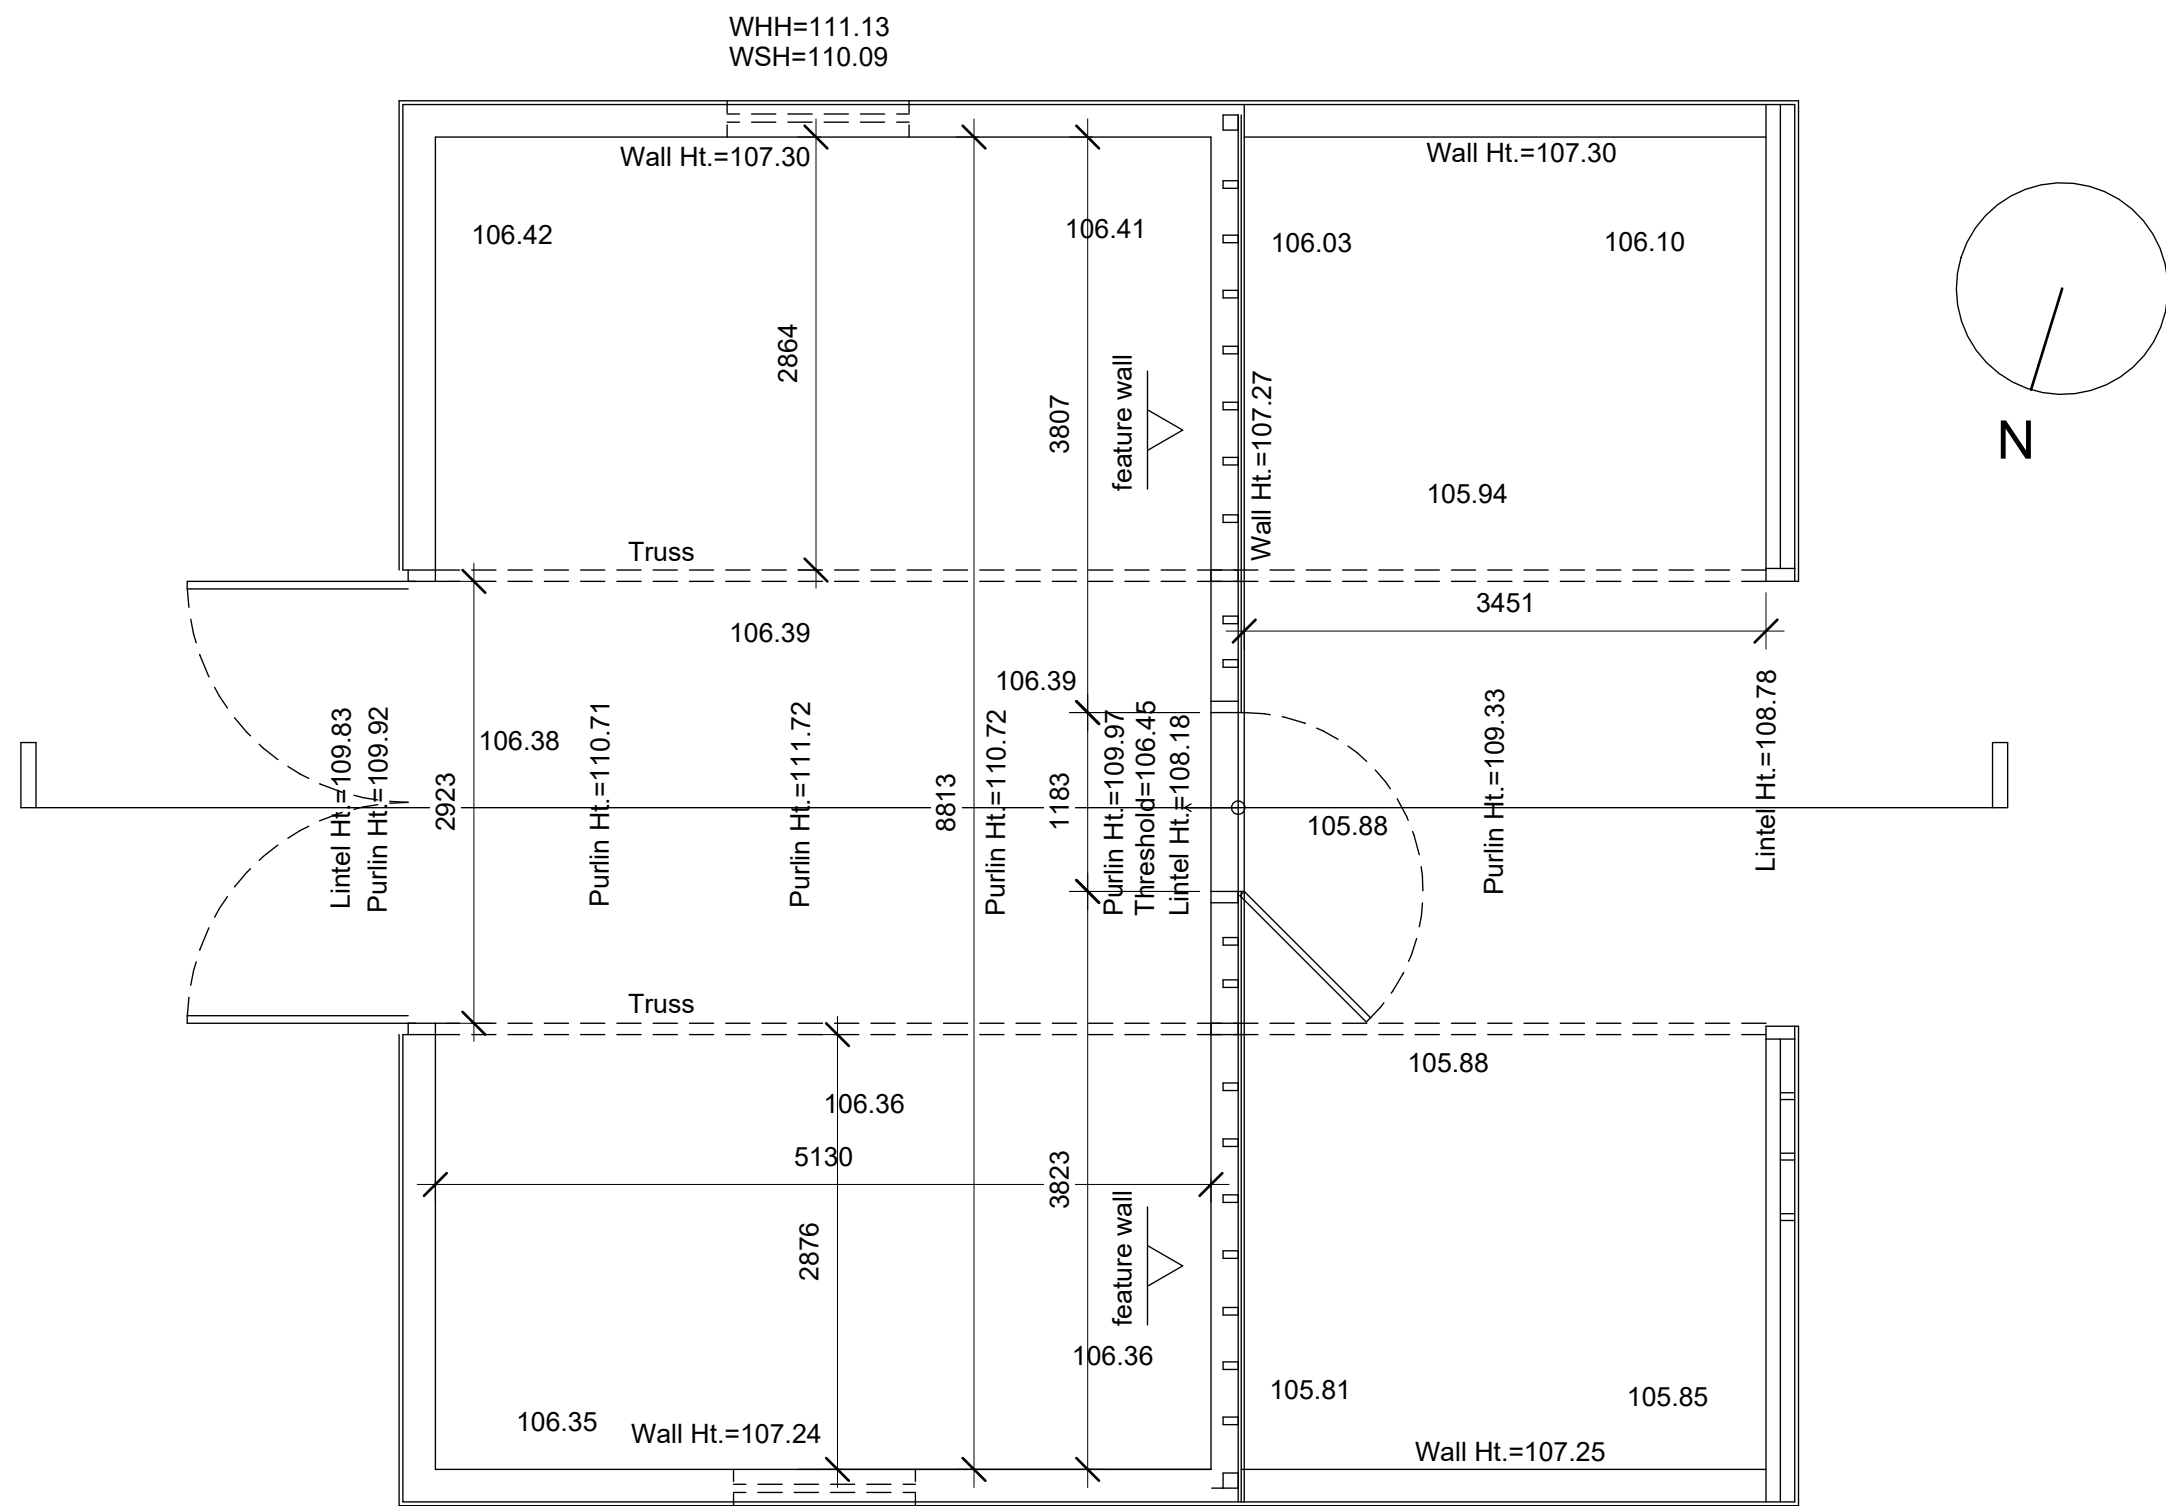
Floor plan  
Footprint = 86.7m<sup>2</sup>  
Gross internal area = 79.4m<sup>2</sup>
