# ARBORICULTURAL IMPACT ASSESSMENT & METHOD STATEMENT

Radcliffe House, Hitchin

April 2026

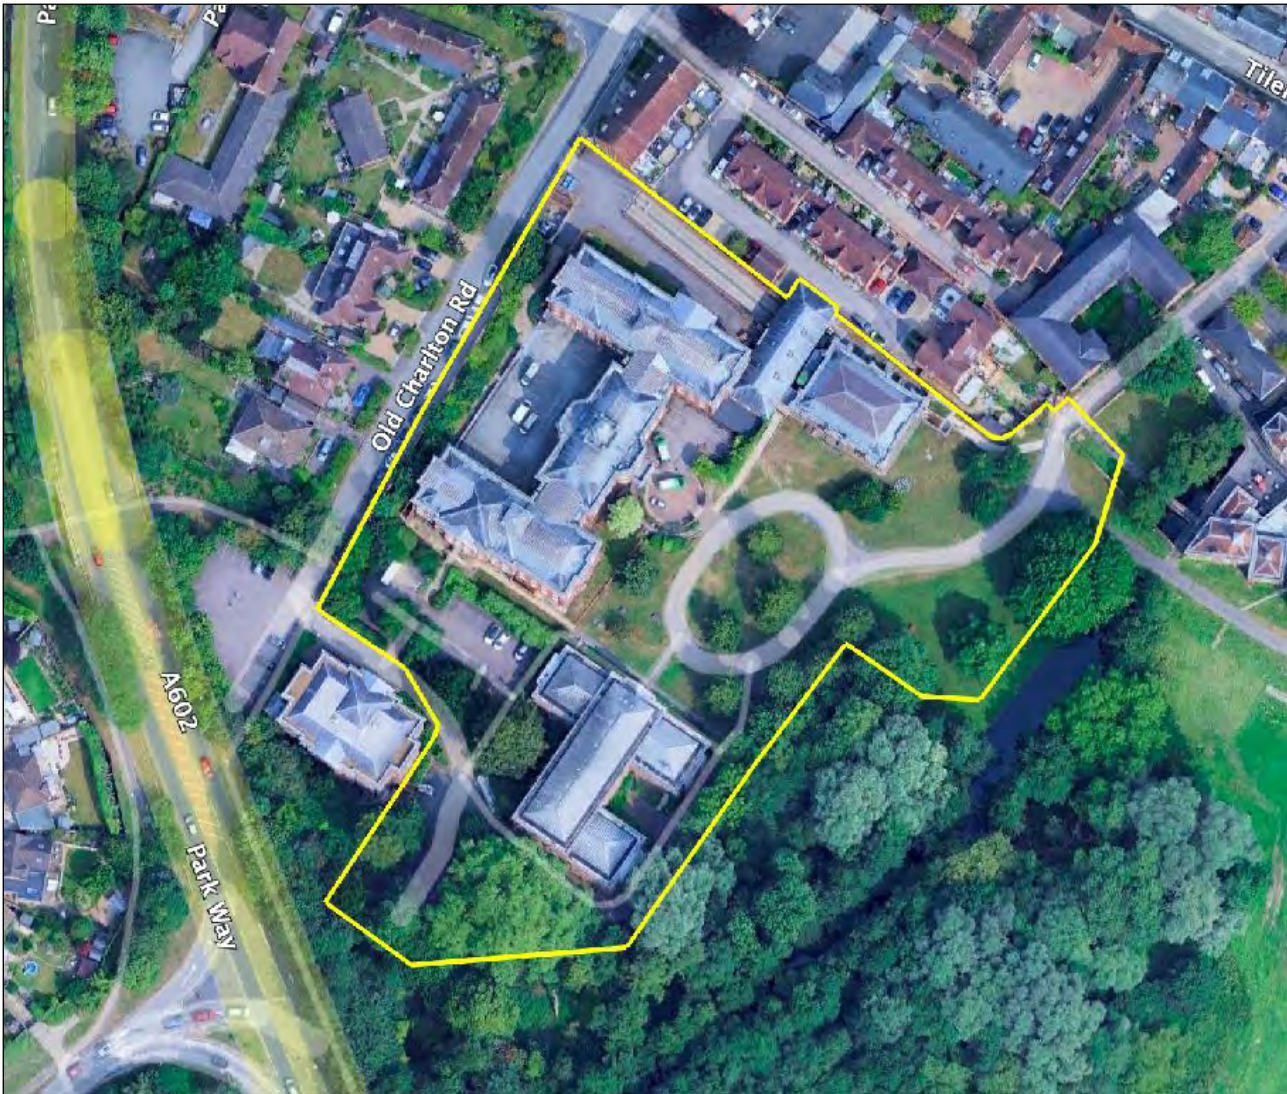
- 2.2. The approximate tree survey area is shown in Figure 1, although the definitive site red line boundary is shown on the separate Landscape General Arrangement Plan MAM-HPL-050\_RH\_HTA-L\_DR\_1100.

Figure 1: Approximate tree survey area edged yellow.

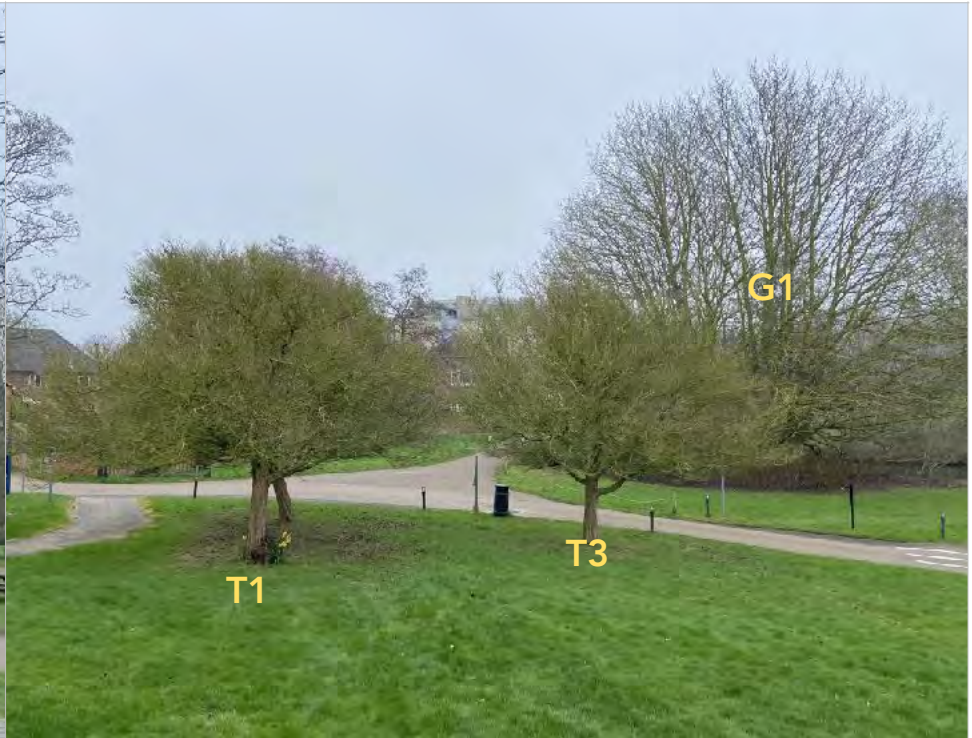
IMAGE 3: The three cockspur thorns, T1 - T3, looking east.

| Ref | Species | On/off site | Height (m) | No. of stems | Est diam? | Calc. / actual stem dia. (mm) | Crown radii (m) N-E-S-W | Av. low crown height (m) | 1st branch ht (m) | 1st branch dir. | Life stage | General observations | Health & vitality | Structural condition | Estimated remaining contribution (Years) | BS 5837 Category | RPA radius (m) | RPA m <sup>2</sup> |
|---|---|---|---|---|---|---|---|---|---|---|---|---|---|---|---|---|---|---|
| T1* | Cockspur thorn | On | 5.5 | 1 | - | 300 | 4.5-4.0-4.0-4.0 | 2.0 | 1.5 | SE | M | No significant defects. | Good | Good | 40+ | B1 | 3.6 | 41 |
| T2* | Cockspur thorn | On | 6.0 | 1 | - | 350 | 5.5-4.5-4.5-3.5 | 2.0 | 1.5 | S | M | No significant defects. | Good | Good | 40+ | B1 | 4.2 | 55 |
| T3* | Cockspur thorn | On | 6.0 | 1 | - | 300 | 4.0-4.5-4.5-4.5 | 2.0 | 1.5 | S | M | No significant defects. | Good | Good | 40+ | B1 | 3.6 | 41 |

- 6.2. Only cockspur thorn, dogwood, and viburnum group G2 (B2) and small, clipped yew hedge H4 (B2) will be removed.
- 6.3. Two of the three cockspur thorns, T1 and T2, in the northeast of the site, will need to be pruned back significantly to allow access along the new private driveway and within the parking area. This is because the crowns of the trees are at only approximately 2m height from the ground. Being a species of hawthorn, although the pruning is significant, the pruned branches would re-grow and so can be maintained at a smaller shape. It should be noted that these trees, like most within the site, are not visible from a public place and so have low public visual amenity value.

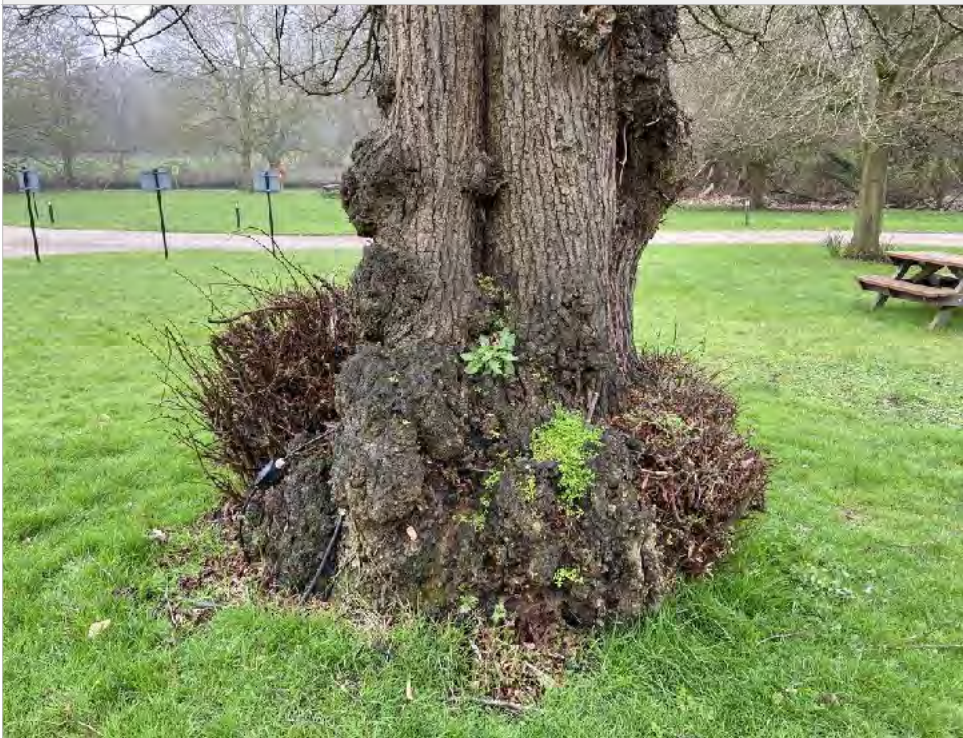
- 4.4. Common lime T7 is located within the oval lawn to the southeast of Radcliffe House. It is a late-mature, pollarded tree with old pruning wounds and likely a column of decay in the trunk. The tree exhibits branch dieback and deadwood, with woodpecker activity on the decayed areas of the upper trunk. While the tree provides important decay habitats, the fungus *Kretzschmaria deusta* is evident on the prominent basal burrs. There is also audible decay and saprophytic fungal bodies on the lower trunk. The condition of the tree, in close proximity to people, reduces the quality to moderate, as it is presumed that its life expectancy is reduced and that further management pruning may be required in the future. As such, internal decay investigation should be carried out to assess the extent of decay and to estimate the safety factor of the tree, so that management recommendations can be made.

IMAGE 4: Detail of the base of the trunk of lime tree T7, which has fungal fruiting bodies of Kretzschamria deusta and requires decay investigation.

| Ref | Species | On/off site | Height (m) | No. of stems | Est diam? | Calc. / actual stem dia. (mm) | Crown radii (m) N-E-S-W | Av. low crown height (m) | 1st branch ht (m) | 1st branch dir. | Life stage | General observations | Health & vitality | Structural condition | Estimated remaining contribution (Years) | BS 5837 Category | RPA radius (m) | RPA m <sup>2</sup> |
|---|---|---|---|---|---|---|---|---|---|---|---|---|---|---|---|---|---|---|
| T7* | Lime (Common) | On | 14.0 | 1 | - | 1020 | 4.0-5.0-5.5-4.0 | 2.5 | 2.5 | - | LM | Pollarded parkland tree which pre-dates the existing buildings, with old pruning wounds, and likely column of decay in trunk. <i>Kretzschmaria deusta</i> fungal fruiting bodies on prominent basal burrs to NW and N. Basal shoots. Audible decay and saprophytic fungal bodies on dysfunctional bark above <i>K. deusta</i> zone. Branch dieback and deadwood. Woodpecker activity on decayed areas of upper trunk. Carry out internal decay investigation and assess safety factor of tree. | Fair | Fair | 20+ | B1 | 12.2 | 471 |

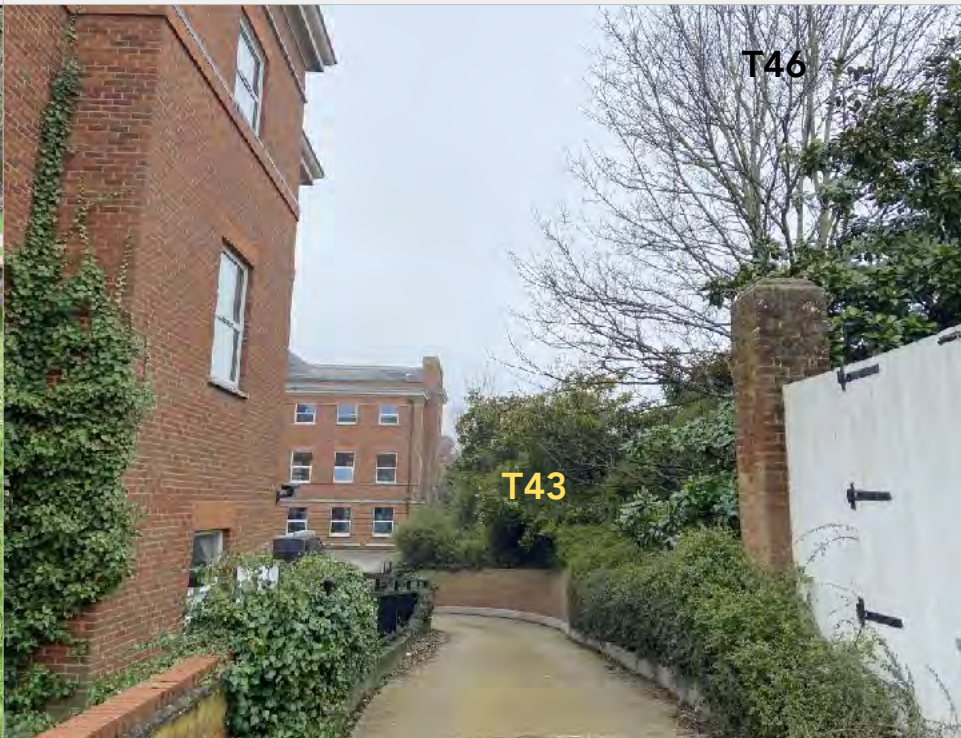
IMAGE 5: View of the existing access ramp and retaining wall at the northern access from Old Charlton Road, looking southwest.

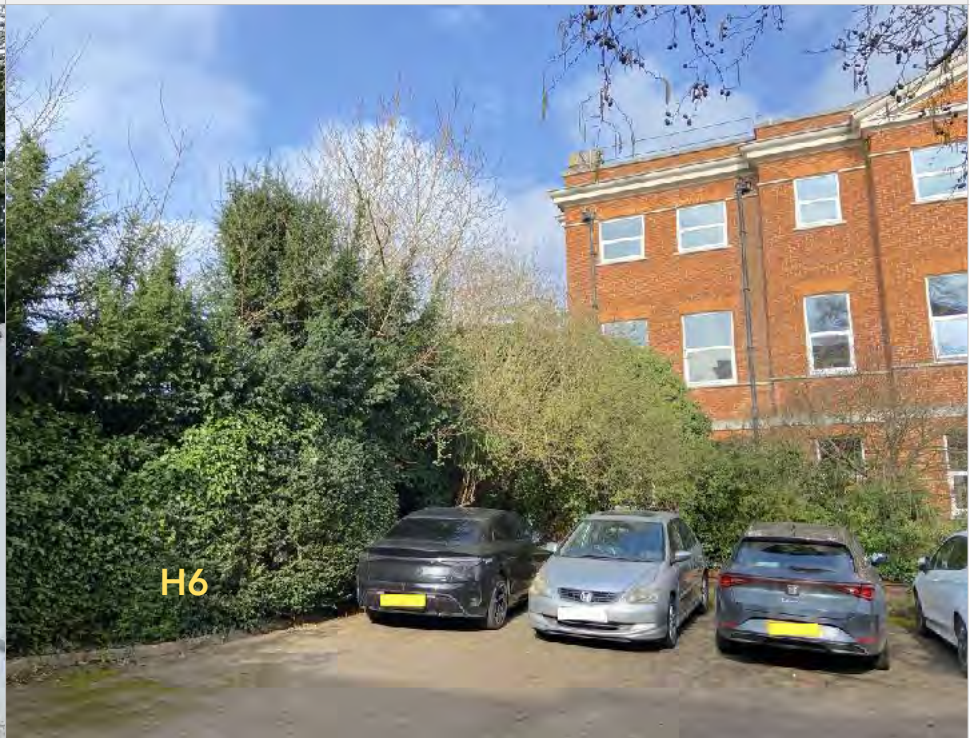
IMAGE 6: The existing car park to the south of Radcliffe House, looking north.
