**THE OLD FORGE,  
27A PARK STREET,  
BALDOCK,  
HERTFORDSHIRE**

**Archaeological Monitoring and  
Recording**

**Ref: MA 417  
Planning ref: 21/02872/FP**

## Archaeological Report for Monitoring and Recording

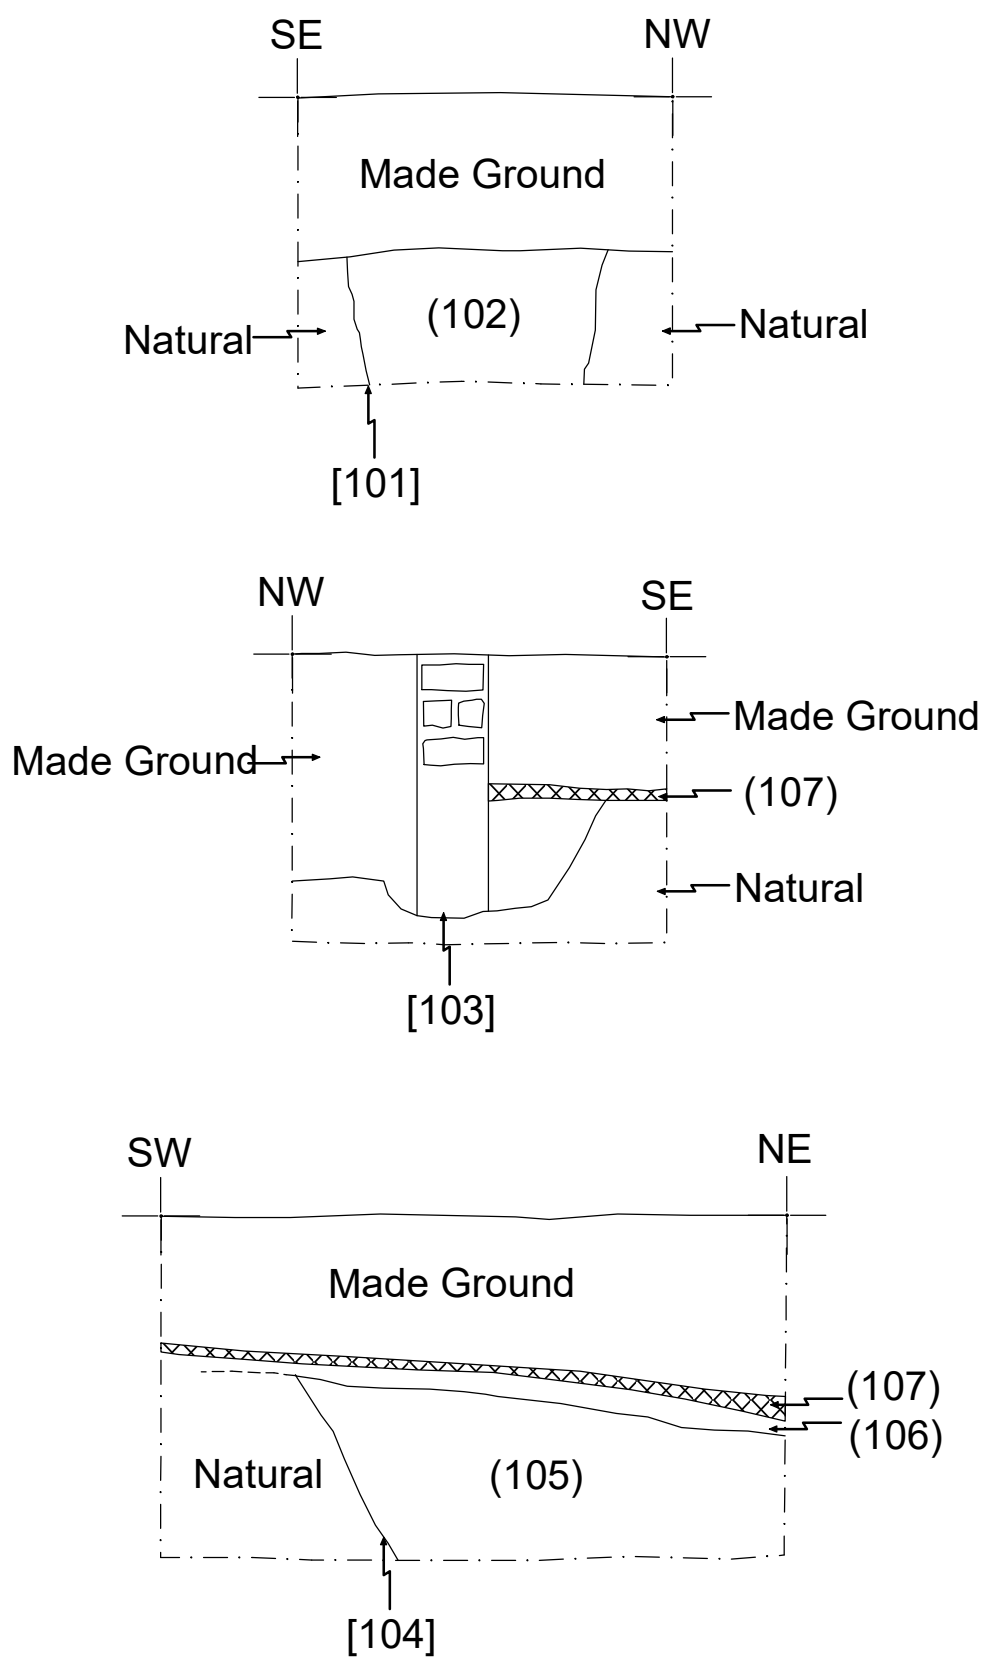
Figure 2

**4.3** All ground reduction comprising footings and oversight were monitored during the course of the development (Figure 2).

**4.7** Four footing trenches were excavated in the area forming the rectangular footprint of the proposed structure. The footings aligned north-west to south-east and north-east to south-west respectively. They measured 5.5m and 15m in length respectively and 0.7m in width and reached a depth of between 0.95 and 1.2m (Figure 2).

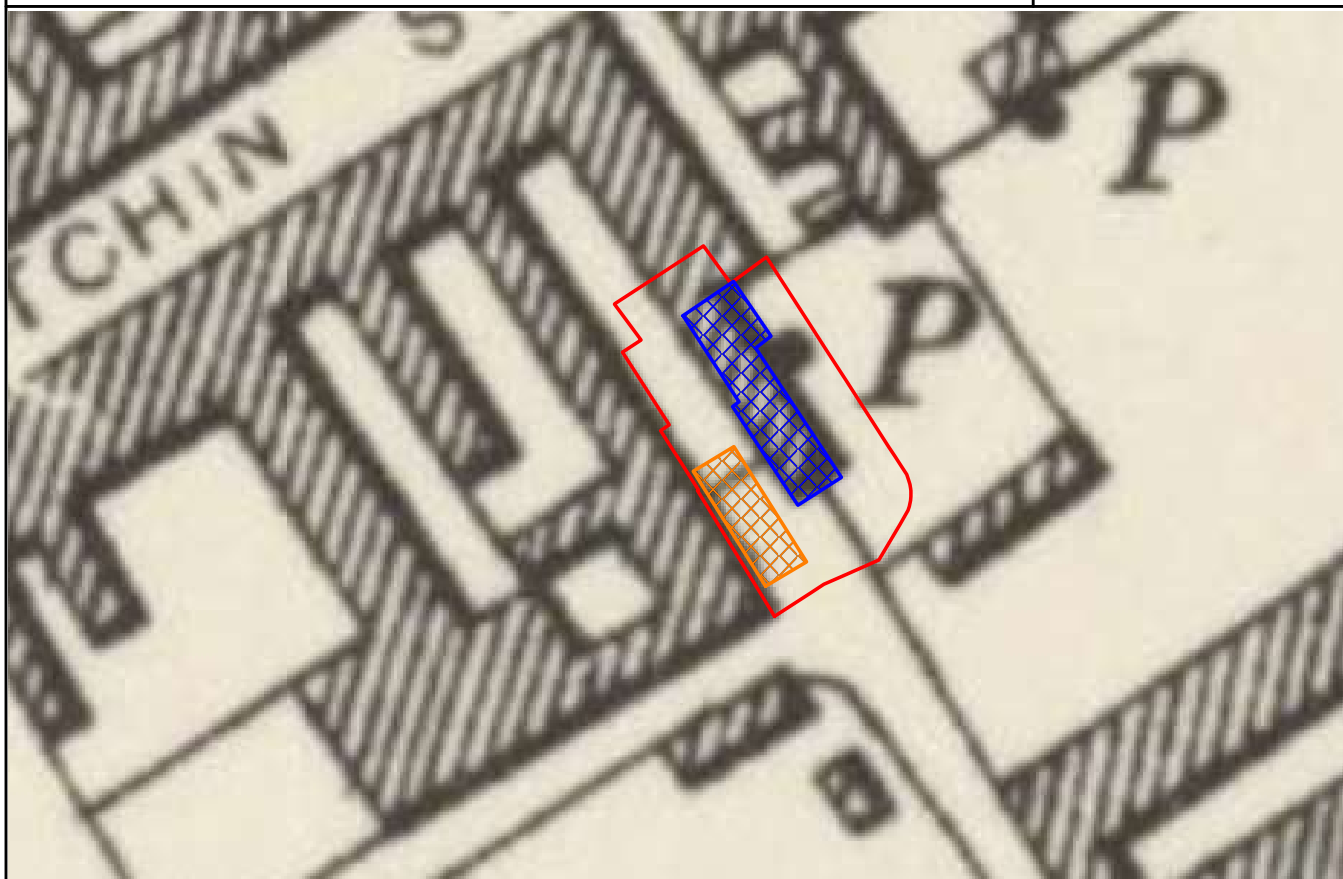
**5.9** The layout of the plot appears to be unchanged until 1899 which shows the demolition of the smaller building and the construction of a partition (Figure 5). As such, the demolition of the earlier structure may have been the cause of the ground clearance observed in the stratigraphy. The division of the plot also coincides with the presence of [103] and may also explain the difference in depths of the overburden on either side (Figure 3; Plate 6).

Ordnance Survey Map, 25-Inch Published 1899

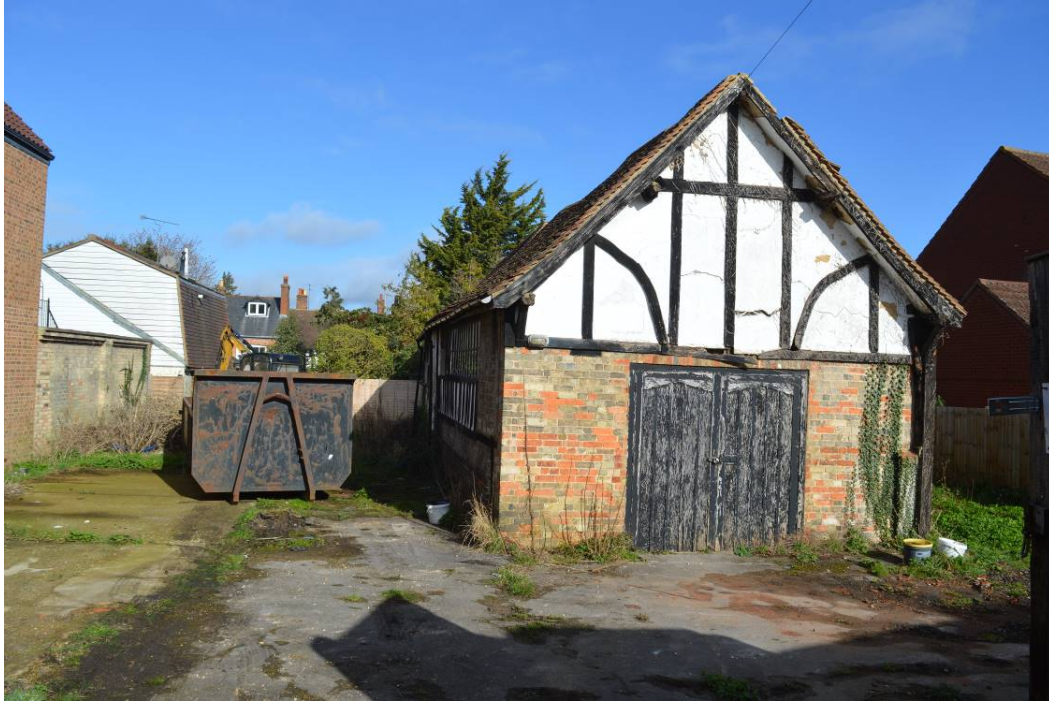
Plate 1: Site – Looking North.

**4.1** The site at Baldock was formed of a roughly rectangular plot of land with a single large building and smaller outbuilding. The site was otherwise composed of a mixture of concrete hardstanding and overgrown vegetation and was bounded by wooden fencing and a combination of brick walls and brick built buildings. The plot was also noted to slope downwards from Park Street to the North (Plate 1; Figure 2).

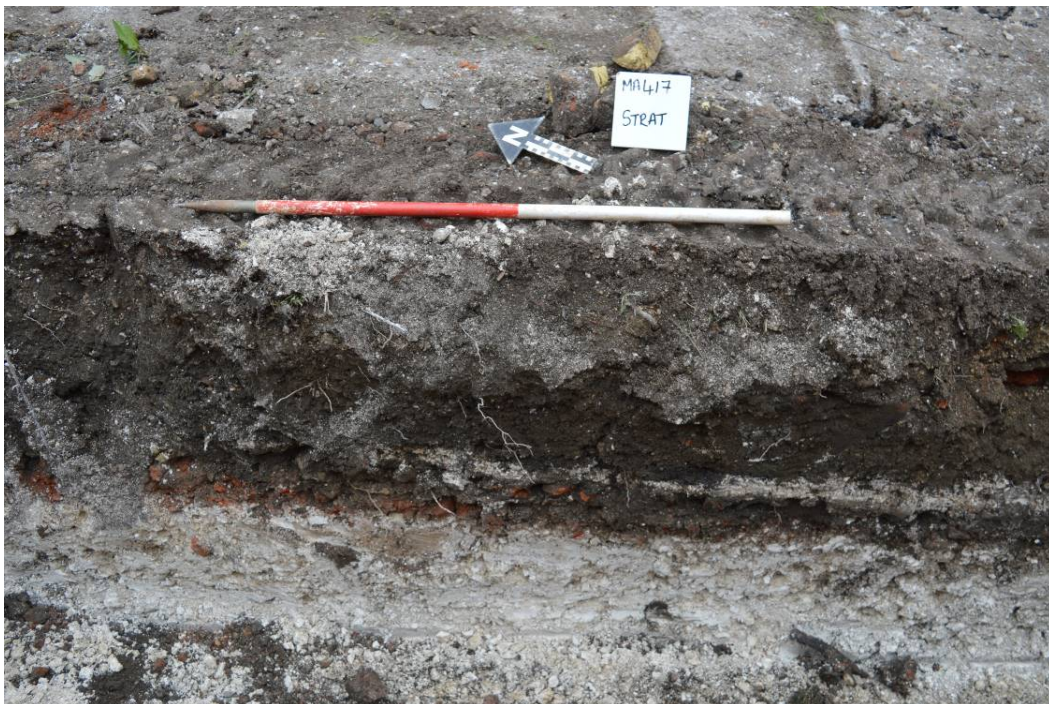
Plate 2: Stratigraphy – Looking North-East.

**4.2** The observed stratigraphy was similar across the areas of groundwork, consisting of various layers of mixed clayey silt with modern and late post-medieval debris interpreted as made ground, between 0.6 and 1m in depth, overlying a natural of compact chalk. The natural was observed in all areas of ground reduction but appears to slope downwards to the north-west of the site, towards Hitchin Street (Plate 2).

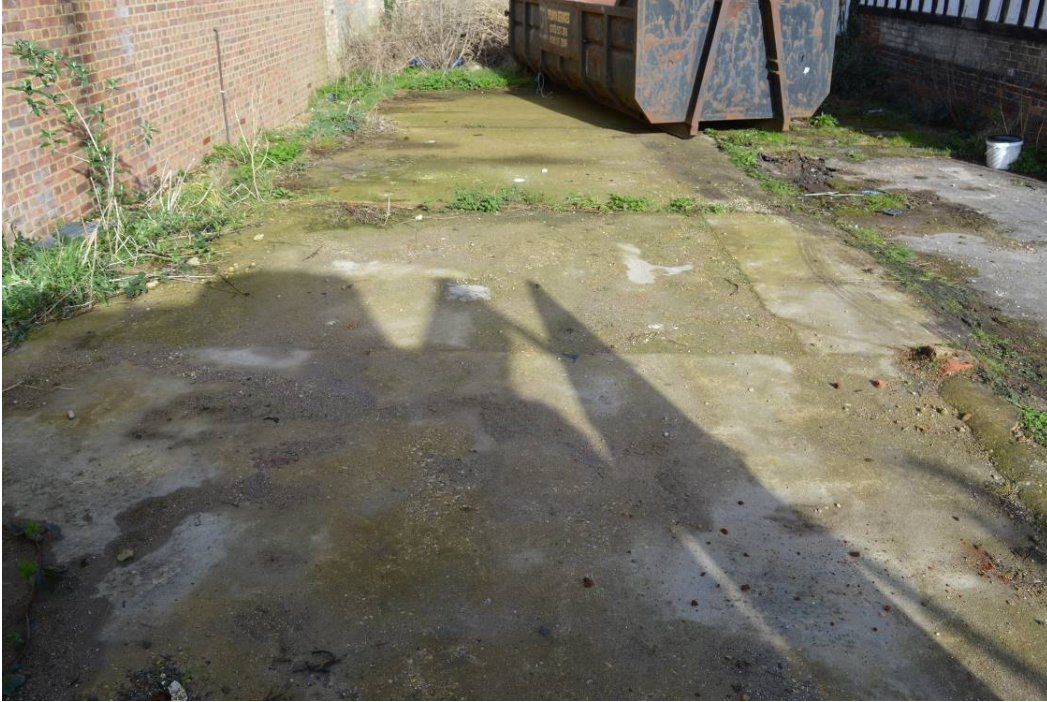
Plate 3: Concrete Hardstanding – Looking North-West.

**4.5** Prior to the excavation of the footing trenches the concrete slab from the garages and associated hardstanding were broken and removed under archaeological supervision. The removal of the hardstanding revealed that the concrete rested directly onto made ground (Plates 3 & 4).

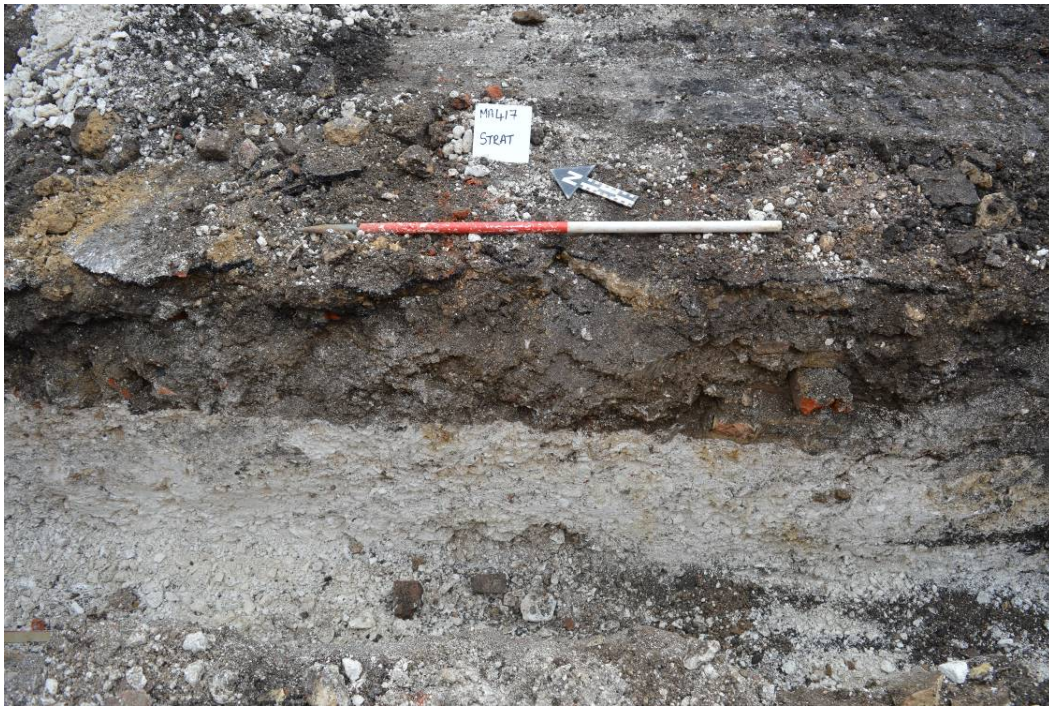
Plate 5: Stratigraphy to show truncation of natural – Looking North-East.

**4.11** The overburden overlay the natural substrate of compacted chalk, which was noted to slope downwards to the north-western end of the site. In some areas of the footing trenches, particularly the south-eastern corner, it appeared that the natural had been truncated prior to the accumulation of (107) (Plate 5).

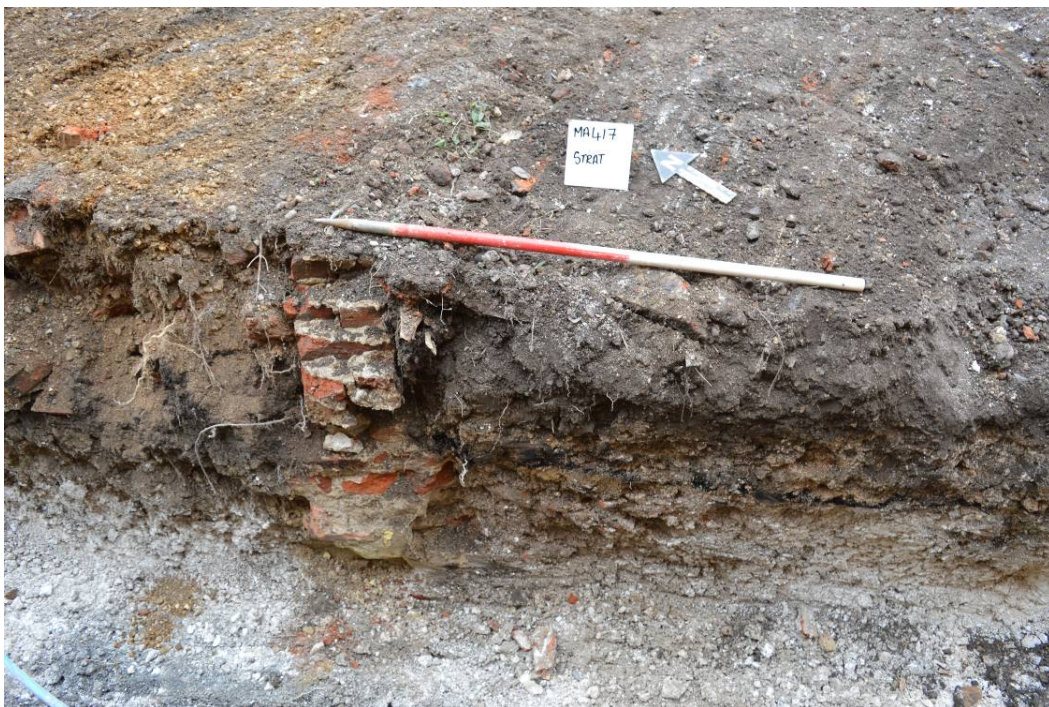
- The latest feature observed comprised the wall foundation of an earlier structure, [103]. The feature was on a north-west to south-east orientation and was composed of frogged bricks which appeared to be in an English bond pattern, bonded with cement (Plate 6; Figure 3). The base of the wall foundation was cut into the natural chalk, however does not appear to be cut through the overburden.

Plate 6: [103] – Looking North-East.

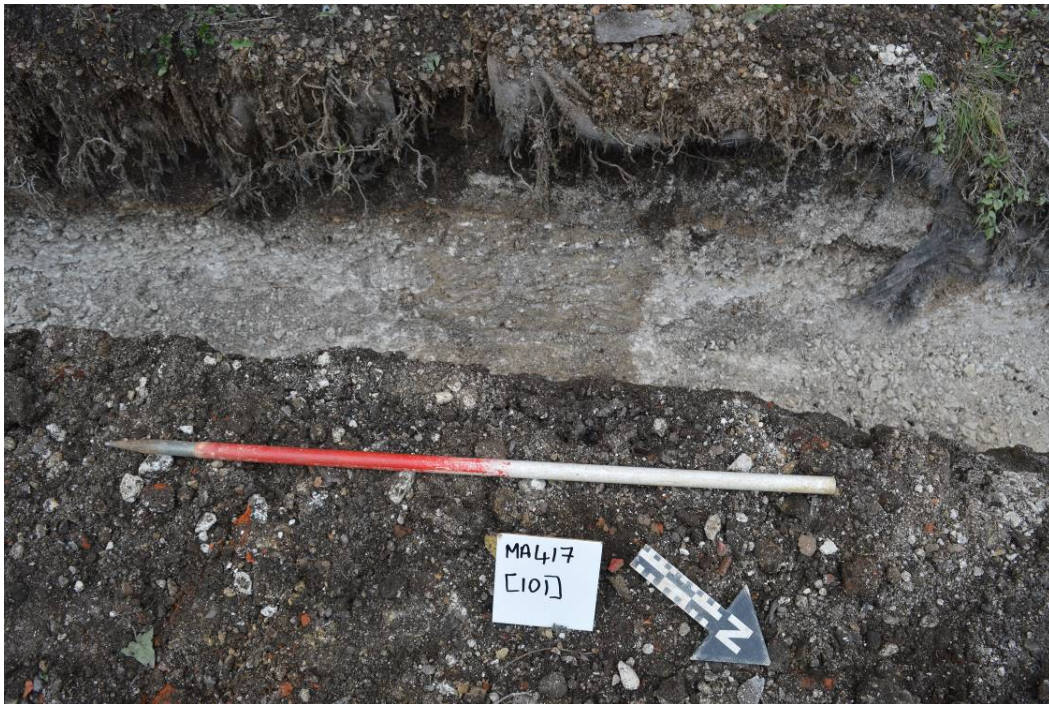
- Predating this was feature [101] which was located broadly on the western side of the footprint, below the overburden and extending into the western baulk. It was unclear in plan but a subcircular edge was visible indicating a possible small pit feature. The feature measured over 0.6m length, 0.7m width and over 0.4m depth with vertical sides and an unclear base (Plate 7; Figure 3). The feature contained a single fill (102) comprising a moderately compacted pale yellowish grey chalky marly clay. The fill contained small chalk inclusions but was otherwise sterile and no finds were observed.

Plate 7: [101] – Looking South-West.

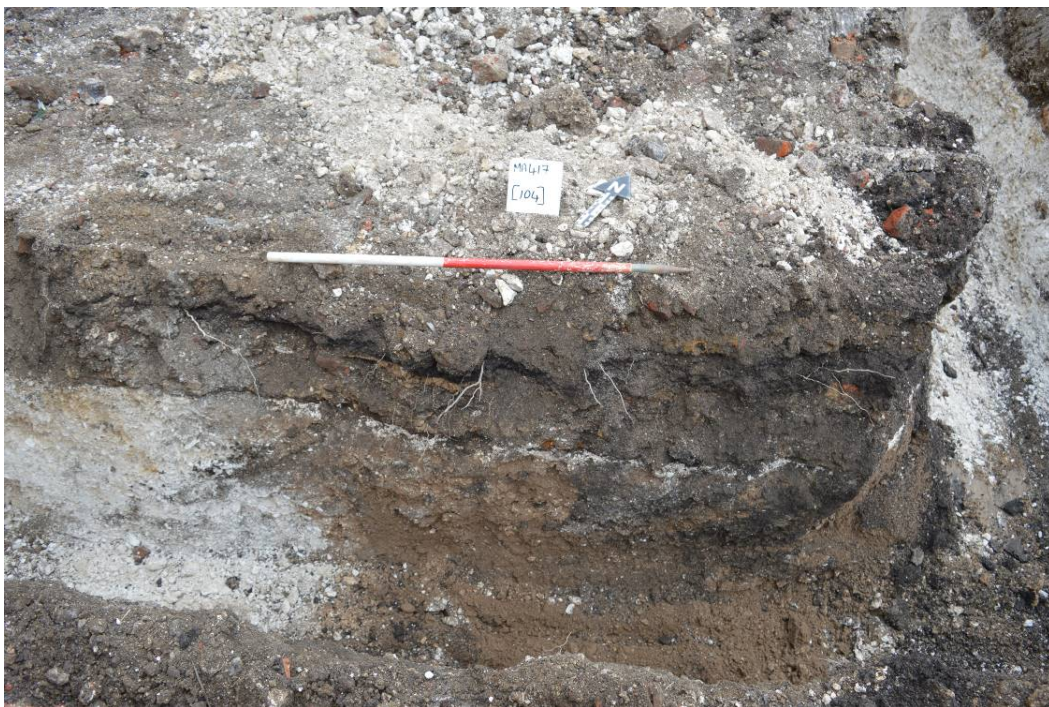
- [104] was also observed below the overburden, in the south-eastern corner of the footprint, extending into the south-eastern baulk. It was subcircular in plan and measured over 2.0m in length, over 0.7m in width and over 0.5m depth, with steep sloping sides. The base was not reached in the footing trench (Plate 7; Figure 3). [104] contained a single fill (105) comprising a moderately compacted mid yellowish brown clayey silt. The fill contained small chalk inclusions and occasional chalk flecks but was otherwise sterile and no finds were observed.

Plate 8: [104] Section – Looking North-West.

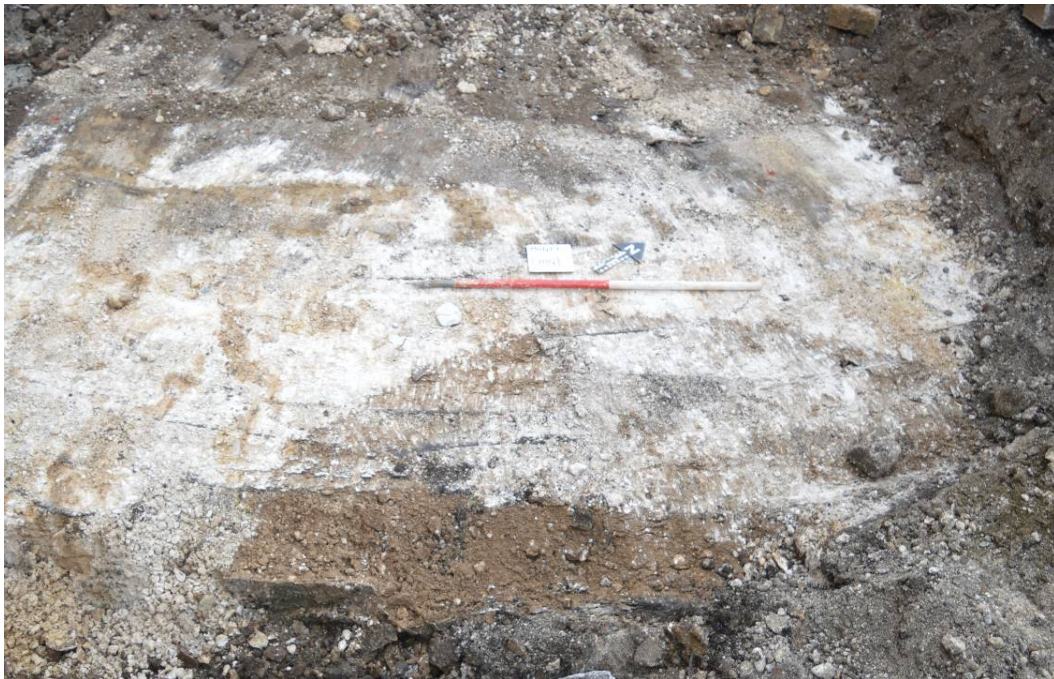
**4.15** At the southern-most end of the footprint the natural was impacted by approximately 0.2m by the ground reduction. This revealed the continuation of pit [104], confirming more of its shape in plan (Plate 8).

Plate 9: [104] Plan – Looking North-West.

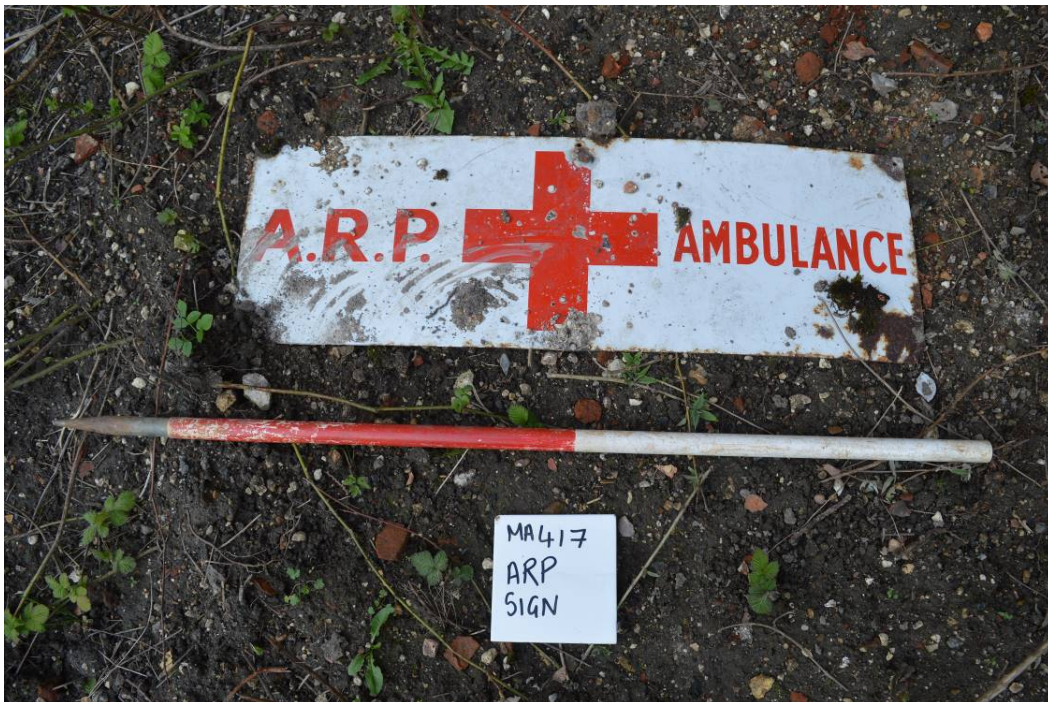
Plate 10: ARP Sign (Front).

**4.17** During the groundworks a single find was noted in the overgrowth on the north-eastern side of the existing building. The find was identified as an Air Raid Precaution (ARP) Ambulance sign of probable World War II date. It measured 0.915m in length by 0.3m width and was composed of post box red letters on white enamel. The sign appeared to be made of sheet metal with six pierced holes for fixing and was in a relatively good condition with only small areas of rusting (Plates 9 & 10).
