Report prepared for: Jason Kitchener

For the Site of: The Old Forge, Park Street, Baldock, Hertfordshire, SG7 6DY

# Emergence and Activity Bat Survey (EBS)

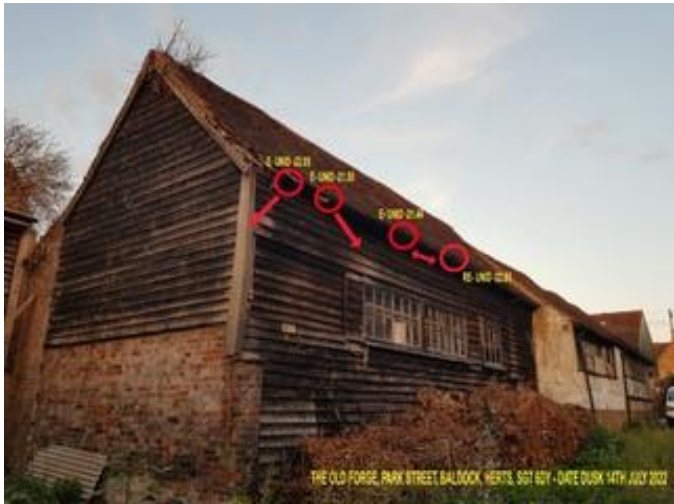
| Surveyor | Building, Tree or Structure | Dates, Times and Survey Type | Bat Activity Observed |
|---|---|---|---|
| PH | B1 | 14/07/2022<br>21:00 to 22:45<br>Dusk Emergence | <p>Common pipistrelle (CP) <i>Pipistrellus pipistrellus</i> was observed at 21:46 emerging from under the eaves at the rear of B1 on the southwest elevation, before entering again under the eaves a little further down.</p> <p>CP was further observed at 21:56, flying from the site entrance along the southwestern elevation of B1 and around the rear of B1.</p> <p>At 21:58 a Brown long-eared (BLE) <i>Plecotus auritus</i> was observed emerging from under the eaves at the rear of B1 on the southwest elevation and flying west.</p> <p>At 22:05 a second BLE was observed emerging from the rear corner of B1 on the southwest elevation and flying south.</p> <p>Figure 2: Locations of emergence and re-entry</p> |

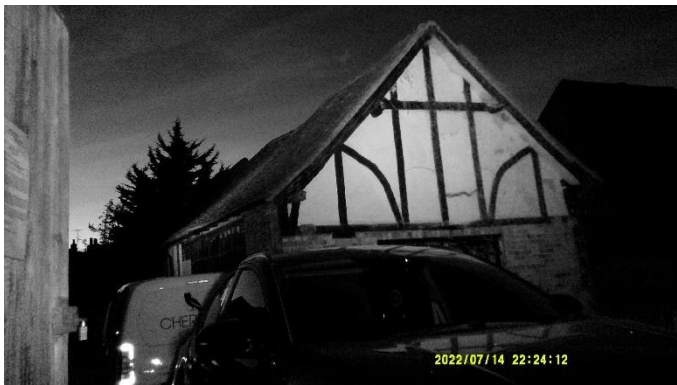
| | | Dusk Emergence | <p>Two distant passes of Leisler (LEI) <i>Nyctalus leisleri</i> were heard but not seen at 22:16 and 22:22.</p> <p>Figure 3: View of infrared camera</p> |

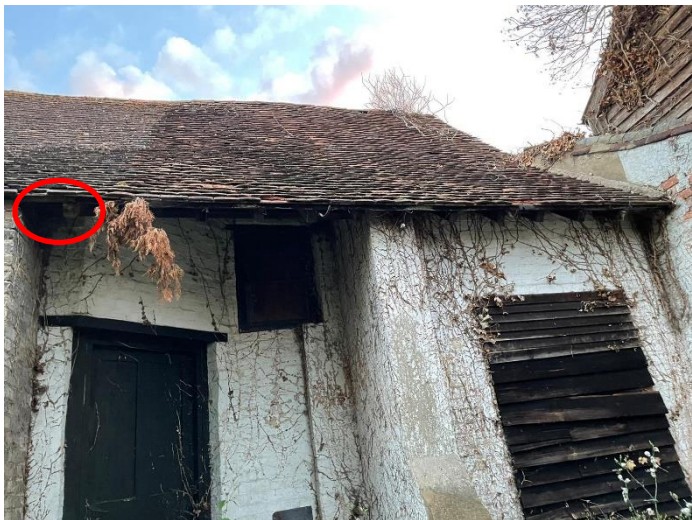
| DR | B1 | <p>14/07/2022<br/>21:00 to 22:45<br/>Dusk Emergence</p> | <p>At 21:44 a CP was observed emerging from the eaves at the rear of B1 on the northeastern elevation, circled round and re-entered at the same spot, before emerging again at 21:45.</p> <p>A further pass of CP was heard at 21:56, flying from the rear of B1 and to the west, likely the same bat that surveyor PH recorded flying round the rear of B1.</p> <p>Figure 4: Location of CP emergence</p> |

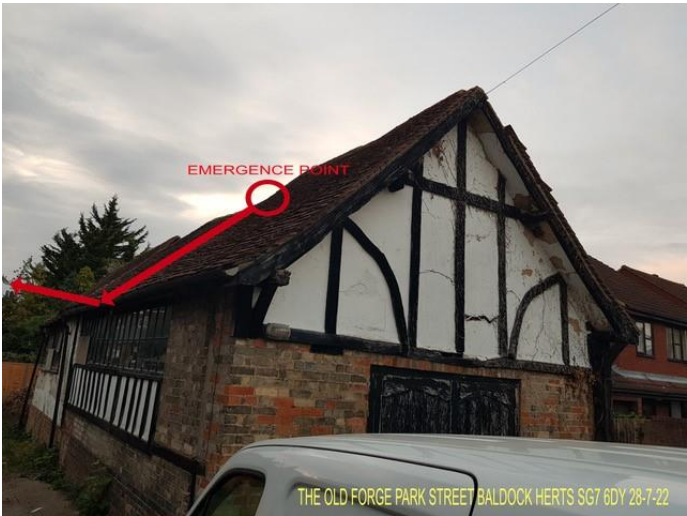
| PH | B1 | <p>28/07/2022<br/>20:43 to 22:28<br/>Dusk Emergence</p> | <p>A CP was observed emerging from under the ridge tiles on the southwest elevation of B1 before flying north.</p> <p>Distant passes of CP were further heard between 21:31 and 21:58.</p> <p>Figure 5: Location of CP emergence</p> |

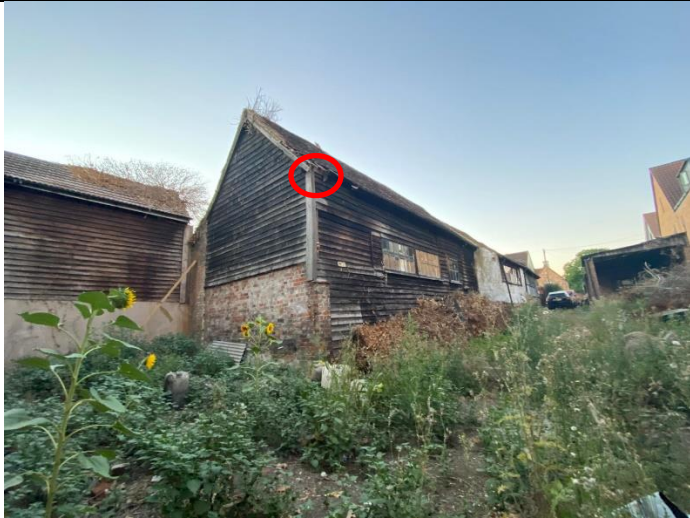
| JP | B1 | <p>12/08/2022<br/>04:09 to 05:54<br/>Pre-Dawn</p> | <p>NOC was heard but not seen at 04:31</p> <p>BLE was observed dawn swarming around the rear corner of B1 on the southwest elevation (the same location of the observed emergence on 14/07/2022), before flying towards the southwest.</p> <p>A distant pass of LEI was heard but not seen at 04:57.</p> |

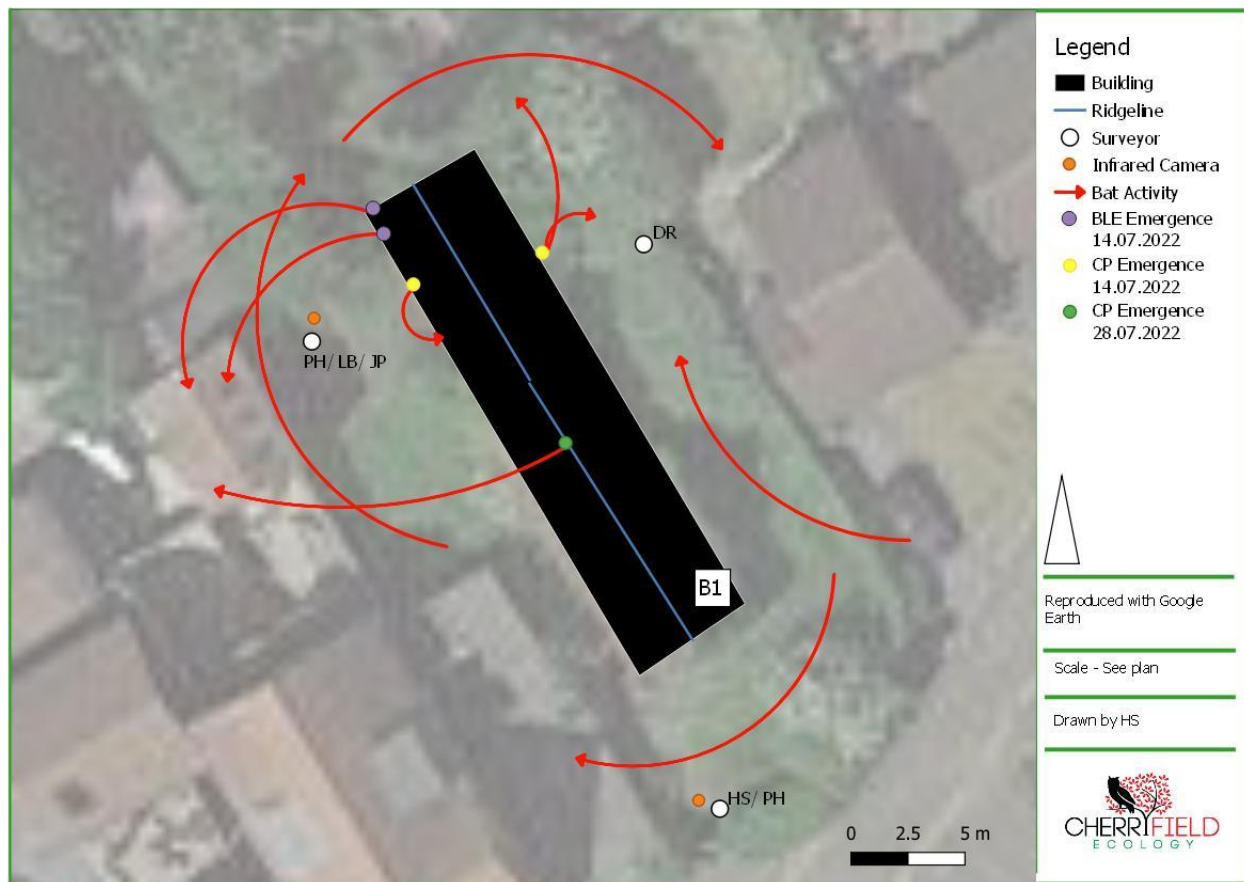
Figure 7: Site Plan

The following section details the structure(s) reference, bats located, evidence located and observed emergence/re-entry (see Figure 7 for Site Plan).

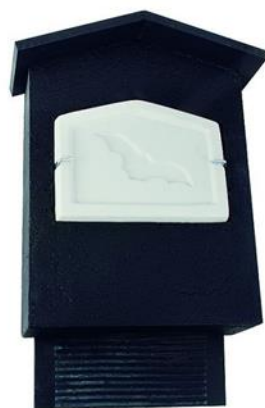
Figure 8: Chillon Woodstone Bat Box (British-made)

A minimum of four Chillon Woodstone bat boxes will be hung on the trees or the building at a minimum of 3m from ground level and face south/southwesterly. These boxes are known to be used by Brown Long-Eared bats (BLEB) and crevice-dwelling species.

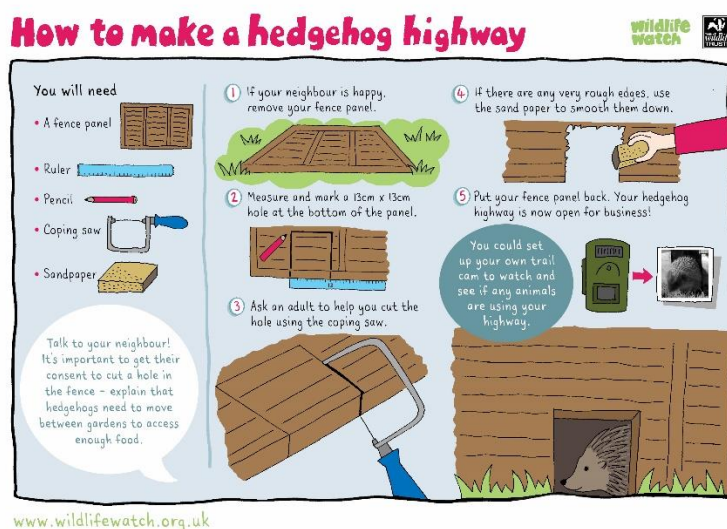
Figure 9: Hedgehog Highway, Source - Wildlife Trust -

- A 13cm-by-13cm is sufficient for any hedgehog to pass through. This will be too small for nearly all pets (Figure 8).
- Remove a brick from the bottom of the wall, creating a 13cm-by-13cm hole.
- Cut a small hole in your fence if there are no gaps.
- Dig a channel underneath your wall, fence or gate.
- Ideally, rather than walls or fences, a hedge will provide foraging, shelter and a route along as well as through the site.
