## **Phase 2 Geo-Environmental Ground Investigation Report**

**Land at St Ippolyts**

**Hitchin**

**Version 1**

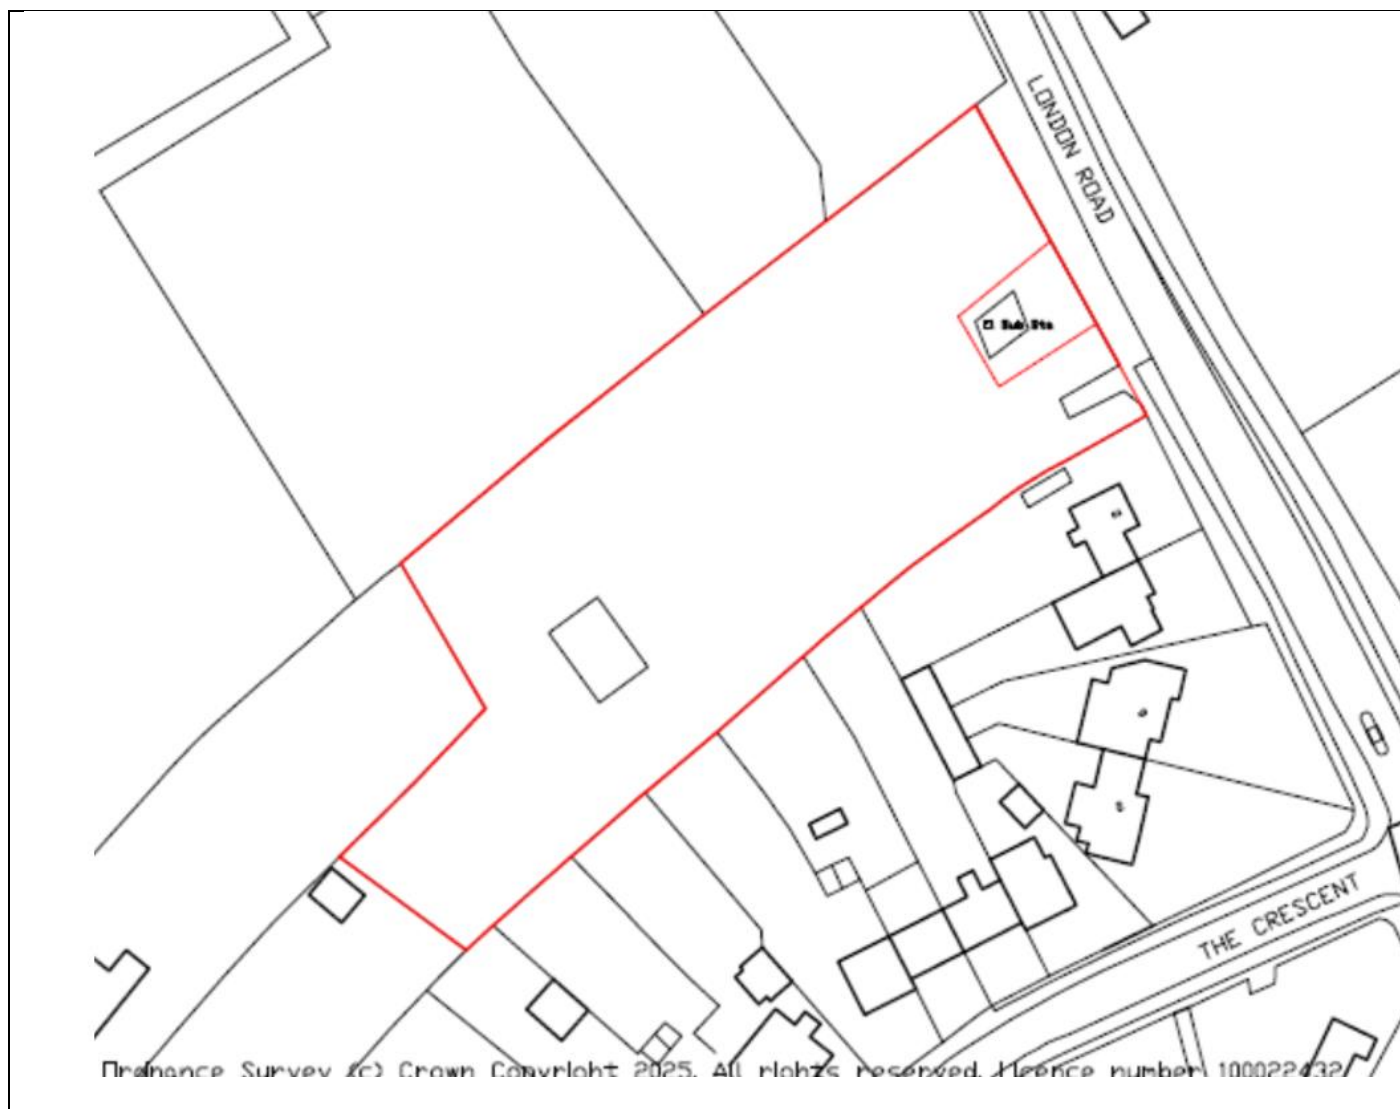
Figure 2

The site is roughly rectangular in shape and has an approximate area of 4,750 square meters. The site lies to the west of London Road, just north of The Crescent.

The site is predominantly rough pasture and has recently been cleared of overgrowth.

An electrical substation is located in the eastern area of the site.

Existing Site Plan

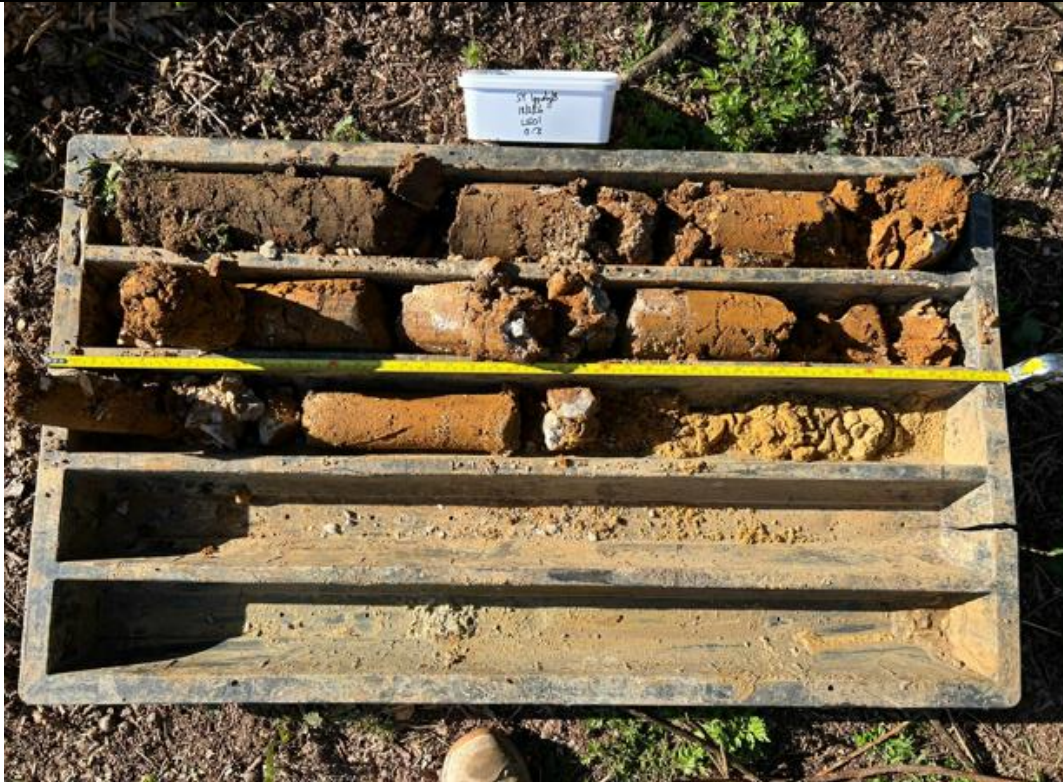
Made Ground was encountered in all of the exploratory boreholes with recorded thicknesses of between 0.30m and 0.40m. The Made Ground generally consists of dark brown sandy clay with flint gravels and occasional brick fragments.

The glaciofluvial deposits generally consist of an approximately 2-3m thick upper unit of orange brown sandy clay with flint gravels overlying pale yellow fine to coarse sand.

Soil core from WS1

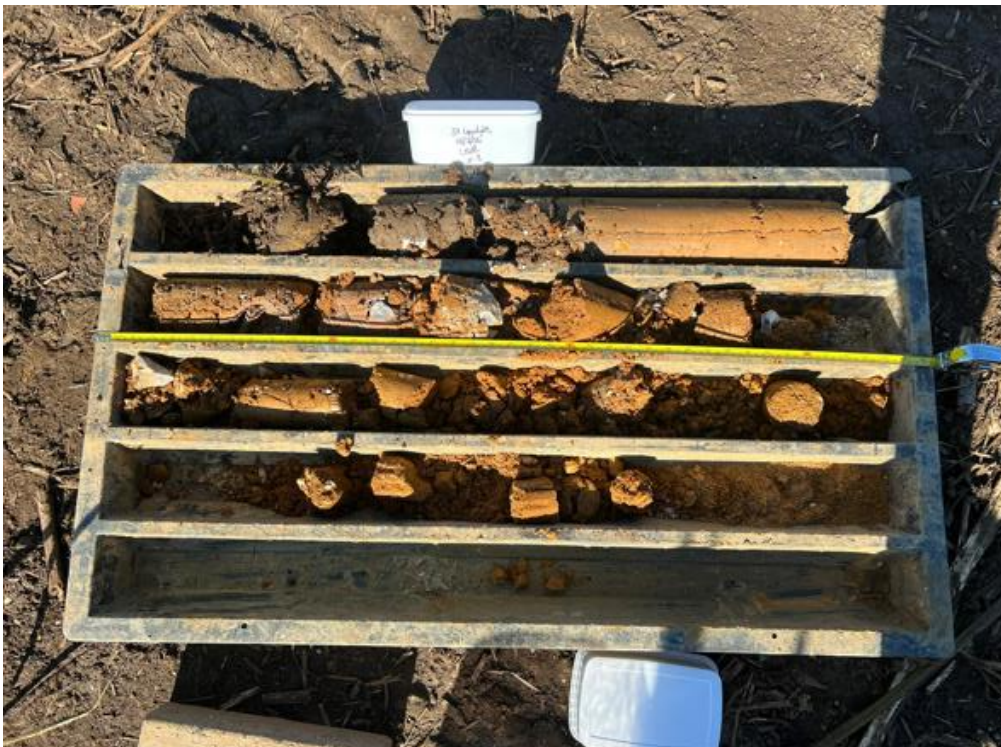
Soil core from WS2

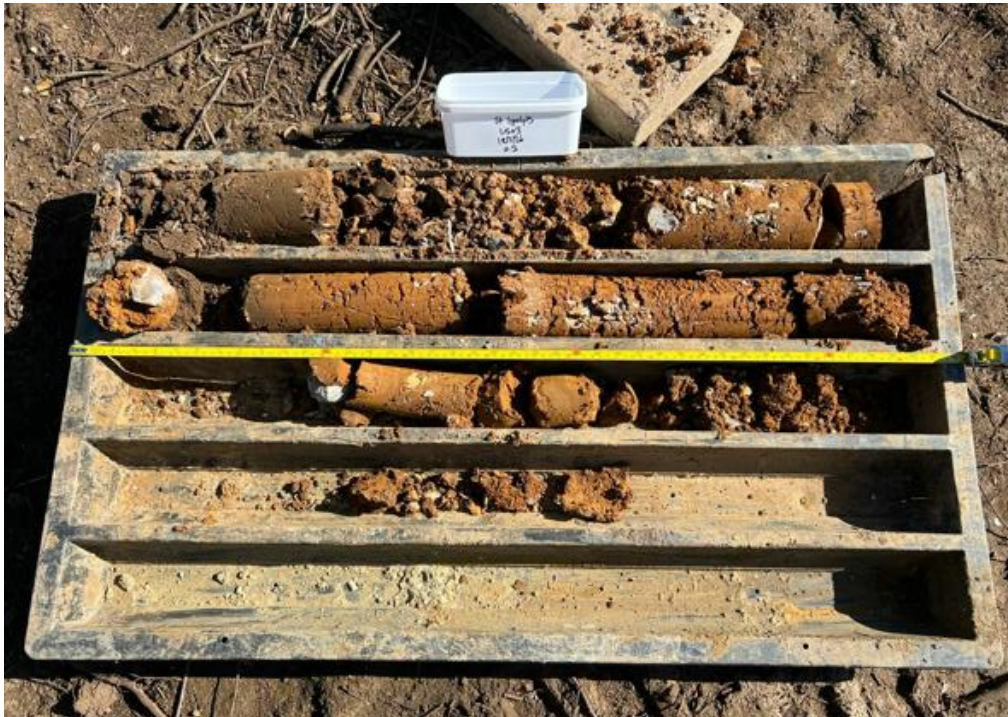
However, a single exceedance of arsenic was detected in WS3 at 0.30m. It is noted that elevated arsenic was detected in all samples. With reference to the British Geological Surveys Normal Background Concentration (NBC) Atlas, the site is indicated to be in an area of elevated arsenic as a result of the weathering of underlying geology and not of any anthropogenic contaminative process. Additionally, the concentration of 40 mg/kg does not exceed the GAC for residential use without plant uptake.

Soil core from WS3

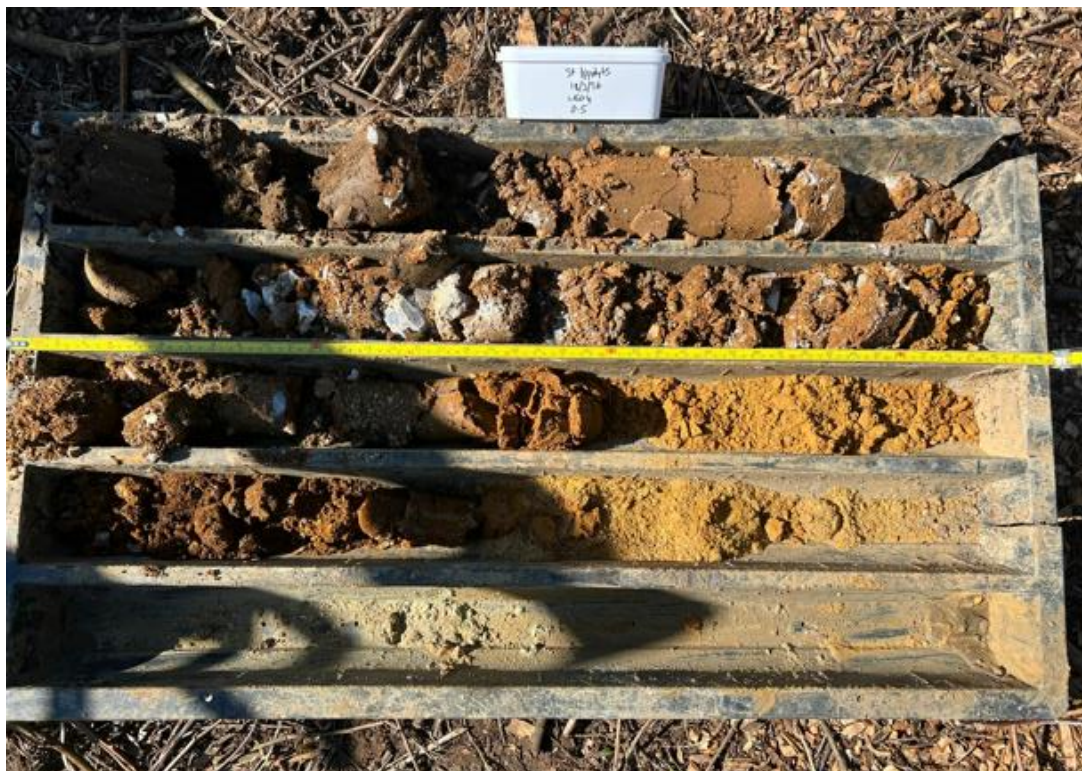
Soil core from WS4
