## Preliminary Ecological Appraisal and Roost Assessment

Baldock Industrial Estate, Baldock, Hertfordshire SG7 6NG

This report is prepared to inform a planning application with the North Hertfordshire District Council. The proposal is described as:  
To demolish the fire damaged parts of the building and to erect a replacement modern steel portal frame metal profile clad building.

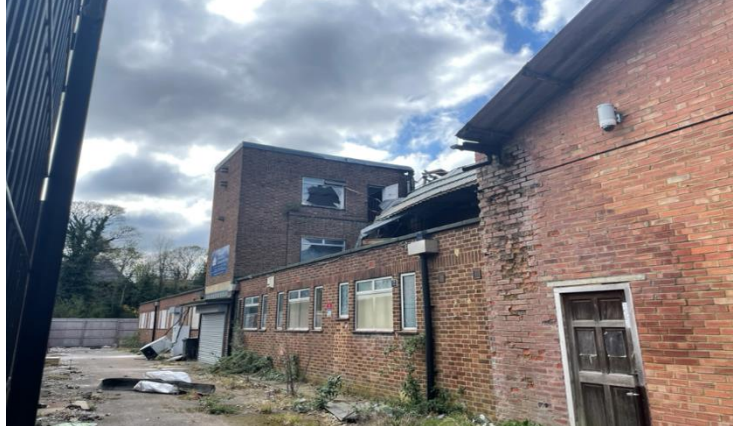
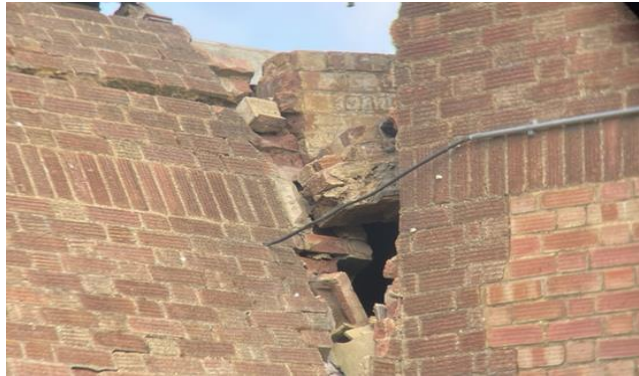
| | <p>There is very limited foraging and commuting opportunities for bats onsite as the site is comprised wholly of hard standing. The small areas of ruderals could provide limited foraging opportunities. The wider landscape is much more suited for foraging and commuting bats with residential dwellings and their associated garden with scattered trees and tree-lined boundaries.</p> <p><b>Roosting habitat</b></p> <p>Buildings to be impacted by the proposed development are assessed for their suitability to support roosting bats below. There is a total of one building on site: the main industrial building (B1). No evidence of roosting bats was identified on or within B1.</p> |
|---|---|
| <p>B1 is a detached part three-storey, part two-storey and part single storey brick and metal-built industrial building.</p> <p>The majority of the pitched metal roof has collapsed due to fire damage and therefore, approximately 80% of the building no longer has a roof. The roof that remains is predominately flat roofs located throughout the large industrial building. The flat roofs are bitumen felt lined and are in good condition with no gaps in which bats could roost. As well as a large, corrugated asbestos Dutch barn roof located in the western corner of the site. The Dutch barn roof is in good condition with no gaps or missing sections under which bats could roost.</p> <p>The doors and windows are metal and wooden framed and appear in relatively condition with no suitable bat roosting sites. However, most of the windowpanes are broken due to the fire, allowing access internally.</p> <p>The majority of the brickwork around the building appears in good condition with no gaps or cracks within which crevice-dwelling bats could roost. However, on the south-eastern elevation, the walls have partially collapsed, creating large gaps within the brickwork. However, these gaps are not a suitable roosting feature as they are too exposed.</p> <p>There are timber and lead flashing soffits around the building which are generally in good condition.</p> | |

| <i>Recommendations</i> | <p><b>Roosting habitat [Buildings]</b></p> <p>It is anticipated that any risk to bats can be reduced to an acceptably low level through the implementation of a precautionary working method during and post-development. This will include the following measures:</p> <ul style="list-style-type: none"> <li>• Works will be scheduled during the winter months (November to March) when bats are least likely to be present, insofar as is possible.</li> <li>• A toolbox talk will be given to contractors to make them aware of the possible presence of bats on the site.</li> <li>• The potential roost features will be removed by hand (where a risk still remains following the pre-commencement inspection) prior to any mechanical demolition.</li> <li>• In the unlikely event that a bat or evidence of bats is discovered during the development all work must stop and a bat licensed ecologist contacted for further advice.</li> </ul> <p><b>Foraging and commuting habitat</b></p> <p>No further surveys are required.</p> <p><b>Artificial lighting</b></p> <p>A low impact lighting strategy will be adopted for the site during post-development which outlines the areas of the site that will be retained as dark corridors. Parameters can be found on the Bat Conservation Trust website: <a href="https://www.bats.org.uk/our-work/buildings-planning-and-development/lighting-2">https://www.bats.org.uk/our-work/buildings-planning-and-development/lighting-2</a></p> <p><b>Suggested biodiversity enhancements</b></p> |

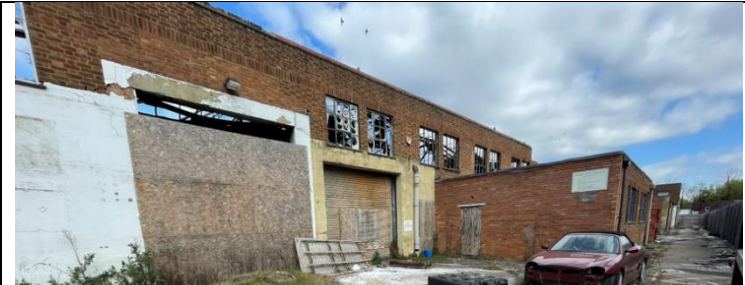
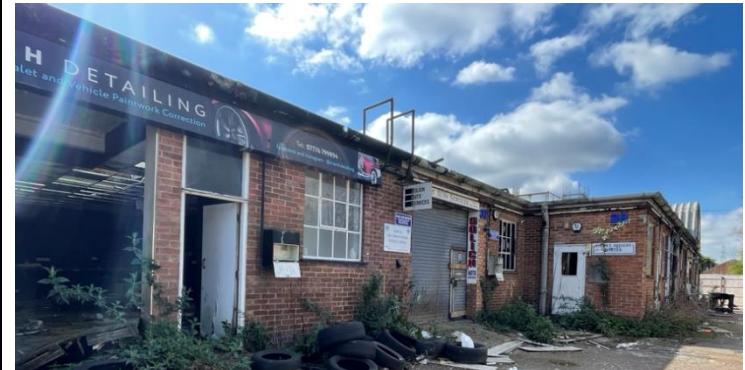
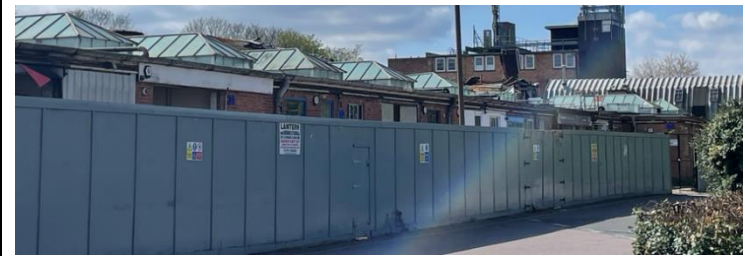
On the single-storey flat roof, on the north-west elevation of the building are 10 large pitched skylights which allow high levels of light internally.

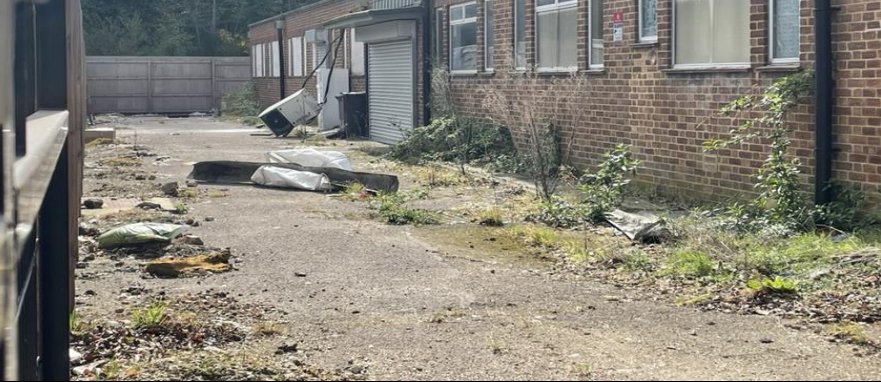
| Developed land; sealed surface | |

| Developed land; sealed surface | |
|---|---|
| | The hard standing surrounding the building onsite. |

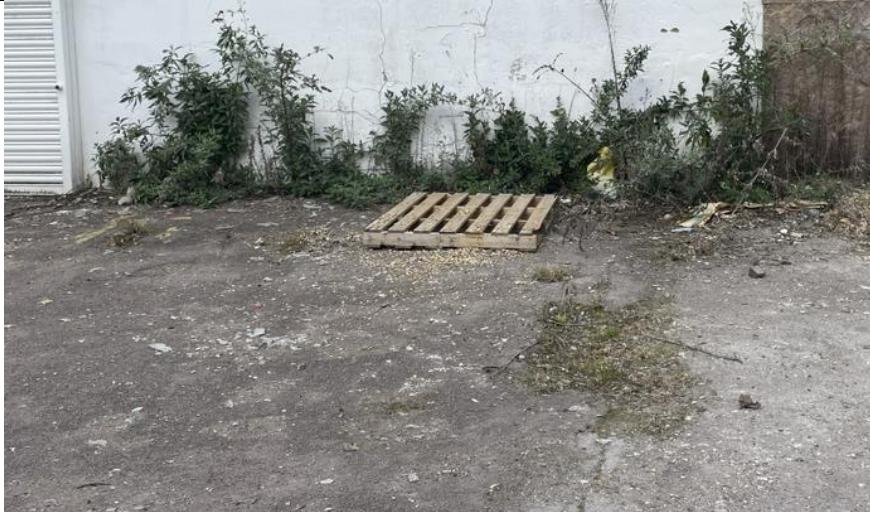
| Developed land; sealed surface | |
|---|---|
| Ruderals within the hard standing | |

| Developed land; sealed surface | |
|---|---|
| | The small areas of ruderals growing through the cracks in the hard standing. |
