Tudor House, Preston (257)

Listed Building Consent

Kitchen Refurbishment and Extension

**Michael Collins Architects Ltd.**

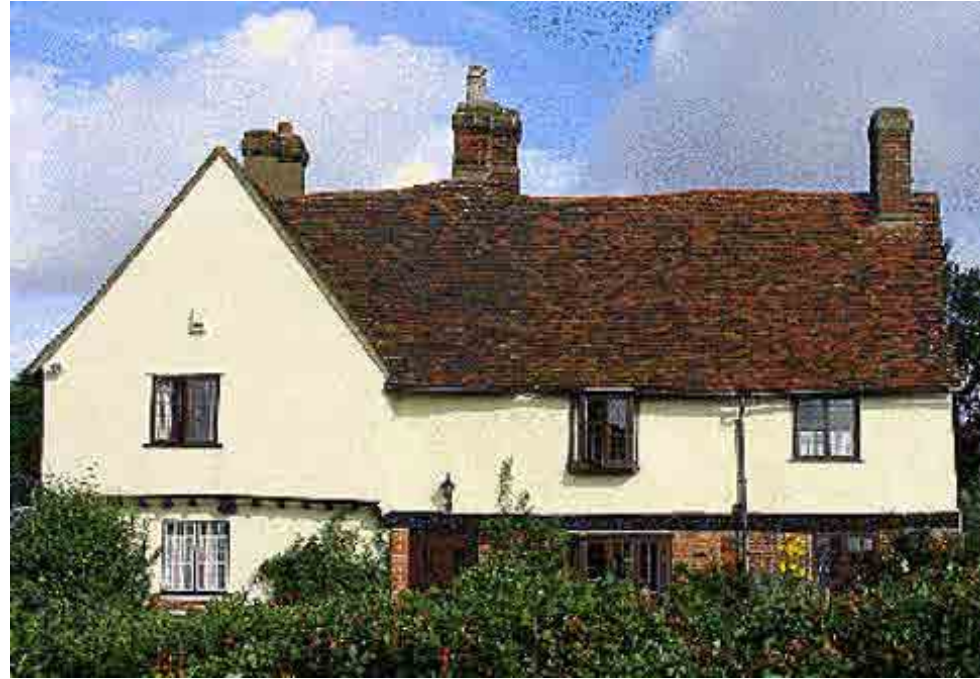
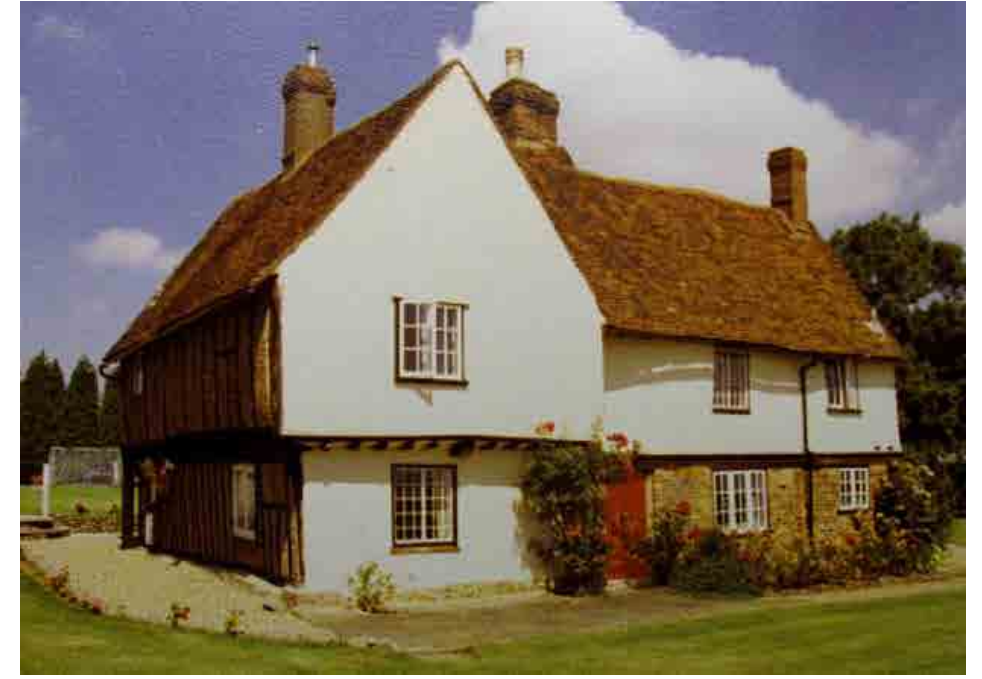
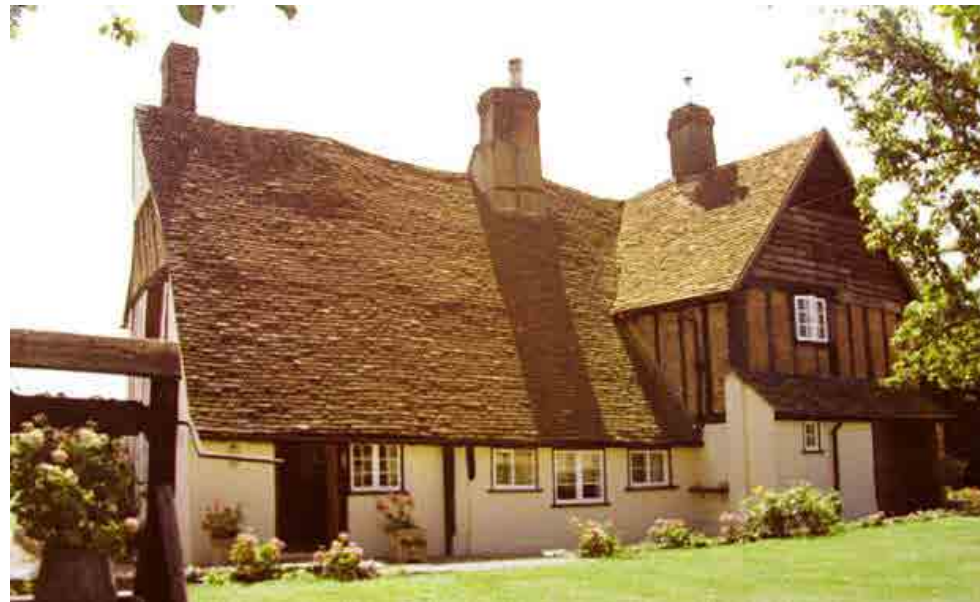
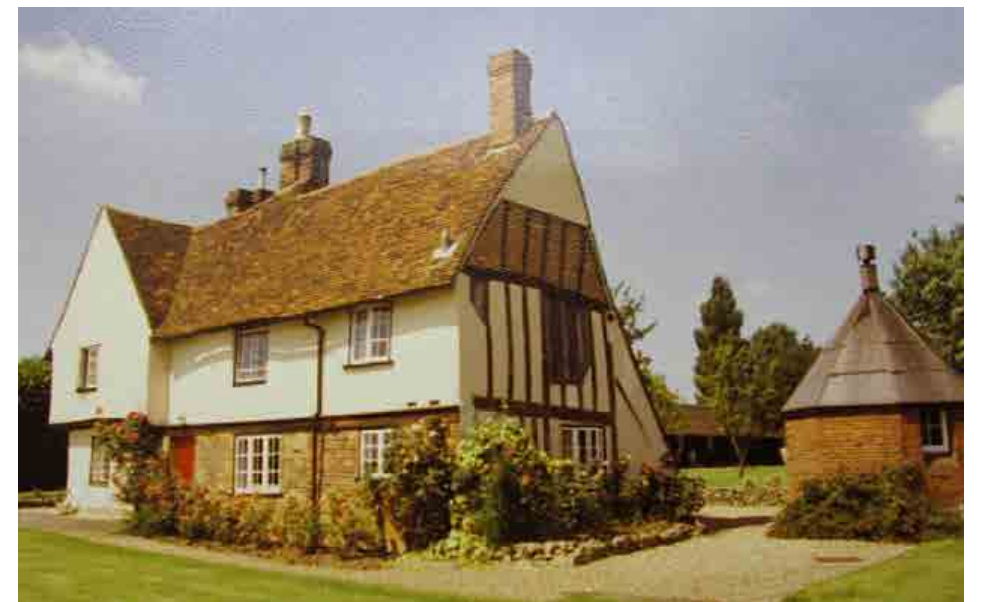
This consideration is supported by photographic documentation illustrating Tudor House in 1980 (see Photos to the right). The photographic documentation clearly indicates the addition to the west elevation of the first-floor extension (the location of a bedroom) and a single-storey extension serving as a continuation of the kitchen in the present day. As indicated by planning application reference 07/02930/1, a carport and studio workshop were erected in 2007.

As evidenced by the planning records (LBC application 88/00756/1), a proposed development in 1988 involved an extension to Tudor House, including the construction of two-storey and single-storey extensions on the main west elevation of the house.

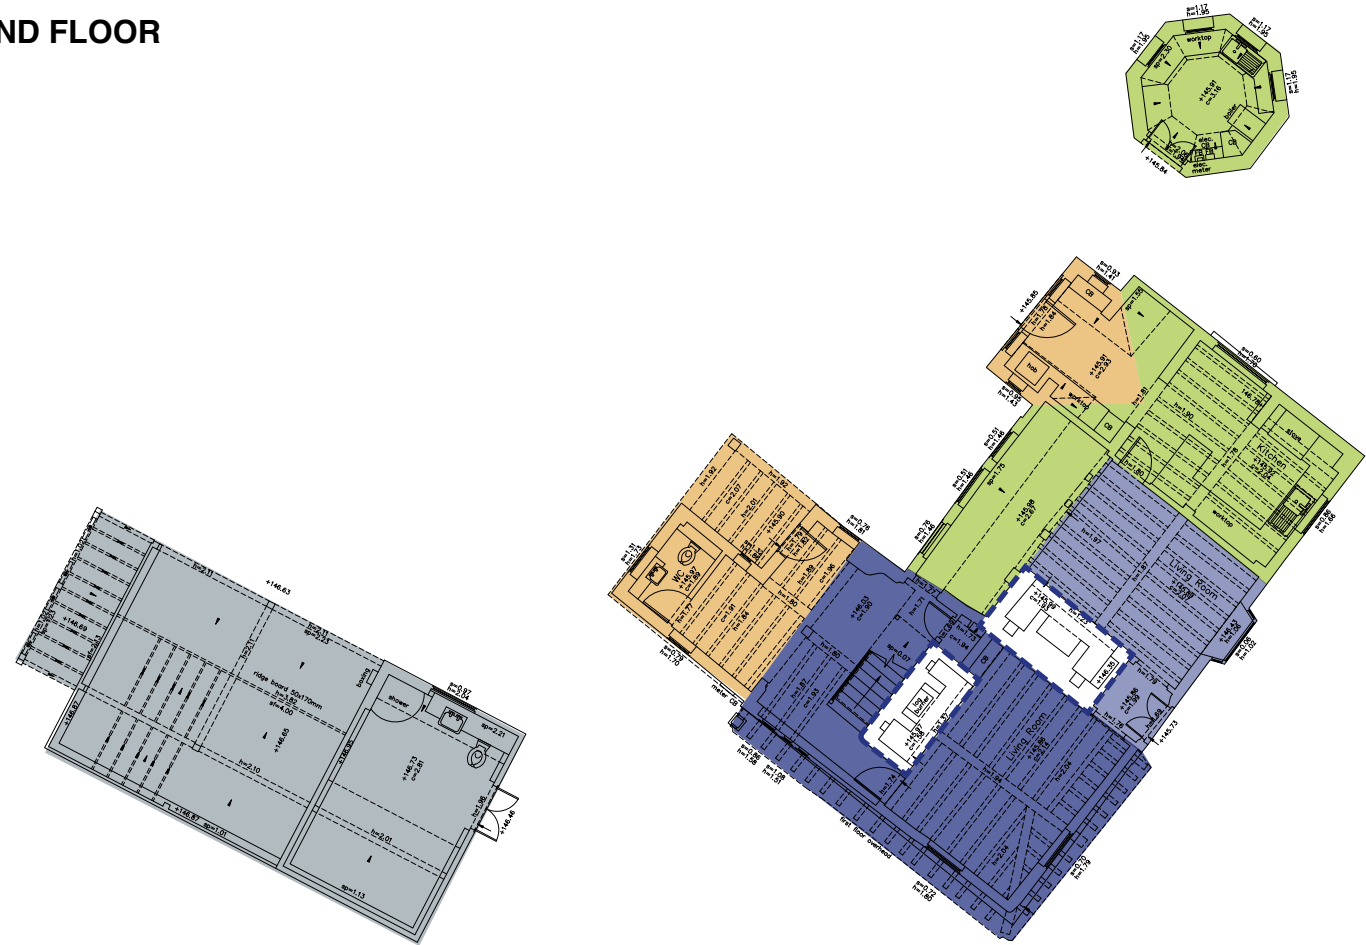
GROUND FLOOR

- 2007 carport and studio
- 1988 single and two-storey extension
- 1800s addition
- 1700s crossing
- 1600s chimney
- 1550s original house
