## Heritage Statement

**Rye End Farm**  
**Codicote**  
**Hitchin**  
**Hertfordshire SG4 8SU**

February 2020

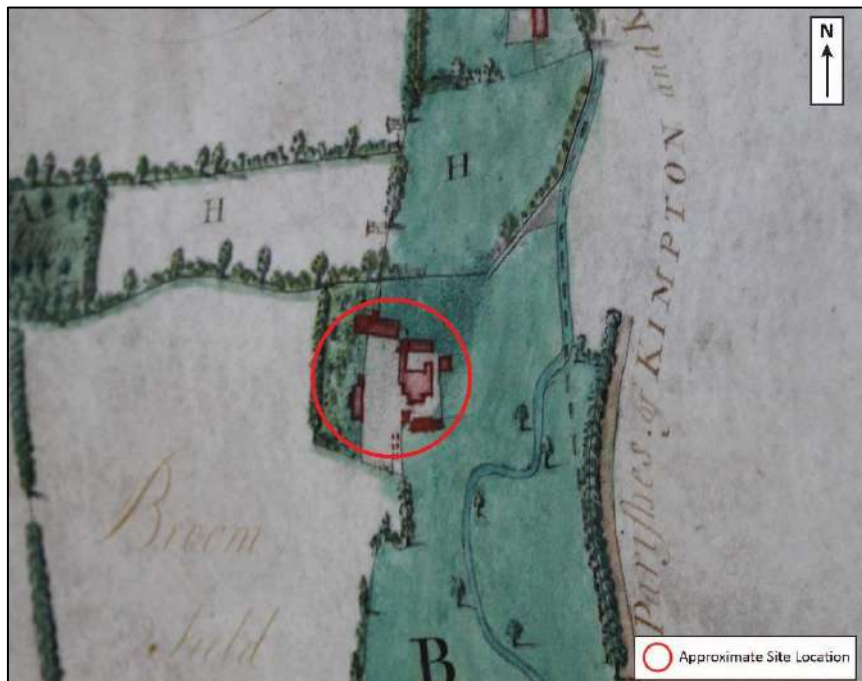
*Fig. 2: Extract from early 18<sup>th</sup> century plan of the Kimpton Hoo estate (HALS Ref. 40443) with Rye End Farm circled in red (Reproduced by courtesy of Hertfordshire Archives & Local Studies).*

The earliest map to show the site in appreciable detail is a detailed plan of the Hoo Estate probably drawn up in the early 18<sup>th</sup> century (*fig. 2*). This plan is of especial interest as it shows the layout of the farmhouse and outbuildings at Rye End Farm in some detail. The basic layout of the farmhouse is shown as comprising the central hall range (with a single bay extension to the S) and cross wing to the E. The farmstead then appears to have been laid out to a loose courtyard plan, comprising a series of outbuildings to the N, S, NW and SW of the farmhouse.

A small detached square structure is shown to the NE of the cross wing, however the existing extension to the E (currently housing the Kitchen and Dining Room) had not been added at that time. A rectangular outbuilding aligned N-S is depicted immediately N of the farmhouse, to which it is linked by a narrow range extending from the NW corner of the farmhouse, with another detached range to the S of the farmhouse. A large farmyard is shown on the early 18<sup>th</sup> century map to the W of the farmhouse, with a substantial E-W aligned structure which is clearly identifiable with the existing barn (which has been dated to the 17<sup>th</sup> century and was probably built as a threshing barn). A detached rectangular building is depicted to the S of the barn in the SW corner of the farmyard but it is uncertain whether this can be identified with the existing brick structure.

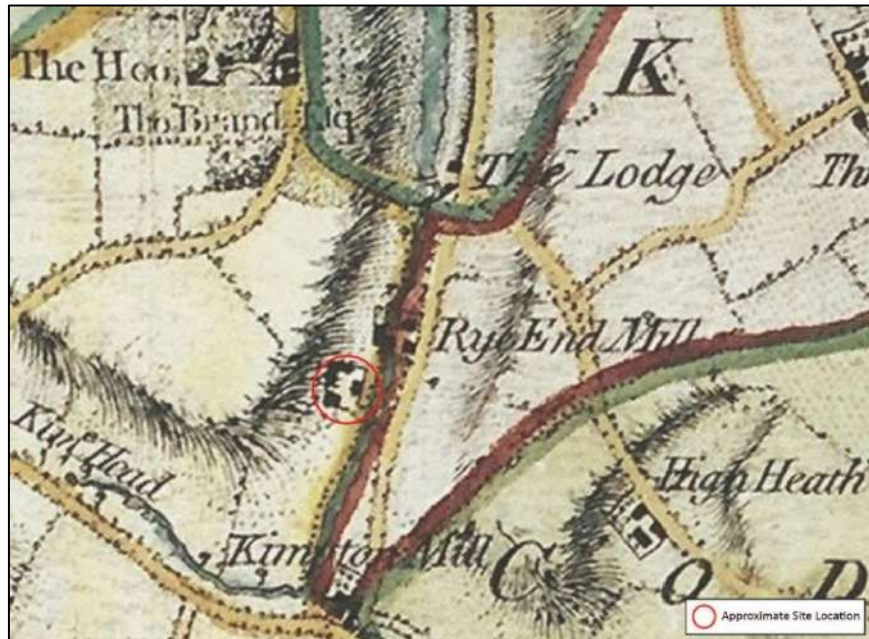
Fig. 3: Extract from Andrews & Dury's Map of Hertfordshire (1767) with site circled in red  
(Reproduced by courtesy of Hertfordshire Archives & Local Studies)

Andrews and Dury's map of Hertfordshire (1766) depicts the layout of the farmstead in somewhat schematic form (*fig. 3*) but the loose courtyard plan appears to have been regularized slightly. The position of the farmhouse is visible on the E side of the farmyard and a range is shown as extending S of the SW corner of the large barn, along the W side of the yard. A detached outbuilding is also depicted in the far SW corner of the complex. The outbuildings shown to the N and S of the farmhouse on the early 18<sup>th</sup> century estate map appear to have vanished by that date. An Ordnance Survey drawing of 1810 (*fig. 4*) appears to show a roughly similar layout of buildings to that depicted in 1766 but it may be noted that the farmhouse appears to have been extended slightly to the E.

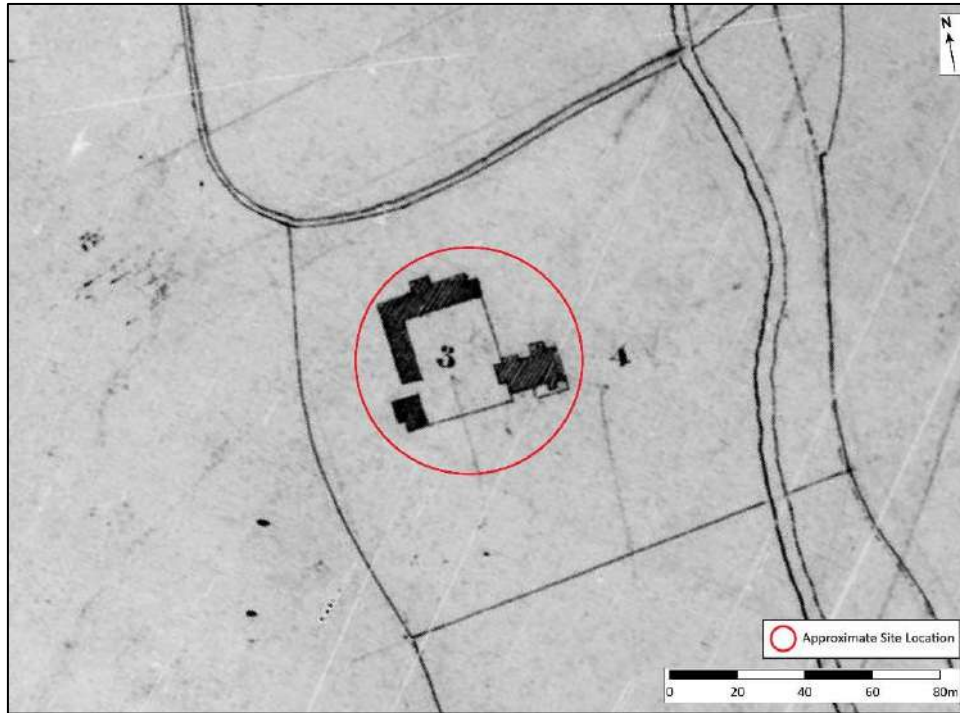
*Fig. 5: Extract from the Kimpton tithe map (1837) with site circled in red  
(Reproduced by courtesy of the National Archives)*

further to the S which can probably be identified with the existing brick structure with attached piggery at the S end of the W stable range. It may be noted that the existing E stable block is not shown on the 1837 tithe map.

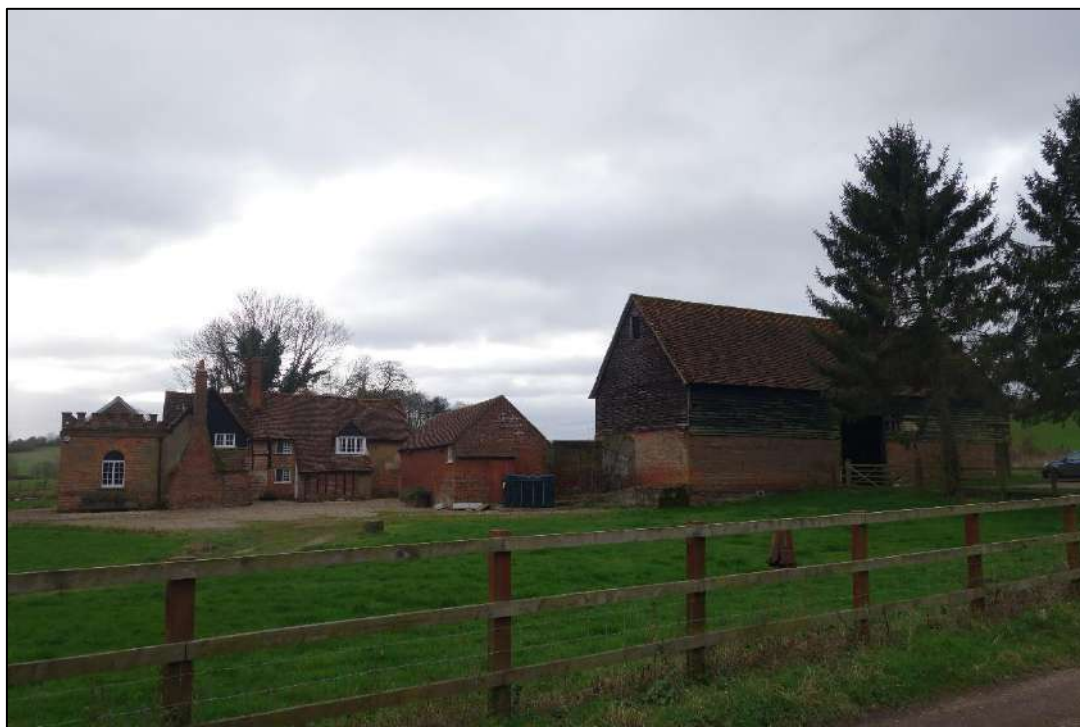
*Plate 1: General view of farmhouse and outbuildings looking SW from trackway*

Rye End Farm is located in a secluded rural setting to the NE of the village of Kimpton, on the W bank of the River Mimram (*Plate 1*).

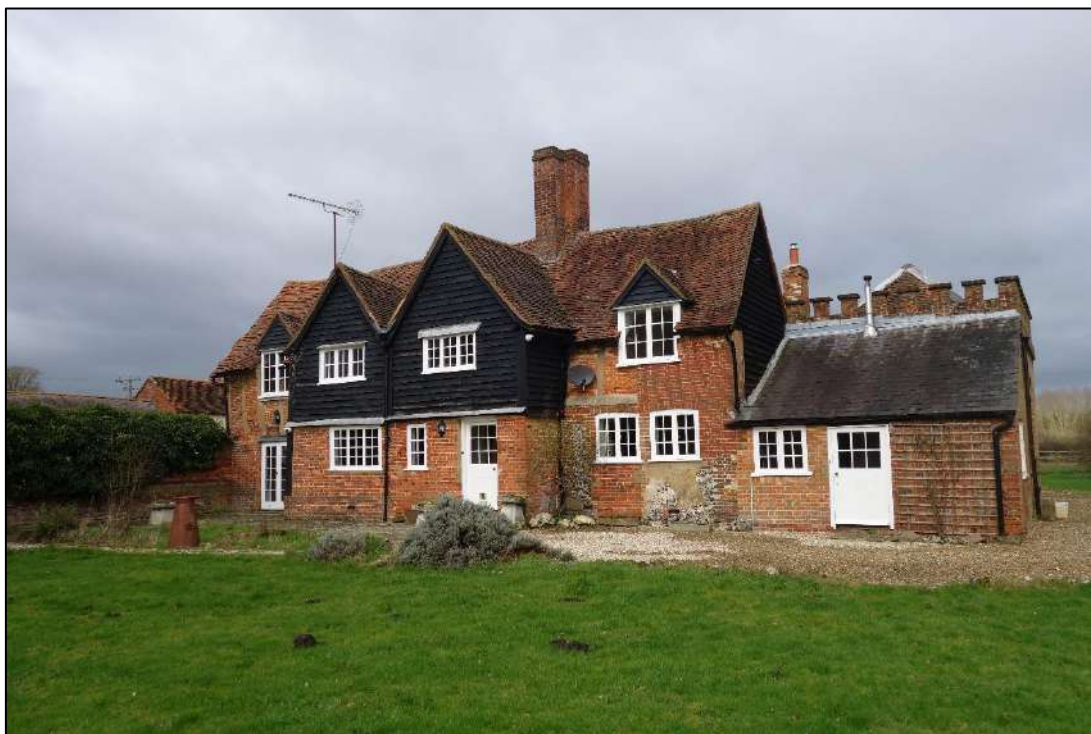
*Plate 2: View looking NW showing rear of farmhouse with outbuildings to W*

The buildings at Rye End Farm (all of which are Grade II listed) comprise the farmhouse itself, of 16<sup>th</sup>-17<sup>th</sup> century date with later additions (*Plate 2*), a two storey L-plan house located on the E side of the side, immediately to the W of which is a complex of traditional farm outbuildings ranged around three sides of a courtyard, the S side of which is demarcated by a brick boundary wall (*Plate 3*). The outbuildings comprise a substantial timber framed barn on the N side, with a five-bay long stable range and piggery of brick and weatherboard construction attached to the SW corner of the barn and extending along the W side of the courtyard and a four-bay brick stable block on the opposite side.

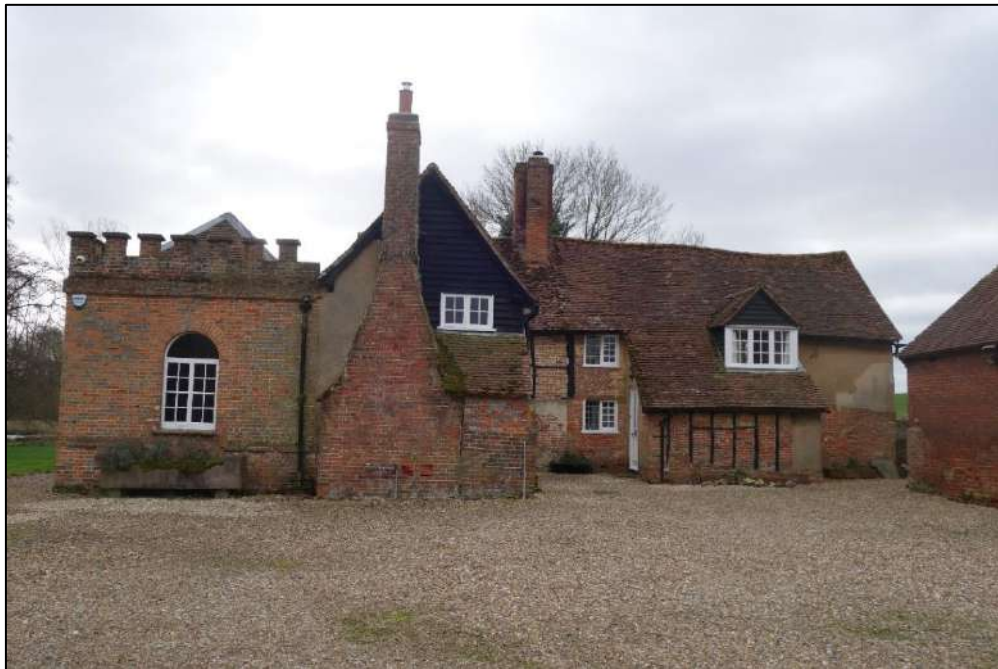
*Plate 4: View looking S towards principal N-facing elevation of farmhouse*

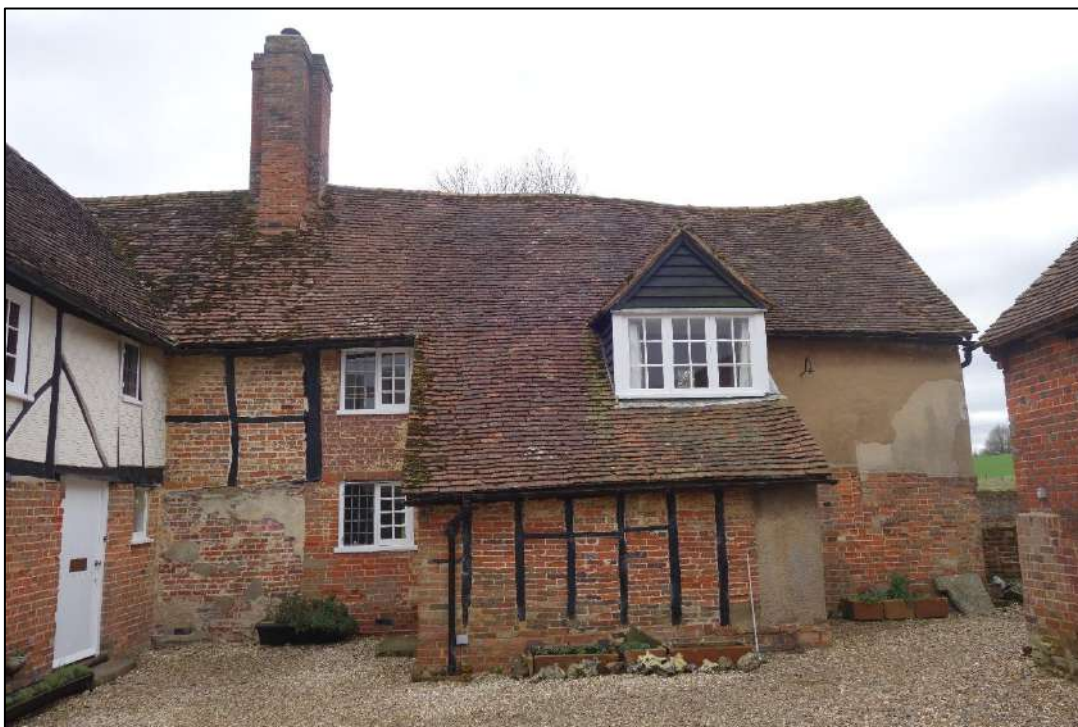
*Plate 5: View looking S showing detail of N-facing elevation of main portion of farmhouse with lean-to entrance vestibule in foreground and cross wing to left of picture*

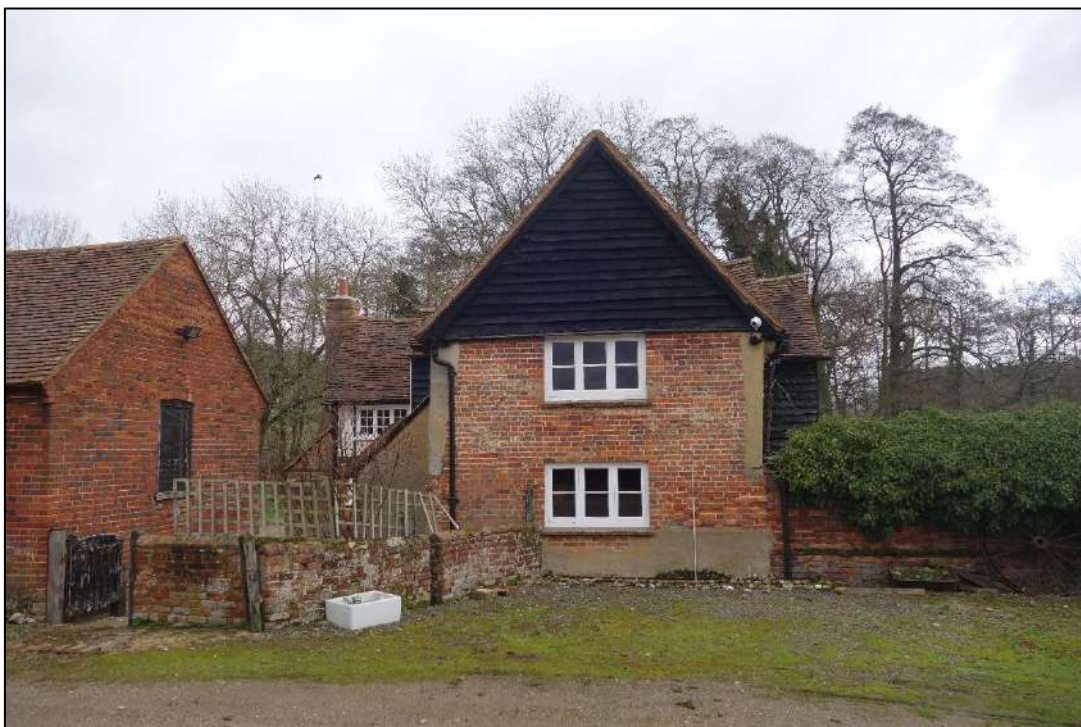
*Plate 7: View looking E showing W-facing gable of farmhouse with mullioned casement windows*

Rye End Farmhouse is a two storey L-plan house, chiefly of timber-framed construction with red-brick and plaster infill and roofed with plain tiles. The main body of the farmhouse, comprising a central hall of probable 16<sup>th</sup> century or earlier origin, is four bays long with a central lean-to extension (again timber-framed with brick infill) with catslide roof with a large dormer casement in the N-facing elevation, housing a vestibule and stairs to the first floor (*Plates 4 & 5*). The roof is surmounted by a tall central ridge brick chimney stack with four joined shafts. The S-facing elevation appears to have been extensively refurbished in brick and the fenestration also displays evidence of having been heavily renewed in places; the central two bays have twin weatherboarded gables (*Plate 6*). The W end of the building also appears to have been partially refaced in brick and has mullioned casement windows and a weatherboarded gable (*Plate 7*).

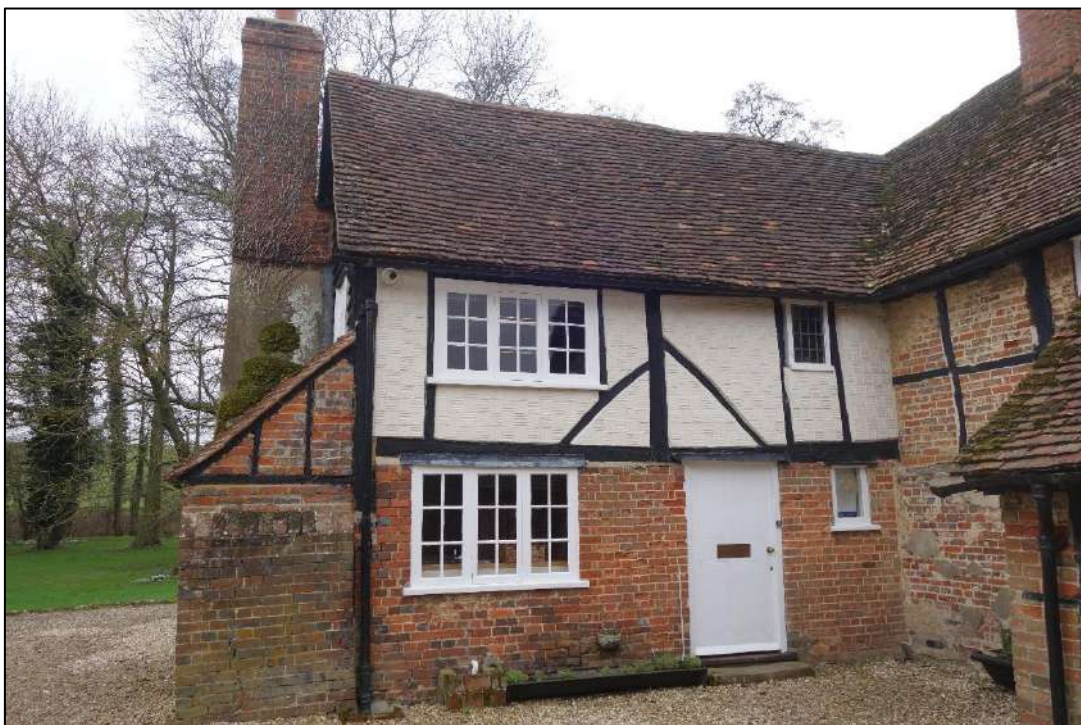
*Plate 8: View looking E showing cross wing of farmhouse with pargetting on upper storey*

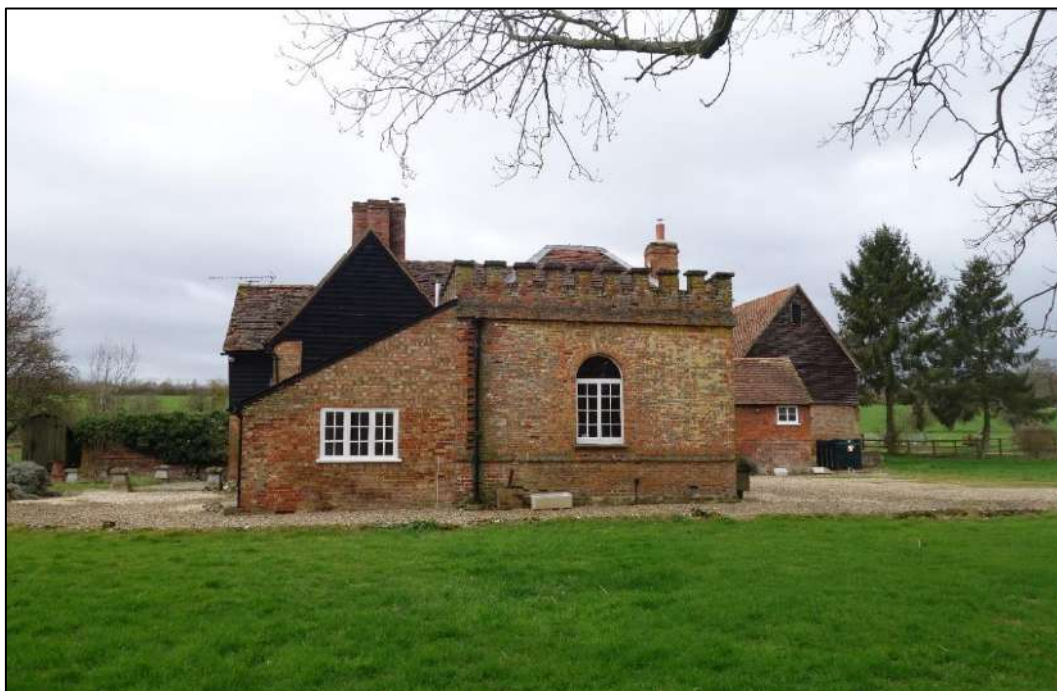
*Plate 9: View looking W showing late 18<sup>th</sup> century castellated brick extension to E end of farmhouse*

Attached to the E end of the cross wing is a two-bay extension (oriented N-S) of red brick construction with crenellated parapet and a hipped plain tile roof (*Plate 9*). It now houses a Kitchen and Dining Room but the location of the building at the rear of the farmhouse, adjacent to the service wing suggests it may originally have accommodated a dairy and cheese room, a suggestion which is further reinforced by the presence of ventilation grilles just above ground level.

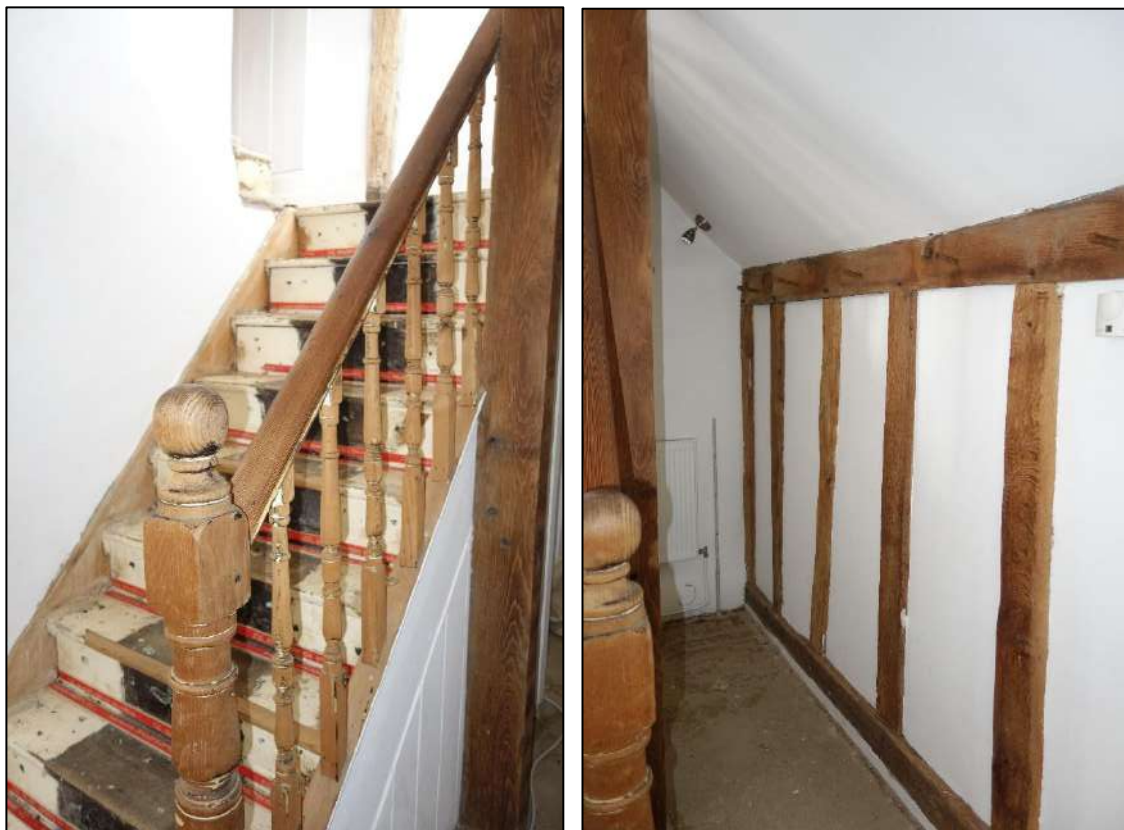
*Plate 10: Internal view looking towards staircase in entrance vestibule in farmhouse, leading up to the first floor*

*Plate 11: Internal view W showing close studded timber-framed panels along N wall of entrance vestibule*

A lean-to vestibule, of timber framed construction with brick infill, provides access to the living room at ground floor and also contains a closed-string staircase with a moulded handrail and newel post and twisted balusters leading up to the first floor (*Plate 10*). The interior of the vestibule has exposed close-studded, timber-framed panels with plaster infill, suggestive of a late 17<sup>th</sup> or 18<sup>th</sup> century date (*Plate 11*).

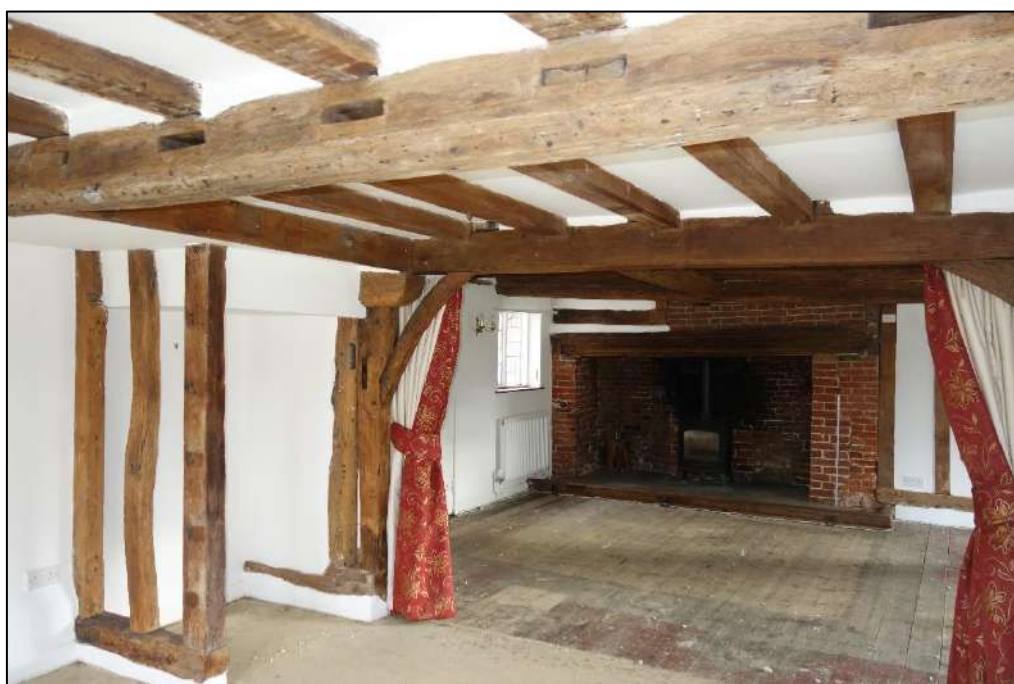
*Plate 12: View looking E showing interior of sitting room showing exposed ceiling beams and partitions and fireplace at E end of room*

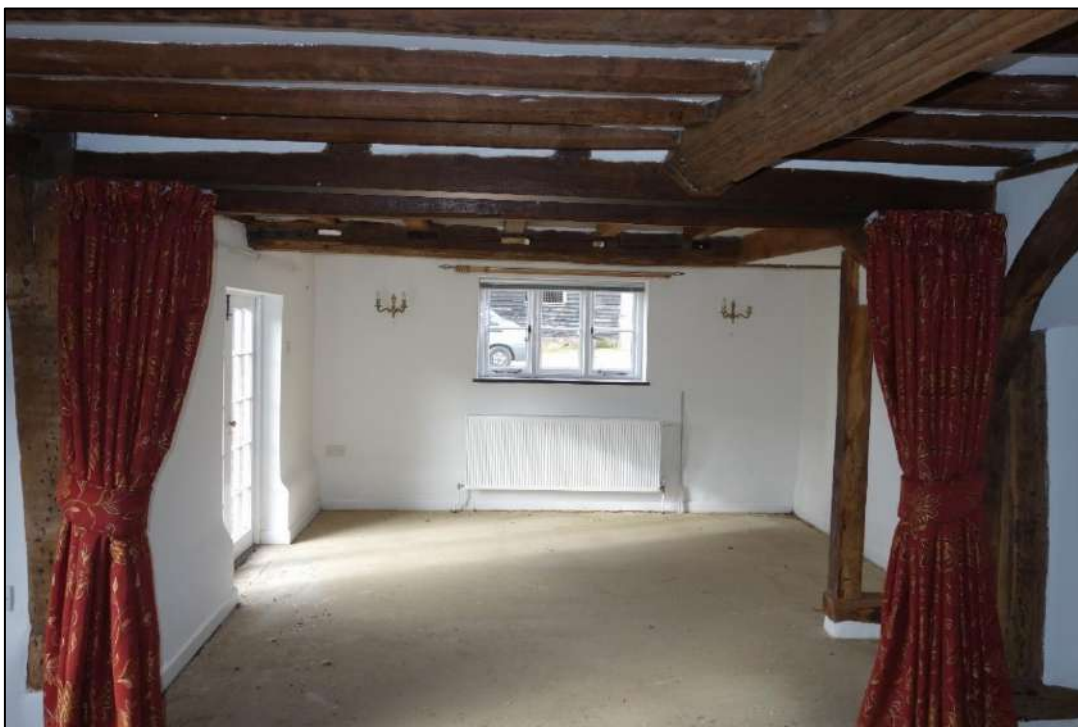
*Plate 13: View looking W towards W end of sitting room with exposed roll moulded ceiling beam (in foreground) and casement window in W wall*

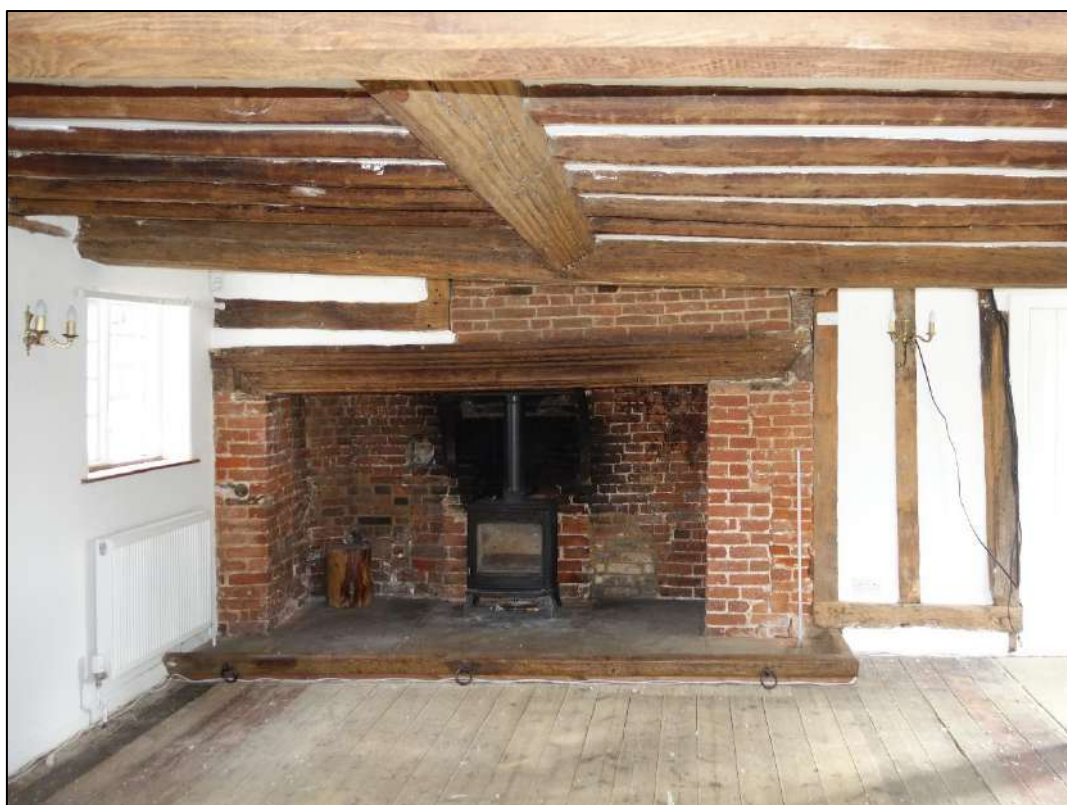
*Plate 14: View looking E towards fireplace at E end of sitting room with moulded lintel and roll moulded ceiling beam above*

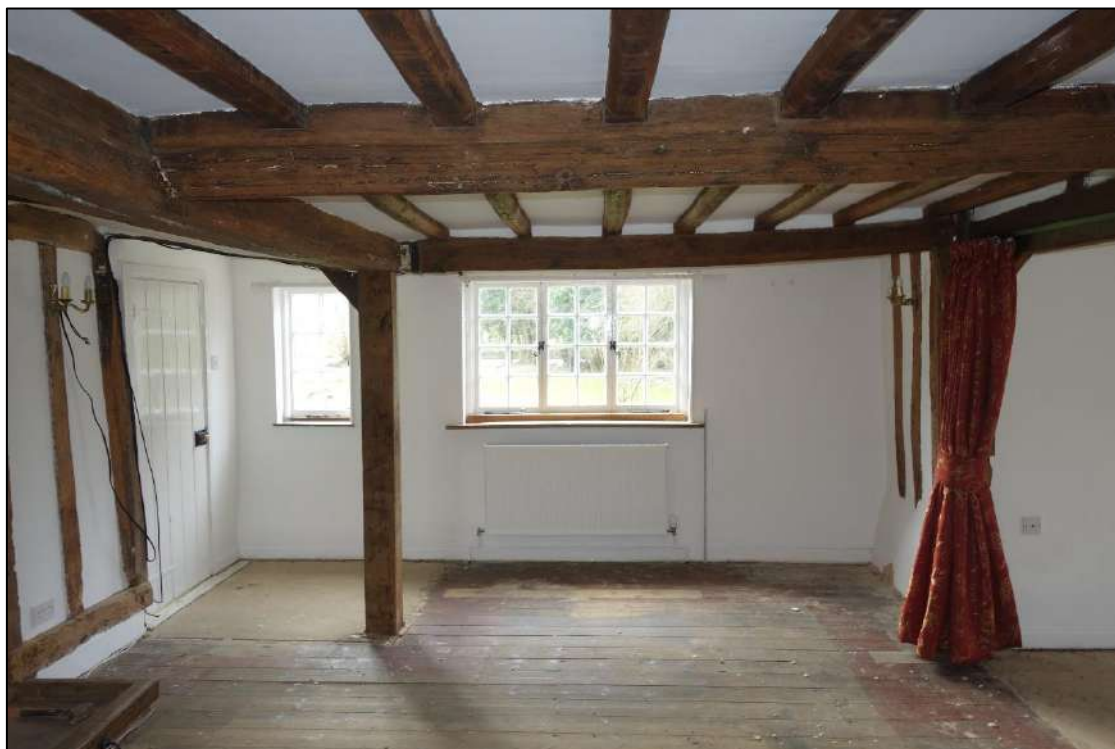
*Plate 15: View looking S towards southernmost bay of sitting room, showing exposed ceiling beams and floorboards*

A single bay on the S side of the sitting room, lit by a three-light casement and a single light casement window, appears to be a later addition of 17<sup>th</sup> or early 18<sup>th</sup> century date, indicated by the close-studded timber-framed walls (*Plates 15 & 16*).

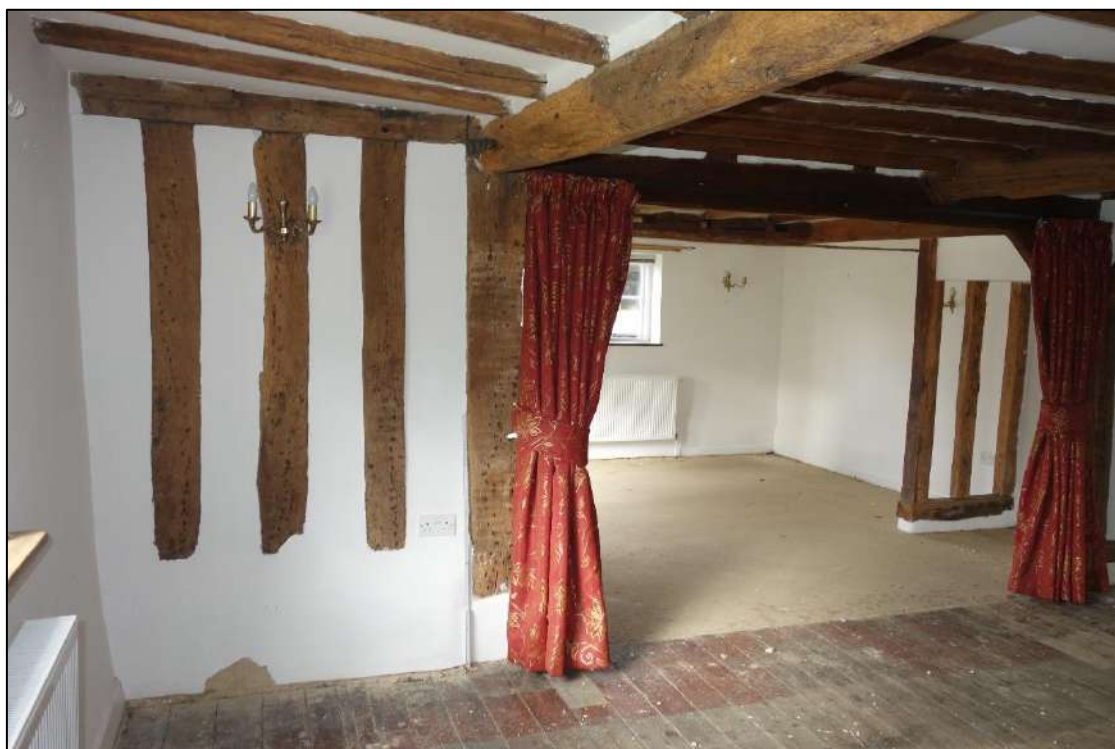
*Plate 16: View looking W showing close-studded timber framed panel in W wall of southern bay of sitting room*

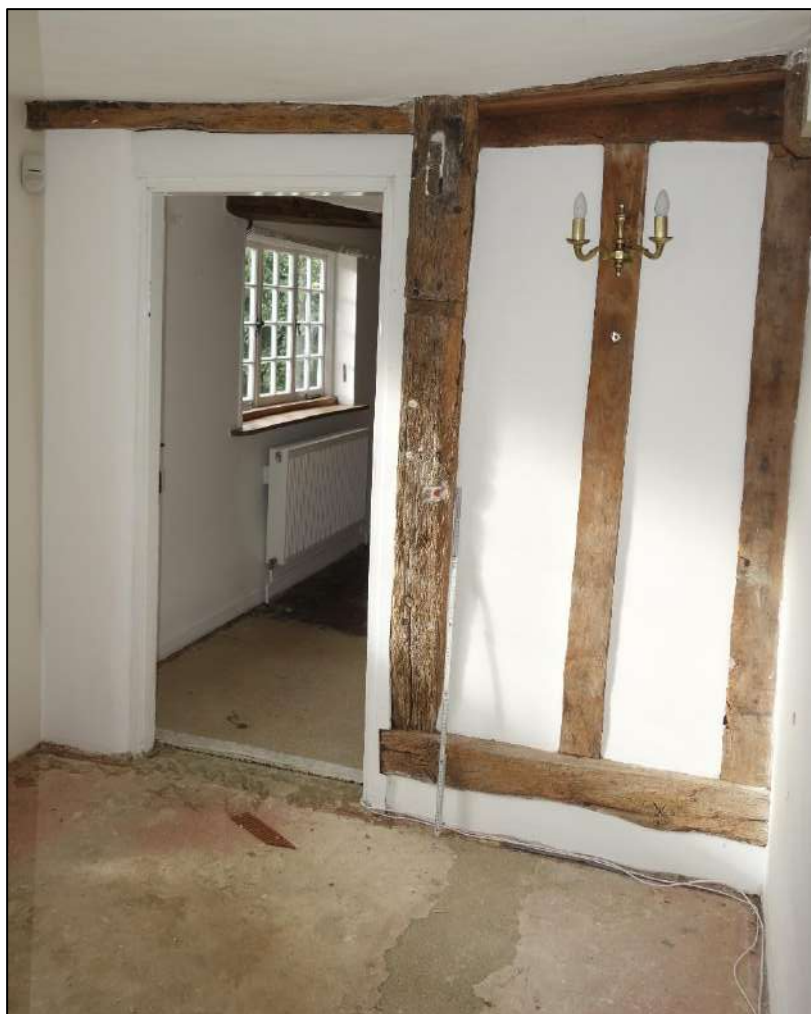
*Plate 17: Internal view looking ESE showing lobby between sitting room and living room with close-studded timber framing*

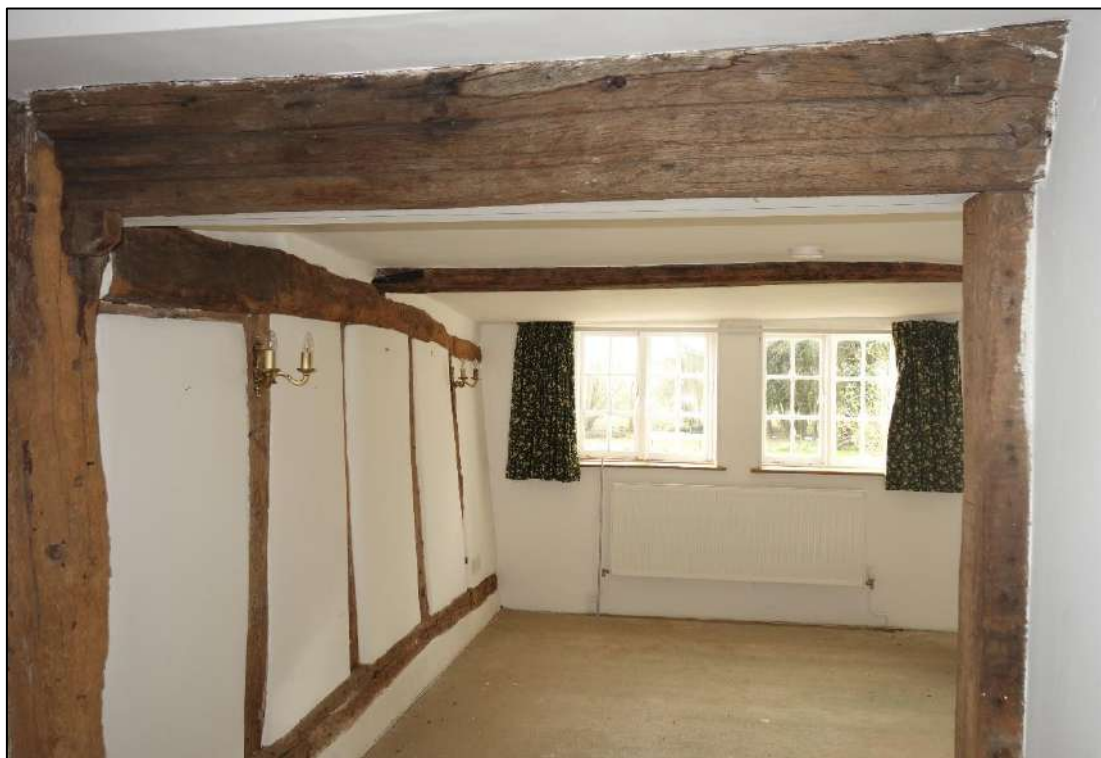
*Plate 18: Internal view of living room looking S showing moulded beam supported by vertical timber posts*

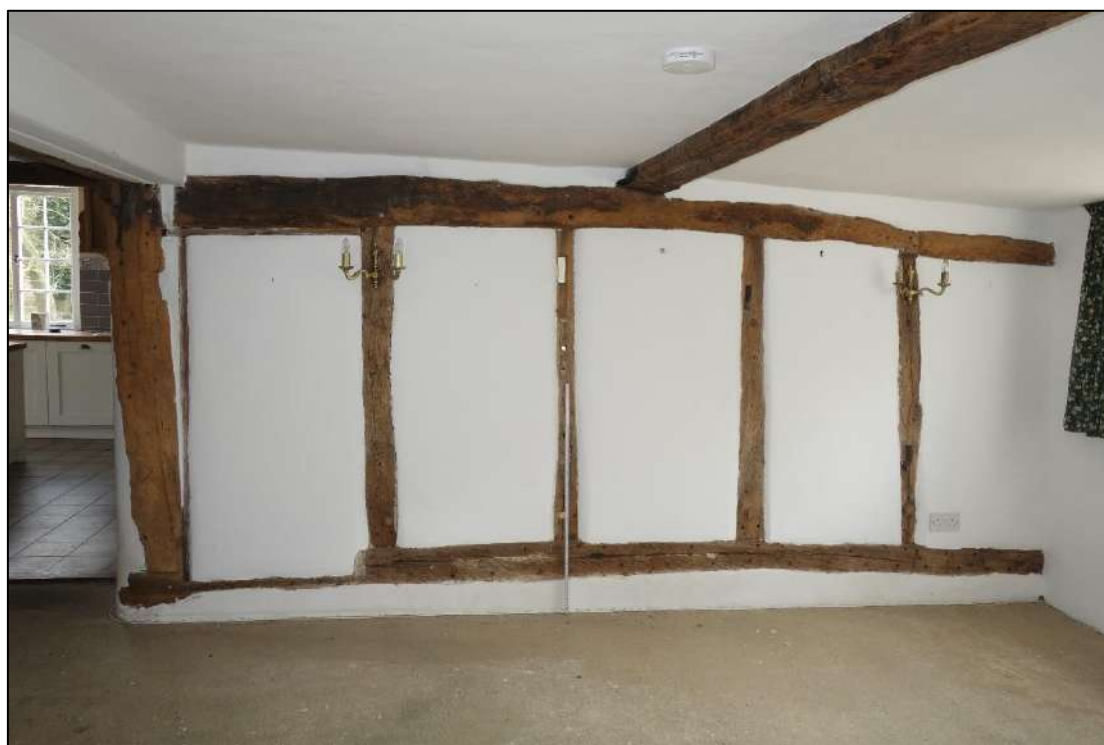
*Plate 19: View looking E within living room showing exposed timber framed panels in E wall*

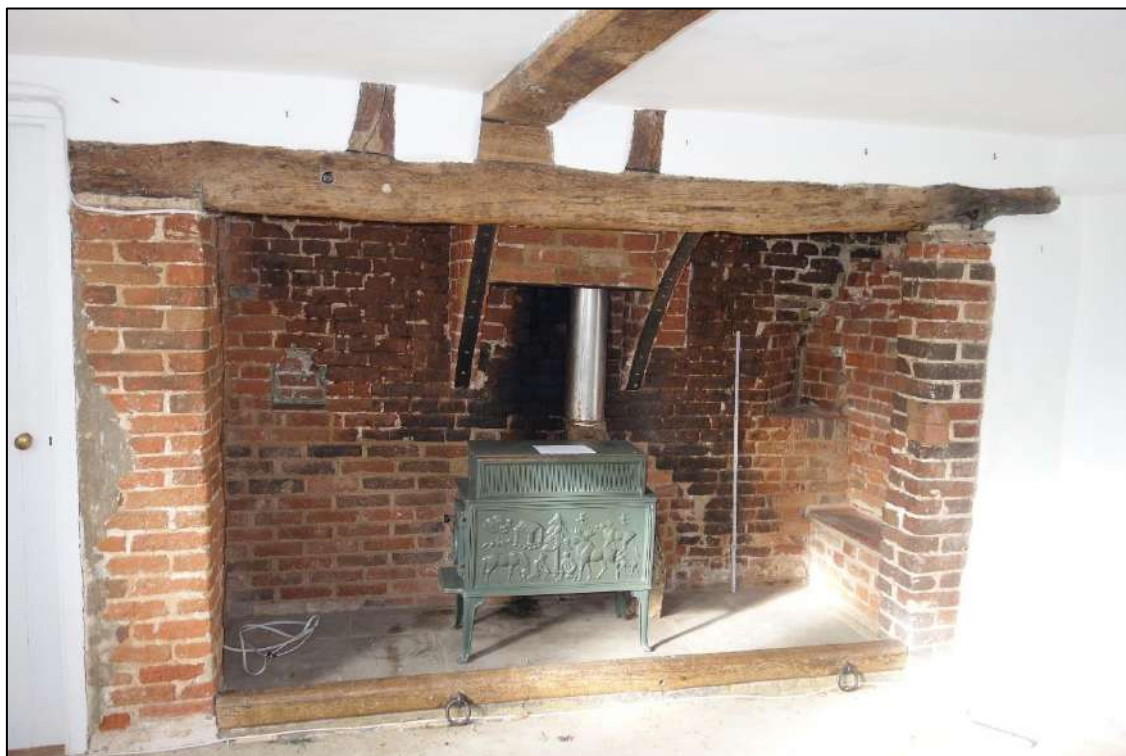
*Plate 20: View looking W showing brick fireplace with inglenook in W wall of living room*

Within the W wall of the living room is a brick fireplace with deep inglenook and a substantial, roughly-hewn timber lintel (*Plate 20*). To the N of the living room is a doorway leading into the Scullery which occupies the N half of the 17<sup>th</sup> century service cross wing; the existing partition wall appears to be a later insertion and it seems likely that the original partition wall was further to the S, its position marked by a substantial horizontal moulded beam supported by vertical timber posts, one of which has circular indentations possibly indicating a former doorway (*Plates 18 & 21*). Within the NE corner of the room is a doorway with moulded skirting providing access to the Kitchen (*Plate 22*).

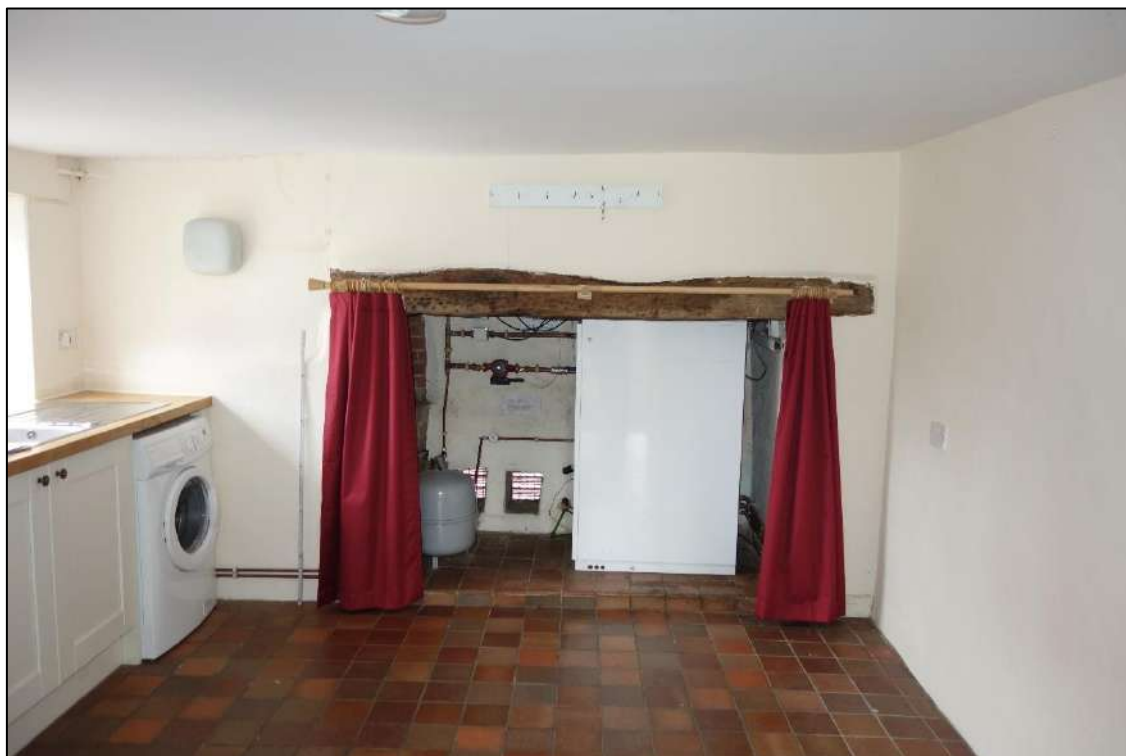
*Plate 23: View looking N showing interior of Scullery with fireplace at N end of room*

The existing partition between the living room and the Scullery appears to be a later insertion, possibly added in the late 19<sup>th</sup> or early 20<sup>th</sup> century. The most noteworthy feature within the Scullery is a large deep fireplace at the N end of the room with a bay for a bread oven to the left of the fireplace, which is surmounted by a substantial wooden lintel. The fireplace and bread oven bay, which now contains a modern boiler and associated piping, appears to have been added in the mid to late 19<sup>th</sup> century (*Plate 23*).

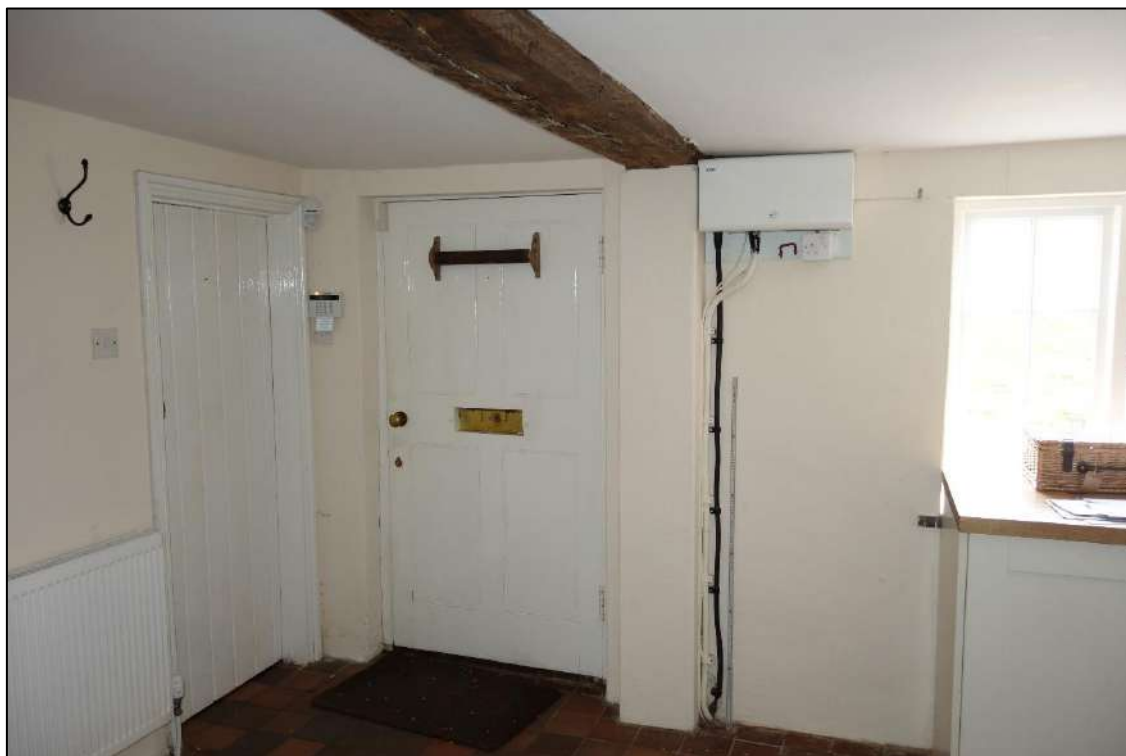
*Plate 25: Internal view looking SW showing doorway from Scullery to yard (to right) with cloakroom to left of picture, with exposed ceiling beam visible above*

At the S end of the Scullery is a doorway leading to a small cloakroom/WC which probably represents a 20<sup>th</sup> century insertion (*Plate 25*). This room has evidently been subject to much refurbishment with the walls being heavily plastered and the floor laid with modern ceramic tiles; the only other features of interest noted were an exposed chamfered horizontal ceiling beam supported by a wooden corbel and a short section of a moulded wallplate at floor level, located towards the S end of the Scullery (*Plate 26*).

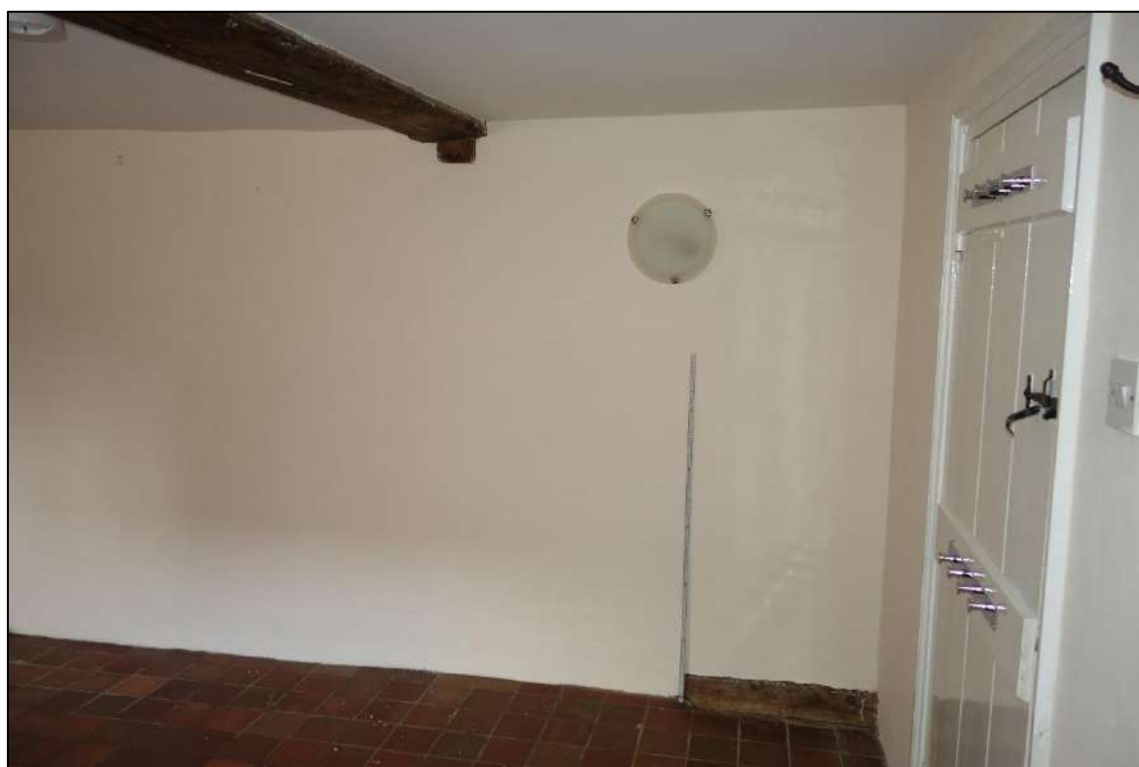
*Plate 26: Internal view showing E wall of Scullery with exposed ceiling beam and remnant of moulded wallplate (to bottom right of picture)*

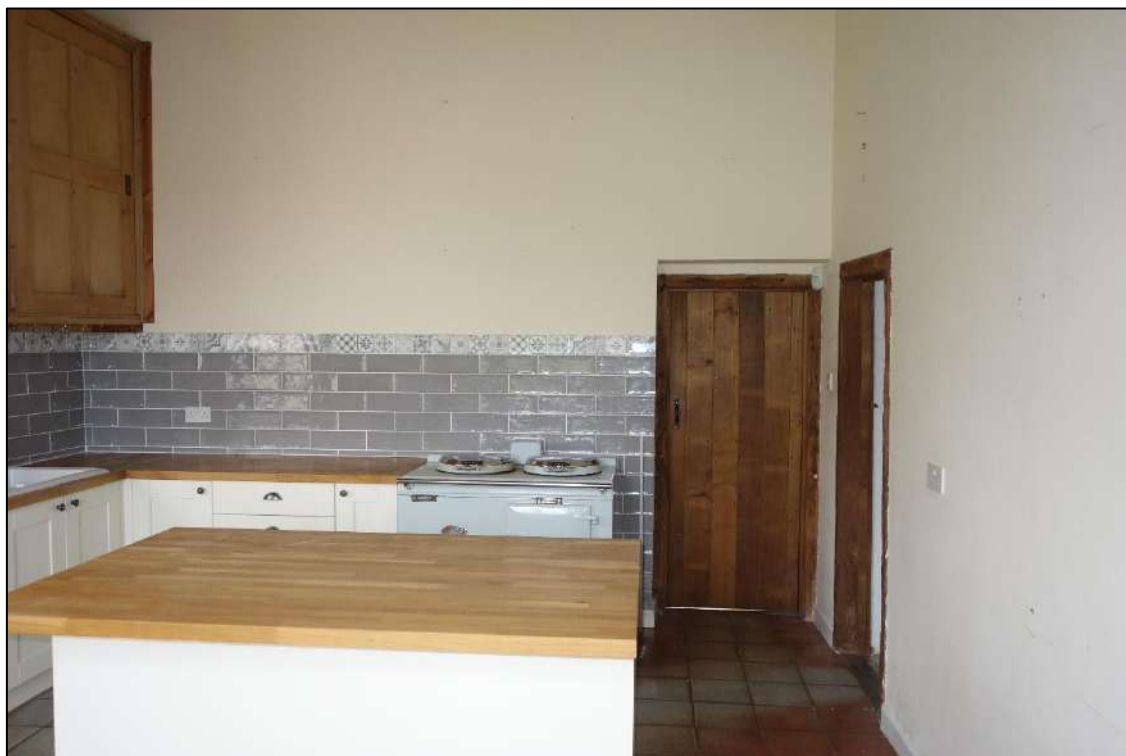
*Plate 28: Internal view of Kitchen looking S showing modern ranges along S wall and doorway to Dining Room*

The annexe housing the Kitchen and Dining Room to the E of the living room appear to have been added in the late 18<sup>th</sup> century. Their function is not altogether clear but they may well have been built to house a dairy and cheese room. This supposition is based on their position at the rear of the farmhouse, the slightly sunken floor level (particularly apparent in the Dining Room), the absence of a chimney and the presence of large windows and grilled vents in the Kitchen to provide sufficient ventilation. The Kitchen is lit by two large round arched casement windows (*Plate 27*) and has evidently been subject to extensive modern refurbishment, with the insertion of a modern ceramic tiled floor and Kitchen range with tiled surround and stove against the E and S walls (*Plate 28*).

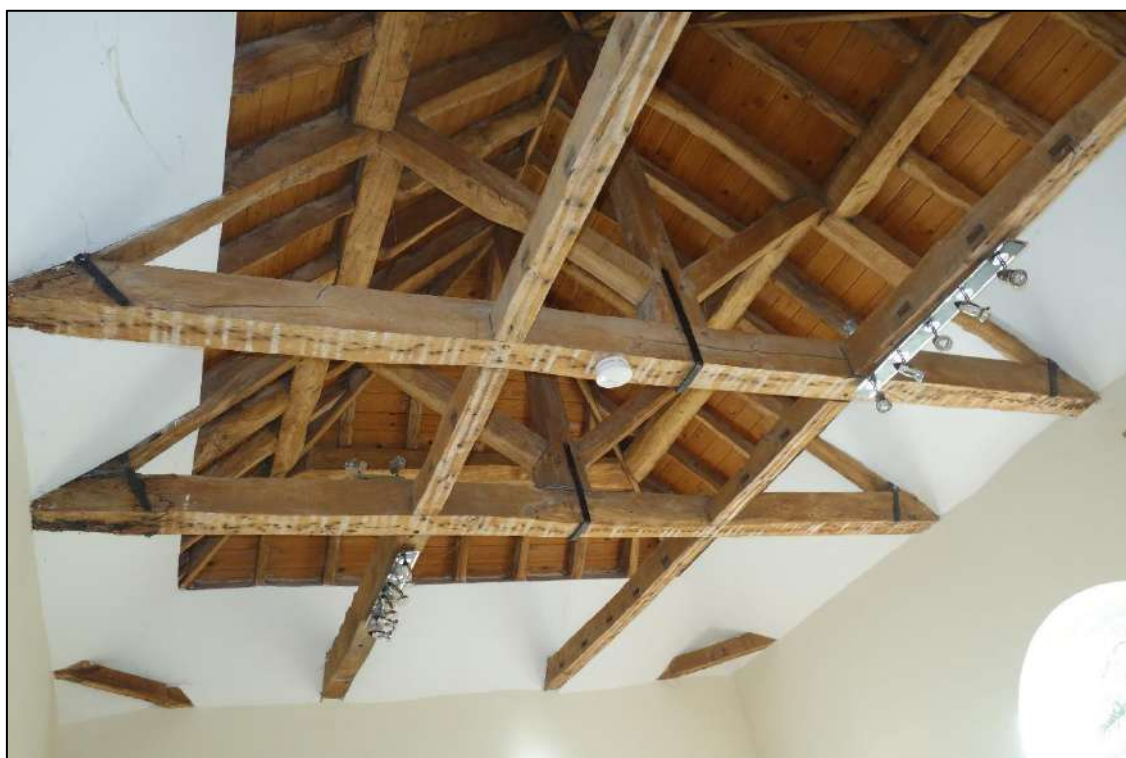
*Plate 29: View showing kingpost roof trusses and ceiling beams in Kitchen*
