## Heritage Statement

**Rye End Farm**  
**Codicote**  
**Hitchin**  
**Hertfordshire SG4 8SU**

February 2020

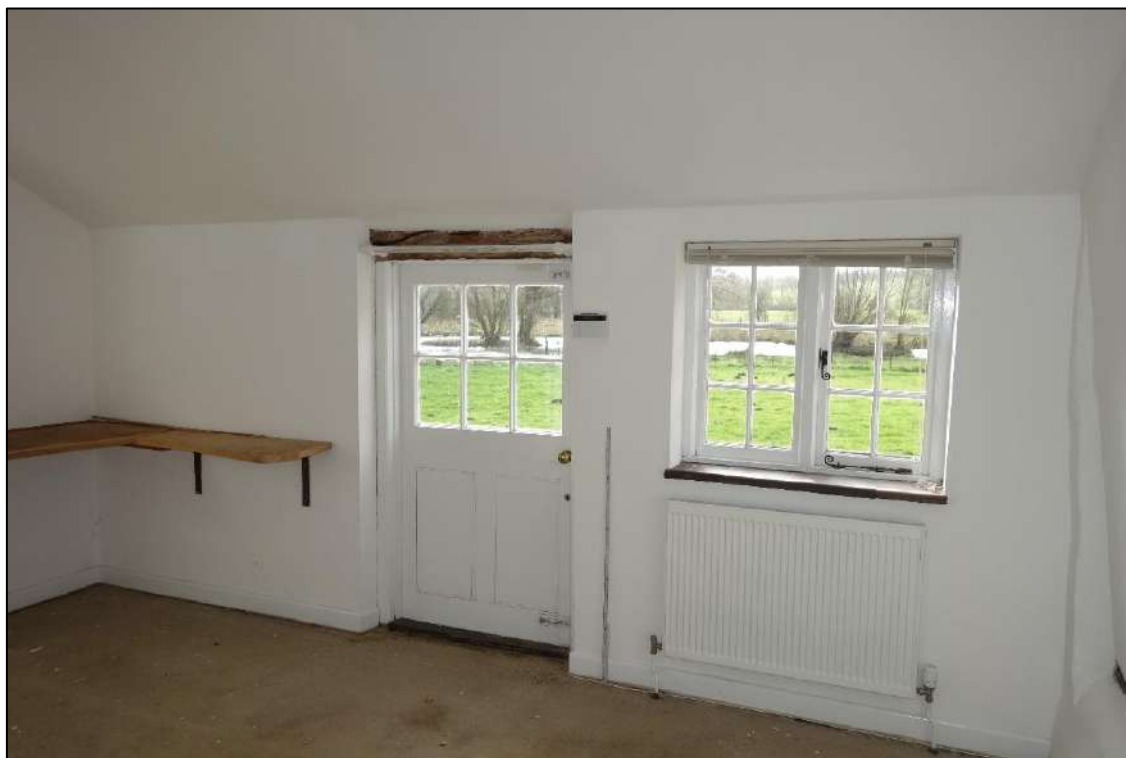
*Plate 30: View looking SE showing interior of Dining Room with casement window and door in S wall*

The Dining Room is accessed from a doorway in the S wall of the Kitchen and has a coved plaster ceiling; it is lit by a single 12-pane casement window with a doorway to the left leading to the garden (*Plate 30*). The Dining Room floor is set noticeably below that of the Kitchen, which might suggest that the original floor level in the latter room was lower compared to its present height (*Plates 31 & 32*).

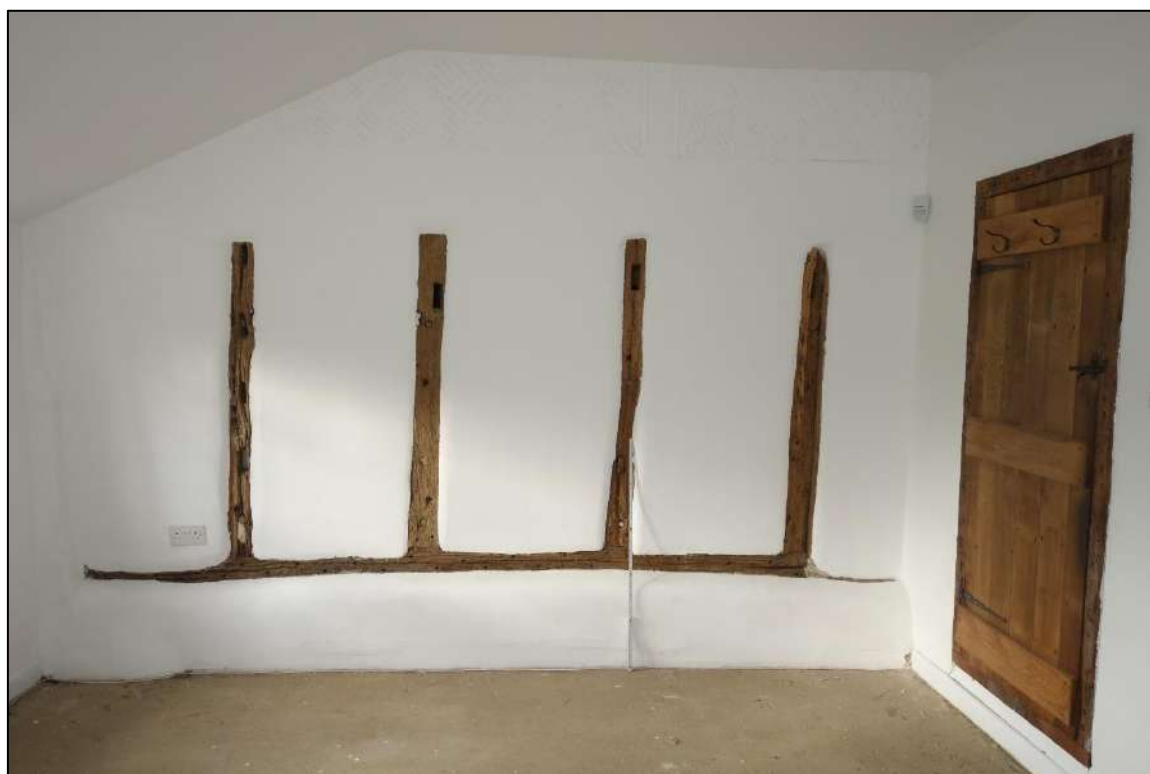
*Plate 31: Internal view looking W showing W wall of Dining Room and sunken floor level*

The reason for this is not entirely clear but it may have been connected with its presumed former usage as a dairy, which would often have a sunken floor in order to maintain a cool temperature for the storage of milk and other dairy produce (Mercer 1975). However, no features associated with its former possible usage (such as stone shelving) were noted within this room; a modern flue has been inserted in the N-wall for the Kitchen stove.

and the insertion of a much wider door opening between the Kitchen and Dining Room would thus alter the appearance and character of both rooms to a noticeable extent, although it should be noted that the distinctive sunken floor in the Dining Room would be retained as part of the proposed works.

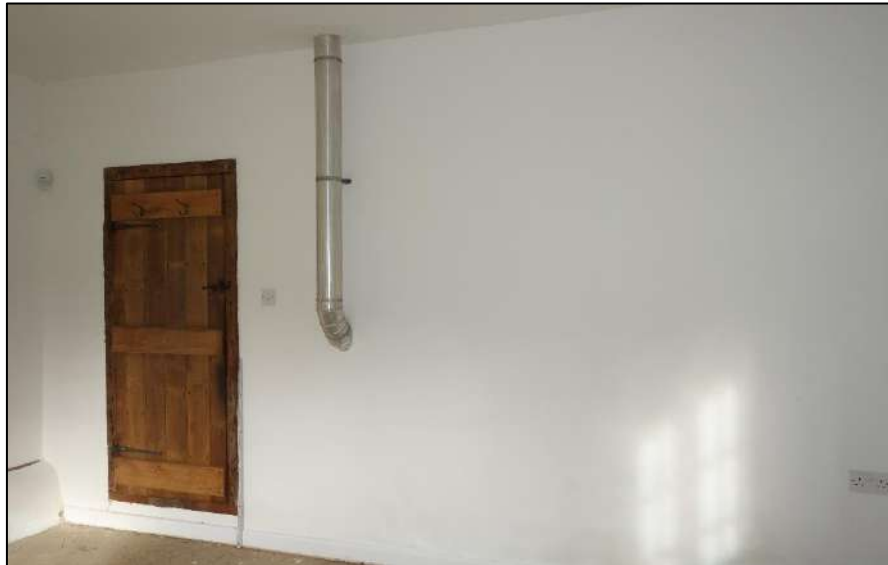
*Plate 32: View looking NW towards N wall of Dining Room showing modern flue to right of doorway*

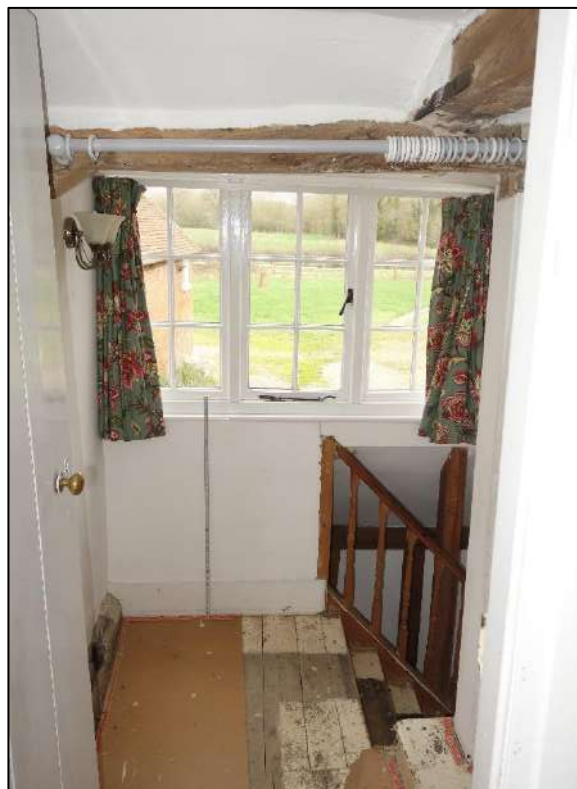
*Plate 33: Internal view looking N showing first floor landing and casement window*

The first-floor landing is accessed from a stairway leading up from the vestibule to the N of the sitting room, which has a coved ceiling with exposed beams and is lit by a mullioned 18-pane casement window (*Plate 33*). Doorways from the landing lead S into the bedroom at the W end of the first floor and E along a corridor running along the N side of the first floor towards the two bedrooms in the cross wing at the E end of the house (*Plate 34*).

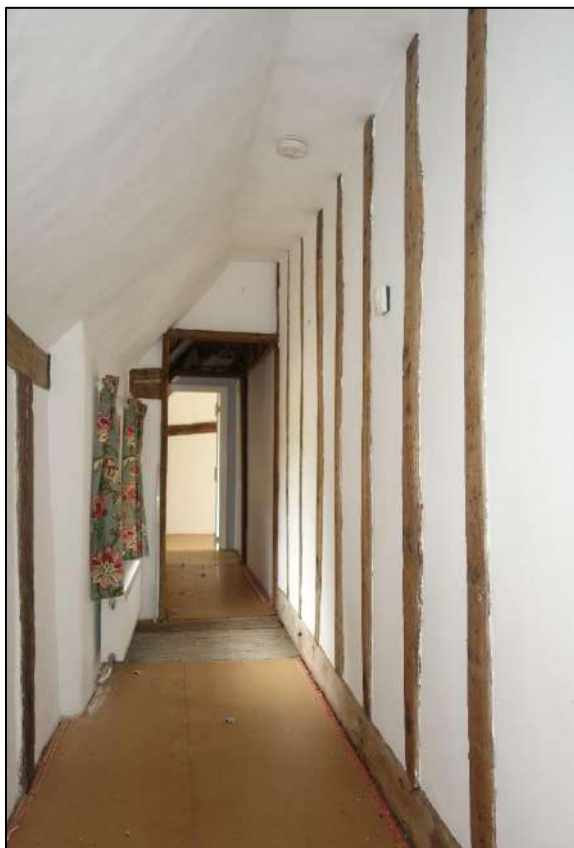
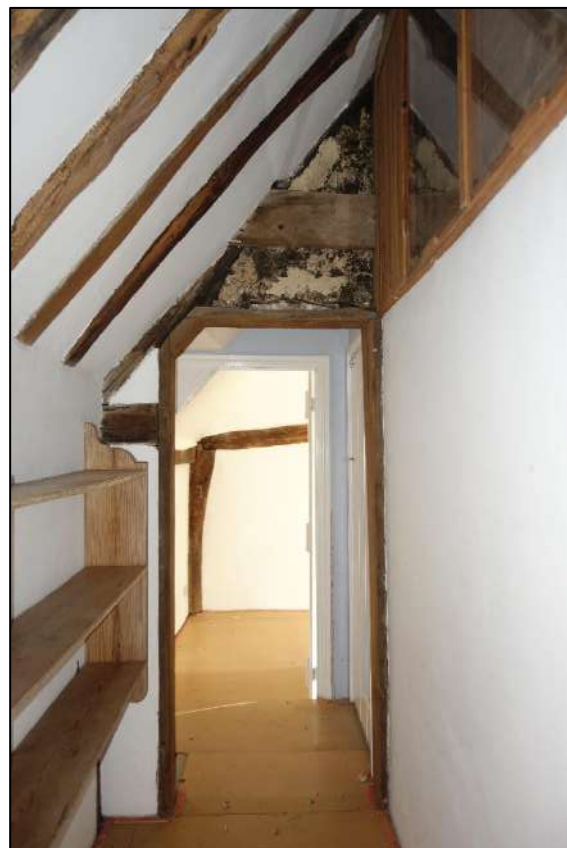
*Plate 34: View looking E along first floor corridor showing exposed timber-framed panels*

*Plate 35: View looking E towards E end of first floor corridor showing sooted plaster in apex with brick chimneystack to right*

The corridor walls have close-studded timber framed panels with plaster infill (perhaps of late 17<sup>th</sup> or 18<sup>th</sup> century date) while the floor is largely covered with modern boards, although these appear to mask evidence of earlier floorboards which are exposed in places. Towards the E end of the corridor, where part of the roof structure has been exposed, a section of sooted plaster is visible in the apex of the roof adjacent to the existing brick chimneystack, which may represent evidence of an earlier 'smoke bay' prior to insertion of the chimney (*Plate 35*).

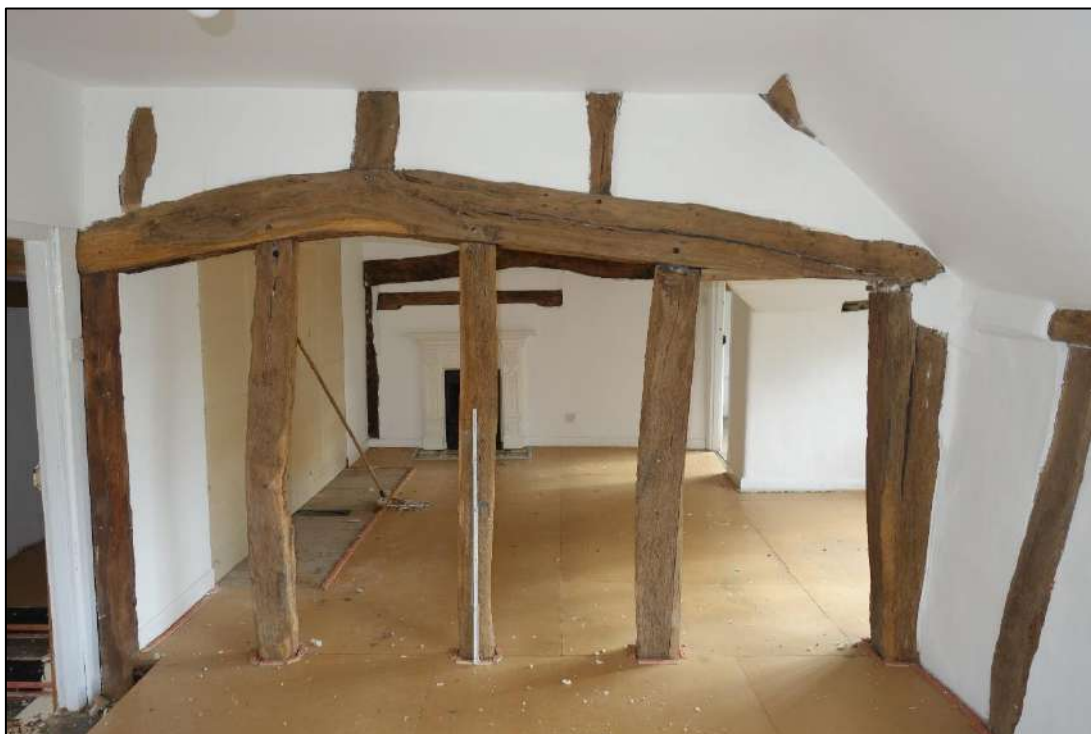
*Plate 36: Internal view looking E within W half of first floor bedroom showing curved tie-beam and studded partition*

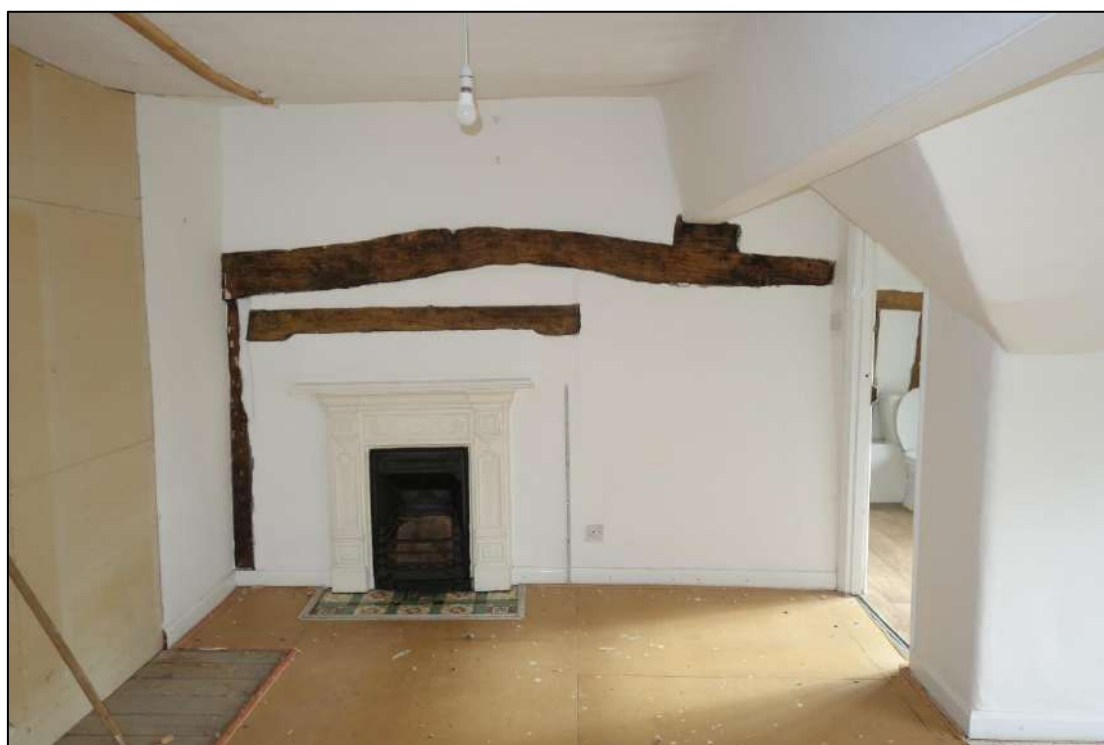
*Plate 37: Internal view looking E showing E end of Bedroom 1 with smoke-blackened beam in wall, above 19<sup>th</sup> century fireplace surround and grate*

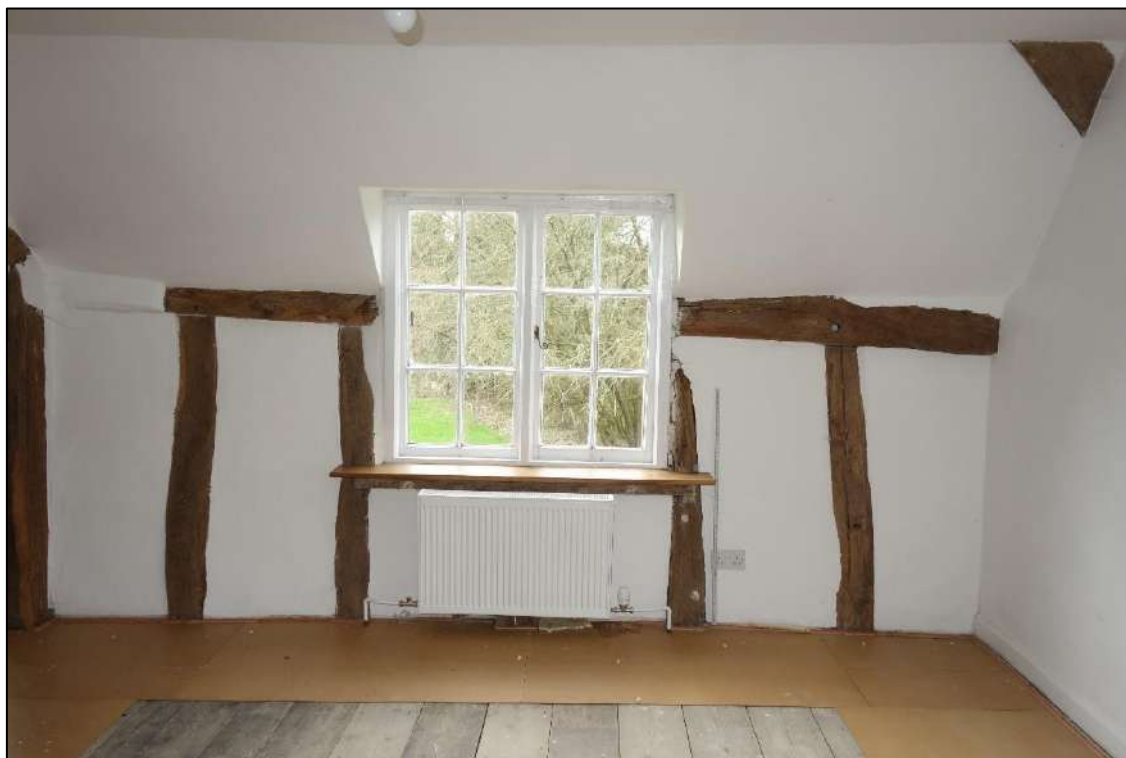
*Plate 38: View looking S showing casement window inserted within earlier timber-framed panels in S wall of Bedroom 1*

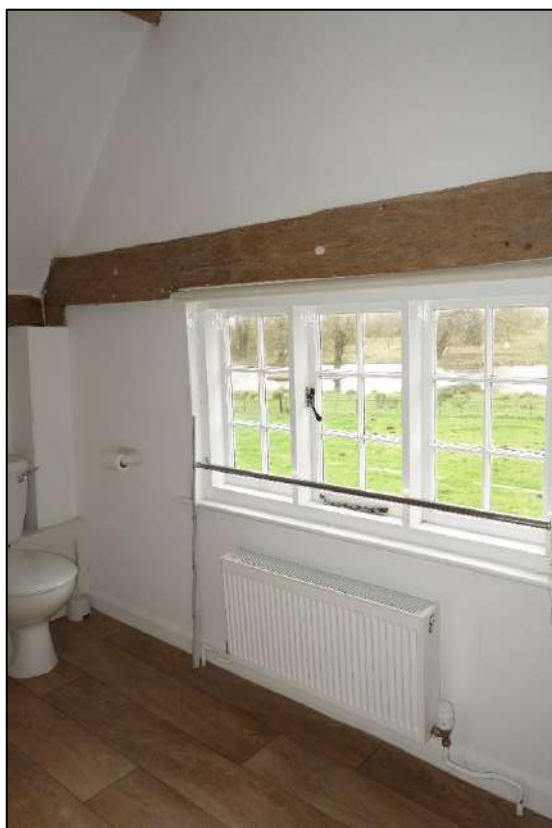
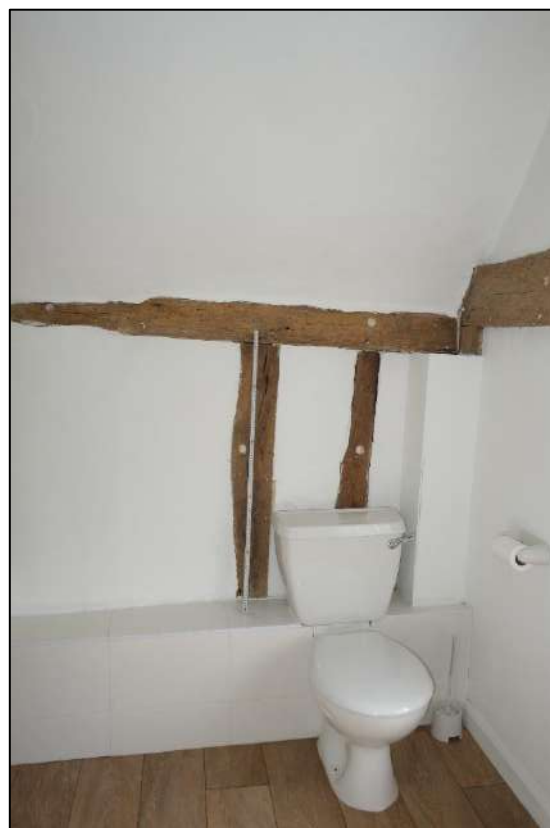
*Plate 39 View looking ESE within bathroom to SE of Bedroom 1 showing casement window with exposed beam above*  
*Plate 40: View looking E within bathroom to SE of Bedroom 1 showing exposed timber framing*

A partial section of exposed close-studded timber framing, possibly of 17<sup>th</sup> or 18<sup>th</sup> century date, is visible in the E wall behind the toilet (*Plate 40*); however, the section of wall immediately to the left of this, behind the existing bath, is clad and plaster and appears to have been heavily renewed, perhaps quite recently (*Plate 41*).

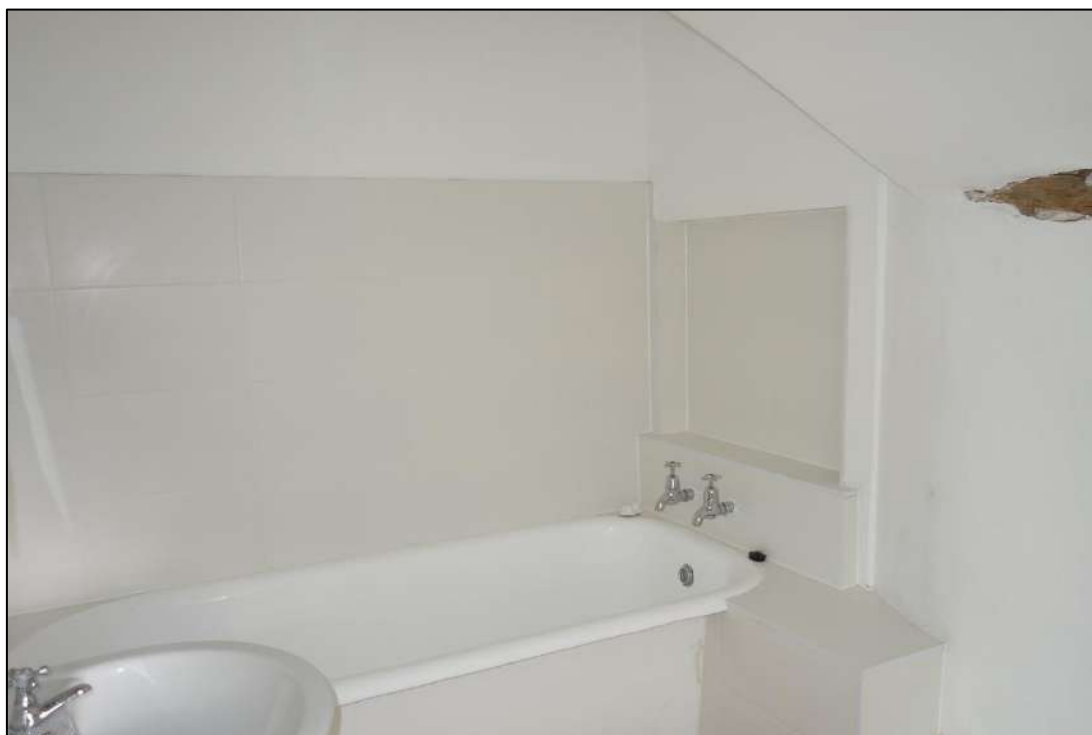
*Plate 41: View looking NE showing partition walls to N and E of bath suite in bathroom to SE of Bedroom 1*

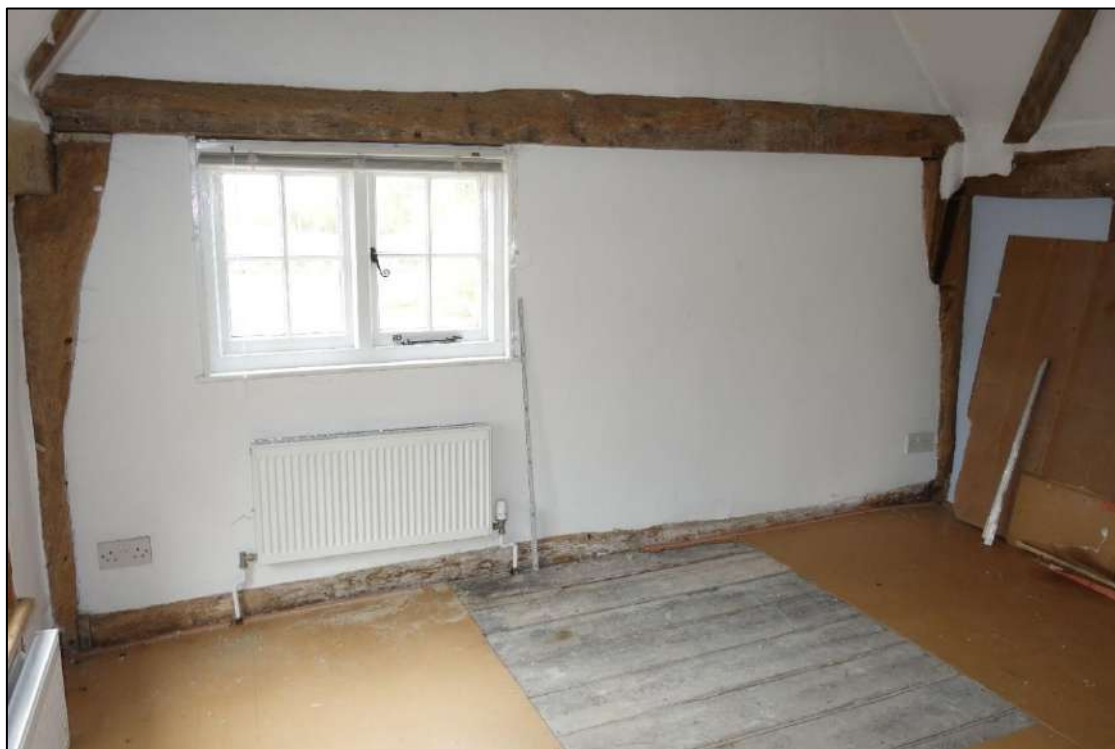
*Plate 44: View looking N showing N wall of Bedroom 2 with exposed timber wall plate and flanking jowelled posts*

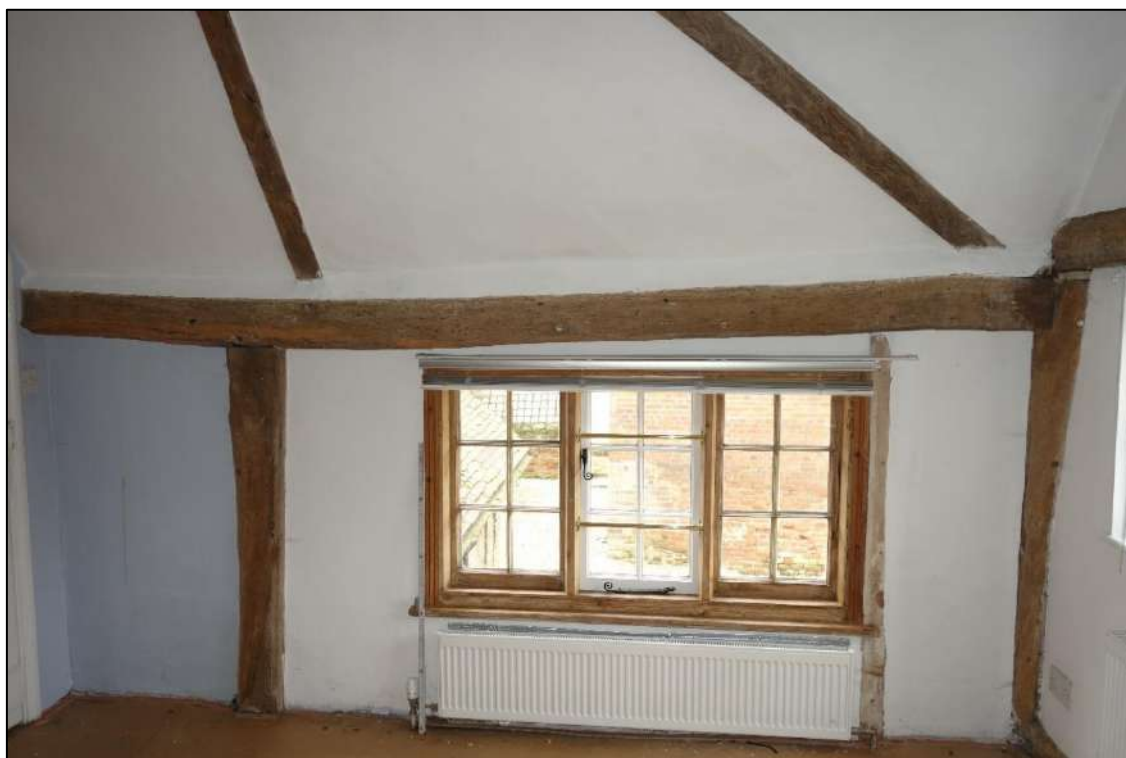
*Plate 45: View looking W showing W wall of Bedroom 2 with mullioned window and exposed timber-framing*

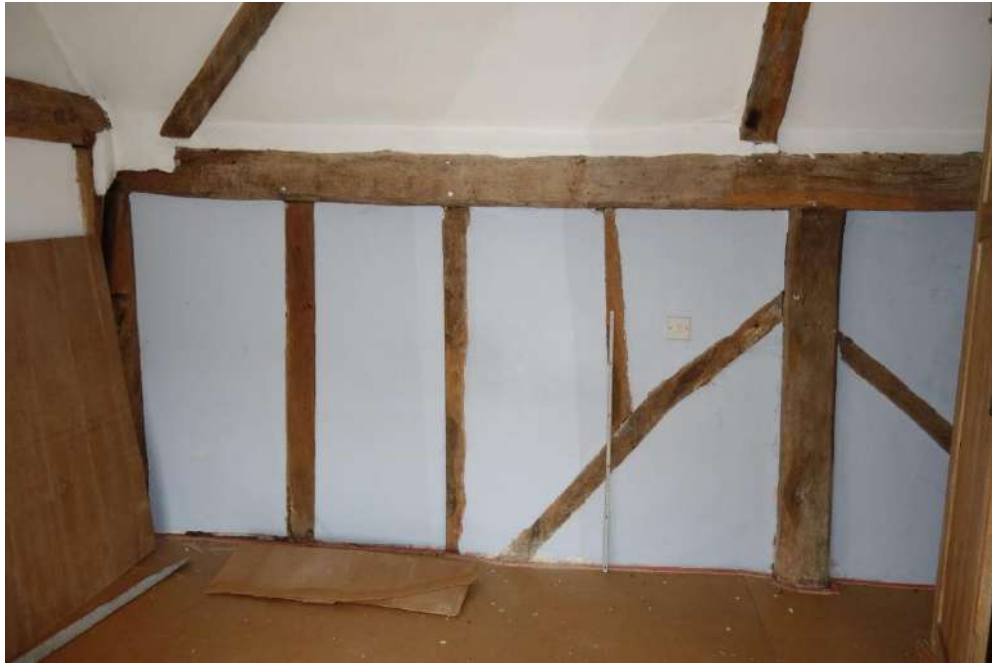
*Plate 46: Internal view looking E showing E wall of Bedroom 2 with exposed timber framed panels with vertical wall-posts and vertical and diagonal studding*

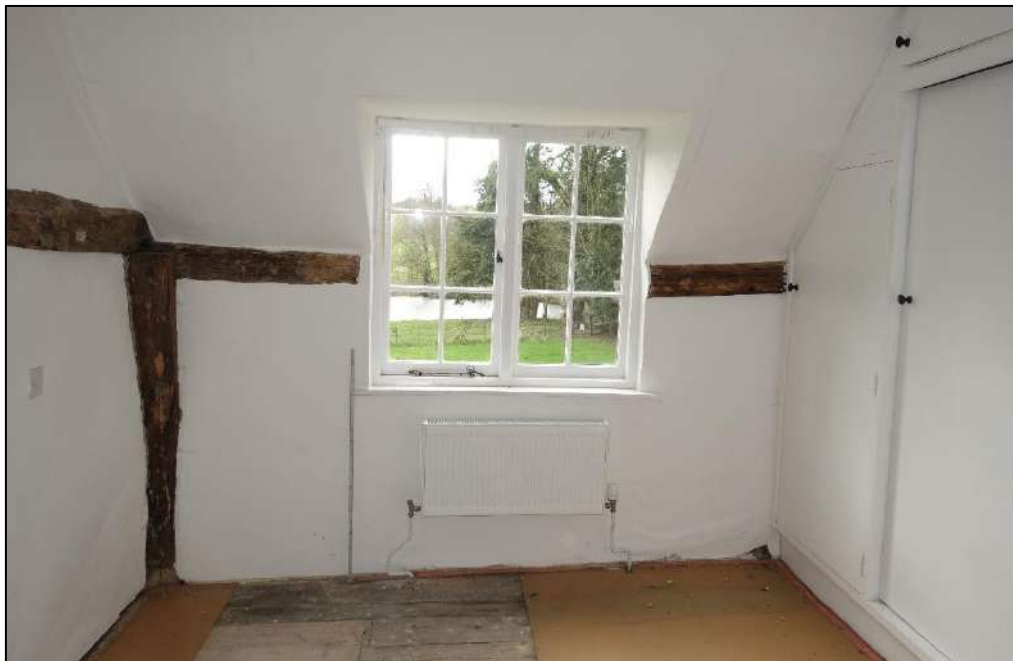
*Plate 47: View looking S showing interior of S portion of Bedroom 3 with exposed floorboard beneath window*

The bedroom to SE of the landing, within the S half of the cross wing (Bedroom 3) appears at some point in the past to have been partially truncated by the creation first floor landing and subsequently by the insertion of a boiler room immediately S of the landing. It has a coved ceiling and is lit by a 12-pane casement window which appears to have truncated an earlier timber-framed panel (*Plate 47*). Evidence of earlier floorboarding is visible towards the S end of the room.

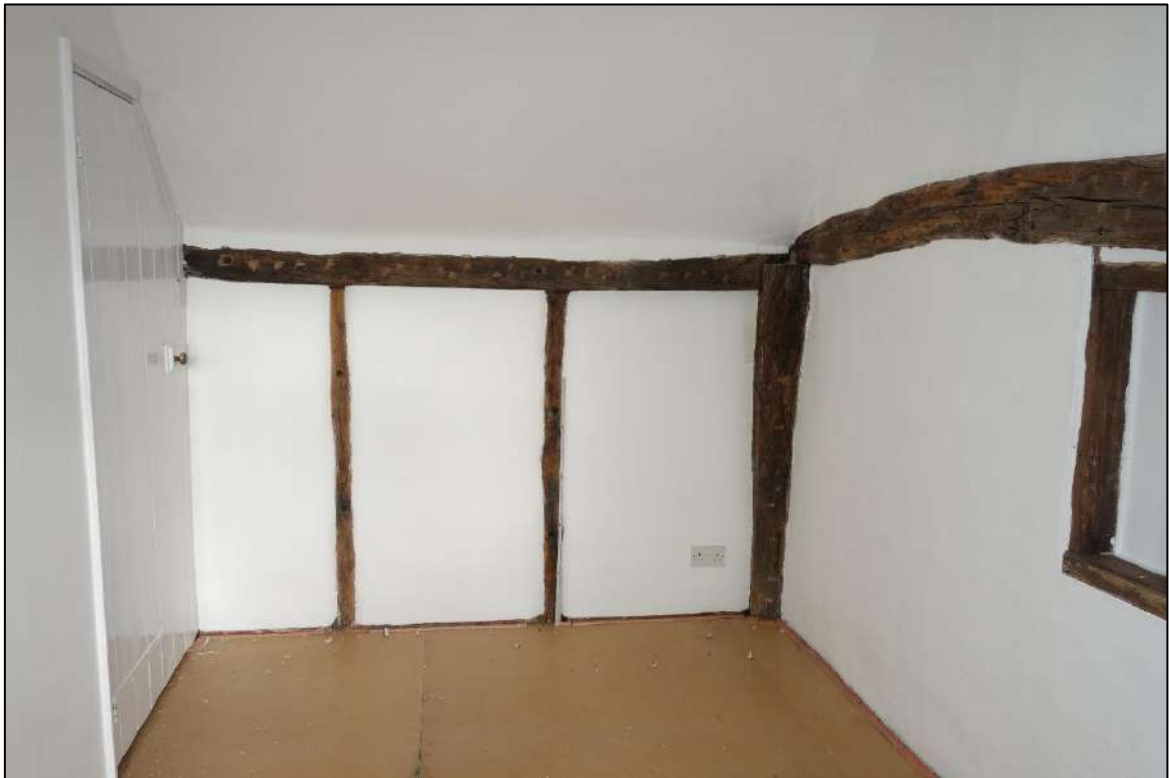
*Plate 48: View looking N showing thin-scantled timber-framed panels with plaster infill in N wall of Bedroom 3*

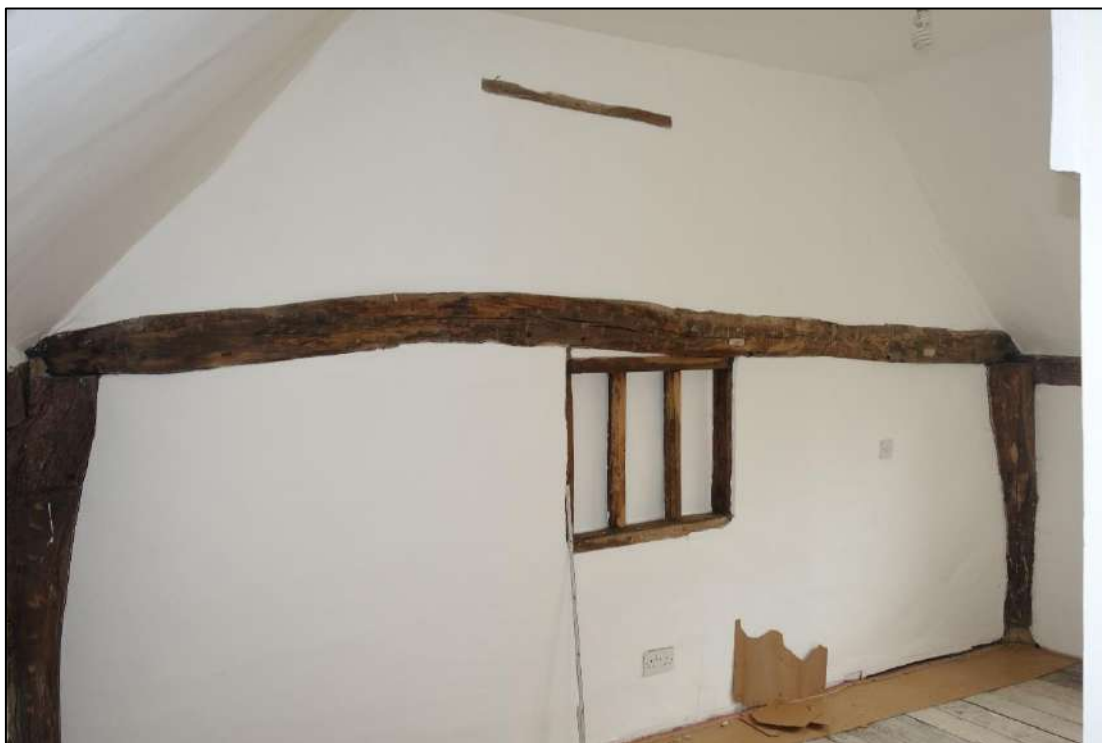
*Plate 49: View looking E showing E wall of Bedroom 3 with exposed timber-framing and blocked three-light mullioned window*

Of especial interest is the exposed timber framing in the E wall of Bedroom 3, with a three-light wooden mullioned window centrally placed in the E wall, which has been blocked up with plaster. Immediately above this blocked window is a curved, roughly hewn beam extending the full width of the wall and supported at either end by two jowelled wall posts (*Plate 49*). This window was set in the E gable of the cross wing and appears to have been blocked up when the upper stages of the gable were clad in weatherboarding, probably when the annexe housing the present Dining Room and Kitchen were added in the late 18<sup>th</sup> century.

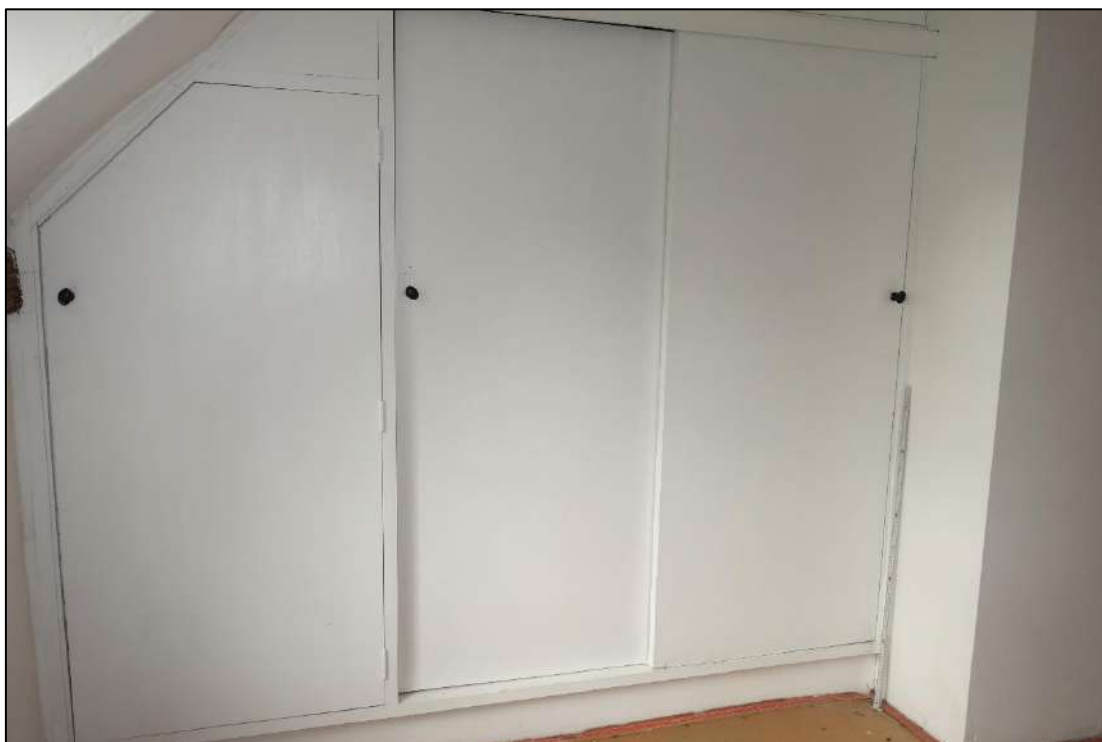
*Plate 50: View looking W showing modern wardrobe in W wall of Bedroom 3*

Three thin-scantled timber-framed panels with plaster infill, possibly of 17<sup>th</sup> century date, are visible in the N wall of Bedroom 3; these appear to have been truncated by the insertion of the existing W partition wall which must almost certainly be of 20<sup>th</sup> century date (*Plate 48*). It is possible that the existing modern wardrobe range along the W wall is contemporary with the insertion of this partition (*Plate 50*).

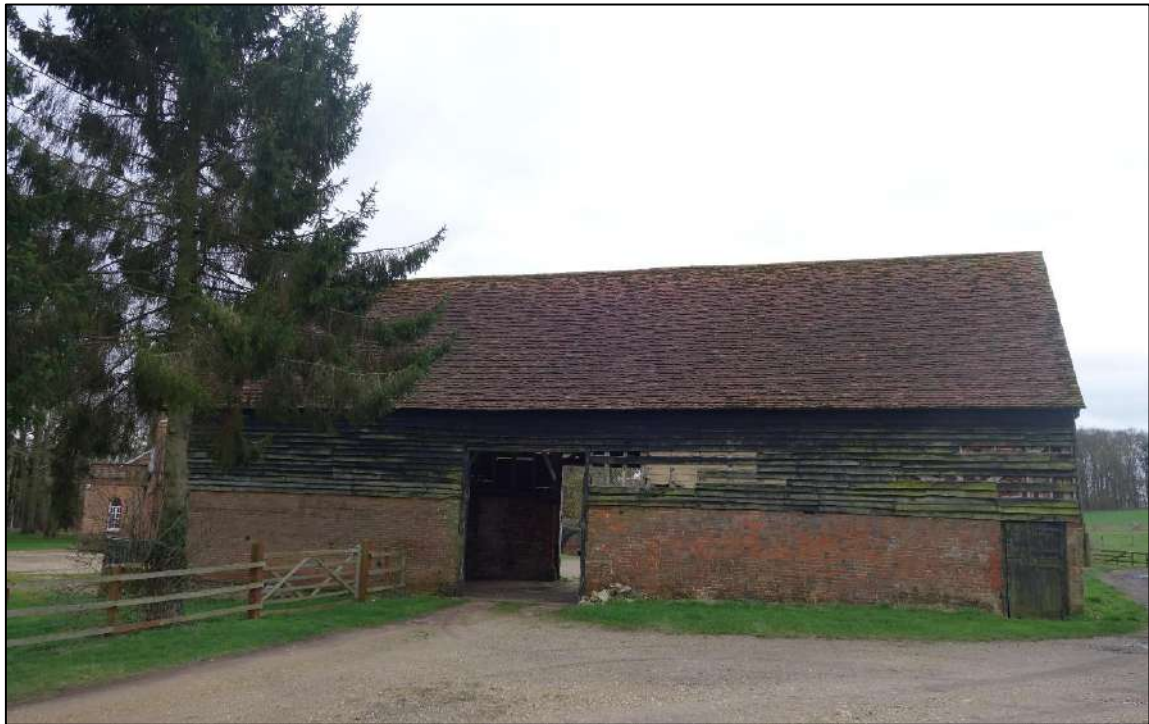
*Plate 51: View looking S showing N-facing elevation of Grade II listed Barn*

Inserted in the centre of the N and S-facing elevations are two tall, wide double door openings which would have provided access for wagons and sufficient draft for winnowing purposes). The 1837 tithe map shows a porch in front of the N-facing opening but this appears to have been removed and no trace of it is now visible.

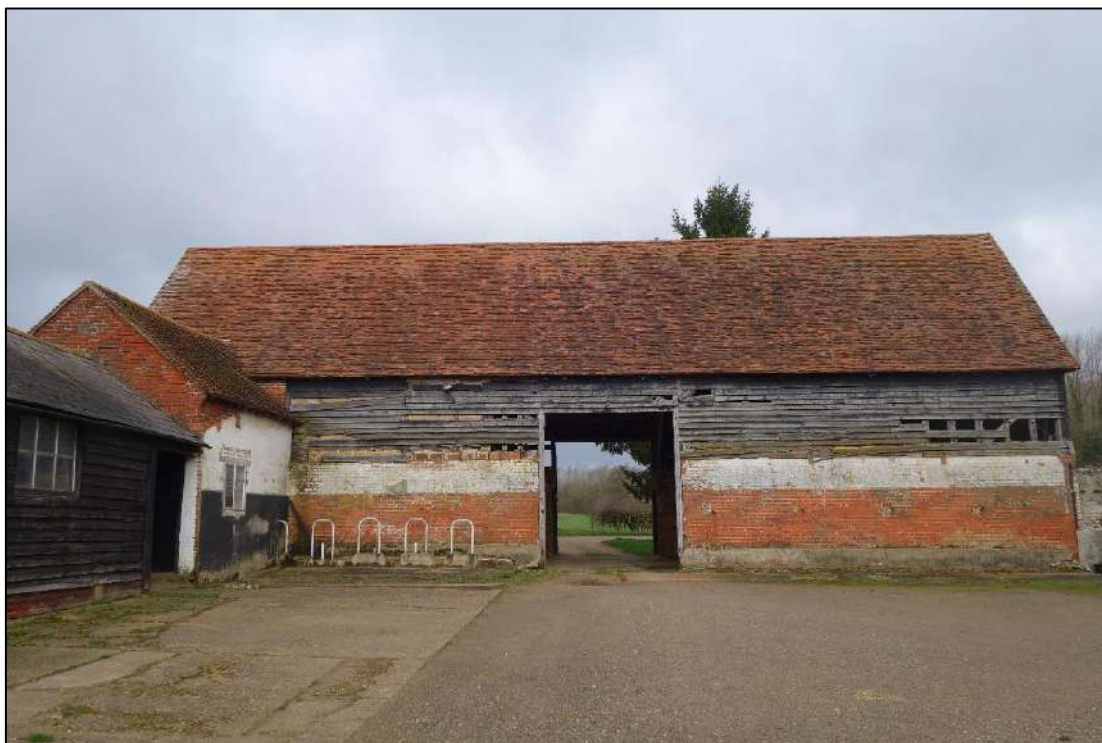
*Plate 52: View looking N showing S-facing elevation of Barn with partially whitewashed brickwork and indentations for former lean-to outbuilding*

The brickwork of the lower stages of the S-facing elevation has been partly coated in whitewash and indentations for beams associated with a lean-to outbuilding or open shed, which can probably be identified with a rectangular structure attached to this elevation depicted on Ordnance Survey maps dated 1897 and 1922 (*Plate 52*). It is likely that this outbuilding (which appears to have been demolished by the late 1990s) was utilised as accommodation for livestock as metal ties are still attached to the brickwork. A doorway at the W end of the N-facing elevation provided access to a room at the W end of the barn which may have been used as a chaff house with granary above (*Plate 53*).

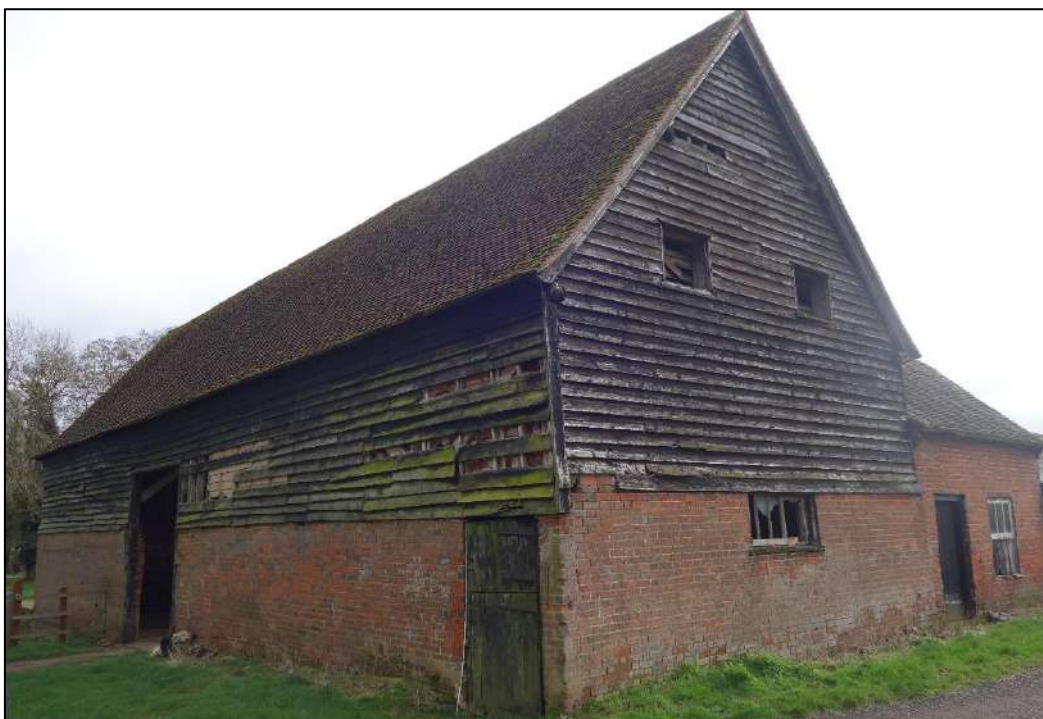
*Plate 53: View looking SE showing weatherboarded W-gable end of Barn with doorway to chaff room and granary at W end of barn and single storey annexe with pitched roof (tack room) to right of gable*

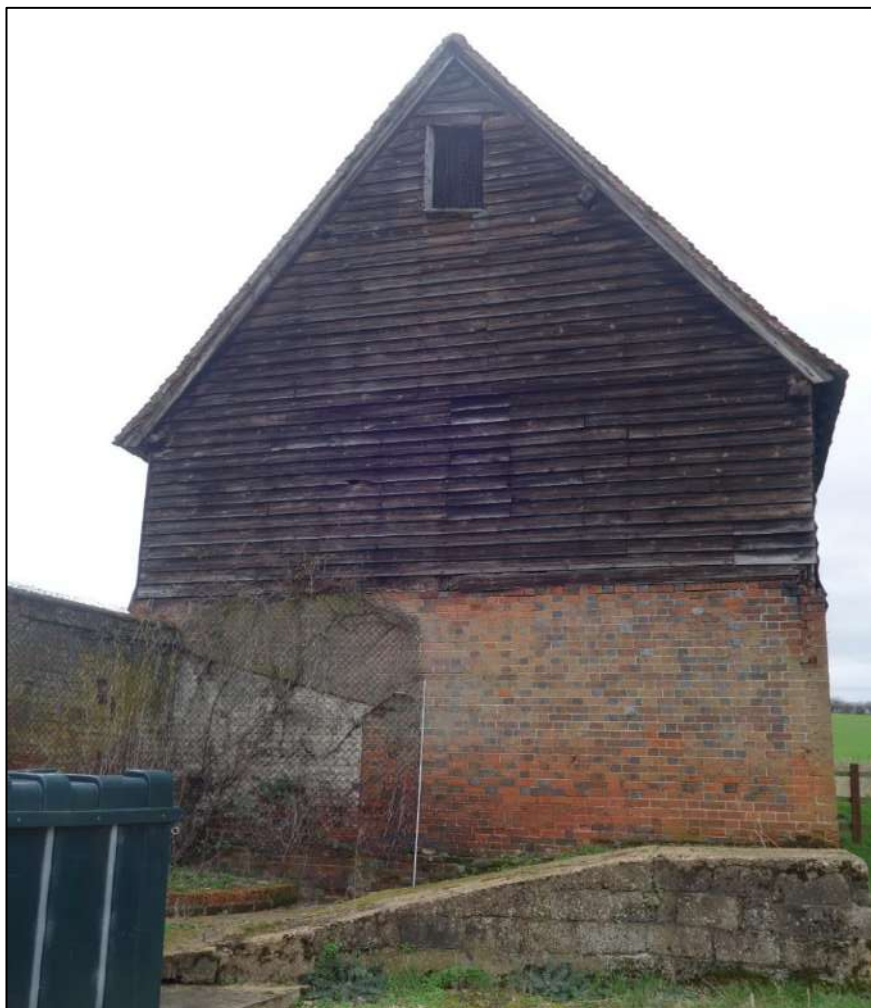
*Plate 54: View looking W showing E-gable end of Barn with outline of demolished early 20<sup>th</sup> century lean-to structure visible to left of picture*

The upper stages of the W and E gable ends of the Barn are both weatherboarded, with ventilation holes in the apex of both gables (*Plates 53 & 54*). The roofline of a lean-to structure is visible in the SE corner of the E-gable wall, below which is a section of whitewashed brickwork (*Plate 54*). It is likely that this relates to a small oblong structure situated immediately SE of the Barn and to the NW of the East Stable, which is first shown on the OS 3<sup>rd</sup> edition map of 1922 and appears to have survived intact at least until the 1970s. A section of whitewashed brick walling between the Barn and the East Stable may represent a remnant of this building. A concrete mounting block, possibly associated with this former structure, survives to the E of the Barn.

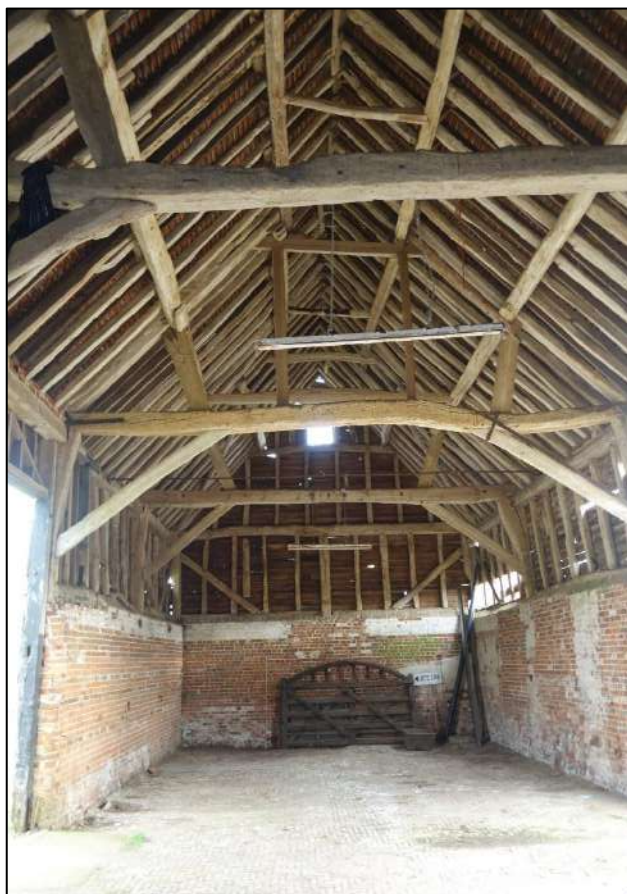
*Plate 55: View looking E showing central and E portion of Barn with queenpost roof structure*

The most notable feature within the interior of the Barn is evidently the substantial, elaborate queenpost roof structure, with vertical queen posts connecting the tie beam to the collar just below the the apex of the truss. The collar beam in turn carries a set of clasped purlins, with another set of purlins lower down, which are connected to the tie beam by a pair of angled struts. The form of the roof (and the presence of clasped purlins) suggests a probable date in the first half of the 17<sup>th</sup> century (*Plates 55 & 56*)

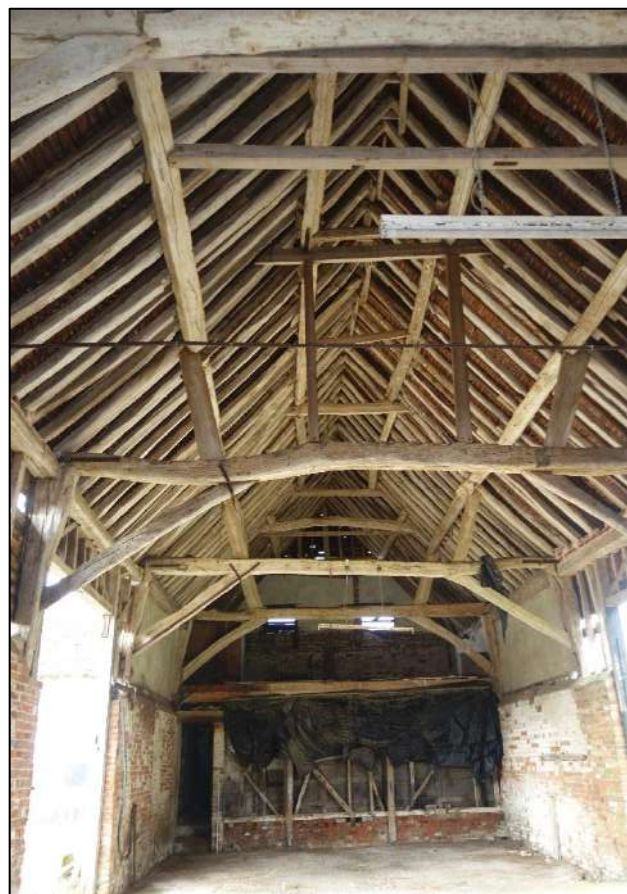
*Plate 56: View looking W showing roof structure in W half of barn with timber framed partition and granary loft at W end*

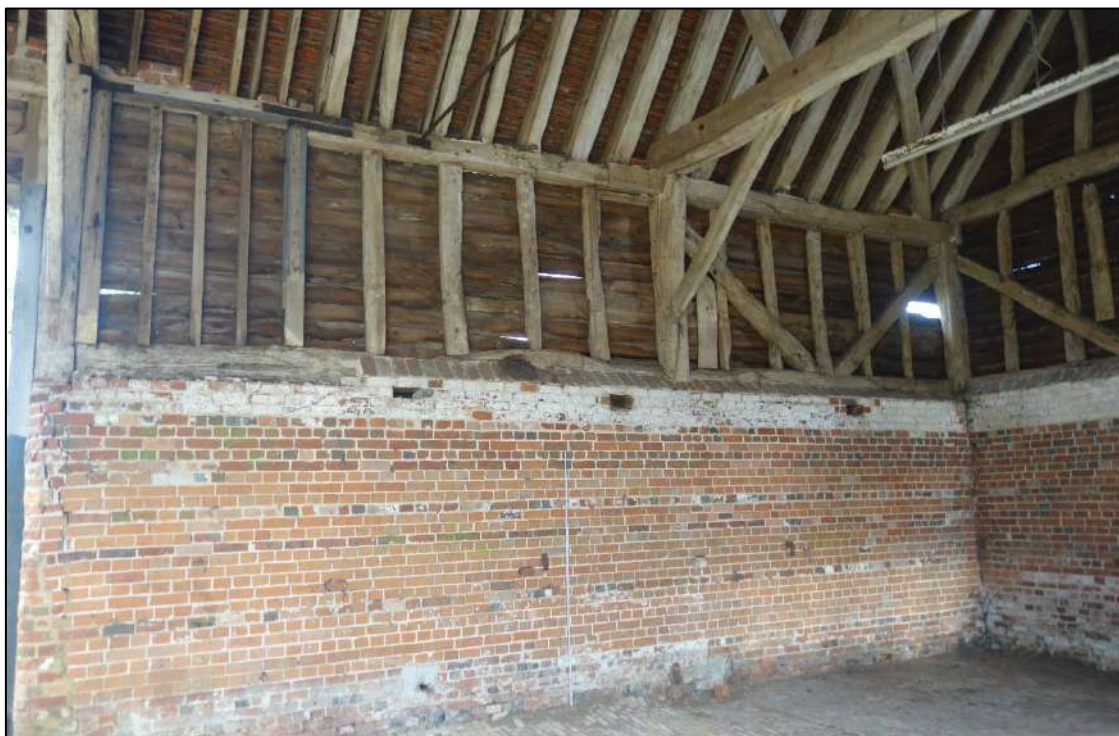
*Plate 57: Internal view looking NE showing partially whitewashed N wall of Barn with timber framed panels resting upon brick walls*

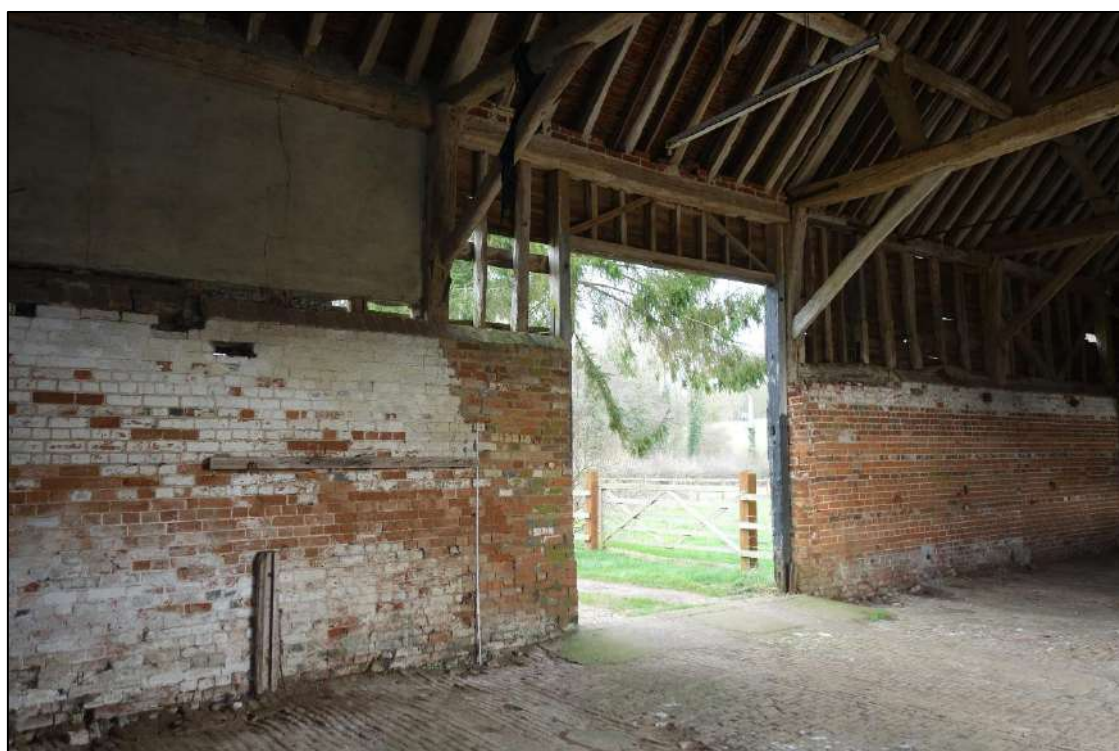
*Plate 58: Internal view of Barn looking NE showing N entrance flanked by whitewashed brick walls and brick cobbled threshing floor to right*
