## Heritage Statement

**Rye End Farm**  
**Codicote**  
**Hitchin**  
**Hertfordshire SG4 8SU**

February 2020

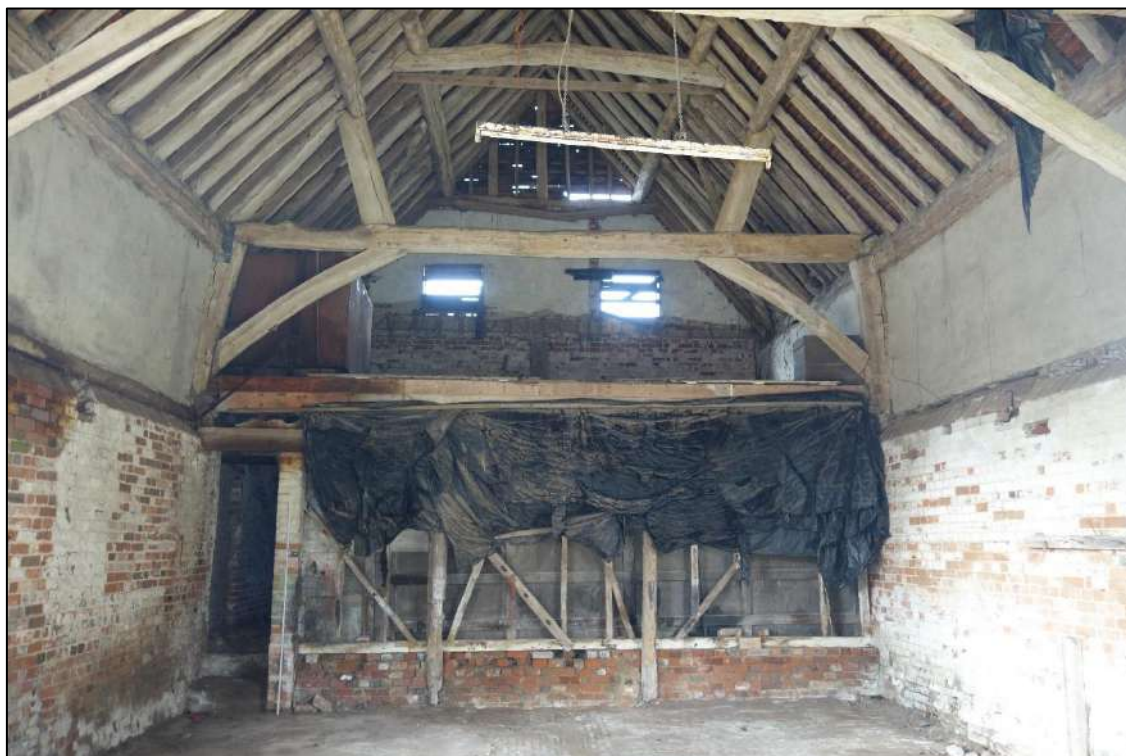
*Plate 59: Internal view showing brick and timber-framed partition at W end of Barn for chaff room and granary loft above*

At the W end of the Barn is a timber framed partition with vertical and diagonal studs resting on a dwarf brick wall which separates the westernmost bay from the rest of the Barn (*Plate 59*). A short flight of steps leads to a room at ground level which may have been used as a chaff room for storing husks from the grain crop (chaff), after it had been threshed and winnowed in the barn, with a loft above which may well have been used as a granary, as evidenced by the ventilation slots above (*Plate 60*).

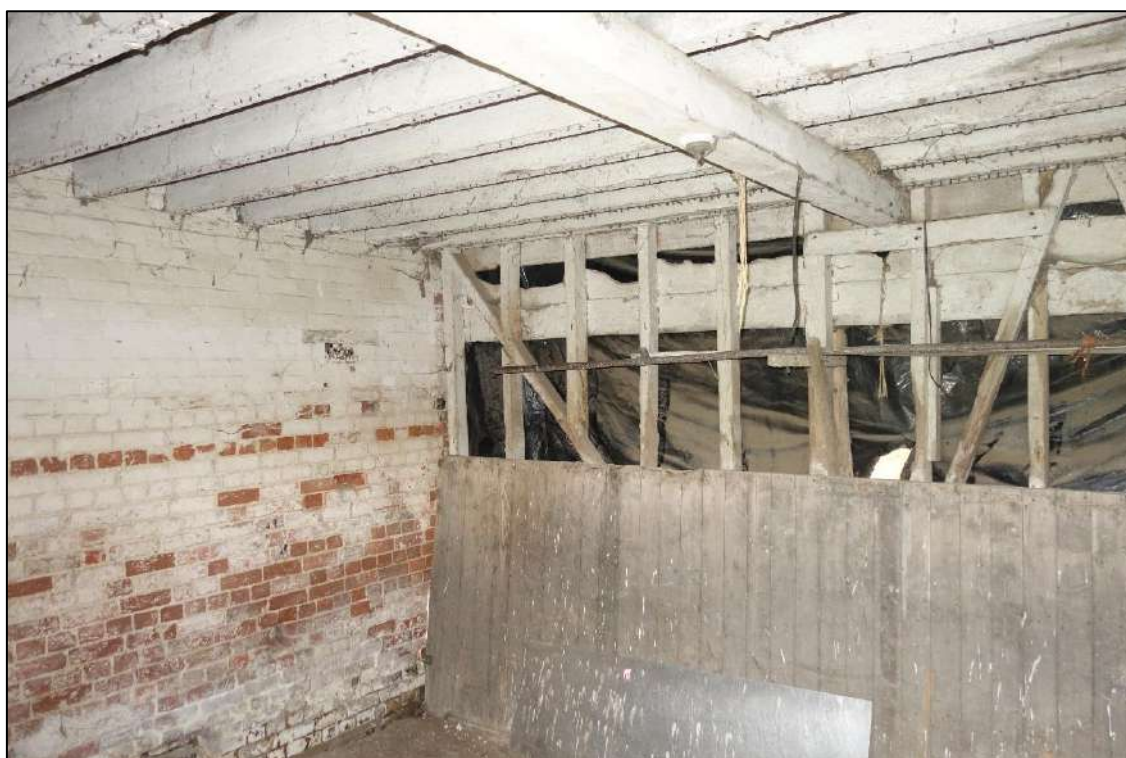
*Plate 60: View looking NE showing interior of chaff room below granary at W end of Barn*

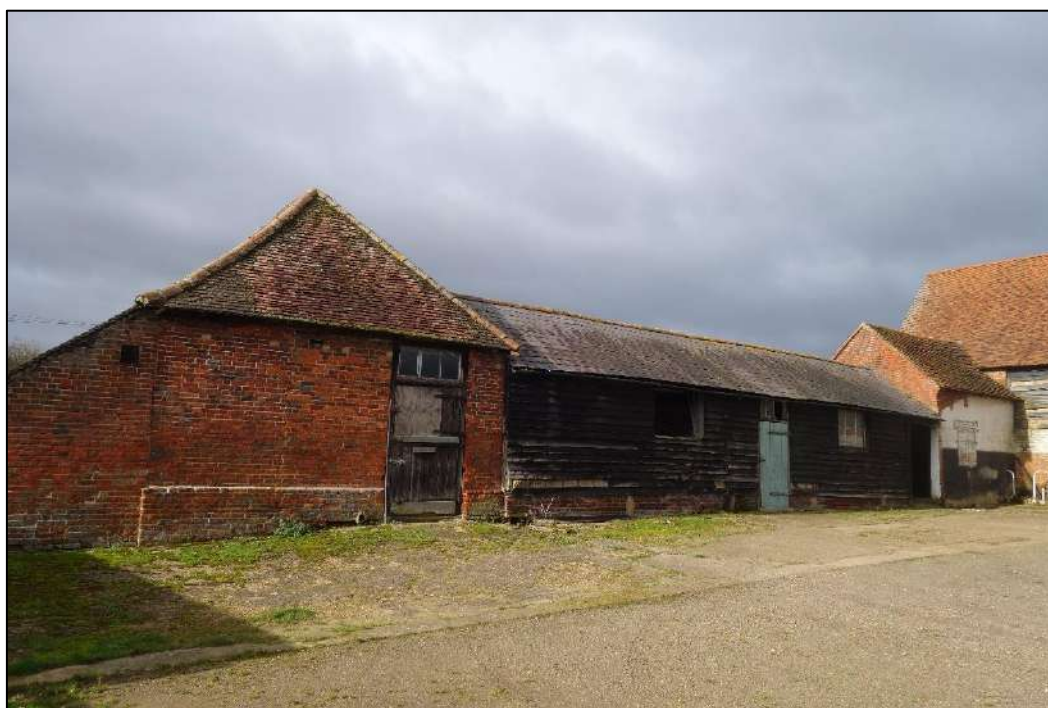
*Plate 61: Oblique view looking NW showing front (E-facing) elevation of West Stables*

Located along the W side of the courtyard is an extensive stable range comprising three distinct elements, which are described from N-S (*Plate 61*). At the N end of the range, projecting S from the SW corner of the Barn, is a single storey gabled brick structure with a clay tiled roof housing a 'tack room' (used for the drying of harness), which is lit by a two-light casement window in the front (E-facing) elevation with a doorway and segmental arched casement window to the rear (*Plate 62*). It is likely that this gabled structure was added in the late 18<sup>th</sup> or early 19<sup>th</sup> century, contemporary with the reconstruction in brick of the lower stages of the Barn. The exterior of the E-facing elevation is whitewashed, which probably dates from when a lean-to outbuilding range was erected to the S of the Barn in the late 19<sup>th</sup> century.

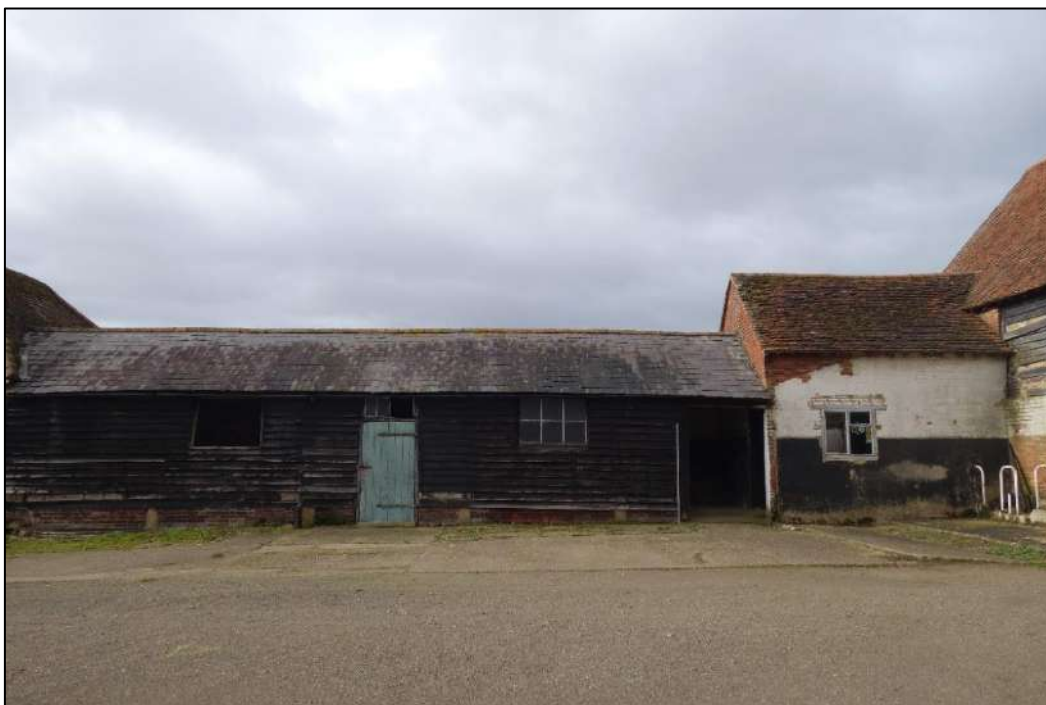
*Plate 62: View looking W showing single storey gabled brick 'tack room' with adjoining weatherboarded stable range to left*

Attached to the S end of the gabled block is a three-bay stable block with a pitched slate roof with weatherboarding on the front (E-facing) elevation while the rear (W-facing) wall is of red brick construction. This range in its present form appears to have been started in the early 19<sup>th</sup> century but was not fully completed until the early 1880s. There are two doorways in the front (E-facing) elevation of the weatherboarded range, one being located at the N end of the range and the other within the central bay. The latter has a plank and batten door with a glazed light above, flanked by two windows placed immediately below eaves level; the right-hand window has a glazed casement while the glazing in the left-hand window has been replaced by metal grille (*Plate 62*).

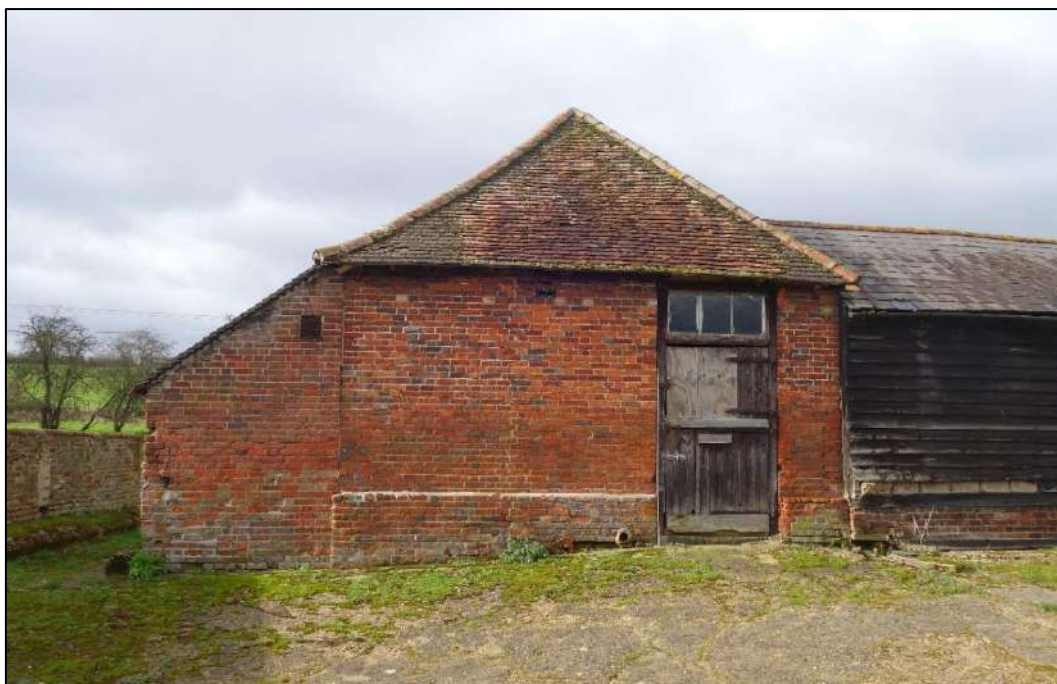
*Plate 63: View looking W showing brick stable block at S end of West Stables with pyramidal tiled roof and attached lean-to piggy to S*

At the S end of this range is a substantial rectangular single-storey stable block constructed of chequered red brick with a pyramidal tiled roof; inserted in the E-facing elevation is a tall plank and batten stable door with glazed light above, extending up to eaves level (*Plate 63*).

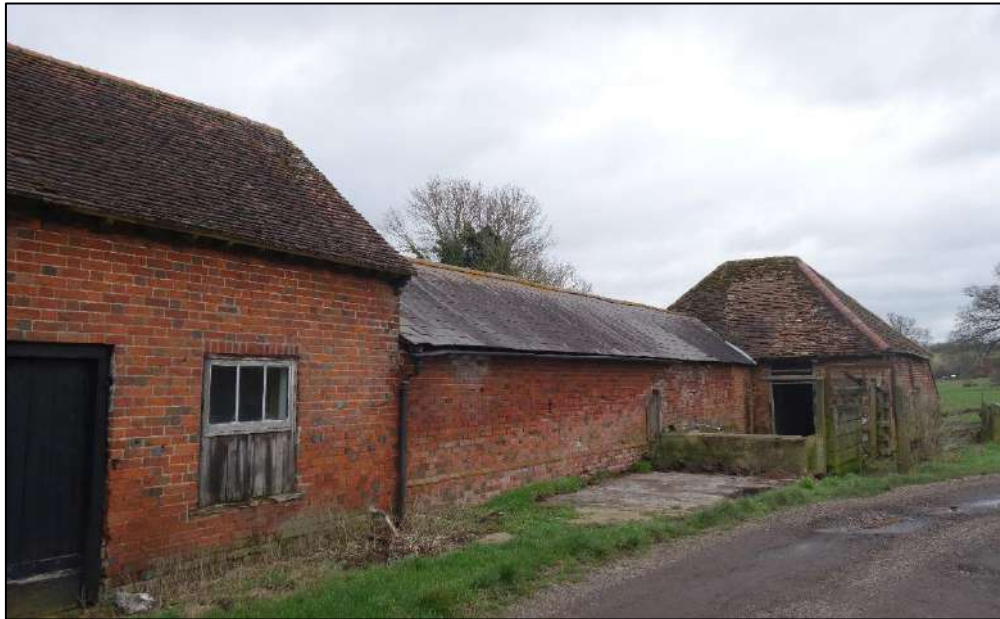
*Plate 64: Oblique view looking SE along rear elevation of West Stables towards late 18<sup>th</sup>-early 19<sup>th</sup> century stable block with pyramidal roof at its S end*

This brick stable block originally appears to have been a free-standing structure (as shown on the 1837 tithe map) and can probably be assigned late 18<sup>th</sup> or early 19<sup>th</sup> century date. It appears that this free-standing structure was finally linked to the stable range immediately N of it at some time in the mid-19<sup>th</sup> century (between 1837 and 1881), as indicated by a construction break towards the S end of the rear elevation of the three-bay range (*Plate 64*). Attached to the S end of the brick stable block is a lean-to brick piggery with tiled roof which appears to have been a slightly later addition, possibly of early to mid-19<sup>th</sup> century date.

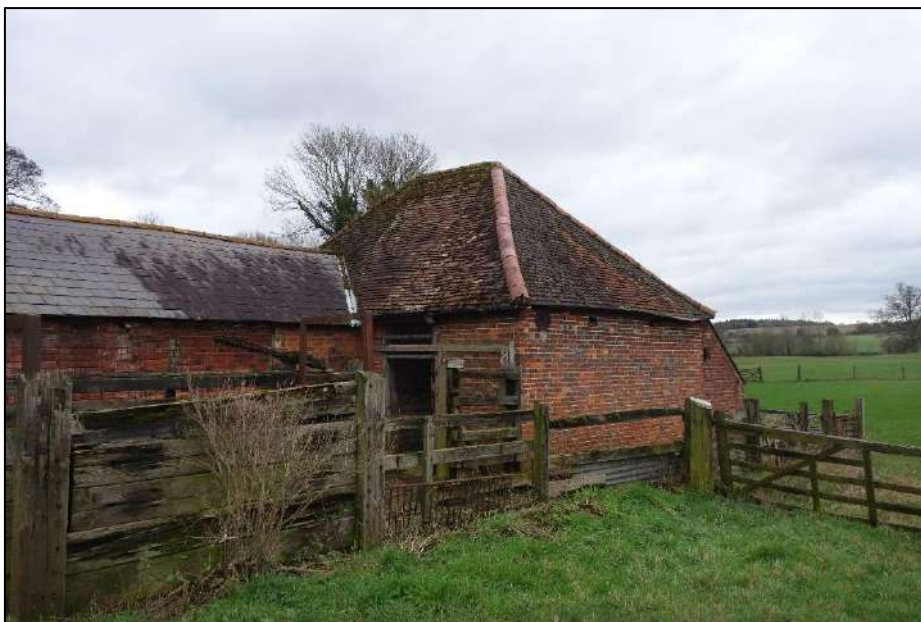
*Plate 65: View looking SE towards two-bay stable block with pyramidal tiled roof*

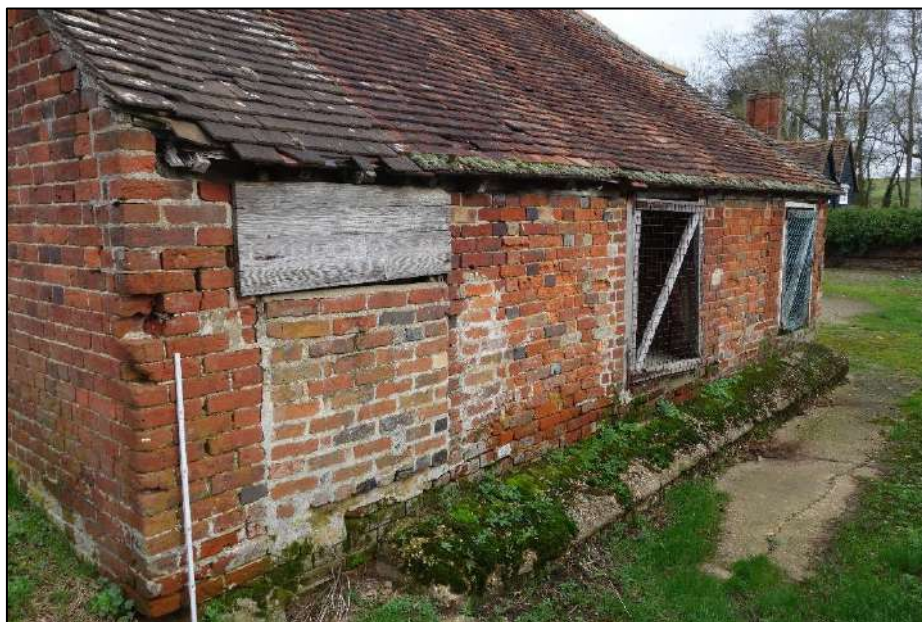
*Plate 66: View looking NE towards lean-to brick piggery attached to the S end of the stable block*

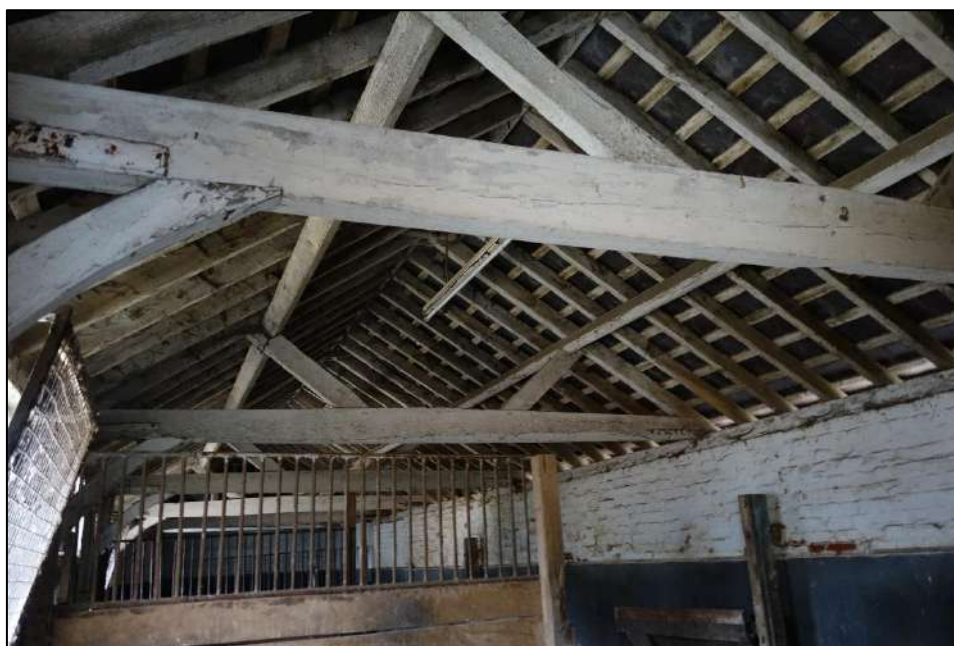
*Plate 67: View looking S along central portion of three-bay stable range, showing loose box partitions and roof trusses*

Due to access constraints it was not possible to access the 'tack house' at the N end of the range; it appears to have a fireplace in the S wall although the chimney stack was removed some time ago. The interior of the weatherboarded stable range has whitewashed walls and is arranged into three loose boxes separated by planked timber and metal rail partitions which appear to be modern in date although the positions they occupy may well be historic (*Plate 67*).

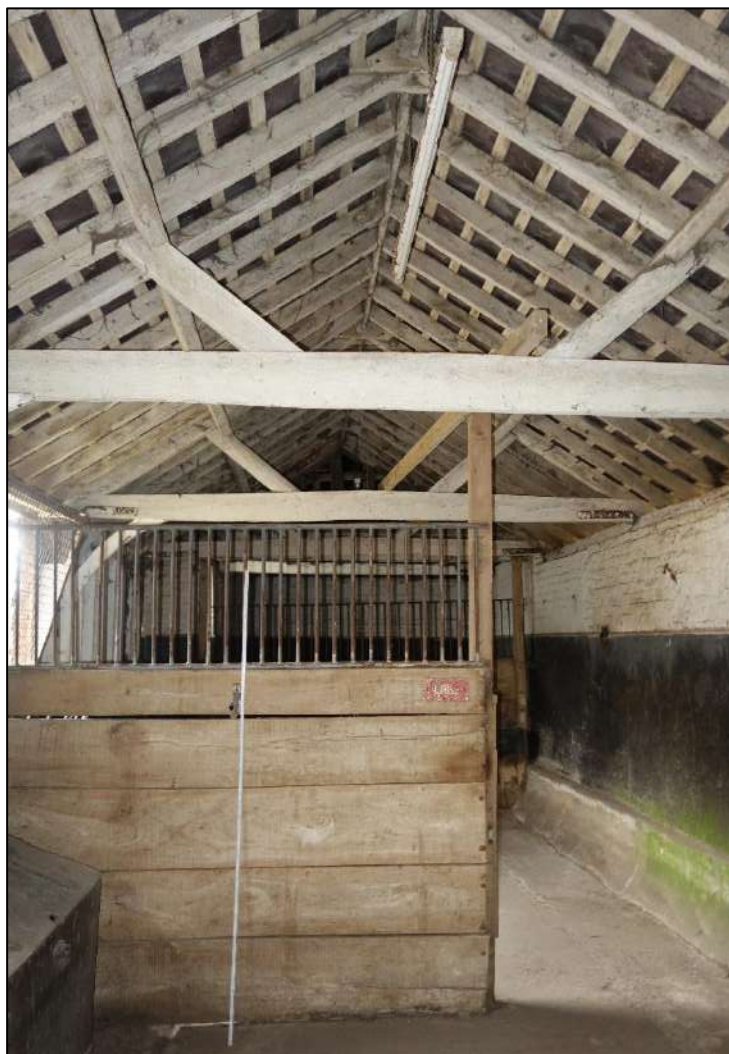
*Plate 68: View looking S showing loose box partitions and open roof structure in S bay of weatherboarded stable range*

The most distinctive feature within the three-bay stable range is the open truss roof structure with angled struts connecting the tie beam to the principal rafters, which in turn are linked by a pair of treenched purlins (Plates 68 & 69). The form of the roof trusses suggests a probable early to mid-19<sup>th</sup> century date which would seem to correspond well with the available cartographic evidence.

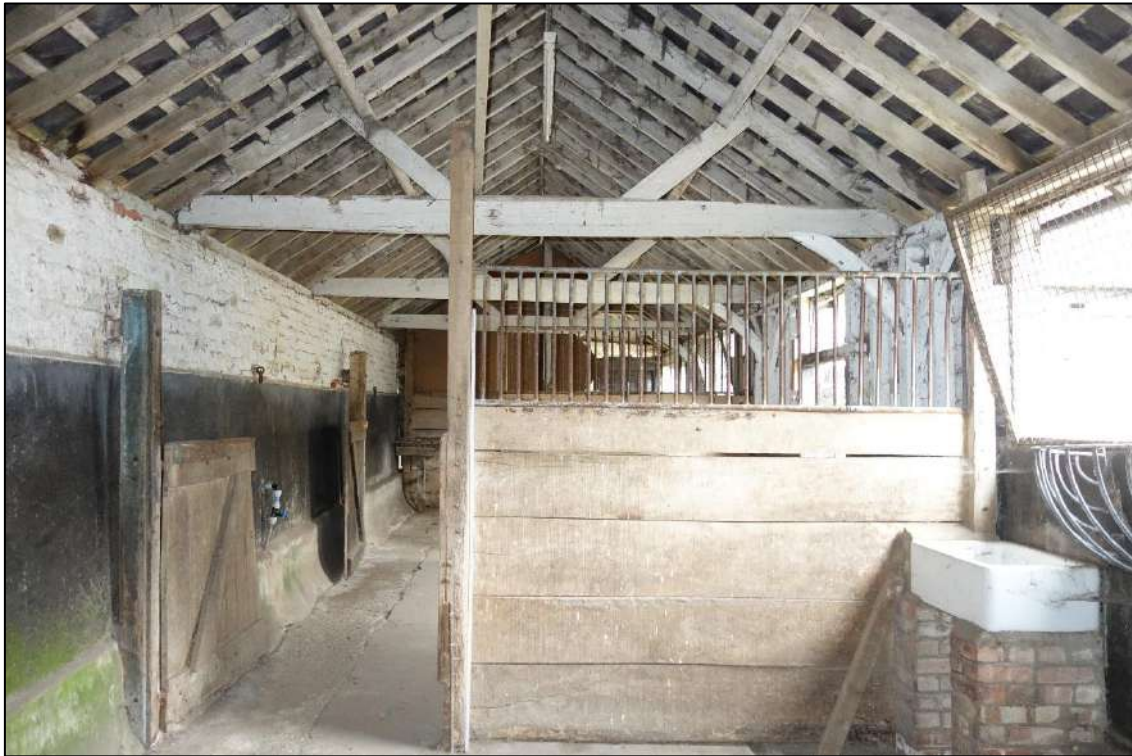
*Plate 69: View looking N within weatherboarded stable range showing detail of open-truss roof structure*

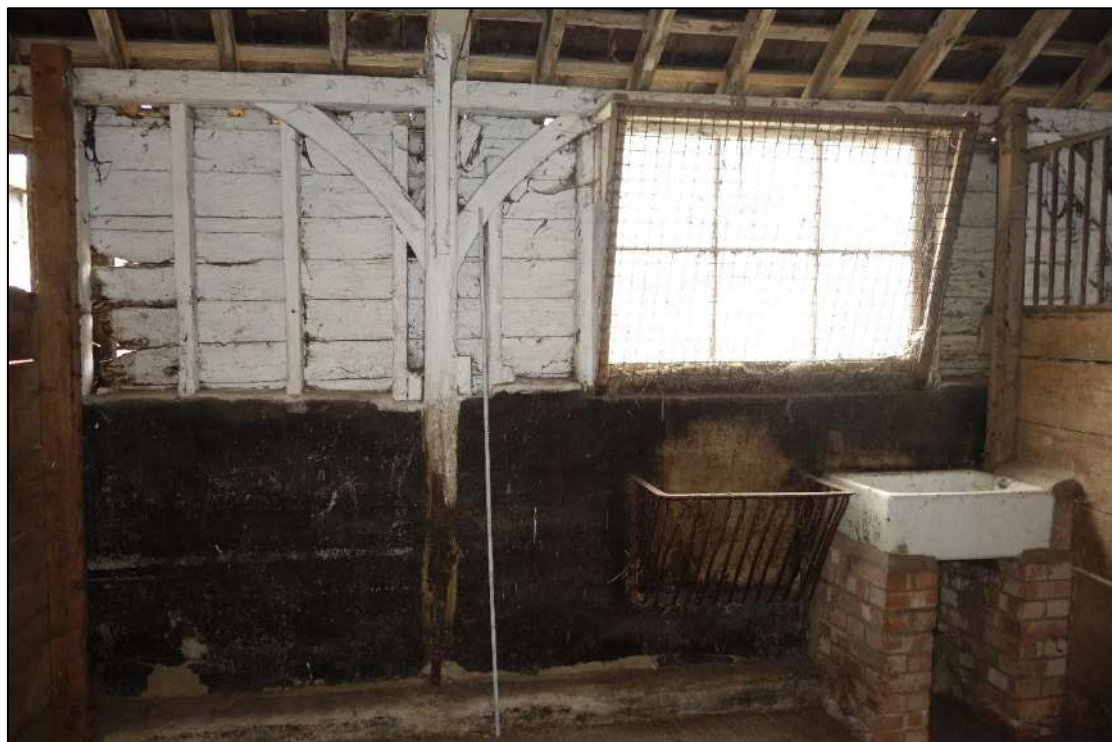
*Plate 70: View looking E showing vertical wall posts and studding along E wall of stable range*

The subdivisions within the bays are marked by a series of vertical timber wall posts along the E wall, each of which has curved braces linking to the tie beam and two flanking curved braces on either side connecting to the wall plate (Plate 70). The wall itself has close studded timber-framed panels to support the weatherboarding. It is evident that the stables have been in use until very recently and considerable evidence of fixtures and fittings associated with their usage have survived throughout this range, including racks, troughs and mangers.

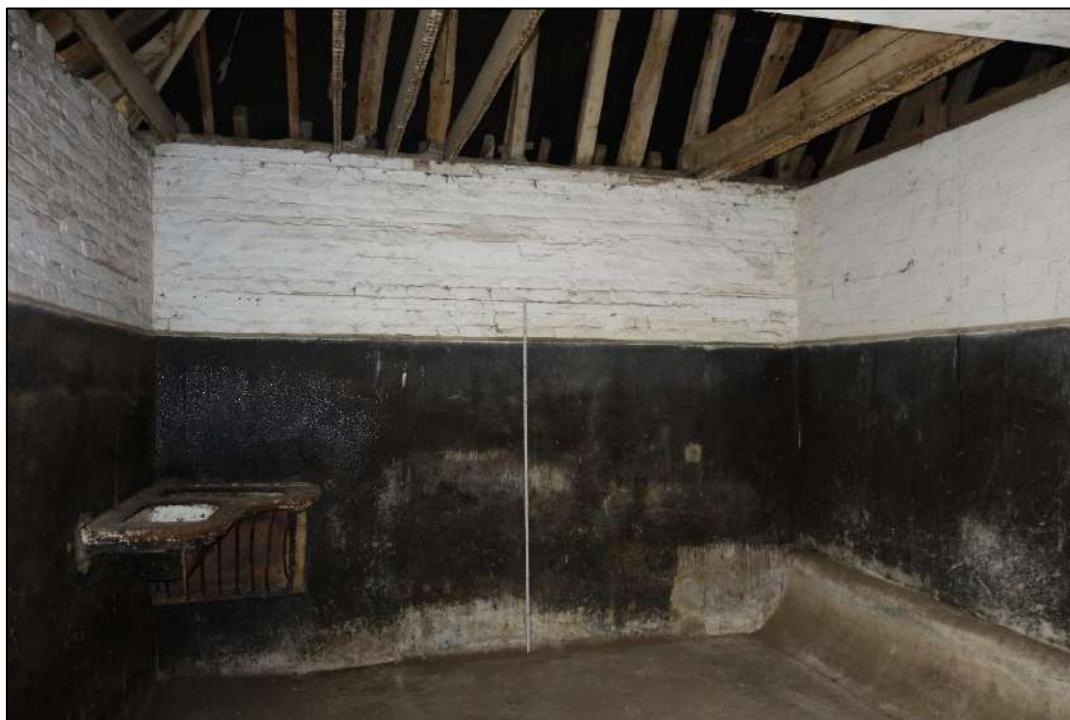
*Plate 72: View looking S within eastern compartment of stable block at S end of West Stables*

At some point, possibly in the late 19<sup>th</sup> century, it appears that a brick wall aligned N-S was inserted, subdividing the stable into two separate compartments, possibly to provide separate accommodation for a mare in foal. This subdivision is clearly marked on the OS 1<sup>st</sup> edition map of 1881. The walls of both compartments within the stable block are coated in whitewash and apart from a feeding trough in the eastern compartment few fixtures and fittings survive (*Plates 72 & 73*).

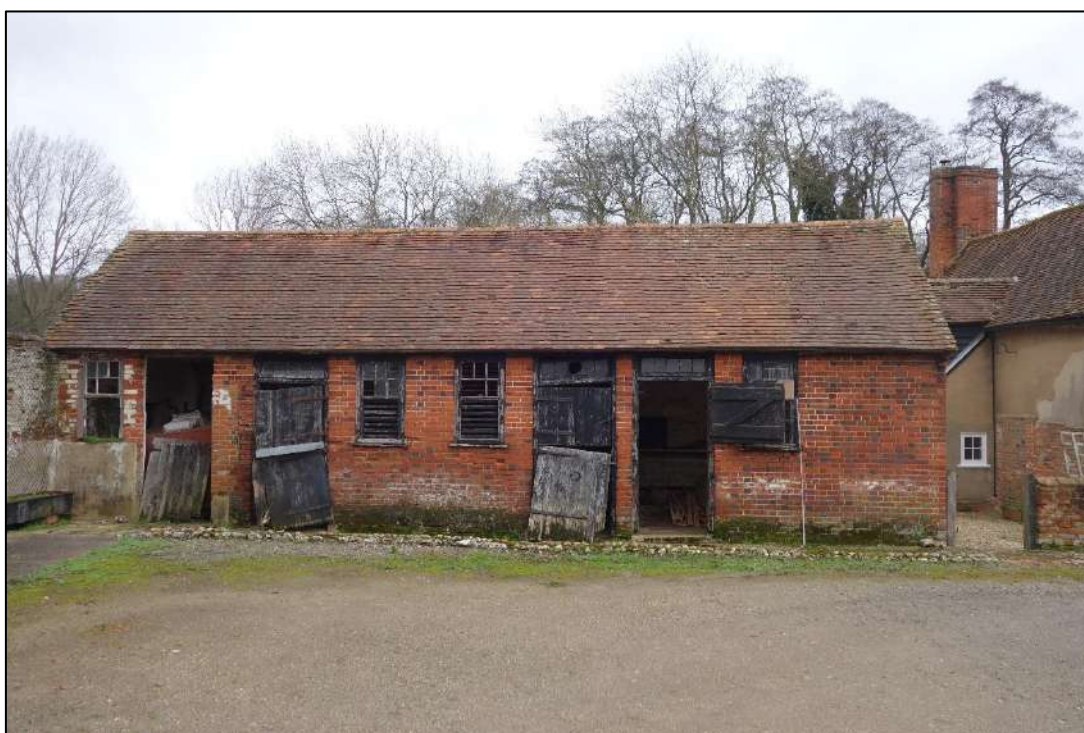
*Plate 74: View looking E showing principal W-facing elevation of East Stables with farmhouse to right of picture*

Located along the E side of the courtyard, immediately NW of the farmhouse is a gabled single-storey stable block, four bays in length (aligned N-S) and constructed of red brick with a steeply pitched clay tile roof (*Plate 74*). Cartographic evidence clearly indicates that this stable block was constructed at some point between 1837 (as it is not shown on the Kimpton tithe map of that date) and 1881 (when it first appears on the OS 1<sup>st</sup> edition map). The brickwork is partially whitewashed towards the N end of the range, which may be associated with a lean-to outbuilding marked in this location on late 19<sup>th</sup>/early 20<sup>th</sup> century OS mapping.

The W-facing elevation has two pairs of plank and batten doors with glazed lights above (extending up to eaves level) set towards the N and S ends of the range; these doors are flanked on either side by part-glazed flat-arched windows, the lower portions of which are glazed with horizontal wooden staves. Within the S gable end of the range is a single tall segmental arched window.

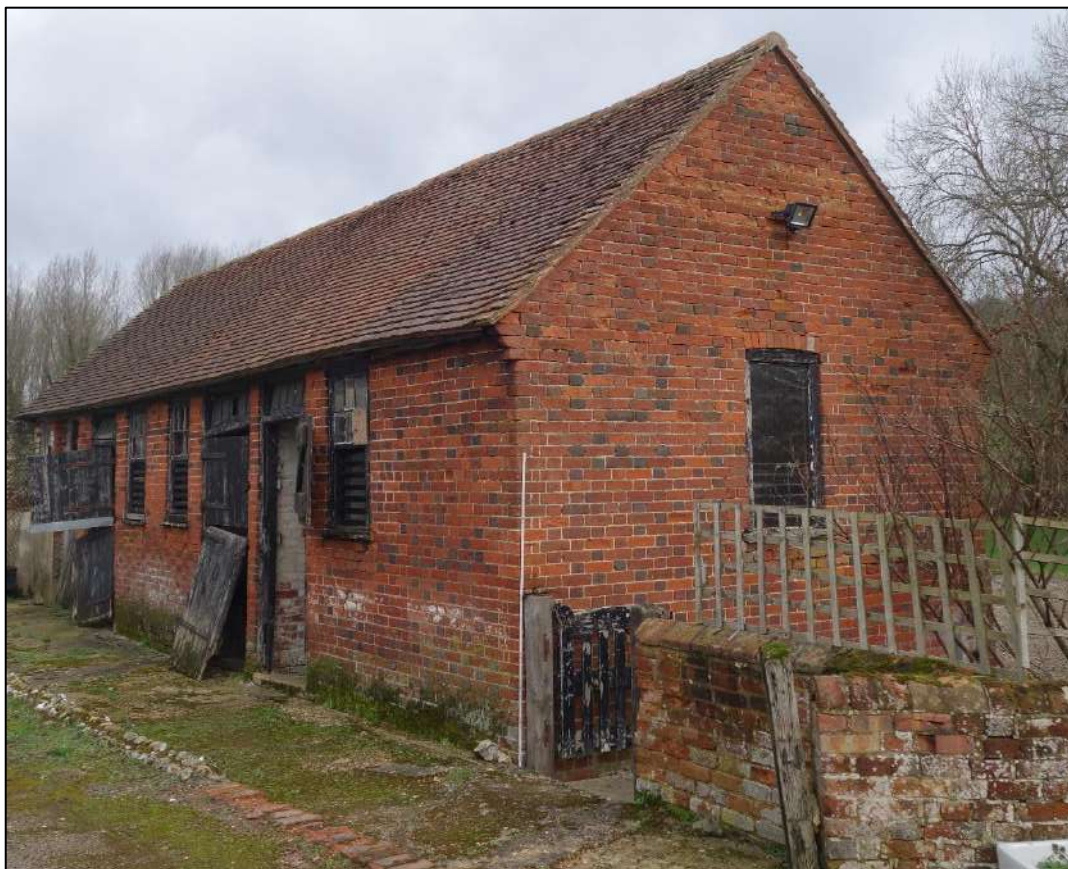
*Plate 75: Oblique view looking NE showing S gable end of East Stables with segmental arched window in gable*

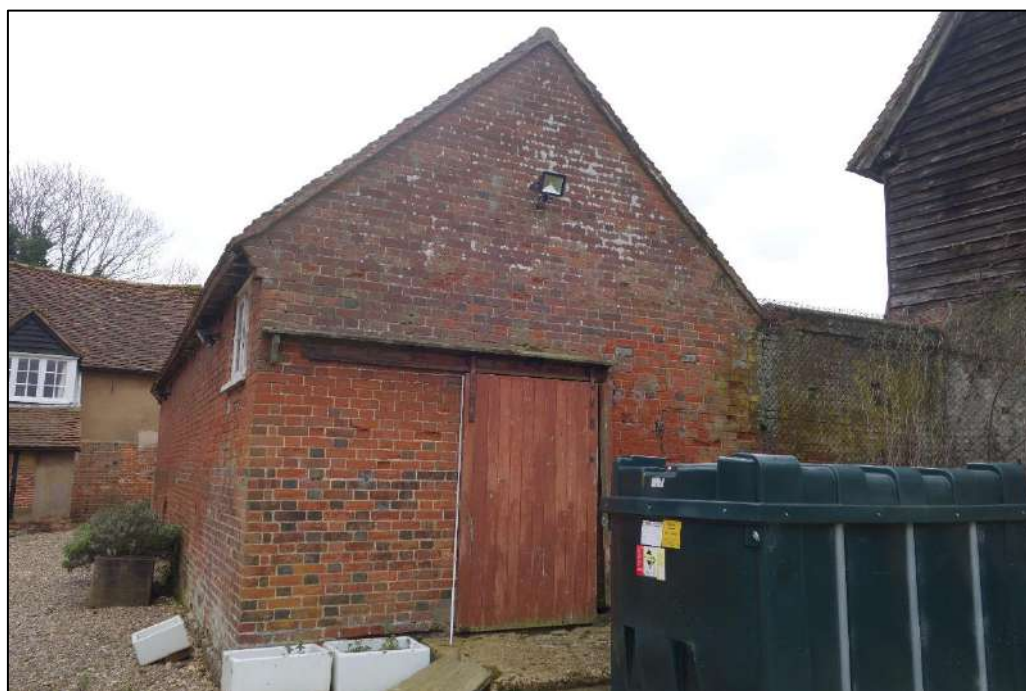
*Plate 76: View looking SSW showing N-gable end of East Stables with modern sliding door inserted for dairy*

The E-facing elevation is largely devoid of fenestration except for a small casement window in the SE corner. A sliding door has been inserted in the N-gable end of the stable range which appears to be of early to mid-20<sup>th</sup> century date and may well be associated with the usage of this part of the building as a dairy. Local newspaper records appear to indicate that Rye End Farm was predominantly a dairy farm in the first half of the 20<sup>th</sup> century.

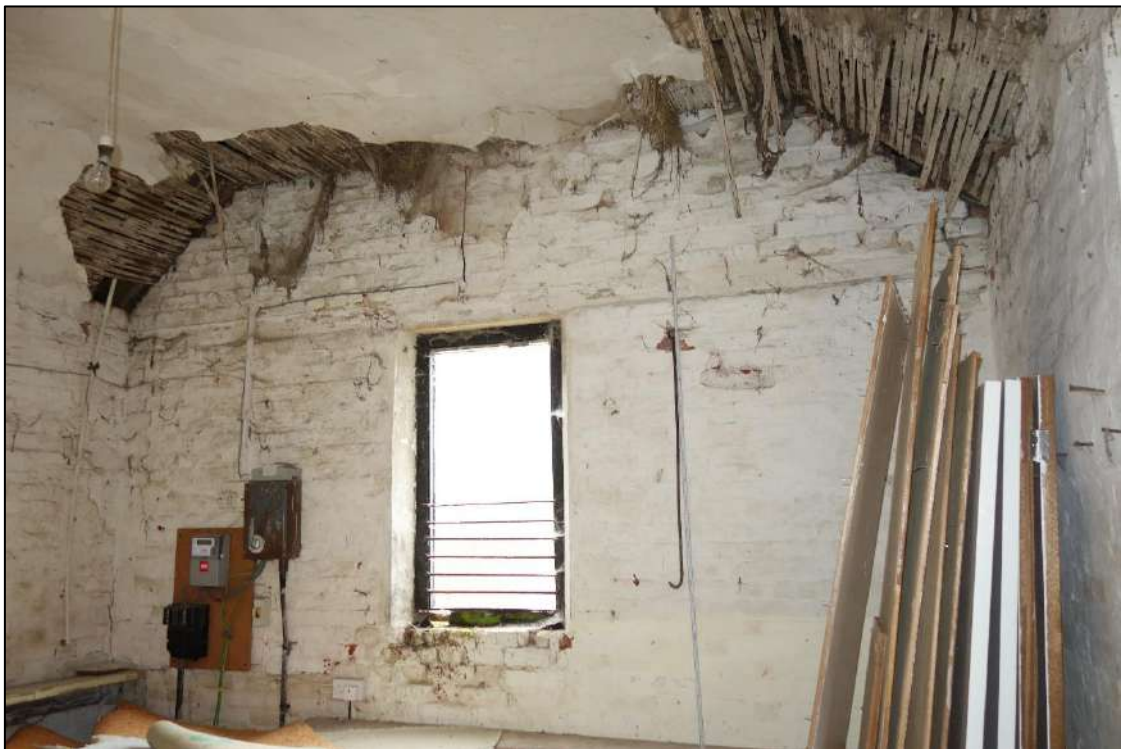
*Plate 77: View looking SE showing compartment at S end of East Stables with coved plaster ceiling*

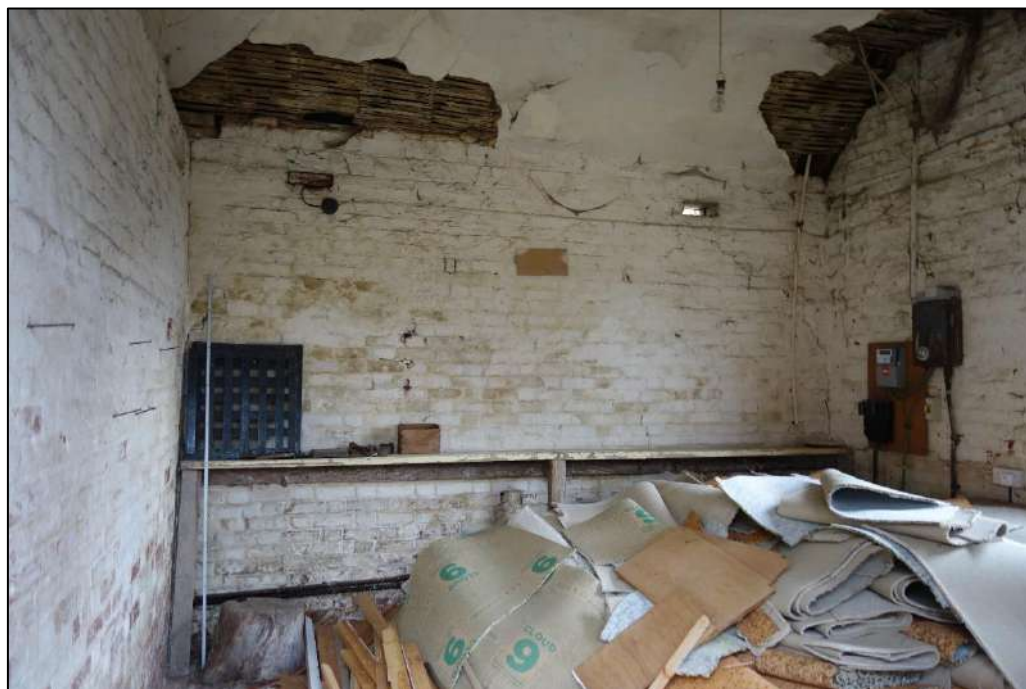
*Plate 78: View looking W showing interior of southern compartment with shelving and nails in wall for harness*

The interior of the stable range appears to have been entirely coated in whitewash and has coved plaster ceilings (which have partially collapsed in places) with lath and plaster exposed in the southern and two central compartments (*Plates 77 & 78; Plate 80*). The southern compartment appears to have been used as a storage and tack room as evidenced by shelving and nails and hooks in the wall which would have been used for hanging harness (*Plate 78*).

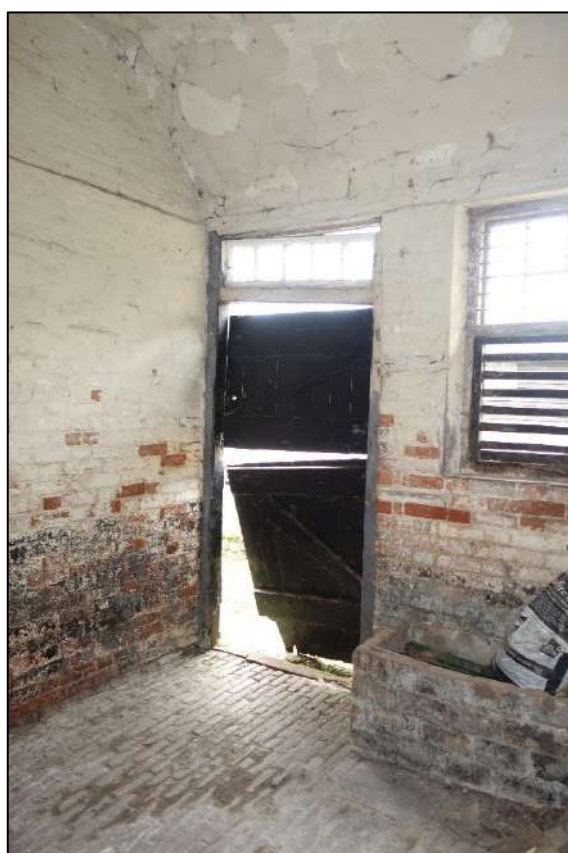
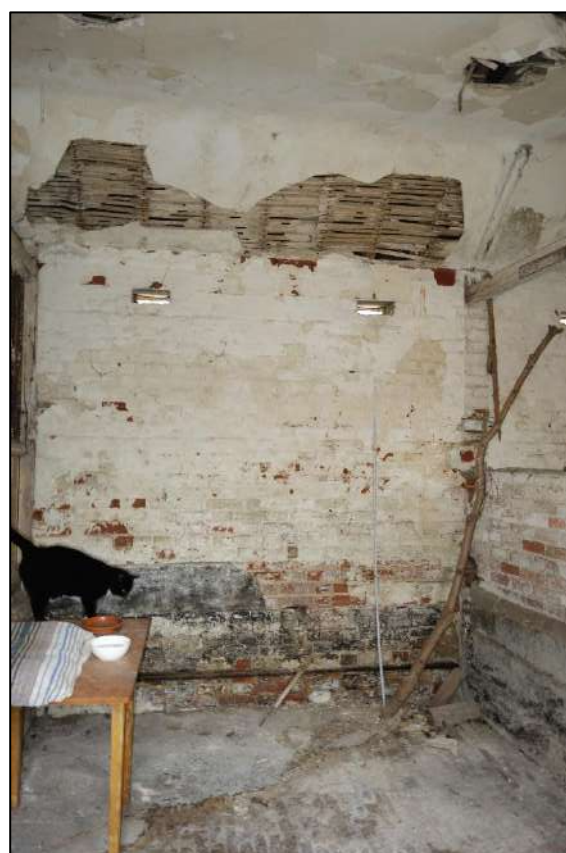
*Plate 79: View looking W showing interior of stable in central bay of East Stable with brick cobbled floor and trough*  
*Plate 80: View W showing interior of stable in central bay of East Stable with low brick partition wall and cobbled floor*

The two central compartments were clearly used as stabling as evidenced by the brick cobbled floors and low brick feeding troughs against the W wall (*Plate 79*). Few other features, fixtures or fittings relating to its previous usage as stabling were noted in these rooms.
