# Stage 1 Road Safety Audit

**Blacksmiths Lane, Reed**

**The Turney Trust**

SLR Project No. 406.V58297.00001

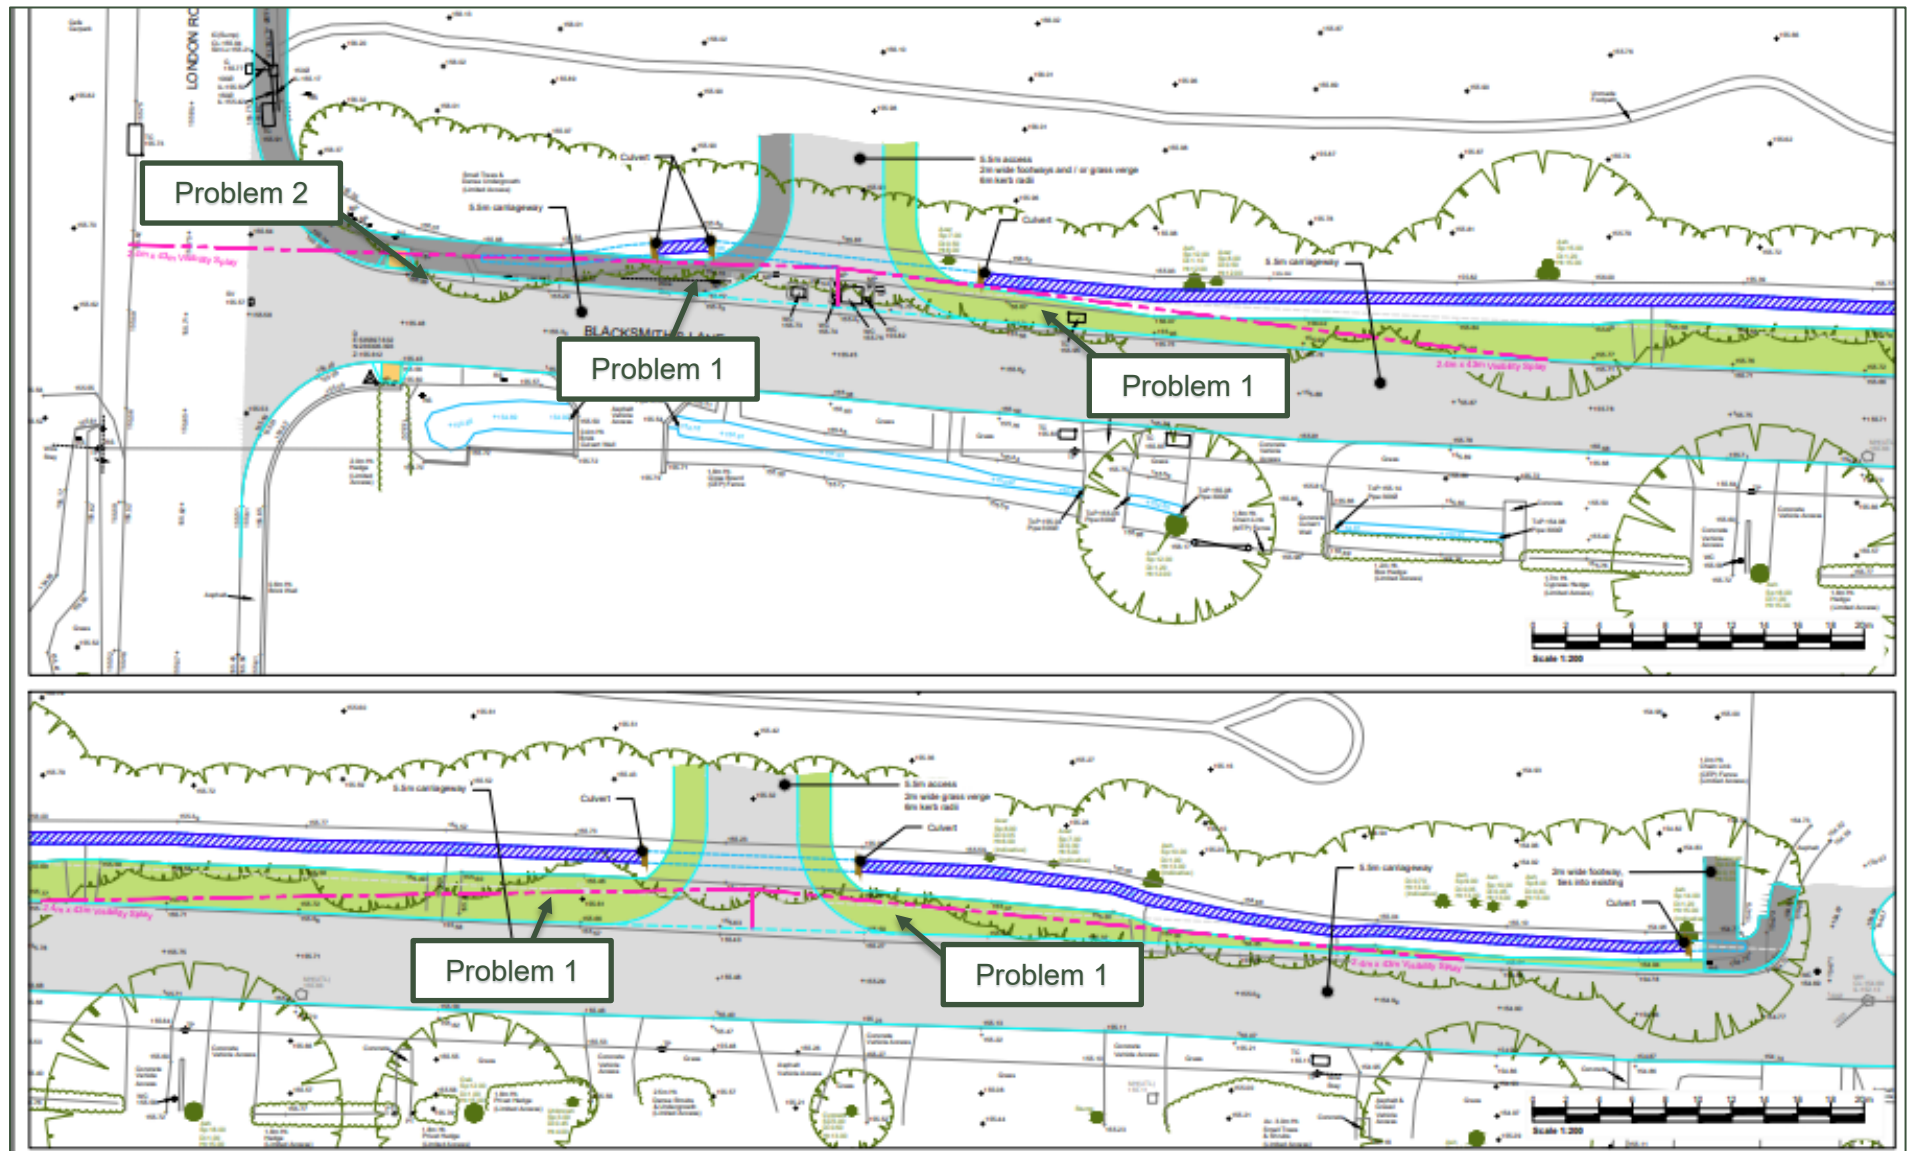
# Appendix C   Problem Location Plan

Location: Visibility Splays

Summary: Vegetation over spills into the visibility splay envelope, forming an obstruction to emerging visibility.

Failure to ensure visibility is kept clear of obstructions could result in side-swipe collisions between vehicles exiting the site and those travelling on the adjacent carriageway.

Location: Blacksmiths Lane junction with A10 London Road

Summary: The 30mph sign on the northern side of Blacksmiths Lane is obstructed on approach to the site, which could result in driver's failing to observe the change in speed limit. It is assumed by the Audit Team that this sign will be relocated to accommodate the new footway works.

Failure to ensure speed limit signage is correctly placed could result in collisions due to excessive speeds.

It is recommended that all vegetation within the extent of the visibility splays at both access points is maintained to a suitable height to ensure unobstructed visibility.

It is recommended that the identified sign be relocated to ensure full view on approach to the change in speed limit.
