**Gallagher Developments Group Ltd.**

# **Highover Farm, Hitchin, SG4 0QW**

Phase 2 Geo-environmental and Geotechnical Site  
Investigation

340110-R01 (01)

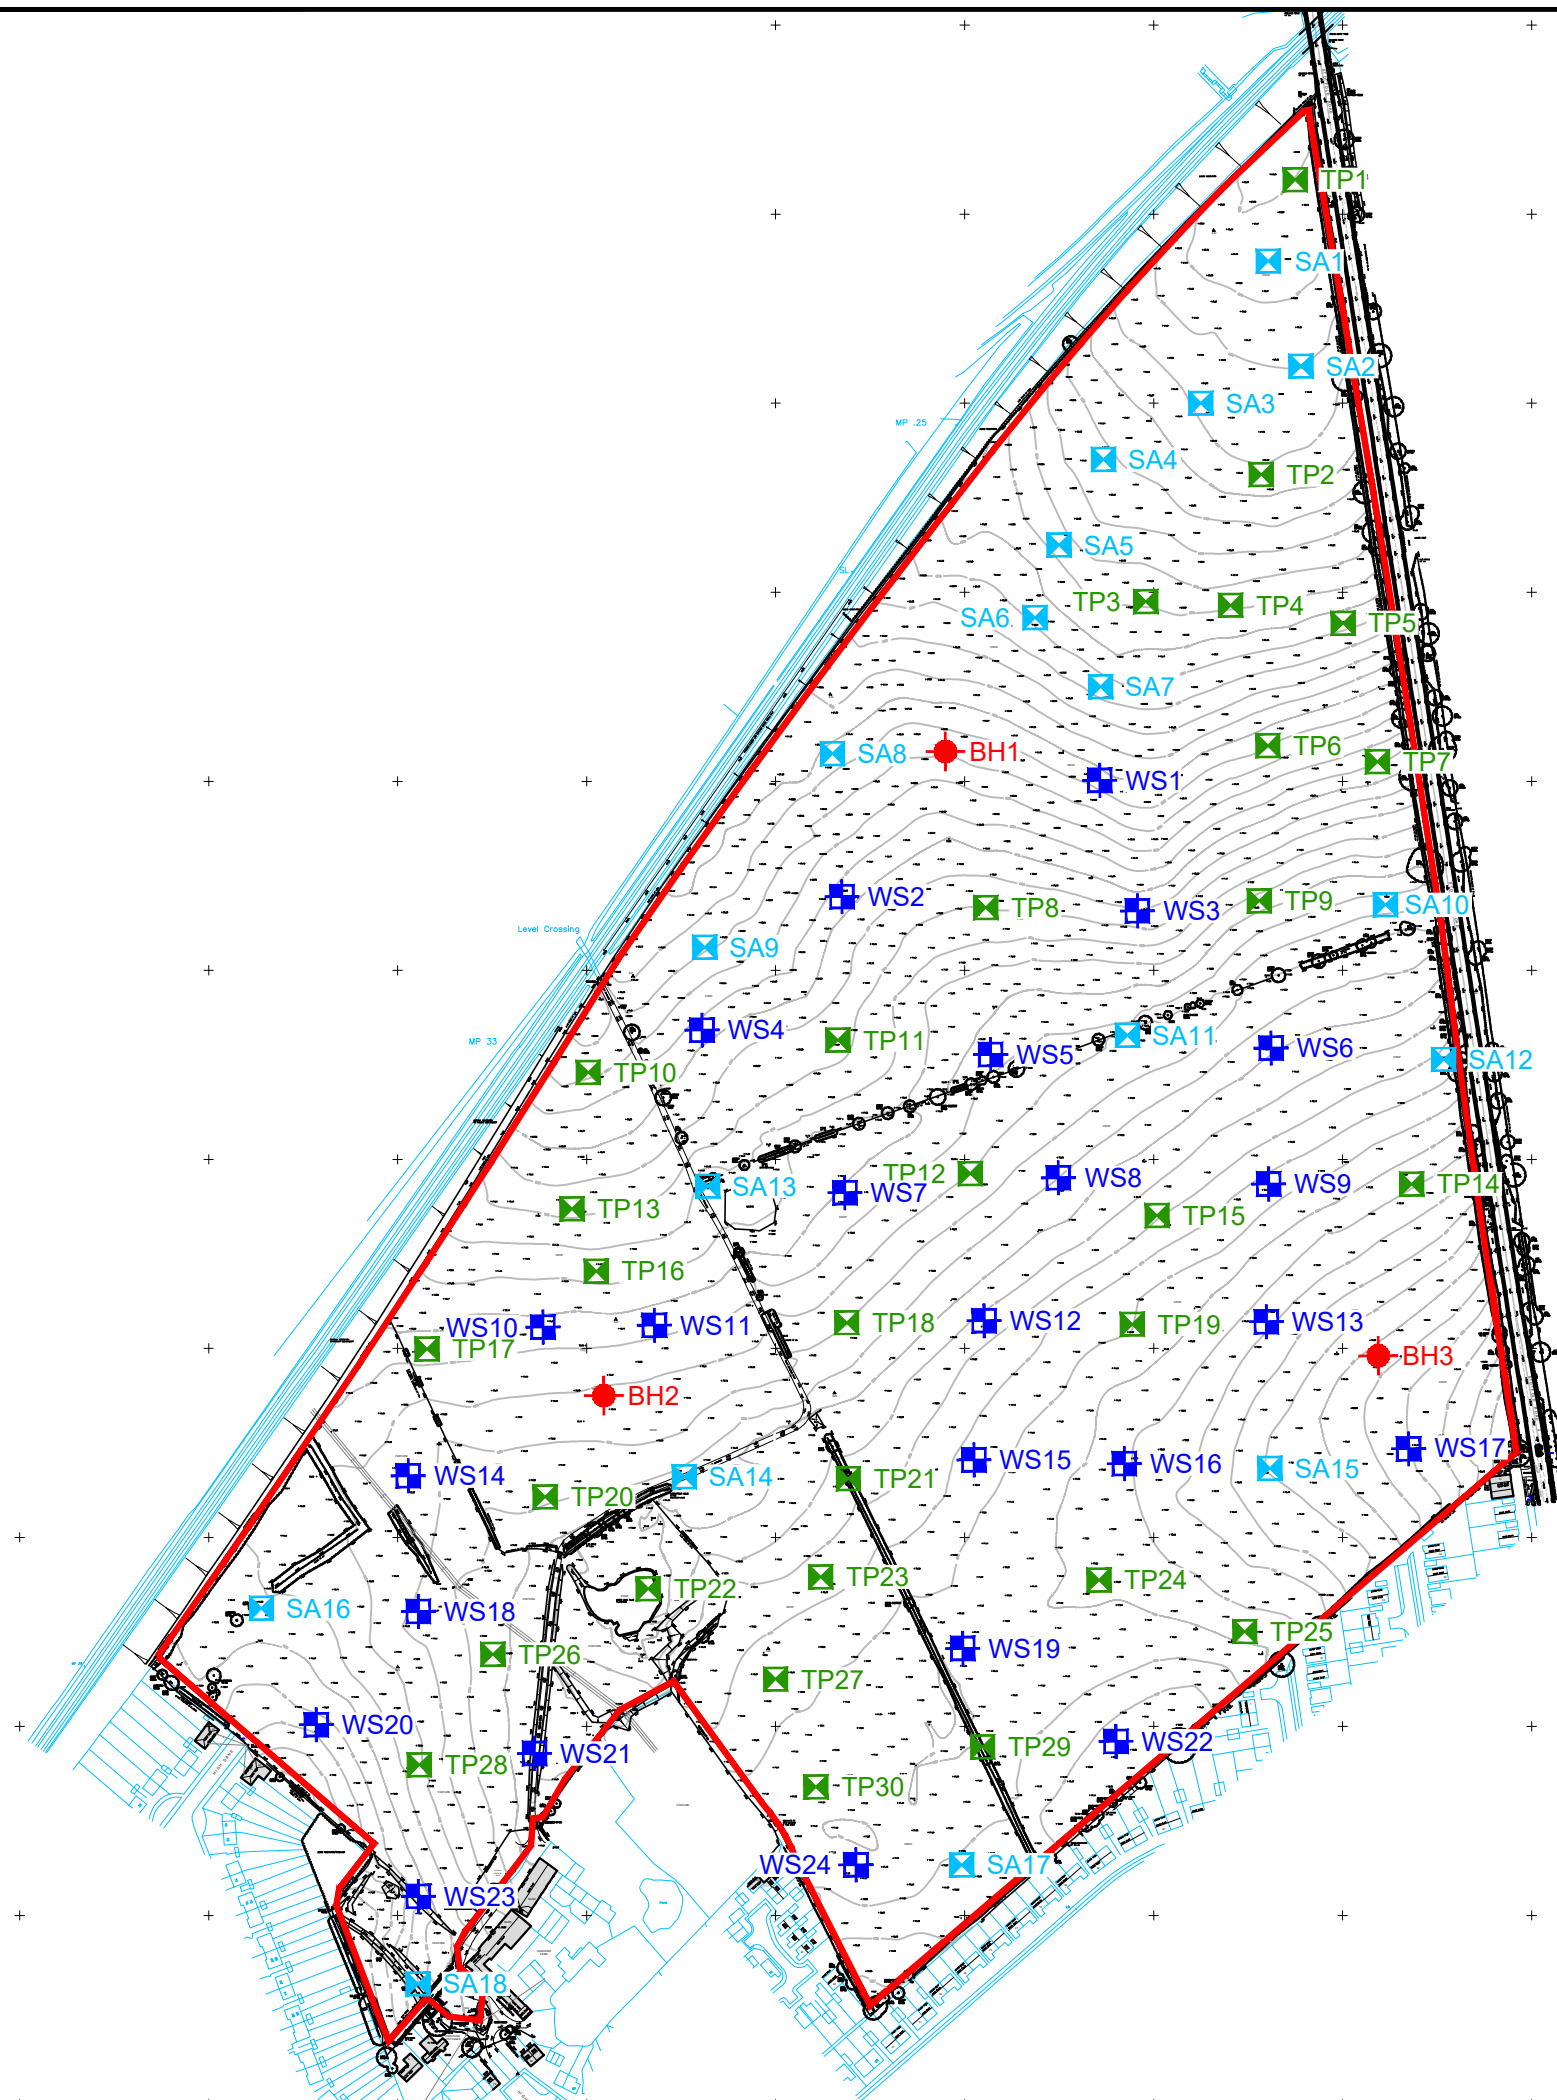
- Site Boundary
- Borehole Location
- Window Sample Location
- Trial Pit Location
- Soakaway Test

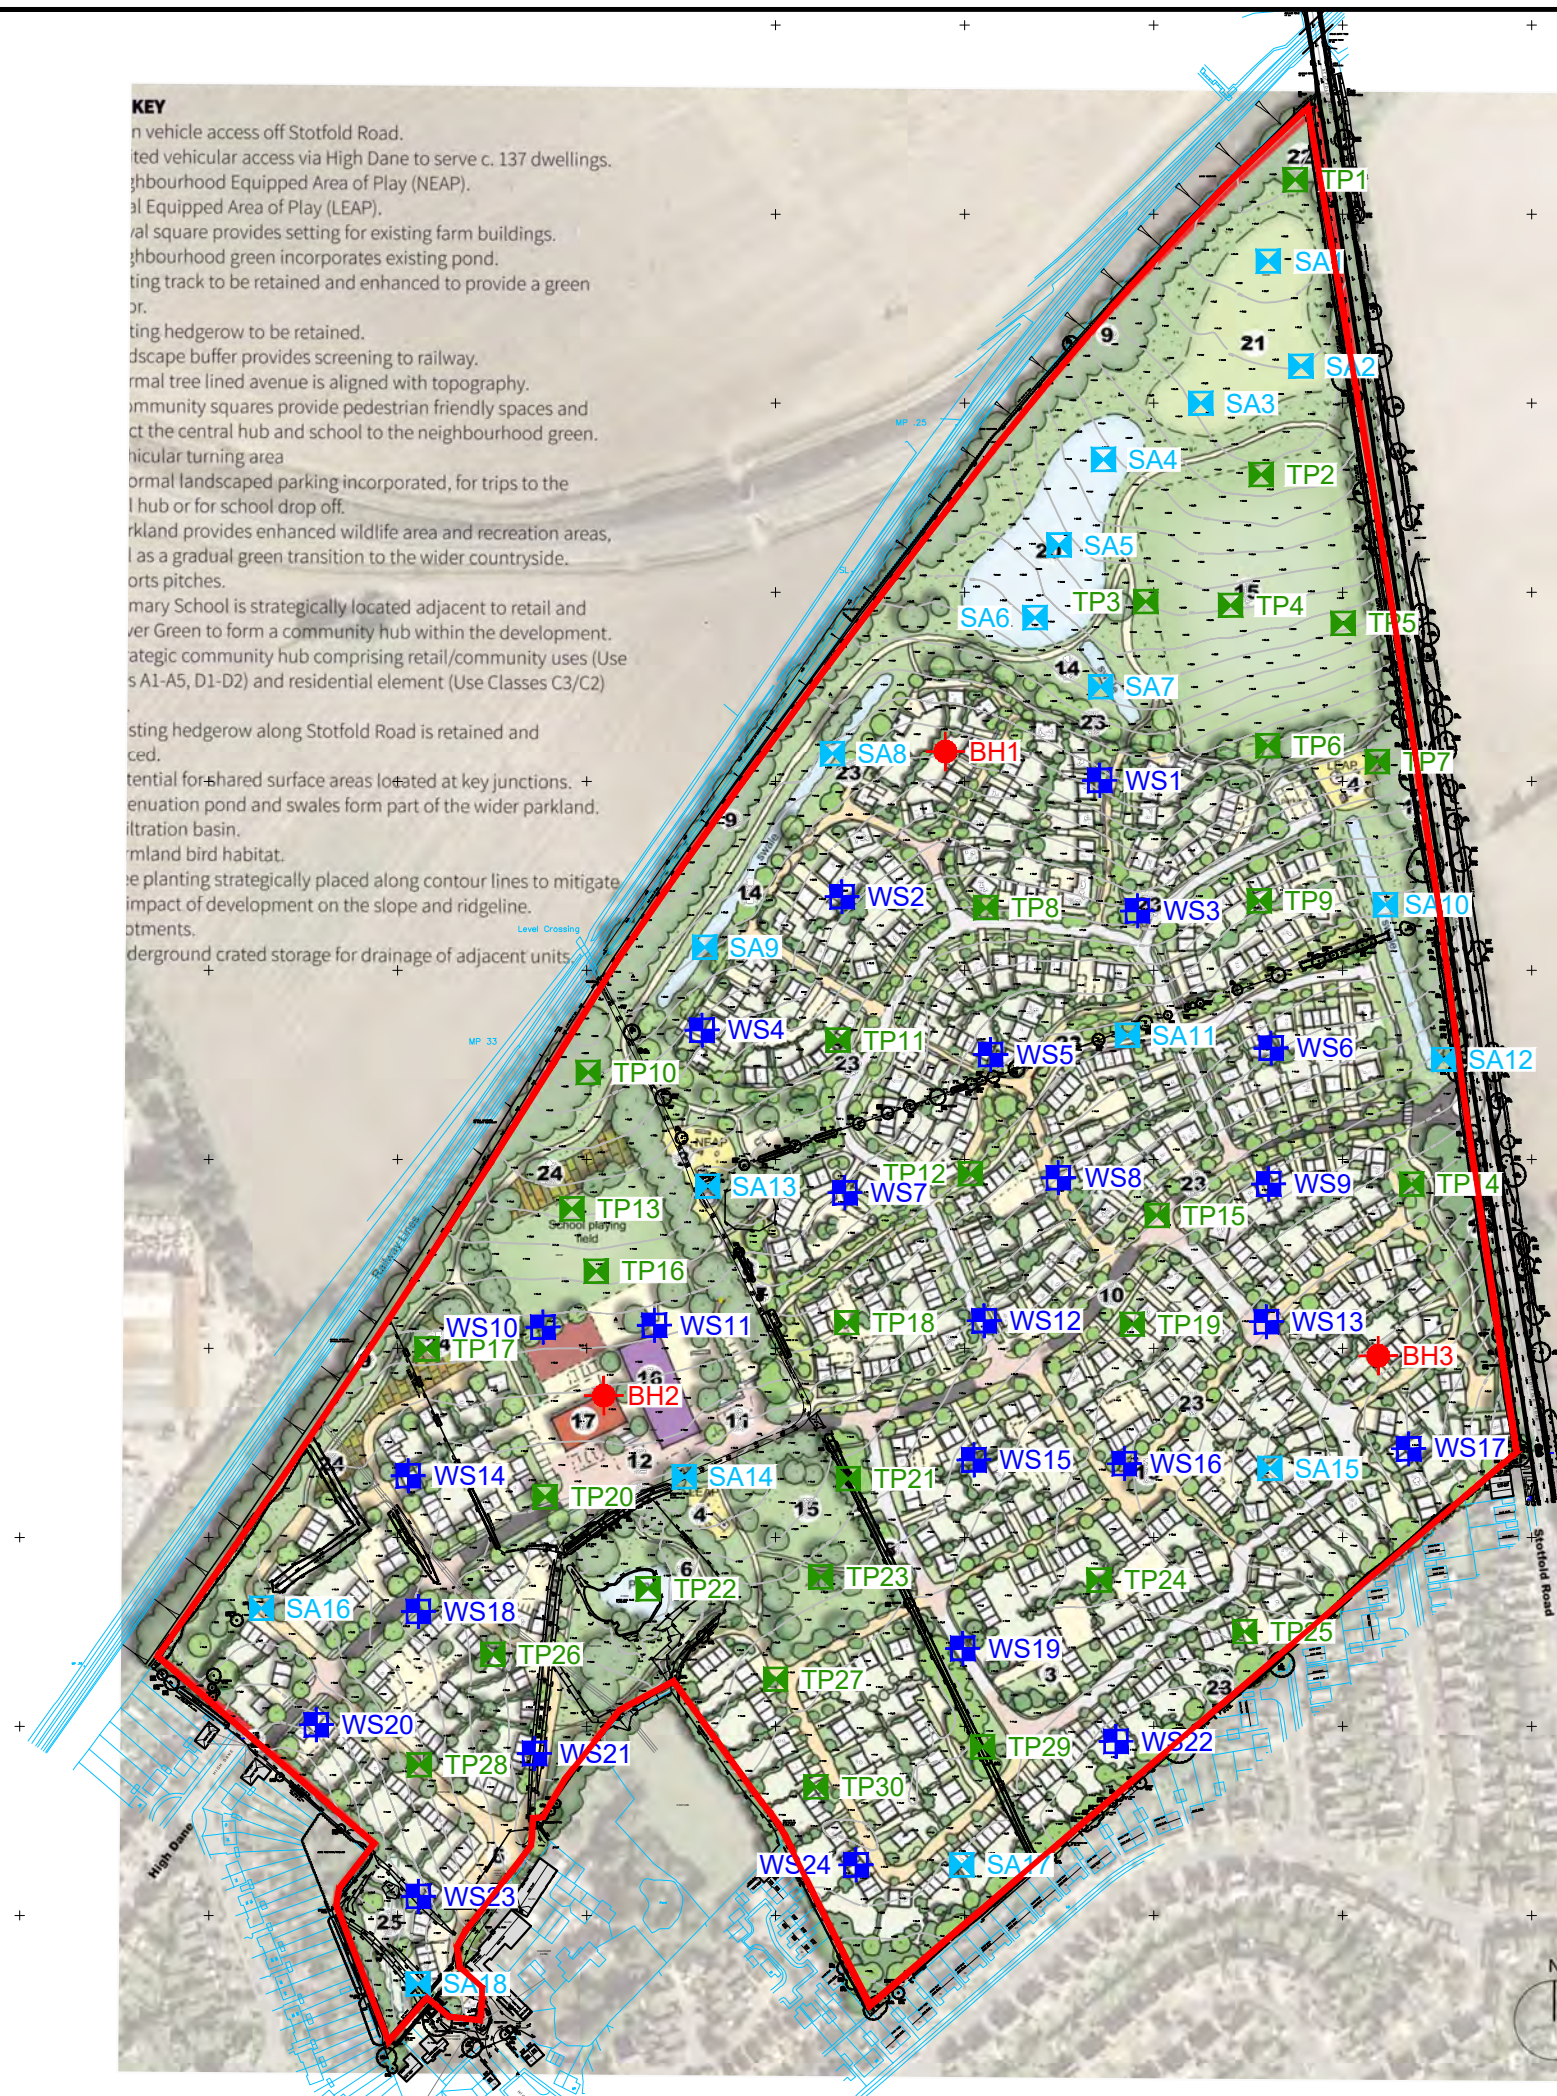
- Site Boundary
- Borehole Location
- Window Sample Location
- Trial Pit Location
- Soakaway Test

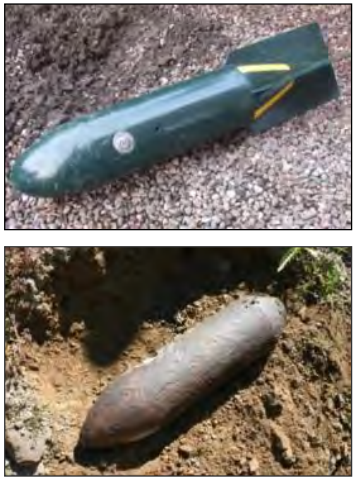
SC 250kg High Explosive Bomb

| Bomb Weight | 245-256kg (540-564lb) |

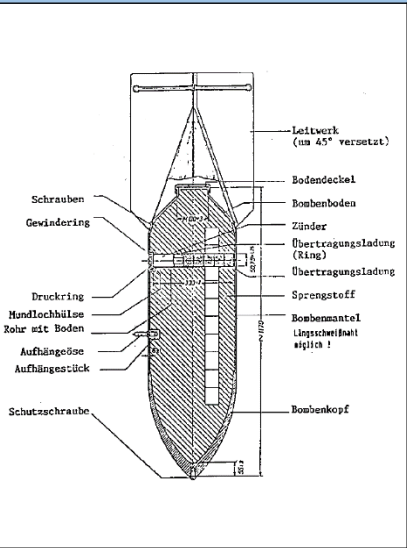
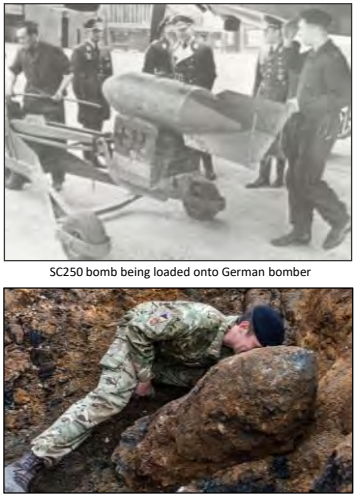
| Use | Against railway installations, embankments, flyovers, underpasses, large buildings and below-ground installations. |
| Remarks | It could be carried by almost all German bomber aircraft, and was used to notable effect by the Junkers Ju-87 Stuka (Sturzkampfflugzeug or dive-bomber). |

SC250 bomb being loaded onto German bomber

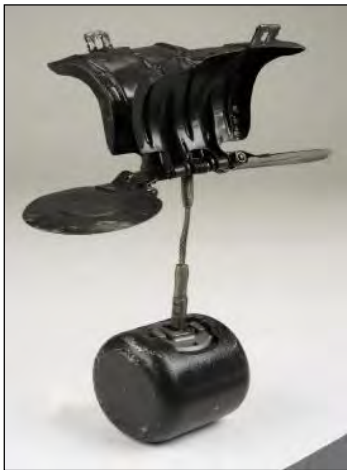
Parachute Mine (Luftmine B / LMB)

| Bomb Weight | Approx. 990kg (2176lb) | | |

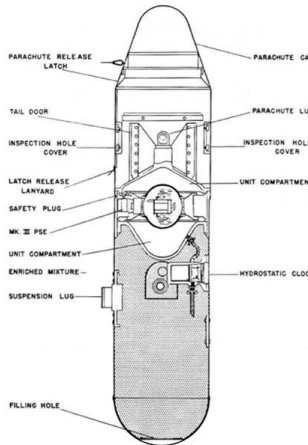
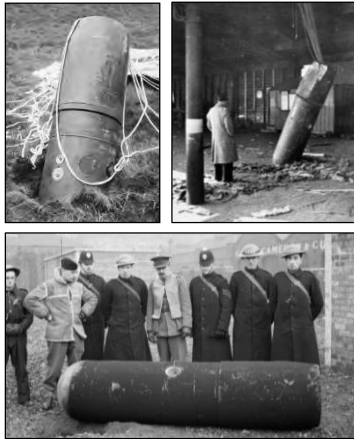
| Explosive Weight | Approx. 705kg (1,554lb) | | |
| Fuze Type | Impact/ Time delay / hydrostatic pressure fuze | | |

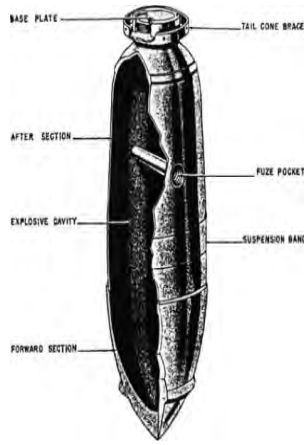
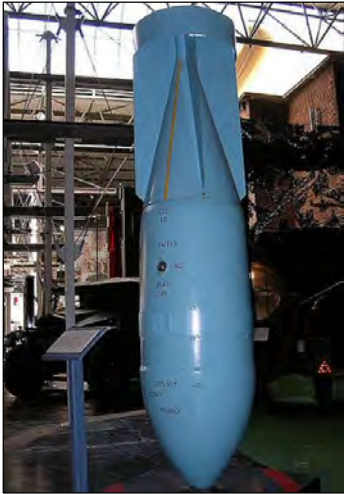
SC 1000kg

| Bomb Weight | Approx. 993-1027kg (2,189-2,264lb) | | |
| Explosive Weight | Approx. 530-620kg (1168-1367lb) | | |
| Fuze Type | Electrical impact/mechanical time delay fuze. | | |

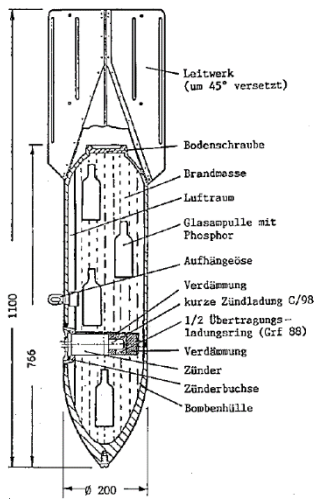
Flam C-250 Oil Bomb

| Bomb Weight | Approx. 125kg (276lb) |
| Body Diameter | 368mm (14.5in) |
| Use | Often used for surprise attacks on ground troops, against troop barracks and industrial installations. Thin casing – not designed for ground penetration |

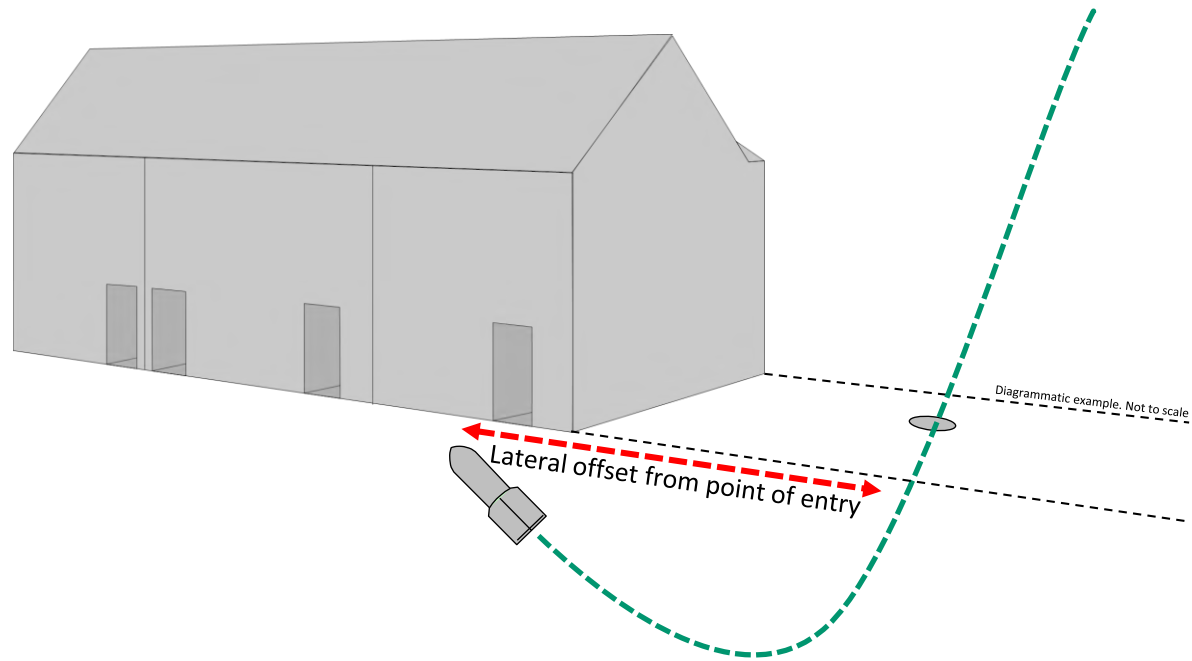
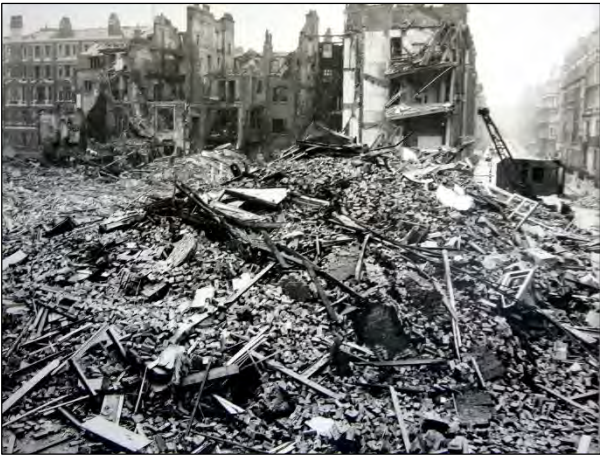
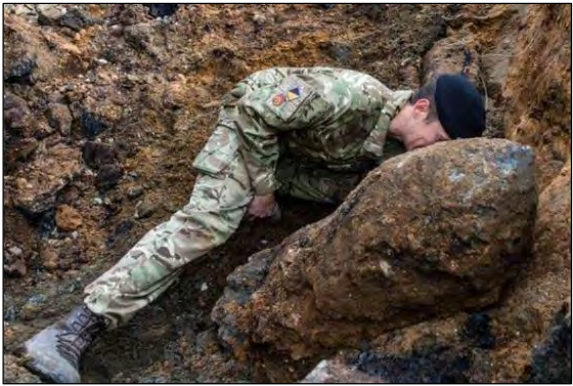
**Top:** J-curve Effect - Due to angle of entry, unexploded bombs would often end their trajectory at a lateral offset from point of entry, often ending up beneath adjacent extant structures/sites. The photograph above shows 250kg bomb found in Bermondsey pointing upwards, demonstrating 'J-curve'

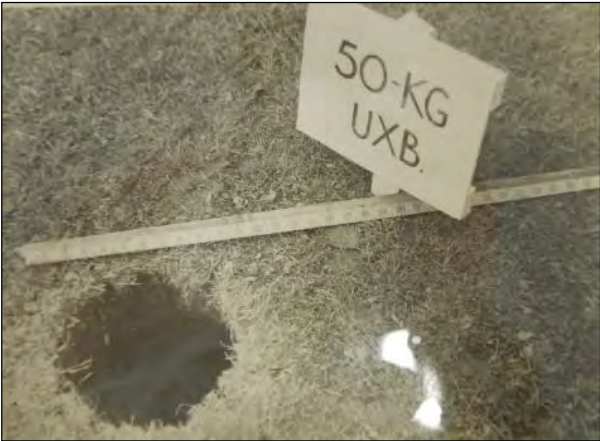
One of the most common scenarios for UXO going unnoticed was when a UXB fell into a 'bomb site' (such as the area shown **Top Left**), the entry hole of the bomb obscured by any debris and rubble present. Note that the entry hole of a 50kg UXB could be as little as 20cm in diameter (**Left**).

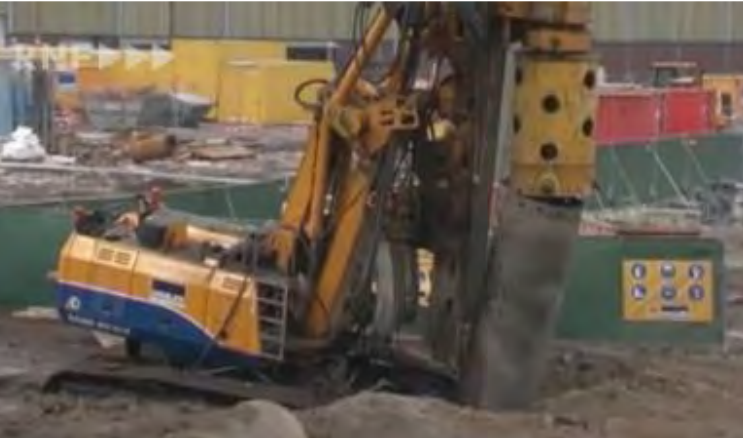
BASF has confirmed that an explosive device, most likely a World War II-era bomb, caused the blast that left one person injured Tuesday at a plant construction site in Germany.

The explosion was reported at BASF's Ludwigshafen toluene diisocyanate (TDI) plant, which recently broke ground for a 300,000 metric tons per year TDI production plant and other construction to expand its facilities.

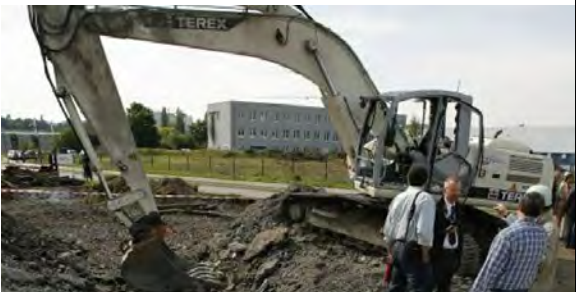
WWII bomb injures 17 at Hattingen construction site

Seventeen people were injured on Friday when a construction crew unwittingly detonated a buried World War II-era bomb in Hattingen.

An excavator apparently drove over a 250-kilogramme (550 pound) American bomb, damaging surrounding buildings. Most of the injured suffered auditory trauma from the blast, and the excavator operator suffered injuries to his hands, police in the German state of North Rhine-Westphalia said.

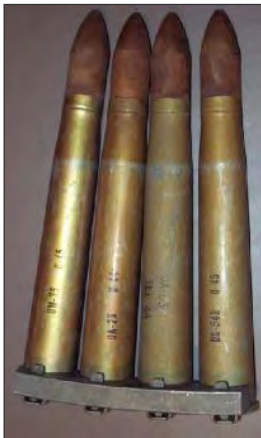
40mm Bofors Projectile

| Projectile Weight | 1.96lb (0.86kg) |
| Ceiling | 23,000ft (7000m ) |
| Remarks | Light quick fire high explosive anti-aircraft projectile. Each projectile fitted with small tracer element. If no target hit, shell would explode when tracer burnt out. Designed to engage aircraft flying below 2,000ft |
